# Modelling and analysis of the stability of a harbour wharf's embankment with regards to its failure

## Abstract

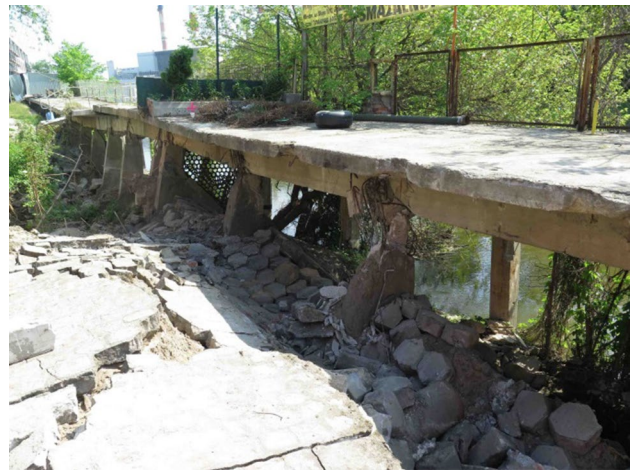
As a result of the construction disaster, the reinforced concrete retaining structure with sheet piling, as well as the embankment of the Odra river with a length of 115.00 m (section of the washed out river bank at a distance of 253 + 750 km to 253 + 865 km), shifted towards the river by 3–4 m, and were practically completely destroyed (Figs. 10, 11).

Fig. 11 View of the embankment part of the damaged RC wharf

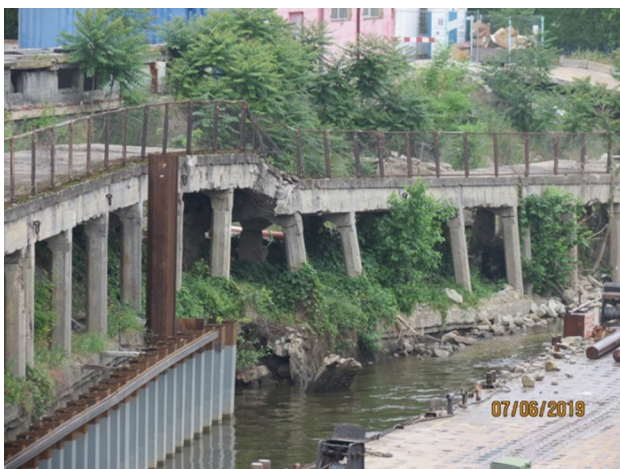
Fig. 10 General view of the destroyed RC wharf

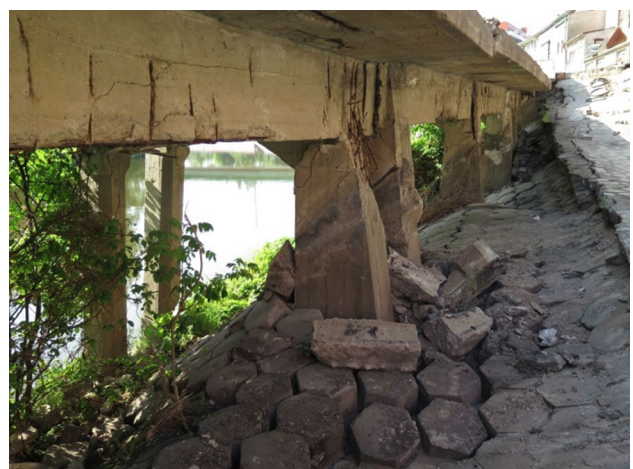
It was also observed that the upper part of the wharf's structure suffered significant displacements (10–14 cm) towards the river and along the shoreline, which was reflected in the displacements of the columns and the reinforcement of the columns and joists (Figs. 12, 13). At the

Fig. 12 View of the damaged RC wharf structure

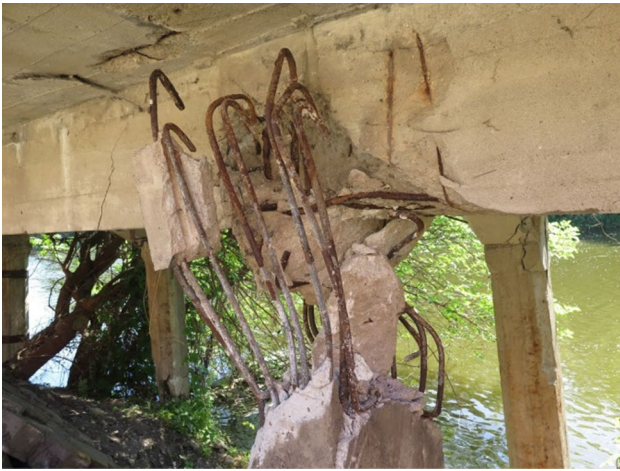
**Fig. 13** View of the damaged RC wharf structure

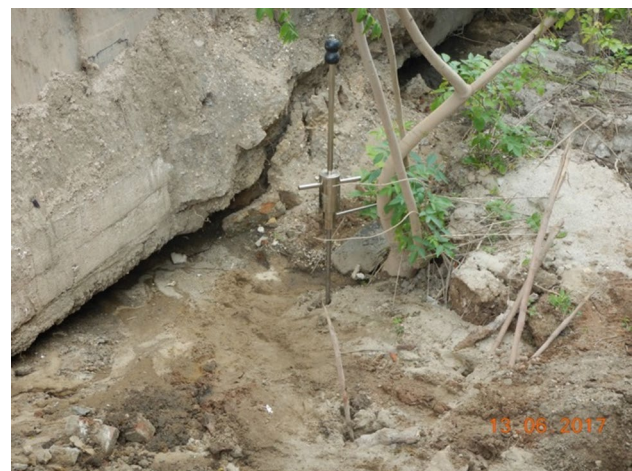
condition tests were carried out in the two available places (Fig. 14). The conducted tests (Fig. 15) showed that under the layer of the loose embankment (approximately 2 m) there are fine medium-compacted sands, the degree of compaction of which ranges from 0.46 to 0.59 (Table 1). During the geotechnical investigations, the depth of the riverbed was also probed in three places located near the reinforced concrete planks. As a result of the research, it was found that the bottom of the river bed is located at a level of approx. 4.5 m below the embankment's reinforced concrete beam, which connects the reinforced concrete planks.

**Fig. 15** DPL dynamic probing

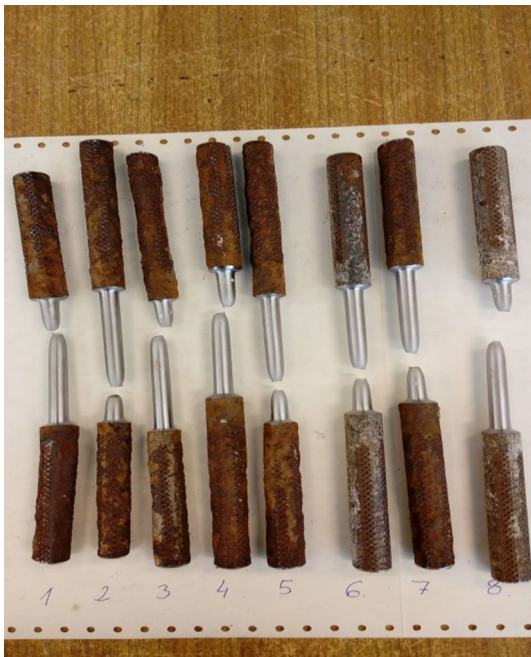
Fig. 18 Steel rebar probes after testing

The tests were performed in an accredited research laboratory. The analysis of the concrete and reinforcing steel allowed the concrete of the wharf's structure to be classified as C12/15 class, and the yield point of the reinforcing steel to be determined to be equal to 210 Mpa (Figs. 18, 19).

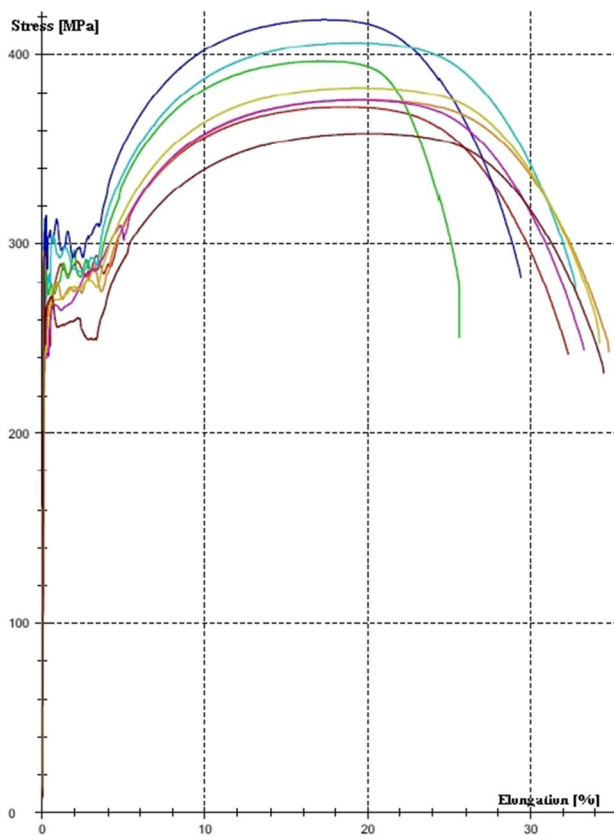
Fig. 19 Steel rebar testing results

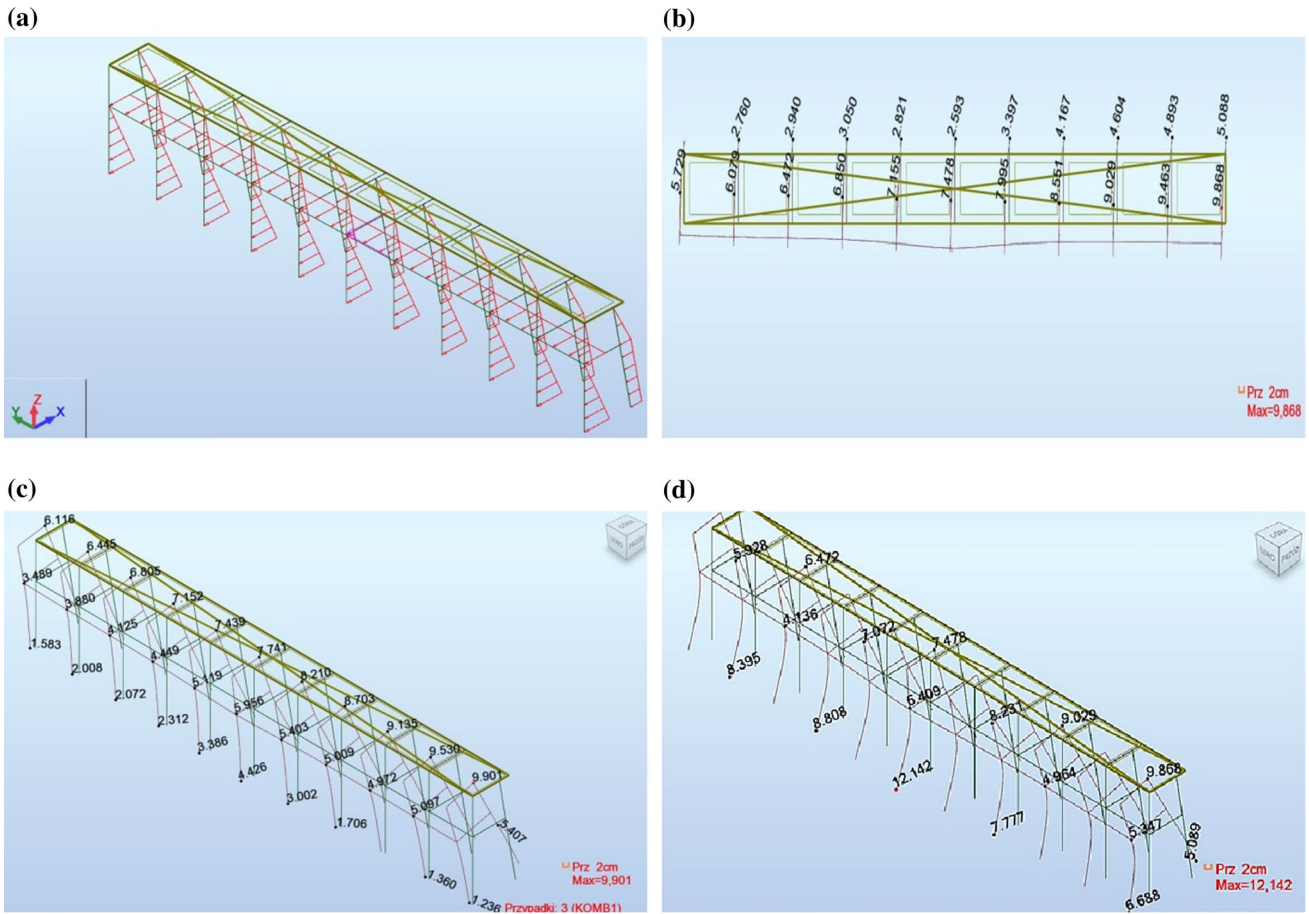
The calculations were made for two variants: in variant I—the nominal cross-sections of the elements were assumed, and in variant II—due to the very high corrosion of the concrete structure of the wharf, and in particular the reinforcement cover, it was assumed that the cross-sections of the columns and the lowest reinforced concrete beam are reduced on both sides by the value of the cover's thickness, and that the height of the upper beams is reduced on one side by the thickness of the cover, i.e. by 3 cm. Based on the assumption that there are concrete corrosion losses, the obtained maximum displacements of the upper edge of the structure from the wharf side amounted to approx. 10 cm (Fig. 24). However, the values of the loads from the forces in the mooring lines of the barges, which were simulated for the above-mentioned variants, exceeded those determined in the calculations of real influences (Chapter 4.4) by an order of value. Therefore, it was found that even with the assumed damage and losses, the forces from the moored barges could not independently cause such large displacements and damage to the wharf's structure, however, they could be a factor that contributed to the emergence of the failure.

Fig. 24 3D numerical analysis of the wharf's structure: **a** load scheme, **b** frame deformation—top view for variant II, **c** displacement of the structure for variant I, **d** displacement of the structure for variant II

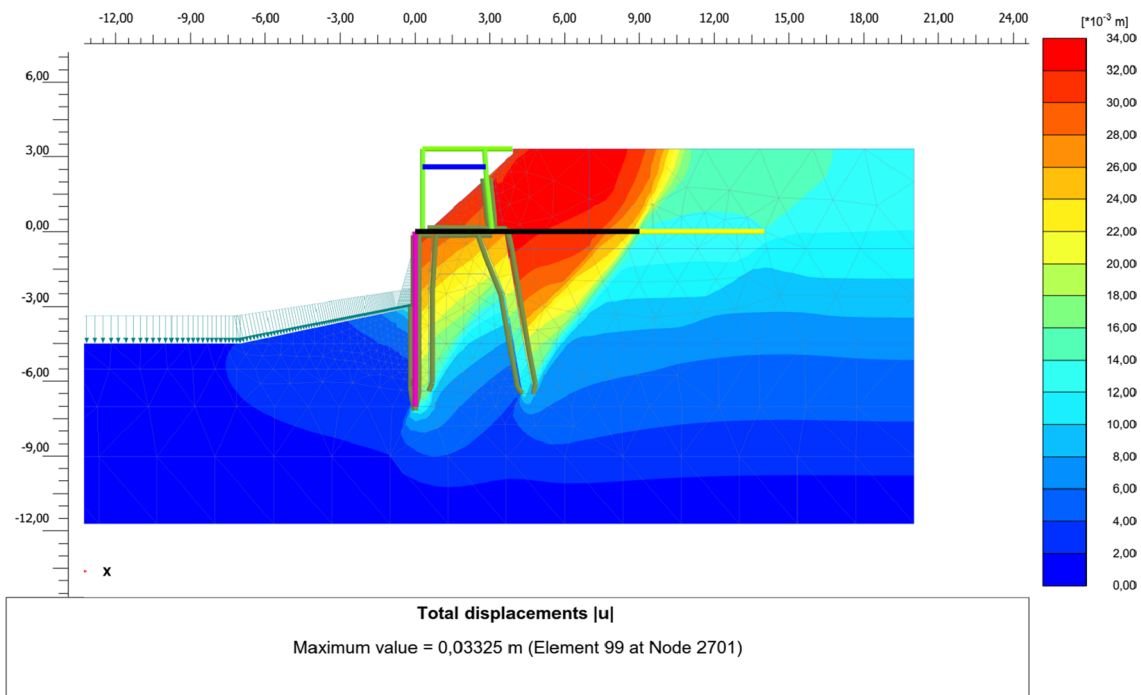
**Fig. 29** The map of soil displacements for scheme I, with the stability index of the wharf estimated at the level of  $F=1.32$

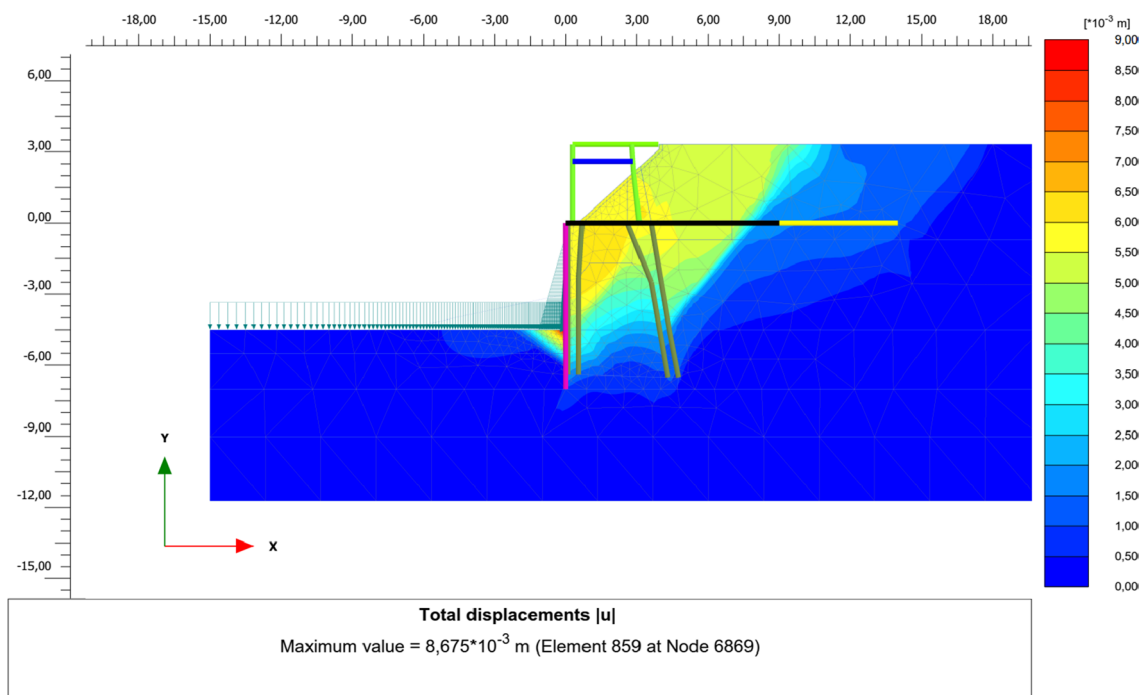
Fig. 30 The map of soil displacements for scheme II, with the stability index of the wharf estimated at the level of  $F = 1.22$

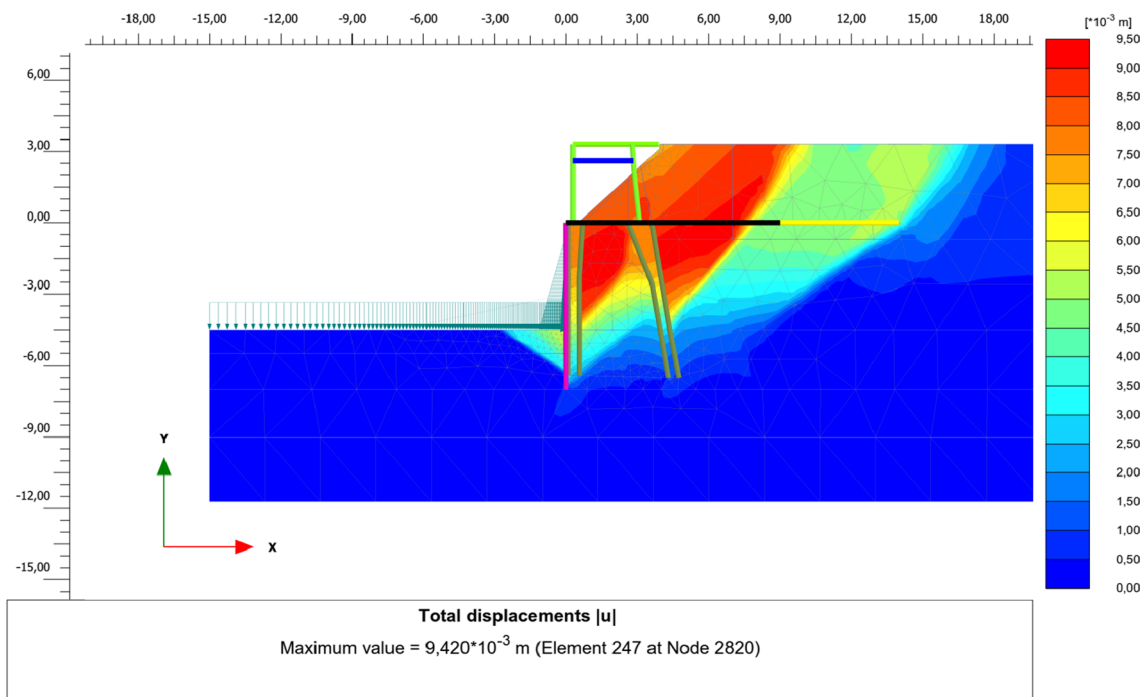
Fig. 31 The map of soil displacements for scheme III, with the stability index of the wharf estimated at the level of  $F = 1.08$

3. Scheme III, based on the conducted archival ground tests in the vicinity of the accident site, takes into account the occurrence of loose non-cohesive soils in the zone between the river's bottom and the top of the wharf's embankment. In this model, the calculated stability index of the wharf is  $F_{\min} \geq 1.08$ . A low value of stability index means that the wharf does not have a sufficient safety margin.

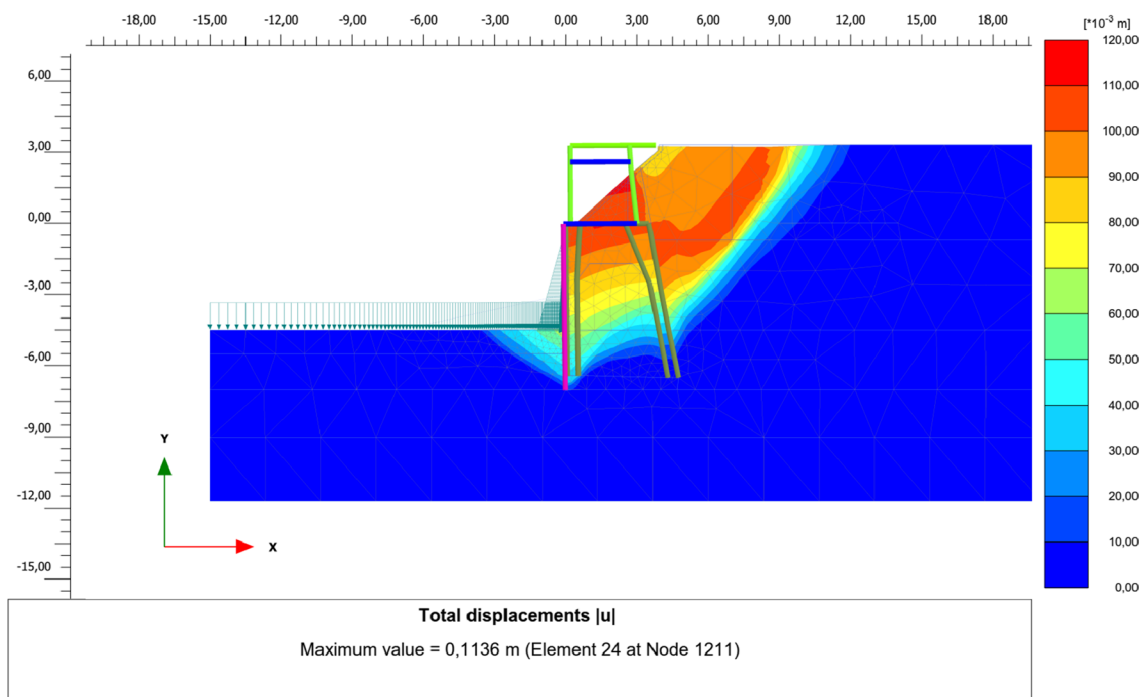
Fig. 32 The map of soil displacements for scheme IV, with the stability index of the wharf estimated at the level of  $F = 0.98 \div 1.03$

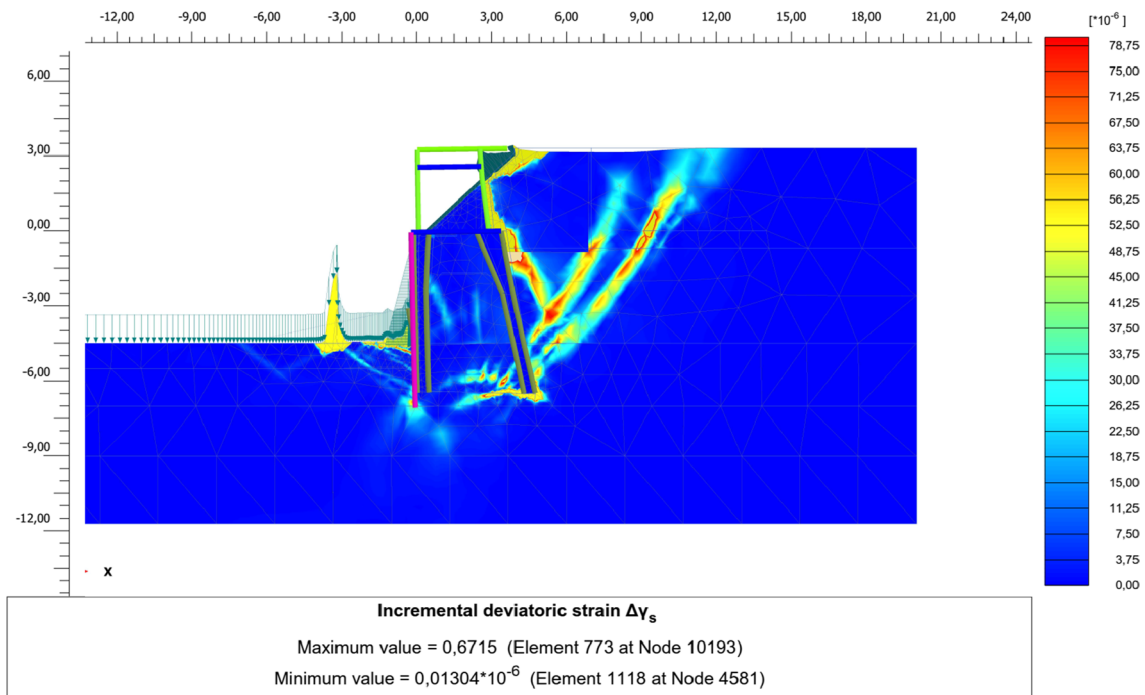
In the case of scheme V, after applying the external load from the barges' mooring forces, the displacements of the system were so large that the computational model became unstable. Therefore, Fig. 33 shows the slip surface

Fig. 33 The slip surface after the application of the load from the mooring forces—scheme V

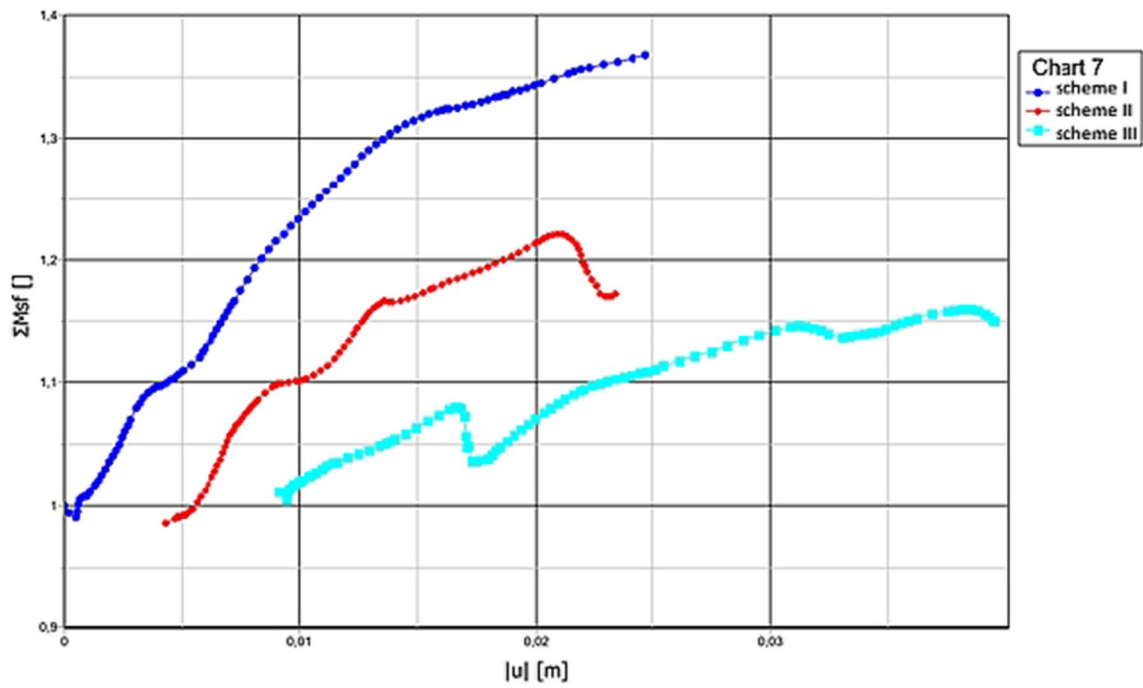
Fig. 34 Chart of the estimated stability indexes of the wharf for the calculation schemes I–III: scheme I:  $F = 1.32$ ; scheme II:  $F = 1.22$ ; scheme III:  $F = 1.08$

Figure 34 shows the estimated values of the wharf's stability indexes for schemes I, II and III. The obtained stability index values of the wharf are higher than  $F = 1.0$ , which means that the wharf is stable. However, it has a small safety margin.

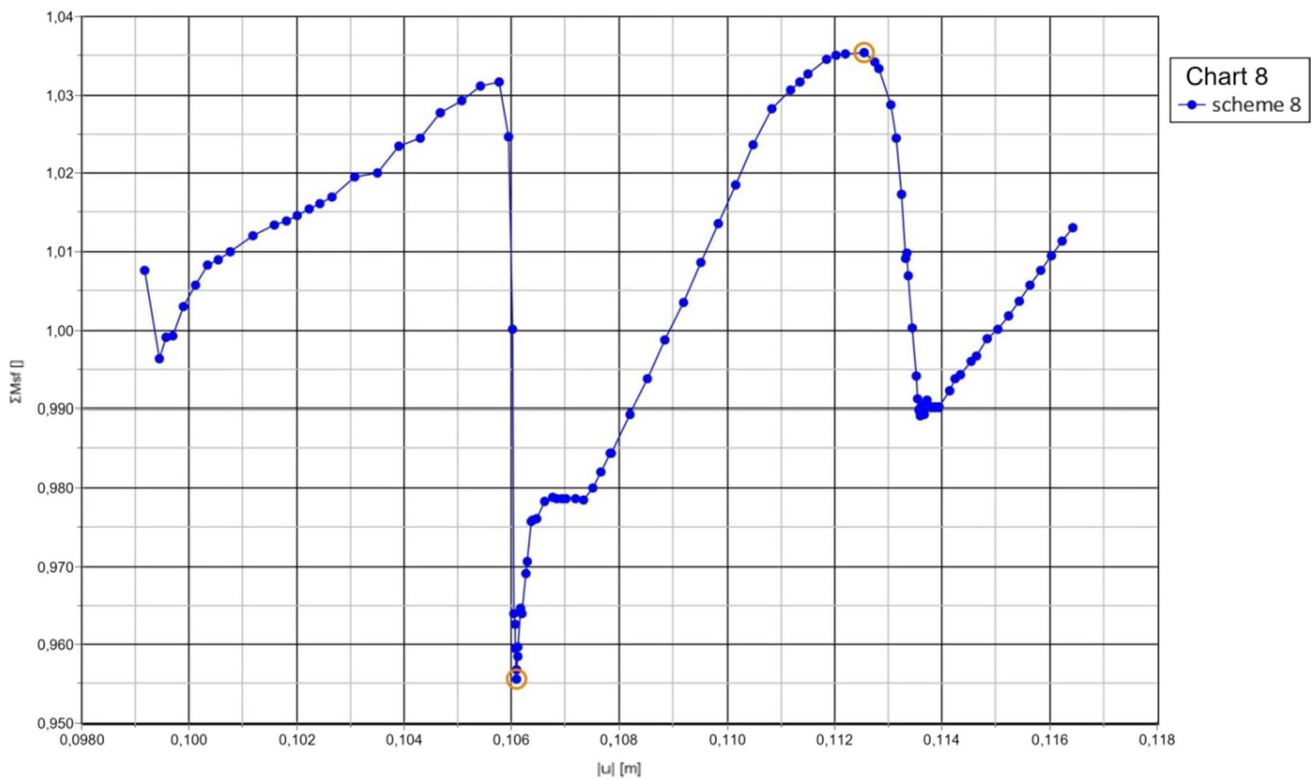
Fig. 35 Chart of the estimated stability index of the wharf for scheme IV:  $F = 0.95/1.03$

Figure 35 shows the stability index of the wharf for scheme IV. The value of the stability of the wharf  $F$  was estimated within the range of 0.98/1.03, which means that it is at the limit of stability, and that a loss of stability may occur.
