# Surface Science and Technology

Quanshun Luo<sup>1\*</sup>, Jing Shen<sup>2</sup>, Xudong Wang<sup>2</sup>, Nick Farmilo<sup>1</sup> and Xiuhua Guo<sup>1,3</sup>

Braking discs play an important role for the safety of vehicles whereas severe frictional contacts in repeated braking operations result in thermal and tribological failures. This paper reports comprehensive surface and subsurface analyses of a used grey cast iron braking disc to investigate its failure mechanisms as well as related microstructure evolution. Thermal cracking, spalling wear and tribo-oxidation have been found to contribute to the wear failure. The flake-type graphite of the grey cast iron triggered propagation and internal oxidation of the metallic matrix. In a depth of 3 mm beneath the rubbing surface, extensive microstructure evolution occurred by severe plastic deformation of the ferritic matrix, nodularisation and partial dissolution of the lamellar carbides, and internal oxidation. The microstructure evolution resulted in decreased surface hardness to HV<sub>0.3</sub> 247 as compared to HV<sub>0.3</sub> 284 of the bulk cast iron. **Keywords** Braking discs, Grey cast iron, Frictional heating, Worn s

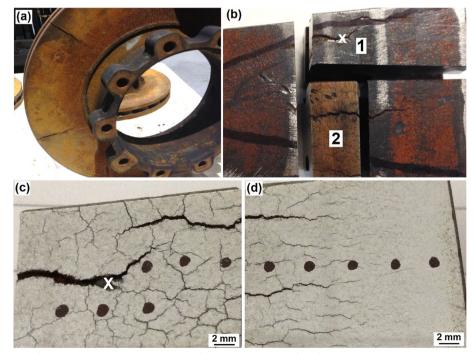
Fig. 1 Visual inspection of network cracking on the rubbing surface: **a** A photograph of the failed disc brake. **b** Sectioned blocks of the disc part. **c-d** Network cracking on the polished disc surface

Figure 1a is a photograph showing the failed brake rotor. The rotor has a double-disc sandwich structure to allow ventilation cooling of the rubbing discs. Several radial macro-cracks had already formed. Figure 1b shows the cutting strategy of a block taken from the failed rotor. The piece marked '1' was for analyses of the disc worn surface which contains various cracks. The piece marked '2' was used for cross-sectional analysis to examine penetration of surface cracks. After applying gentle grinding and polishing to remove the surface oxide layer of the rubbing surface marked '1', this piece is imaged in Fig. 1c and d where both macro radial cracks and network-like small cracks become visible. The black marks were made as position references for surface hardness testing.

In addition to these wear features as shown in Fig. 4, the subsurface had been full of thermal crackles, radial cracks and circumferential cracks. These cracks became visible only after removing the rubbing features by a gentle grinding and polishing treatment, as shown in Fig. 1 c-d. These cracking features have been frequently reported not only in grey cast iron brake rotors but also in other materials [6, 7, 9, 11, 15]. The current investigation found that the crack distribution was dense in the middle band of the disc corresponding to the intense rubbing interaction, whereas crack density became much less dense towards the outer circumference where rubbing traces were less. The varying crack density confirms that the predominant cause of the cracking was thermal stresses due to the frictional heating induced hot

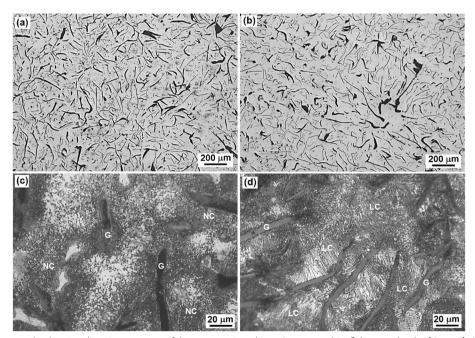
Fig. 2 Optical micrographs showing the microstructure of the grey cast iron disc: **a** A-type graphite flakes at a depth of 2 mm; **b** A-type graphite flakes at the core part; **c** Nodularised carbides in the matrix at a depth of 2 mm; and **d** pearlitic matrix in the core part. The marks 'G', 'NC' and 'LC' stand for graphite, nodularised carbides and lamellar carbides, respectively

Moreover, the OPM and SEM observations revealed nodularisation of lamellar carbides in the pearlitic matrix adjacent to the rubbing surface. It can be seen in Fig. 2c that the carbide phase exhibits a nodularised shape differing from the typical lamellar morphology, which implies some kinds of microstructure evolution in small depths adjacent to the rubbing surface. Figure 3 also indicates some other evidences of the evolution. Firstly, the graphite flakes seem to have been enveloped each with a shell, as shown in Fig. 3b. In Fig. 3c, the shell has a clear interface separating itself from the pearlitic matrix. Secondly, Fig. 3b also shows some areas where the carbide constituents are nodular instead of pearlite. Such an important phenomenon was not reported in literature, to the best of our knowledge. More details of the microstructure evolution are shown in Sect. 3.3.

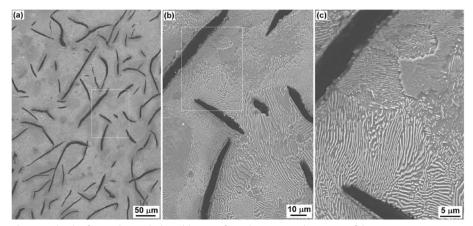
Fig. 3 SEM images taken at a depth of 4 mm beneath the rubbing surface, showing pearlite matrix of the cast iron at various magnifications. Note partial dissolution of the carbide lamella due to the frictional heating

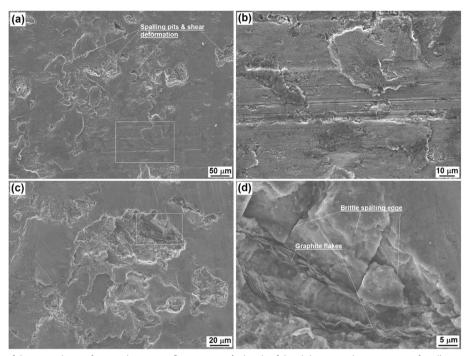
The rubbing surface was observed using SEM, Fig. 4. The smooth worn surface shows dispersed spalling pits and shear deformation edges, Fig. 4a. A small zone was further enlarged to present a few straight scratches, Fig. 4b, indicating the occurrence of abrasive wear. Figures 4c and 4d show details of the spalling wear. There are a few small fragments with straight edges at the boundary of the spalling pit, showing an evidence of wear by brittle fracture. Such worn surface embrittlement has been confirmed in reciprocating sliding wear of steels [21, 22]. In the bottom of the spalling pit, two graphite flakes were exposed to show multilayer substructures. The appearance of such graphite was seen in the first time, which are consistent to the solidification mode of flake-type graphite that it is known to growth along its (0001) crystalline plane.

Fig. 4 SEM images of the worn disc surface: a a low-magnification view; b details of the sliding scratches; c an area of spalling pits and (d) exposed graphite flakes inside a spalling pit as highlighted in (c)

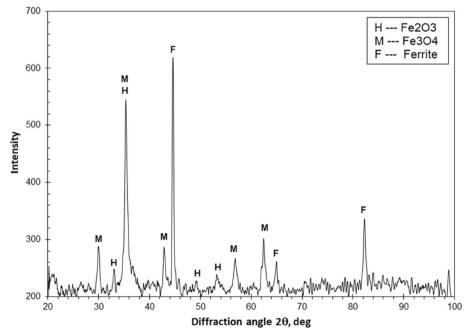
The worn disc surface was examined by X-ray diffraction to determine the tribo-oxidation products, as shown in Fig. 5. In addition to the ferrite peaks from the cast iron matrix, two types of iron oxides were detected, namely magnetite  $Fe_3O_4$  and hematite  $Fe_2O_3$ . Obviously the major oxide is magnetite  $Fe_3O_4$  in addition of the remaining ferrite phase. This result is consistent to the analyses of other researchers [16–18]. The tribo-oxidation should be attributed to high temperature of the rubbing surface that the combined high temperature and deformation should be associated with variation of its hardness property.

Fig. 5 X-diffraction analysis of the disc worn surface

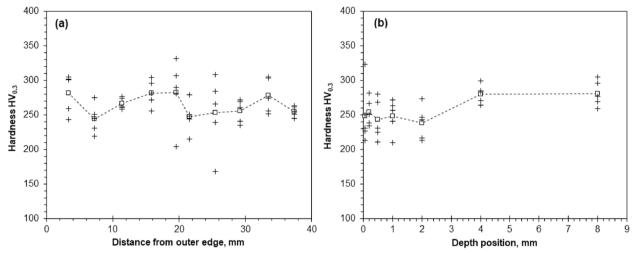
In Fig. 6, the hardness profile of the polished rubbing surface (seeing Figs. 1c and 1d) and that of the cross-section are illustrated, respectively. In Fig. 6a, the hardness property shows scattering in a large range, giving an average value and deviation of  $HV_{0.3}$  260 ± 30. In Fig. 6b, the rubbing surface shows a relative lower

hardness value and larger data scattering in a depth of 3 mm, namely,  $HV_{0.3}$  247 ± 28. Beyond that depth, the bulk disc shows higher hardness and narrow data

scattering of  $HV_{0.3}$  281 ± 16. It is obvious that the rubbing surface has become substantially softer than the bulk material with a larger scattering of the measured

Fig. 6 Microhardness properties of the worn disk: a radial profile of hardness in the rubbing surface and b subsurface profile of hardness in a vertical cross-section

hardness values. The different hardness property should be attributed to wear induced microstructure evolution.

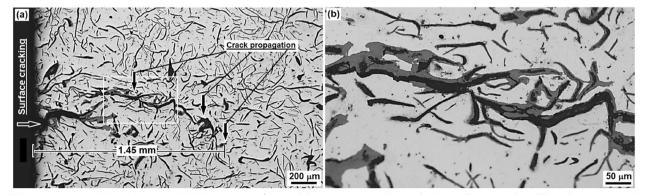
Figure 7 presents optical micrographs of a polished cross-section of the worn disc from its top worn surface to certain depth. The random distribution of graphite flakes is identical to those presented in Fig. 2a. The major feature in Fig. 7 is that a crack perpendicular to the worn surface has been under penetration to a depth of 1.45 mm, as shown in Fig. 7a. Such cracks were observed in other places in which the penetration depths were in a range of 0.2—7 mm. These cracks correspond to the surface network cracks as shown in Fig. 1 c-d. Figure 7b shows an enlarged image highlighted in Fig. 7a. The crack propagation followed the graphite flakes. This finding is consistent to the results published in literature [5, 7]. In addition, some graphite flakes close to the cracks co-exist

Fig. 7 Cross-sectional optical micrographs showing a a surface crack having propagated into a depth in millimetre scale and b cracking associated with internal oxidation of ferrite matrix along graphite flakes

with a band showing an intermediate brightness. These bands were assumed to be internal oxidation, which has been confirmed by SEM–EDX analysis as presented later. It seems that the graphite flakes played two roles, namely, the channel for crack propagation and for inward diffusion of oxygen to cause oxidation.

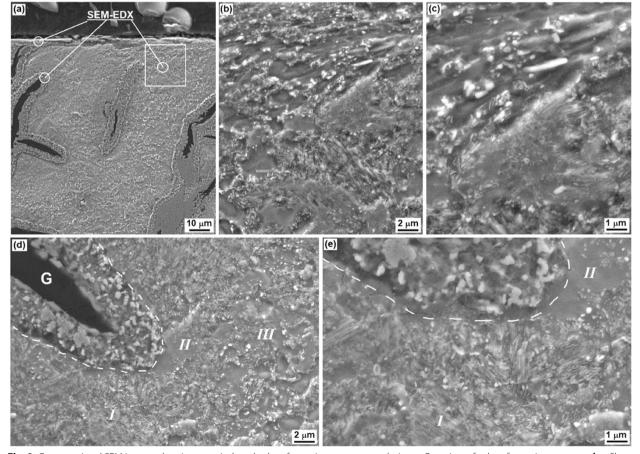
Figure 8 shows the results of cross-sectional microstructure observations using FEG-SEM. Figure 8a is a low-magnification image showing microstructure evolution in a depth beneath the worn surface. The worn surface shows a thin layer differing from the matrix, which is known to be a tribofilm. The disc shows shear deformation in a depth beneath the worn surface. The graphite flakes in close vicinity of the worn surface were all enveloped with a shell having morphology different from the matrix. The carbide in the pearlite matrix had been nodularised no longer showing any lamellar stacking.

Figure 8b shows the matrix microstructure just beneath the worn surface. In the upper part of Fig. 8b, the carbide had completely nodularised where the matrix exhibits a strong orientation indicating the occurrence of shear deformation. In the lower part, however, there are islands containing extremely fine lamellar carbide. Figure 8c provides more details of these microstructure features at a better spatial resolution. Such mixtures of nodularised carbides and lamellar carbides are also shown in Fig. 8de. For example, the area marked 'I' shows lamellar carbides and those marked 'II' and 'III' show nodularised carbides in the ferrite matrix. Obviously, evolution of eutectoid carbide took place in a depth below the worn surface.

Figure 8d and e also show details of a shell enveloping a graphite flake (marked 'G'). The shell exhibits clearly different morphology as compared to the nearby matrix by showing more large granular particles. There seems a clear boundary of the shell separating it from the matrix, where an artificial dash line has been drawn to show the interface.

Fig. 8 Cross-sectional SEM images showing wear induced subsurface microstructure evolution: **a** Overview of subsurface microstructure. **b-c** Shear deformation within a depth of 20 μm. **d-e** Internal oxidation adjacent to a graphite flake (marked 'G') and nodularised pearlite matrix

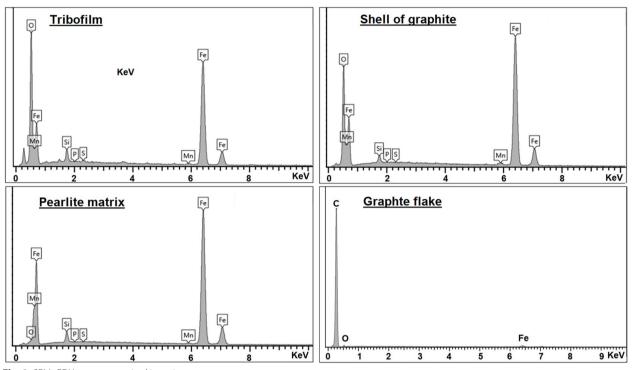
presented in Figs. 9 and 10 and Table 1. Figure 9 shows typical spectra of the selected areas whereas quantified results are shown in Table 1. The tribofilm shows a high content of oxygen, followed by the shell of graphite. The

Fig. 9 SEM-EDX spectra acquired in various areas

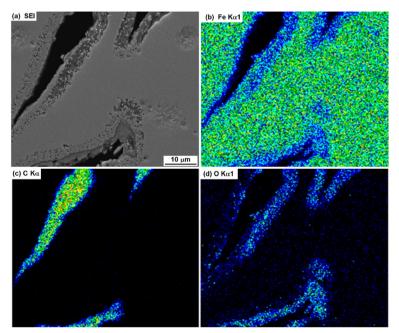
Fig. 10 SEM-EDX mapping analysis showing the internal oxidation

as shown in Fig. 10. The graphite and matrix show high brightness of C-K<sub> $\alpha$ </sub> and Fe-K<sub> $\alpha$ 1</sub>, respectively. The graphite shells, on the other hand, show higher brightness of O-K<sub> $\alpha$ </sub>. These results suggest intense internal oxidation of the pearlitic matrix through the channels provided by the graphite flakes, in addition to the formation of tribofilm on the worn surface top.

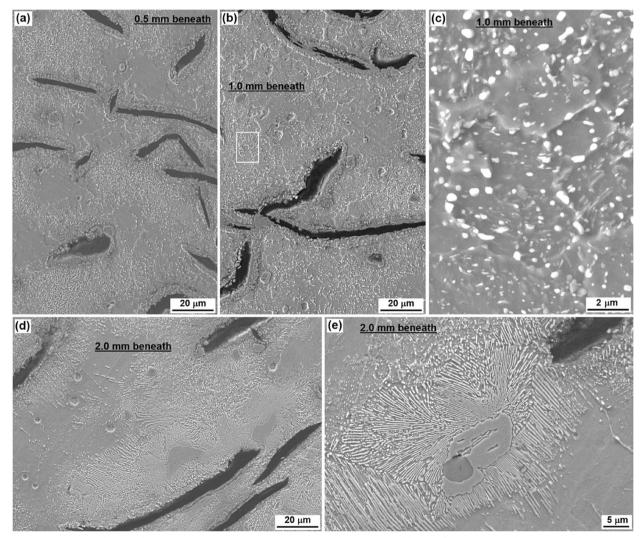
In addition to the SEM observations as shown in Figs. 8 and 11 shows the microstructure at depths of 0.5, 1.0 and 2.0 mm beneath the worn surface. The SEM images taken at the depths 0.5 mm and 1.0 mm show similar microstructure features from the graphite flakes enveloped in oxide shells to the nodularised pearlitic matrix, as shown in Fig. 11a-c. Some areas in the matrix

Fig. 11 SEM images showing the microstructure evolution at various depths beneath the rubbing surface: (a) 0.5 mm; b-c 1.0 mm and (d-e) 2.0 mm

are featureless free from any carbide particles, indicating the occurrence of substantial carbide decomposition. In the carbide-containing areas, as shown in Fig. 11c, the carbide particles have been mostly in round shape. Such evolution of the carbide phase is also seen in deeper places as shown in Fig. 11d-e, where both carbide-free areas and carbide modularisation are visible. Figure 11e shows the frontier that the eutectoid lamellar carbides underwent decomposition at the depth of 2.0 mm. These features of carbide decomposition form a striking difference to the microstructure at further depths, e.g., the lamellar pearlitic carbides at the depth of 4 mm as shown in Fig. 5.
