Inglesinhos convent: Compatible renders and other measures to mitigate water capillary rising problems

Journal of Building Appraisal (2009) 5, 171–185. doi:10.1057/jba.2009.28

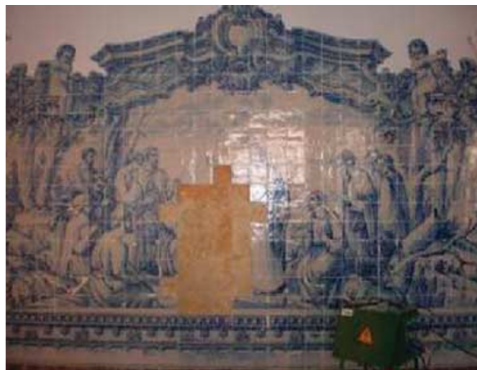
Figure 3: Lacuna in the interior glazed tiles ('azulejos') showing the old lime plaster.

The building plan is composed of rectangles and is organized into large circulation and distribution corridors; the ground floor roof is executed in groined vaults. The old renders and plasters were based on lime mortars, with a pinkish coloration, as it was possible to observe in a lacuna existent in the entrance hall wall cover, constituted by beautiful ancient glazed tiles ('azulejos') (Figure 3).

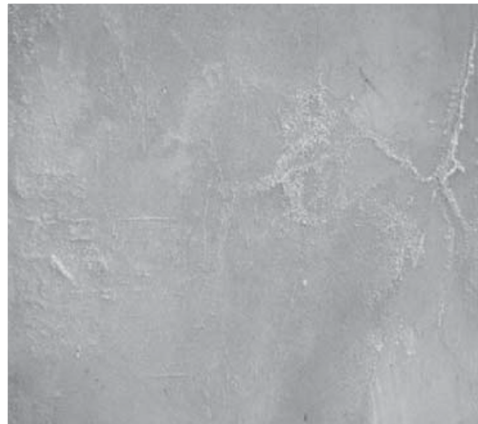
Several anomalies appeared after application of the new renders and plasters: dark moisture stains, salt efflorescences, loss of cohesion of the paint, blisterings and detachment of the paint (Figures 4–6).

Figure 4: Efflorescences in the rendering cracks.

the anomalies. The conclusion was that the anomalies were a consequence of the high accumulation of water in the walls and ceilings. From the distribution of moisture in the walls, the water appeared to have different origins: (i) capillary rising water from underground through foundations and walls; (ii) capillary rising water from the soil surface, owing to the accumulation of rain water near the external walls, and to the absence or disability of drainage systems; (iii) water infiltrations from the exterior with saturation of the roof over a long period before the intervention; (iv) localized infiltrations in some areas of the exterior walls; (v) localized problems in interior walls owing to rupture or defects of canalization; and (vi) condensation moisture in the interior walls (Henriques, 2001; Magalhães, 2002 and Massari and Massari, 1993).

The presence of water inside the walls was extended in time owing to difficulty in its removal through the new adopted coverings. In fact, these coverings reduced the evaporation ability, when compared with the old renders, which were based on air lime

The impermeable external coverings were removed – synthetic finishing, polymeric paints and other polymeric products – and were replaced by a lime-based finishing coat for the regularization of the walls and a silicate-based paint. The lime-based finishing

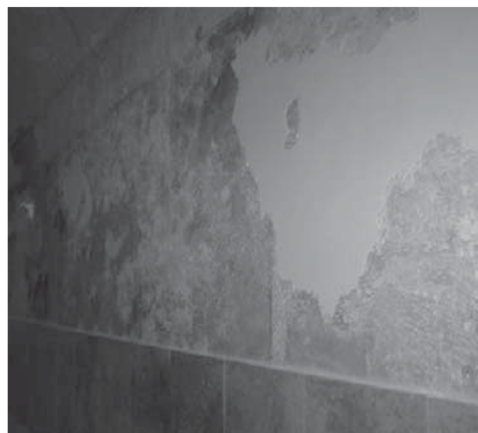
Figure 5: Detachments (large lacuna) of internal finishing.

In the internal space, ventilation during the works was achieved by opening the windows and installing portable fans. The cement and lime plaster of the walls and ceilings were removed and replaced with air lime and sand mortars, with a volumetric dosage of 1:3 (lime:aggregate), and were covered with a traditional plaster composed of gypsum and air lime (Figure 19). This traditional gypsum plaster should not to

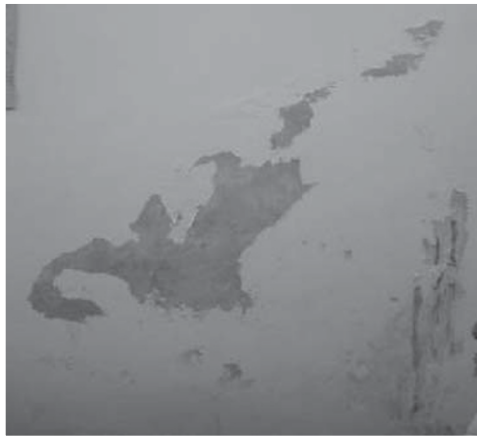
Figure 6: Detachment of the render painting.

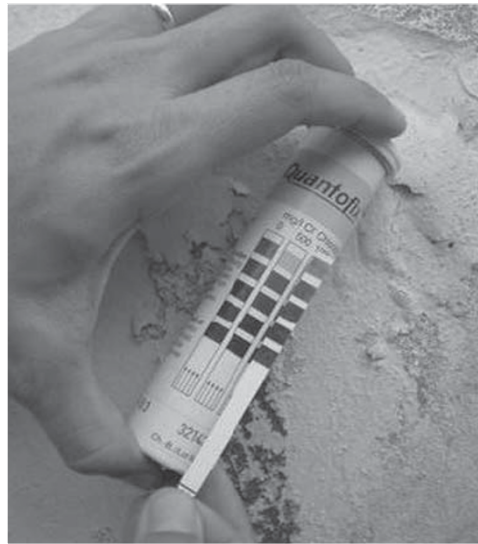
The salts present were found to be mainly sulphates (large content in one of the interior walls) and chlorides, but some nitrates were also detected. Their presence was probably due to the interaction of contaminated water from the ground, to the presence of cement in the mortars and to the existence of salts in other wall materials or in the ground. Salts can be transported in a porous material only if dissolved in water (Lubelli *et al*, 2006), and thus their presence indicates water transport through the walls. Despite the lower dissolution rate of sulphates, when compared with the other salts present, the circulation of water in the walls can promote their dissolution and dissemination (Ottosen *et al*, 2008).

Figure 10: Strip tests – semi-quantitative determination of salts.

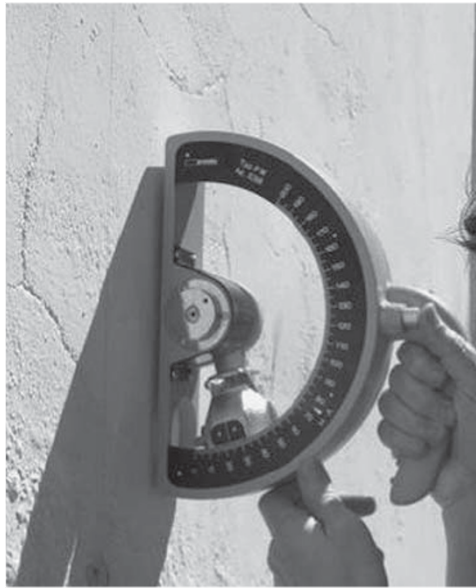
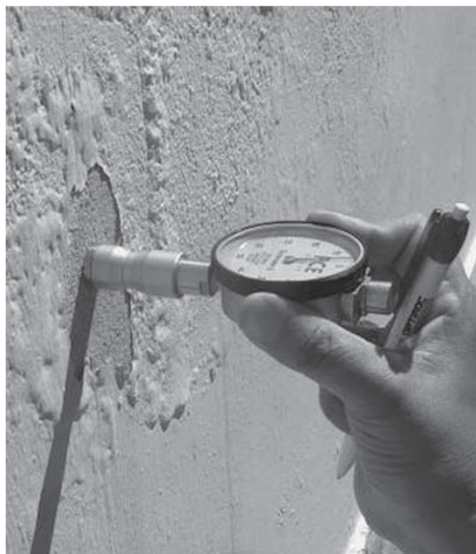
The tests showed the reduction in mechanical strength and cohesion of the degraded renders, by comparison with measurements performed on experimental panels made *in situ* and with determinations carried out in previous case studies on sound mortars (Tavares *et al*, 2008). The tests with the pendular Schmidt hammer were more expressive than those with the Durometer, which affects more superficial layers.

Figure 11: Pendular Schmidt impact hammer test.

Figure 12: Durometer test.

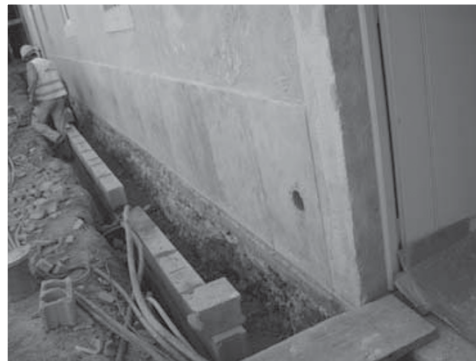
Figure 13: Execution of a ventilation ditch near the building façade.

The repair of the roof, of the drainage systems and of the collectors of rainwater was performed. Drainage ditches along the exterior walls were constructed to prevent the accumulation of rainwater, and ventilation ditches were also executed in order to facilitate the evaporation at the base of the exterior walls of water rising from the ground (Figures 13 and 14). Inside the apartments, ventilation tunnels were executed under the floor of the ground floor, where perforated tubes were introduced and connected to the

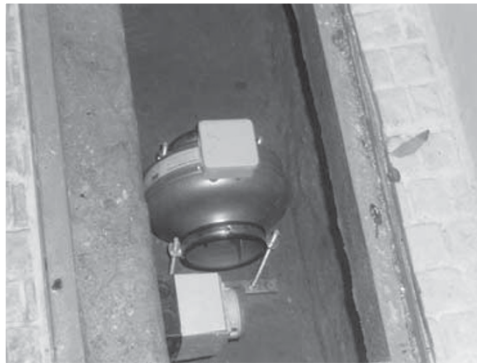
Figure 14: Electric equipment to force ventilation.

exterior (Figures 15 and 16) with the purpose of preventing capillary rise. In order to promote air circulation, electric fans were installed in the exterior ventilation ditches.

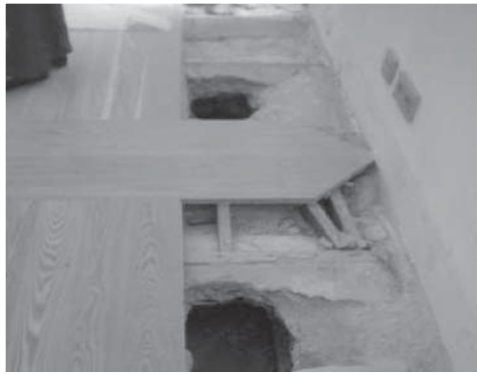
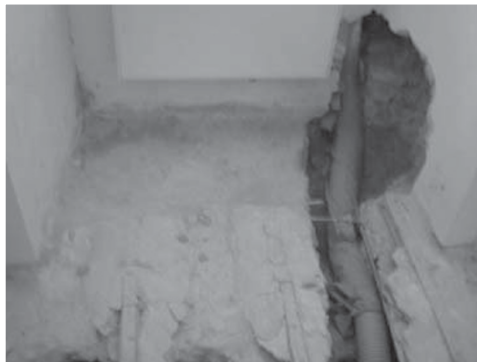
Figure 15: Small tunnels were opened under the ground floor.

Figure 16: Introduction of the ventilation tube in the underground tunnels.

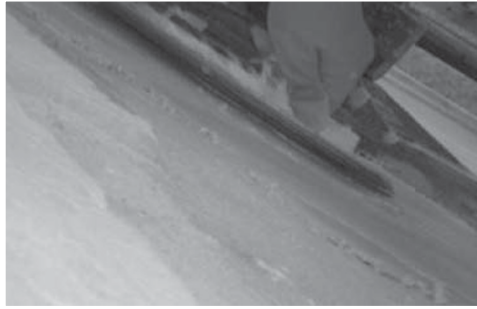
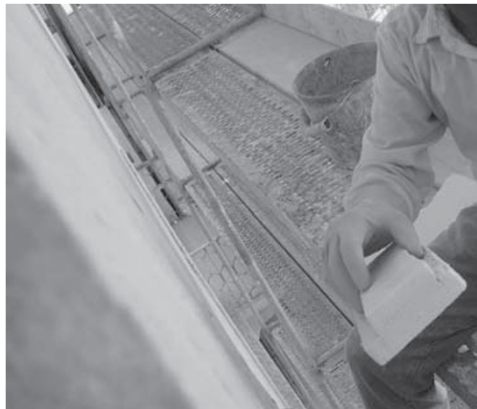
Figure 17: Application of the lime finishing coat.

Figure 18: Finishing with the passage of a polystyrene sponge on the mortar.

coat, consisting of a thin air lime mortar, executed with siliceous sand and calcium carbonate, with volumetric dosage 1:3 (lime:aggregate), was carefully applied, with a soft squeeze with a mason trowel and periodic sprinkling of water (Figures 17 and 18). It was left to dry for 1 month before the application of the final paint.

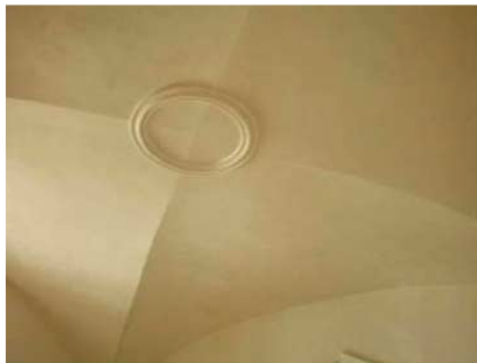
Figure 19: Application of traditional plaster on the ceiling of apartment 4.6.

be painted for at least 2 years to improve the evaporation of the water retained inside the vaults and walls. A gap between the floor footers and the walls was created for ventilation of the interior walls, to allow for continuous drying of masonry over time.
