Analysis of a building collapse: An examination of investigation methodology

Journal of Building Appraisal (2006) 2, 246–259. doi:10.1057/palgrave.jba.2950045

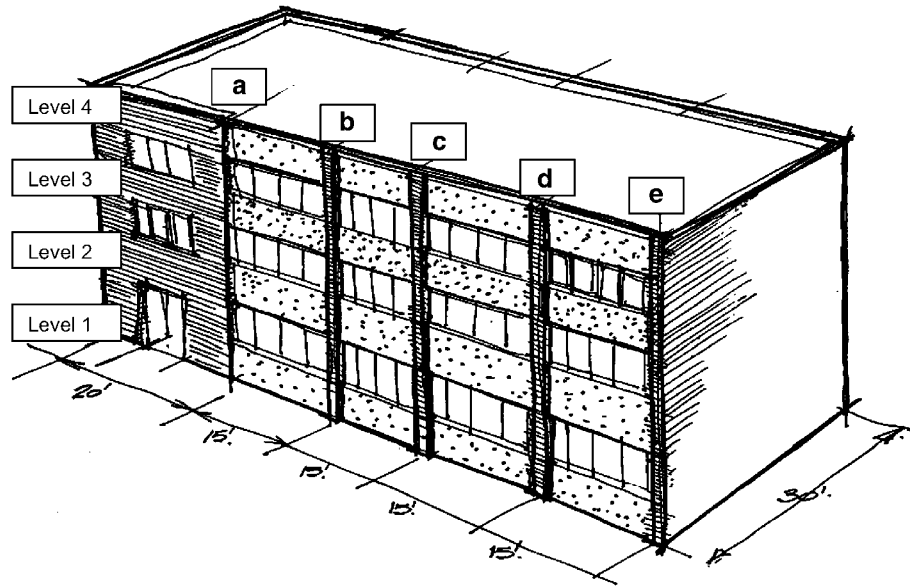
The building had been constructed for Wickens Holdings Ltd around 1969. It was 25 m wide and 9 m deep and was originally a single-storey building (Hollis, 1997). Some months later, perhaps as long as a year (Bingham, 2000), Wickens arranged for two further floors to be added on top of the single-storey structure. When completed, the building comprised four bays of about 5 m width plus a further 7 m cavity brick and block core containing toilets and the staircase (Figure 1).

Figure 1: Sketch of south face of the building before refurbishment work began in 1995. Dimensions in feet (15 feet equals 4.56m). Alphanumeric code to reference locations

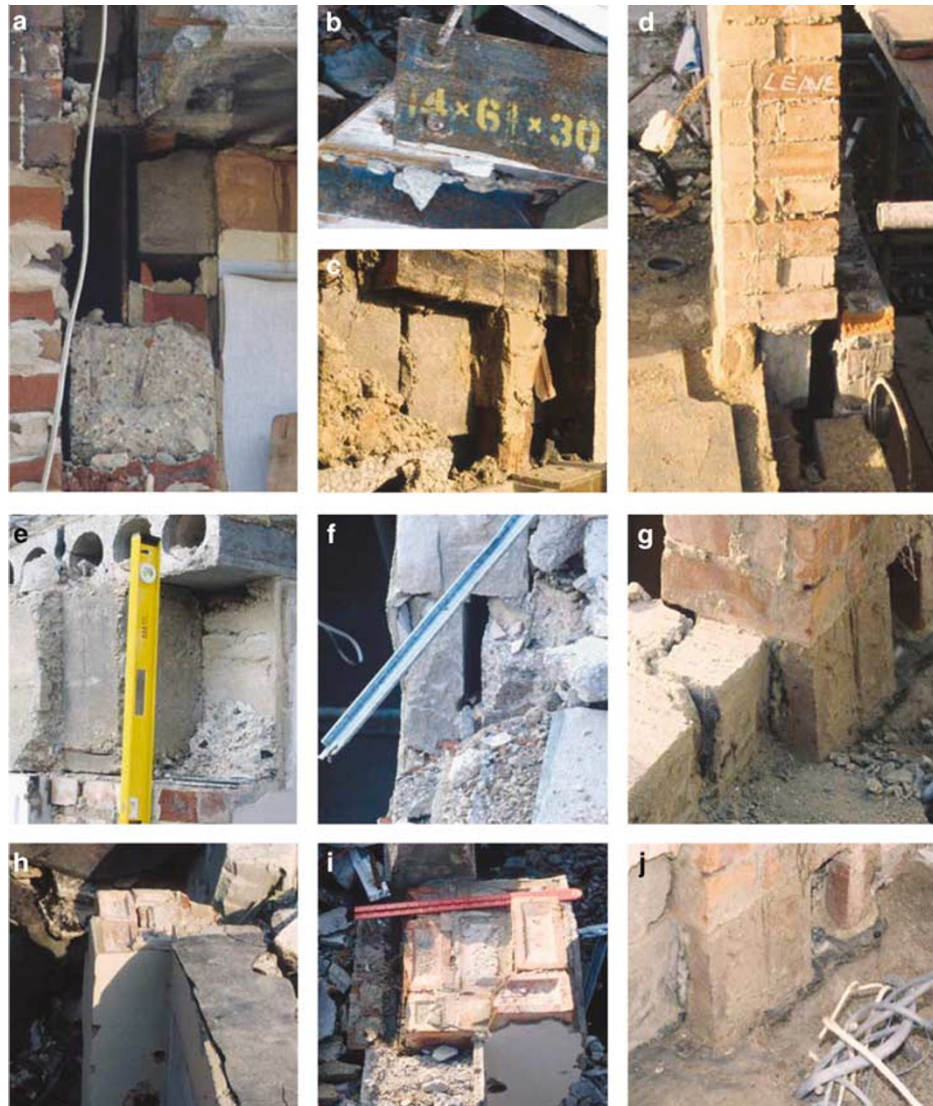
The four-bay east side of the completed building was constructed with brick piers supporting steel beams over the window openings, with pre-cast concrete slabs or planks laid across the width of the building, all of which were supported on the steel beams (Figure 2a and e). The brick piers ran through the height of the building, but were

There were marked weaknesses at the floor junction with the brick piers and to the head of the ground floor where the piers were raised on top of a 100 mm block that had been part of the former first floor building's parapet (Figures 2c, d, f and g).

Figure 2: A selection of photographs taken during the deconstruction of the building showing the steels (and dimensions) (b), the support for pier A2 (c), (d), (f), (g) and (j), brick pier dimensions (h) and (i) and a steel-encased beam at B1/B2 (e)

Many of the Witness Statements dealt with what the witness recalled having seen immediately before the collapse. One witness wrote that he saw a hole in the brick pier 10 inches wide 2–3 ft above the floor and that the blockwork had come away from the pier. A hole had been there before and had been covered by the blockwork (Mark May). Under cross-examination, this evidence changed to place the hole at one foot above the floor and a recollection that within the hole the witness had seen that the pier was saddled over the block former parapet wall in the same way as the remaining 'pier' between non-collapsed brickwork and remains of sub-first-floor window panel B2/C2 (Mark May) (See Figure 2c and d).

damp-proof membrane. To the upper floors the effective depth of the piers was 230 mm (see Figure 2d). The upper brick piers were only 50 per cent of the area of the designed columns and those to the lowest level 75 per cent. As a result, each pier was less substantial than those shown on the design drawings. On the basis of the analysis of the information from the original drawings and the comparison with what was built, we note

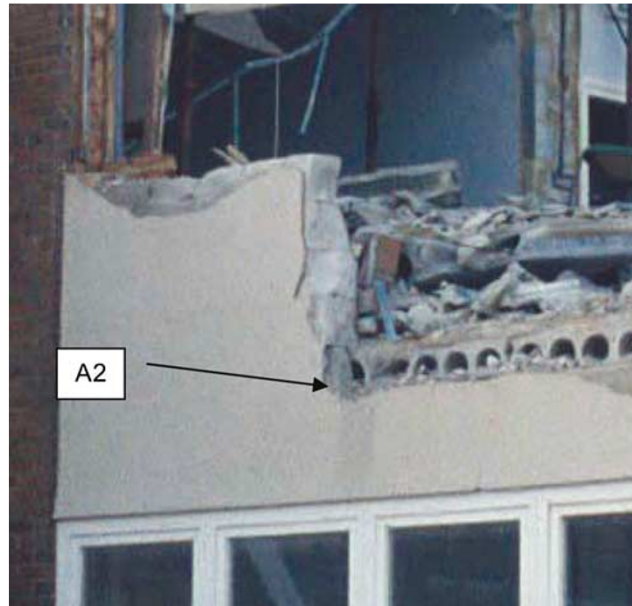
The collapse is believed to have been caused by the failure of the block supporting column B at level 2 (first floor), leading to the sudden collapse of the four bays of the building (Figure 4) (HSE, 1999a, b). It is believed that when cutting away the apron blockwork at first floor level the presence of a 100 mm block was encountered. It is not known whether the vibration caused by the use of a Kango or similar rotary demolition hammer resulted in the failure of the blockwork at B2. The extent of the collapse was much greater than might have been expected because of the lack of structural continuity

Figure 3: Photograph of part of the south elevation. The remaining ground floor section of the south elevation showing the block panel below the first floor window that had been cut through to form the channel for the new steel columns. The presence of the single-block part of the former parapet can be seen arrowed and sits at the end of the concrete Bison planks below the 200mm infill apron panel. This section of blockwork was carefully deconstructed to reveal the remains of the construction at this point. An assumption has been made that similar construction was present to the remainder of the building

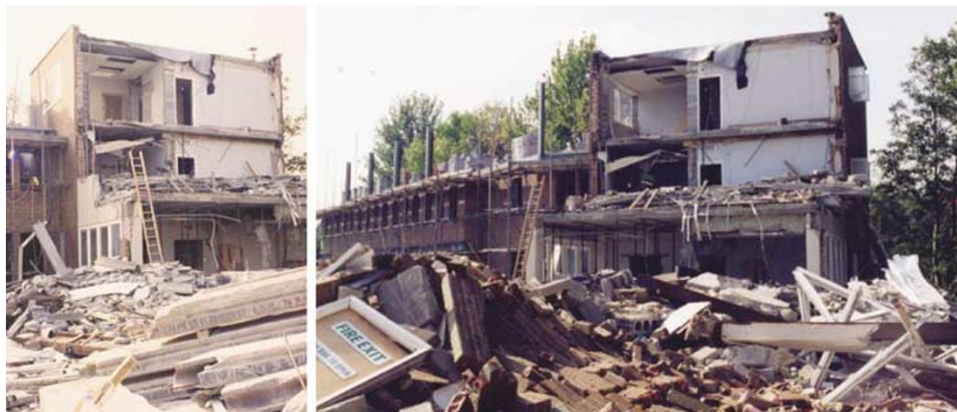
Figure 4: The building after the recovery of the bodies

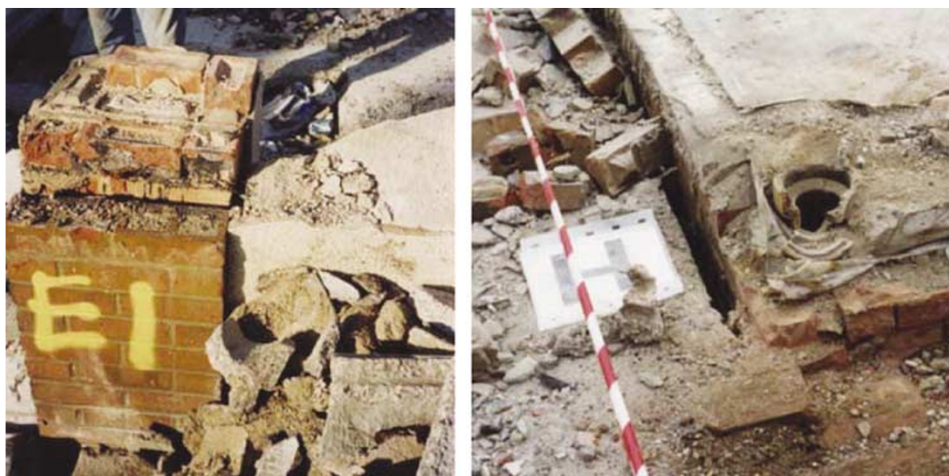
Figure 5: The base of pier E and the detail of the floor slab with gully below

The drawings did not show the detail of the rainwater discharge from the roof. The rainwater down pipes ran alongside two of the brick piers and discharged into gullies located beneath the piers (Figure 5). The material that had been repositioned during the period of recovery of the bodies was examined and tested to determine whether there was a fault in the manufacture of the Bison beams, defects in the concrete, mortar, steel or bricks used. The crushing strength of bricks and blocks could be established, but not the quality of those bricks and blocks that may have been in a critical location within the building prior to the collapse.

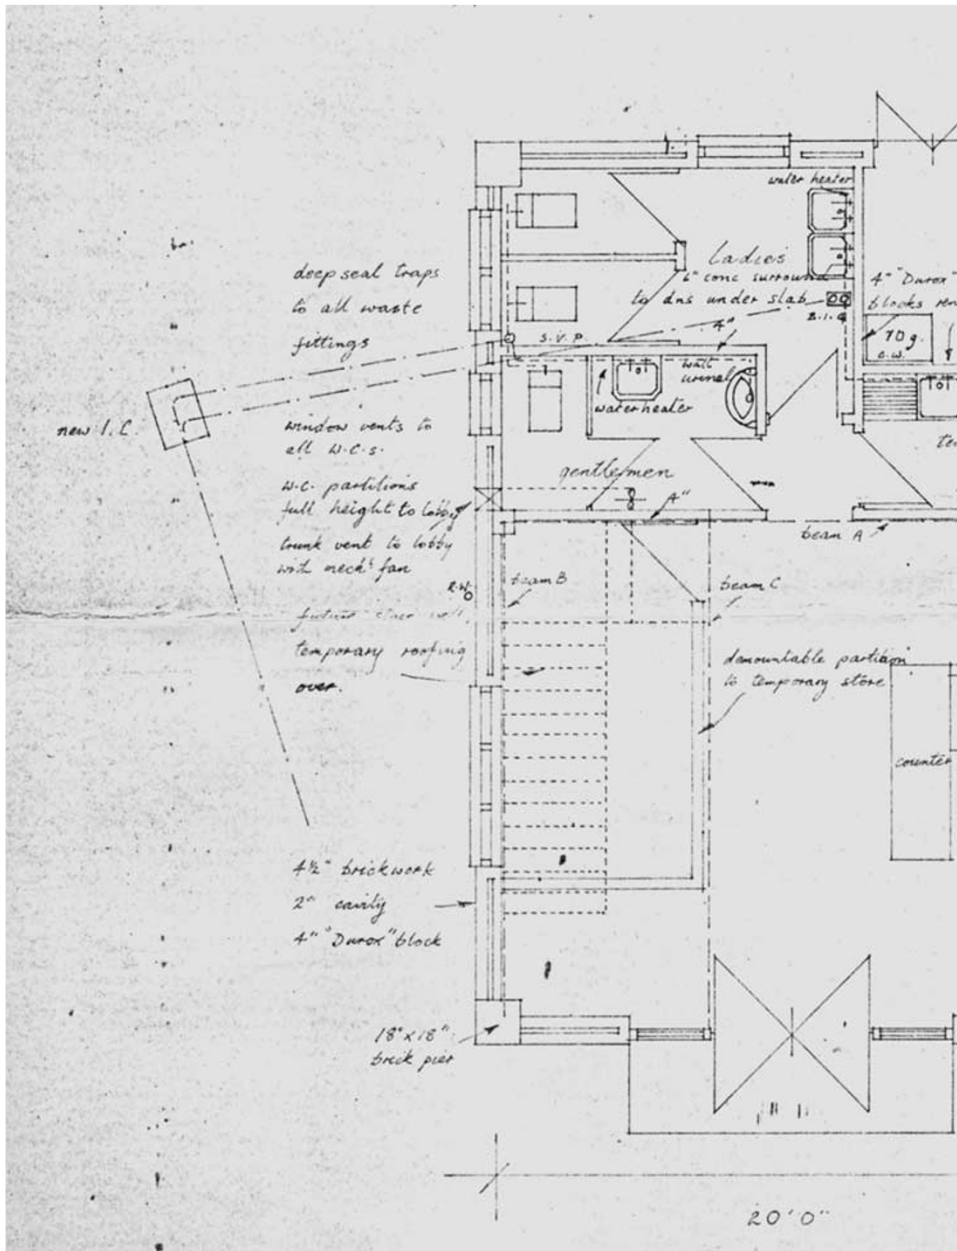
The original drawings of the 1969 development comprised floor plans and sections that contained limited detail. There were two sections through the proposed construction, one showing a three-storey building and one showing a single-storey building together with its floor plan. The ground floor plan of the single-storey building shows provision for a staircase and a temporary roof over (Figure 6).

The drawings showed construction that was not present in the completed building. The lintel over the ground floor windows was intended to have been a reinforced concrete. One assumes that had such a beam been installed, it would have been a single beam across the width of the elevation, serving all four bays. The lintel installed was a concrete encased steel beam installed as individual lintels over each bay opening. The lintels to higher levels were all shown to have been designed to be reinforced concrete when steel beams (not encased in concrete) were used. This resulted in the building that was constructed being more vulnerable to total collapse than that which had been designed.

Figure 6: Single-storey plan. A temporary store with a demountable partition is shown in the area of the future staircase that has been dotted in position on this plan. The annotations on the plan include 'Future stairwell, temporary roof over', 18" by 18" brick pier (that is about 450 mm by 450 mm or 2 bricks wide by 2 bricks long). The inner leaf of the cavity wall and internal partitions are all shown to be 100 mm Durox blocks

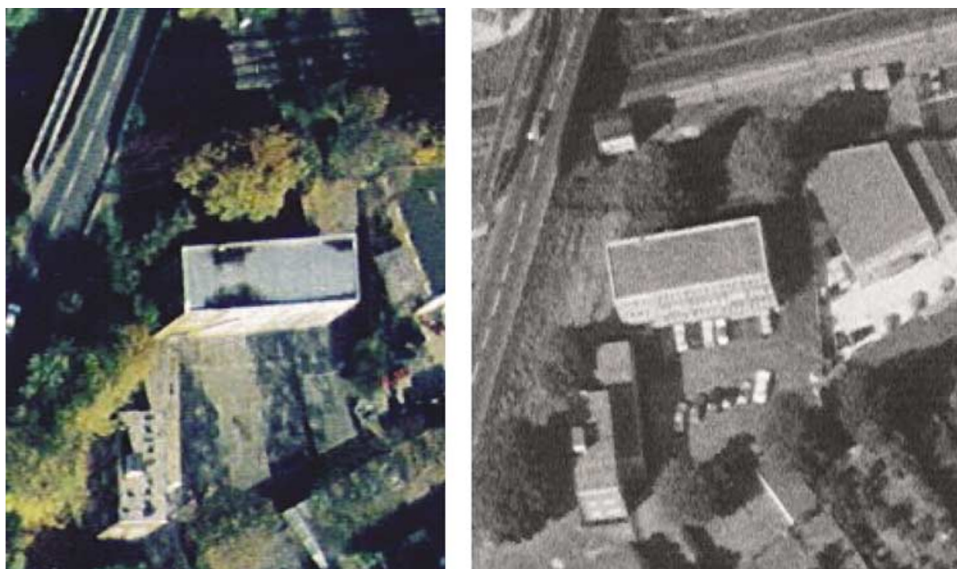
- There was evidence to suggest poor maintenance (visible ponding on the main roof around the rainwater drops).
- The trees surrounding the site had expanded, and more trees were present at the time of the collapse.
- The building across the railway line running along the north boundary of the property had been demolished and a new and larger building had been erected.
- The cars had been parked (in the earlier photograph) against the south wall.

Figure 7: 1995: rainwater outlets blocked (left) and 1970: cars parked against south wall (right)
