Understanding terra-cotta distress: Evaluation and repair approaches

Journal of Building Appraisal (2007) **2**, 282–293. doi:10.1057/palgrave.jba.2950049

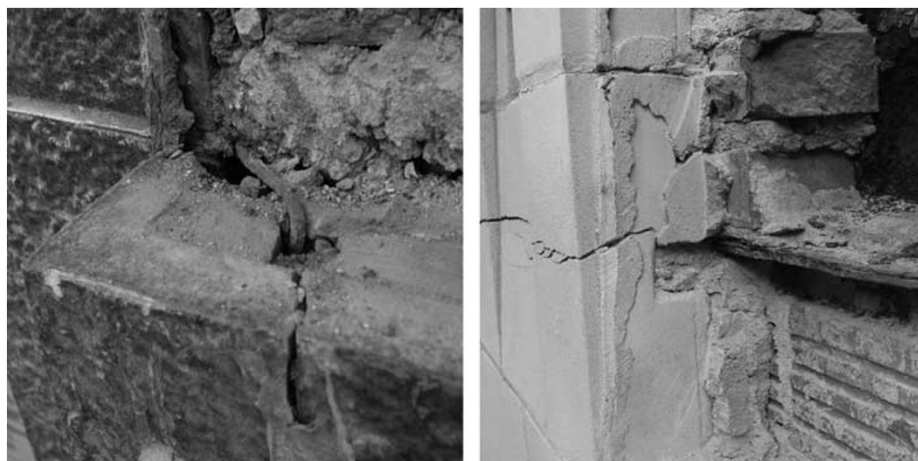
Typically, terra-cotta is a very durable material and may perform well in an exterior environment; most of the decay mechanisms of terra-cotta facades are a result of deterioration of the system rather than deterioration of the terra-cotta material (Figure 5). The main mechanisms, which cause deterioration of terra-cotta cladding systems, include moisture, thermal cycling, and built-up compressive forces. Water inevitably enters all building facades. The amount of water entering the system typically accelerates as materials deteriorate and stresses accumulate.

Figure 5: Representative distress of terra-cotta cladding. Cracking at lateral tie (left) and cracking at shelf angle location (right)

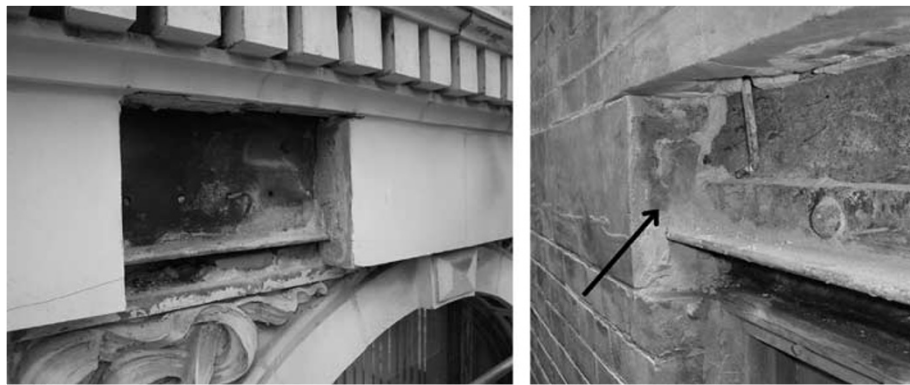
Horizontal cracks most often form in hung units, roughly corresponding to location of the supporting bar. In notched units, cracks often propagate at the location of the notch (Figure 6). This cracking may be the result of the corrosion of the supporting shelf angle, from unaccommodated vertical stresses in the cladding system, or eccentric loading of the notched piece.

Figure 6: Horizontal cracking at shelf angle locations

Hung units, such as those typically found and lintels, with horizontal cracks generally cannot be adequately repaired *in situ*. Installing pins has limited applications and should be cautiously considered since the piece will rely almost entirely on the pins for support

rather than the redundancy of the cladding system. Removal and repair of the units is an option that could be considered; however, the durability of the repair is critical due to the lack of redundancy of the hung portions and reliance on the repair itself. Often, these units are less ornate and it may be most efficient and offer a higher level of confidence of the repair to replace damaged units. Further, replacing these units typically requires dismantling fewer adjacent units. Once one of the hung units is removed, it is often efficient to remove the remaining units at lintel locations without damage. This allows for proactive coating of the steel support and replacement of the supporting hooks and anchors with a stainless steel to prevent future damage at this vulnerable location.

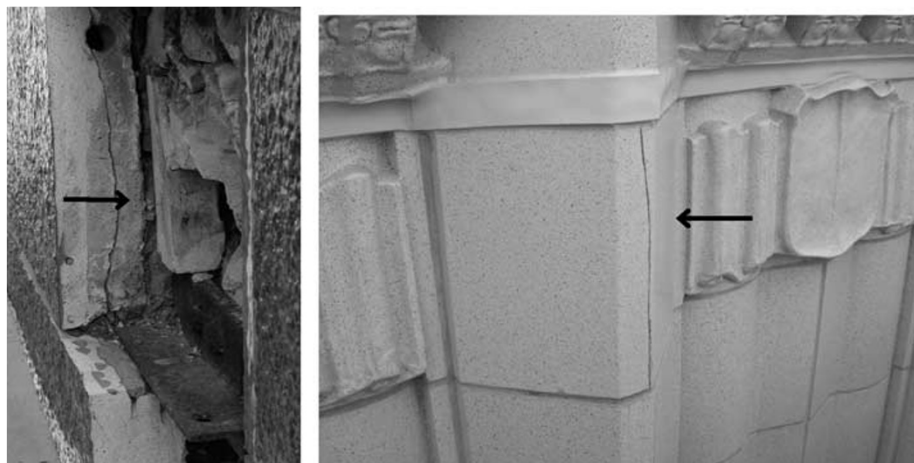
Vertical cracking is often an indication of systemic issues within the cladding system. Isolated vertical cracks within non-projecting piers or blank wall areas may be related to the corrosion of the lateral restraint bars. A crack within a pier or blank wall area may be related to a combination of corrosion of the restraint bars with unaccommodated expansion of the cladding system (Figure 7). Stresses resulting from restrained expansion tend to create either vertical cracks across multiple units or outward displacements at support locations. The vertical cracks form as a result of a weakness within the wall created by intermittent localised points of distress.

Figure 7: Vertical cracking within the plane of terra-cotta (left) and through the face (right)

Vertical cracking may result in two independent units, which if properly supported vertically and horizontally can be repaired *in situ*. Since vertically cracking generally correlates to the lateral anchorage, it is prudent to assume that each portion of the unit is not laterally supported. As a result, repairs should include through face pinning followed by routing the crack to a uniform width and depth and installing a bond breaker and sealant or routing, and pointing the crack with mortar depending the anticipated future movement of the crack.

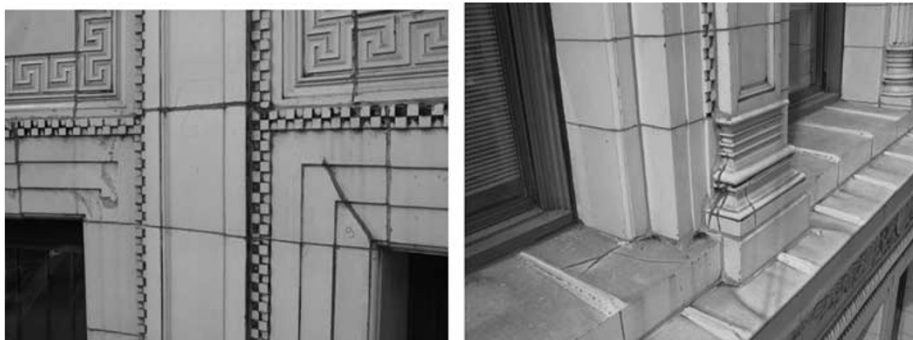
Diagonal cracking is much less common in terra-cotta cladding system and is often the result of units being subjected to multiple forces causing the units to be in a complex state of stress. The most common example of this complex state of stress is the end windowsill unit, which extends into the adjacent piers (Figure 8). The portion of the unit below the masonry opening has no significant prolonged stresses imposed, while the portion of the unit that extends into the pier may be subjected to significant compression forces from the units above. Inevitably, cracks will develop in these units roughly corresponding to the interface of the sill and pier. This is exacerbated since sill units are typically thinner than other units, and the bending caused by the force imposed by the pier is resisted in weak axis bending of the unit.

Figure 8: Example of diagonal cracking in terra-cotta

The cracking of sill units is generally not a significant issue depending on the orientation and position of the crack. If the cracking has essentially resulted in creating two pieces rather than one, the crack can be effectively treated as a joint and repaired to minimise moisture infiltration. These types of cracks are generally best repaired by routing the crack to a uniform width and depth and installing a bond breaker material and sealant, since there will likely be continued movement between these now two separate terra-cotta units. Exploration openings at selected areas may help to determine if each portion of the terra-cotta unit still retains adequate lateral and vertical support. If multiple cracks exist in the unit, it may be necessary to add supplement pins to secure fragments or in extreme cases replace the unit. Replacing these units, typically, necessitates removal of the masonry material above the embedded portion of the sill to install a new piece.

If a lintel unit is cracked from the masonry opening into the pier area, resulting in two independent properly supported units, the piece may be repaired similar to a sill. This crack configuration results in the units acting as a flat arch with the cracked portion within the window area acting as a skewback to resist the thrust of the arch. If the crack extends vertically or diagonally into the masonry opening area above the window, the piece is likely wedged in place, but the resulting arch is much less stable. Depending on the configuration of supporting assembly, these pieces may still be properly supported, but likely should be replaced.

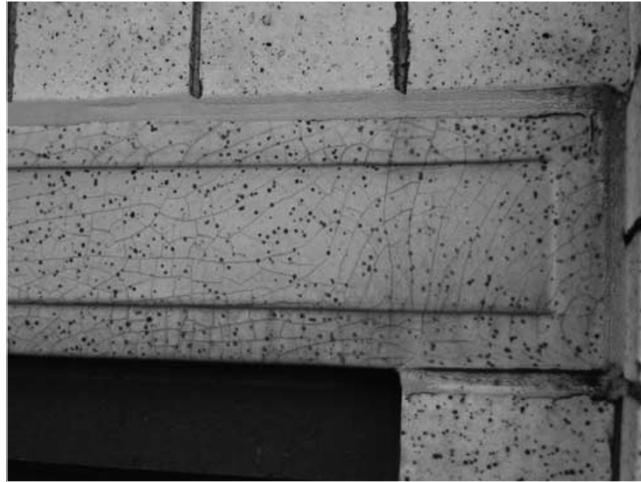
Diagonal cracking also occurs when lintel units extend into the pier area from the masonry opening for the window. Since these units are often substantially larger and deeper than the sills, the bending resistance is much higher. If the strains in the unit have not reached the point of fracturing the piece and depending on the finish on the terra-cotta, fine cracks within the terra-cotta glaze may mirror these opposing forces (Figure 9).

Figure 9: Fine cracks (crazing) reflecting stresses within terra-cotta unit

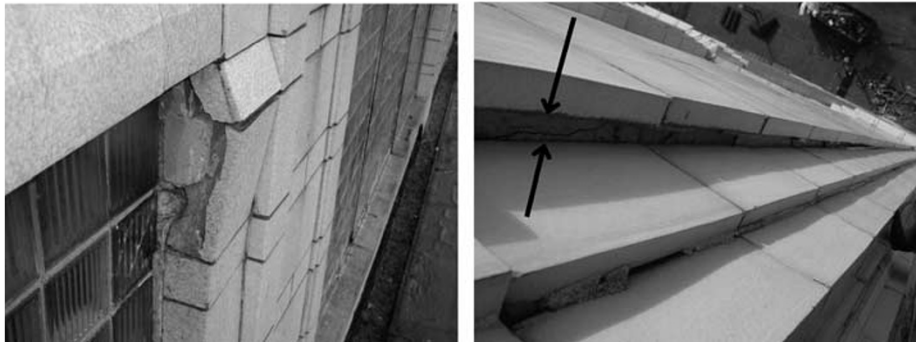
Displacement of cladding system is an indication of a systemic problem within the cladding system. Similar to vertical cracking, displacement is an indication of unaccommodated expansion. The displacements typically occur at shelf angle and restraint locations and may or may not be accompanied by vertical cracking (Figure 10). Some

Figure 10: Examples of displaced individual terra-cotta units (left) and entire wall area (right)

If displacement is not excessive, strain relief cuts can be made without reconstruction of large areas of the wall. Relief cuts will likely render the lateral anchorage for the units below the support ineffective. Therefore, supplemental lateral anchorage should be installed in these units. If the displacement results in the centre of gravity of the terra-cotta being outside the middle third of the unit, the units should be removed and reset. If the glaze exhibits fine cracks that do not extend into the bisque of the terra-cotta, no repair of the individual units may be necessary. It may be desirable, however, to provide strain relief to accommodate stresses within the wall.

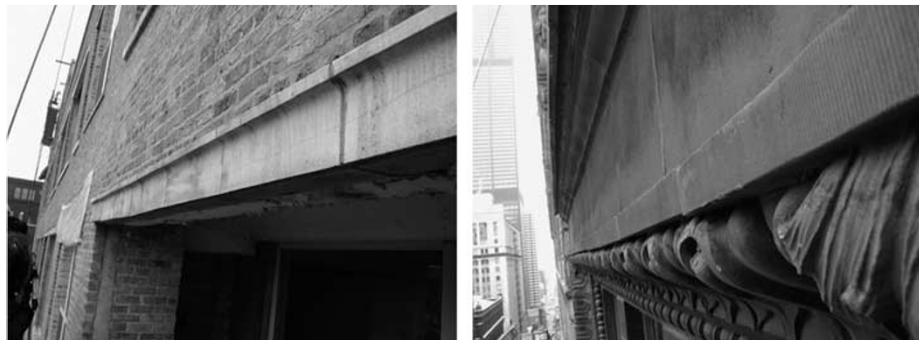
Figure 11: Vertical displacements of terra-cotta units over window openings

Vertical deflections of hung lintels above window areas are common with larger spans (Figure 11). Chicago-style windows, typical in historic terra-cotta buildings, combine large fixed units flanked by double hung windows, frequently result in masonry openings in excess of 5 m. Support of the terra-cotta units above these openings were typically designed using empirical techniques. This resulted in sizing of steel-supporting members that were adequate in strength, but exceeded today's recognised deflection criteria for masonry. Accepted limits of deflection in contemporary structural design range from 1/600 to 1/720 of the span. Therefore, for a 5-m span, deflections should range from 6 to 8 mm. These deflections have been measured by the authors in excess of 20 mm. Deflection of this magnitude can result in premature deterioration of the mortar joints and potential corner edge spalling. Assuming the supporting structure is in serviceable condition, an increased maintenance cycle for the mortar should be anticipated, but no significant repairs are likely necessary. Localised distress, which may require repair, include spalling and cracking of individual units and displacement of larger areas. Corrosion of the steel support members may lead to a loss of cross-sectional area reducing the structural capacity of the steel element so that the element no longer adequately supports the required load.

Vertical deflections of hung lintels above window areas are common with larger spans. Assuming the supporting structure is in serviceable condition, the units are properly supported, no repair or replacement may be necessary, but an increased maintenance cycle for the mortar should be anticipated.
