# Damage event analysis of vertical ground source heat pump systems in Germany

Paul Fleuchaus\*

and Philipp Blum

\*Correspondence:  
paul.fleuchaus@kit.edu  
Institute of Applied  
Geosciences (AGW),  
Karlsruhe Institute  
of Technology (KIT),  
Kaiserstraße 12,  
76131 Karlsruhe, Germany

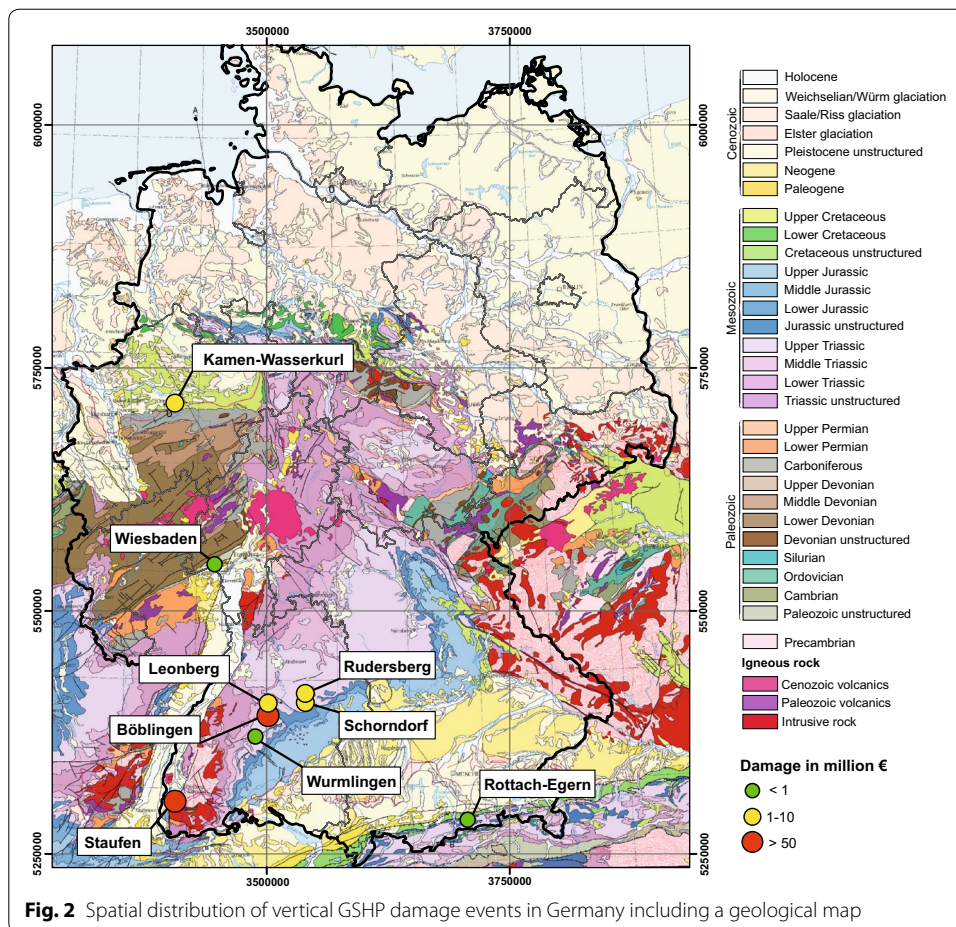
**Fig. 2** Spatial distribution of vertical GSHP damage events in Germany including a geological map

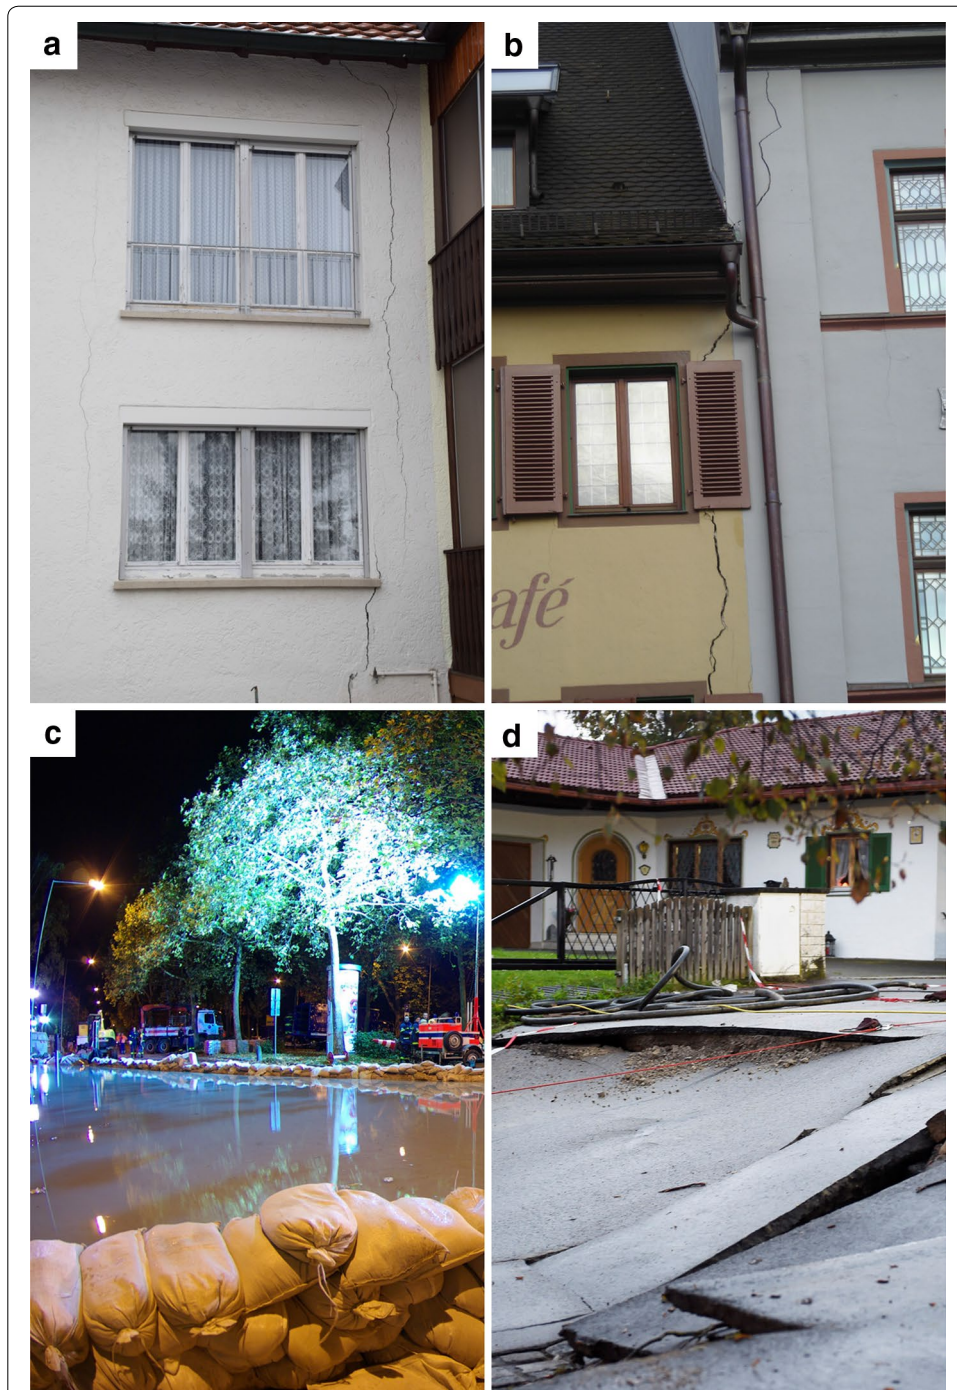
reported first cracks in their buildings, which rapidly propagated (Fig. 3b). In two published status reports, the Geological Survey of Baden-Württemberg (LGRB) provided evidence of the fact that these ground uplifts had been induced by the geothermal drillings (LGRB 2010, 2012). Initialisation of swelling processes by earthquakes was excluded (Sass and Burbaum 2012). With a final depth of 163 m, the drillings penetrated the anhydrite-bearing Keuper formation. Anhydrite turns into gypsum when it comes into contact with water. The transformation process is accompanied by a volume increase of up to 61% (Butscher et al. 2016a).

The swelling process occurred relatively slowly due to its kinetics and medium-to-low hydraulic permeability in this zone (Sass and Burbaum 2010; Butscher et al. 2016b). The swellable anhydrite layers were located at a depth between 61.5 and 99.5 m below ground level. One of the seven drillings had intersected the basis of the Middle Keuper formation. A leaky backfilling created a hydraulic contact between the unconfined groundwater of the Lower Keuper formation and anhydrite-bearing layers (Fig. 4). Ascending groundwater found its way into swellable zones. In October 2016, geodetic measurements revealed a total uplift of 58 cm in the town hall area after a period of 8 years. Lateral displacement was measured to be 43 cm (Stadt Staufen 2016). The first remediation measures started in 2009, 2 years after first damages had been reported.

**Fig. 3** Damages in Böblingen (**a**), Staufen (**b**), Wiesbaden (**c**), and Rottach-Egern (**d**). ©: **a** Paul Fleuchaus, **b** Christoph Butscher, **c** Michael Ehresmann, and **d** Thomas Plettenberg

In November 2009, drilling activities for a near-surface geothermal energy application on behalf of the Hessian Ministry of Finance induced flooding in the city centre of Wiesbaden. Drillings reached a depth of 130 m when a 7-m-high groundwater spring erupted from the borehole. Up to 6000 l/min of groundwater poured over a 400 m<sup>2</sup> large area around the drilling site (Fig. 3c). Even though the borehole was filled with 56 m<sup>3</sup> cement late at night, water discharge could not be stopped. New springs were formed in the vicinity of the borehole. At a depth of 130 m, the exploration drilling hit an artesian aquifer (Fig. 4). With the discharging water, large amounts of loose material were flushed out of the ground. Due to potential subsidence processes, there was an increased hazard of land subsidence. Seismic follow-up investigations, however, did not show any irregularities in the subsurface. The costs of damage were estimated to be 500,000 Euros (FAZ 2010).

In October 2016, a borehole was drilled for the installation of a vertical GSHP system in Rottach-Egern (Bavaria). When drillings reached a depth of 45 m, a 20-m-wide and 2-m-deep sinkhole started to appear (Fig. 3d). Only little information is available about the cause and processes of subsidence. According to first assumptions, drillings hit a groundwater-filled subsurface cavity. The cavity is a relic of a buried ice block formed by landslides during glacial periods (TS 2016). Damage is estimated to be 500,000 to one million Euros.

These measures consisted in the suppression of the leaky backfilling and lowering of the groundwater level by pumping. The uplift rate was reduced from initially 11.0 to 3.5 mm per month. Since it is not possible to recover penetrated water from sulphate-bearing layers, swelling will stop only when there is no more inflow of groundwater (Ruch and Wirsing 2013). The uplift damaged more than 269 buildings (Sass and Burbaum 2010)

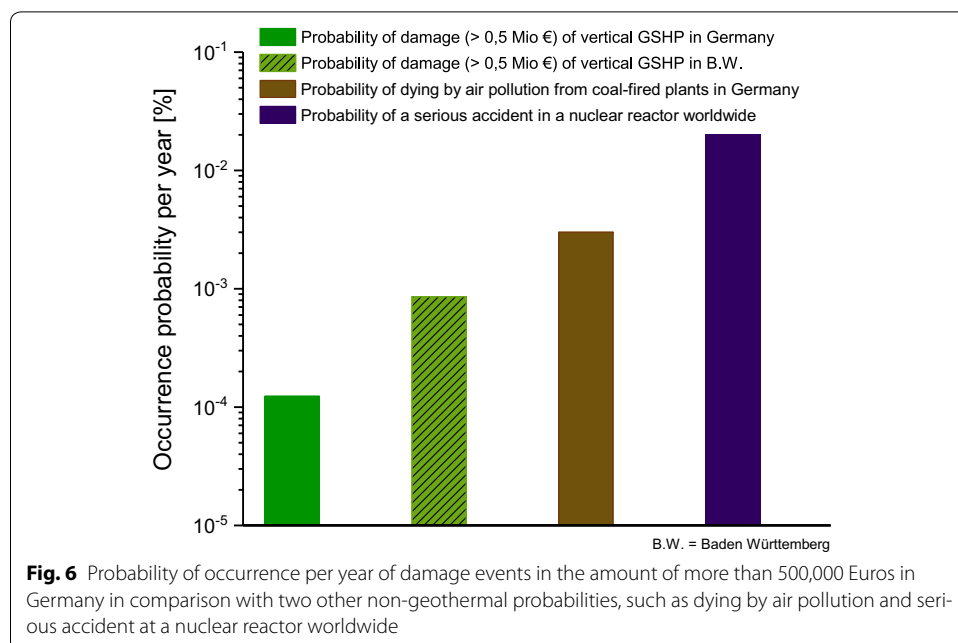
The probability of a serious damage is higher by a factor of 10 in Baden-Württemberg (Fig. 6), which is mainly caused by the specific geological and hydrogeological conditions of the Keuper-Muschelkalk transition. According to a first estimation, the probability of damage is increased by a factor of 40, when the drilling intersects this transition (Grimm et al. 2014). Except for the case of Kamen-Wasserkurl, damages in the amount of millions were entirely linked to the presence of swellable minerals in the underground (Fig. 4).

In general, usage and installation of vertical GSHP systems in Germany can be considered fairly safe compared to other technologies. Figure 6 compares the probability of a serious damage event of vertical GSHP with the probability of dying from air pollution caused by coal-fired plants in Germany [0.003% per year (Grimm et al. 2014)] and the probability of a serious accident at a nuclear reactor worldwide [0.02% per year (Grimm et al. 2014)]. Even though the idea of this comparison is to emphasize the low probability of serious damage events in Germany, the higher energy output of fossil-based energy sources is obvious.

**Fig. 6** Probability of occurrence per year of damage events in the amount of more than 500,000 Euros in Germany in comparison with two other non-geothermal probabilities, such as dying by air pollution and serious accident at a nuclear reactor worldwide
