Structural damage to houses and buildings induced by liquefaction in the 2016 Kumamoto Earthquake, Japan

Hendra Setiawan^{1,2*}

, Yuko Serikawa¹, Mitsuru Nakamura¹, Masakatsu Miyajima¹ and Masaho Yoshida³

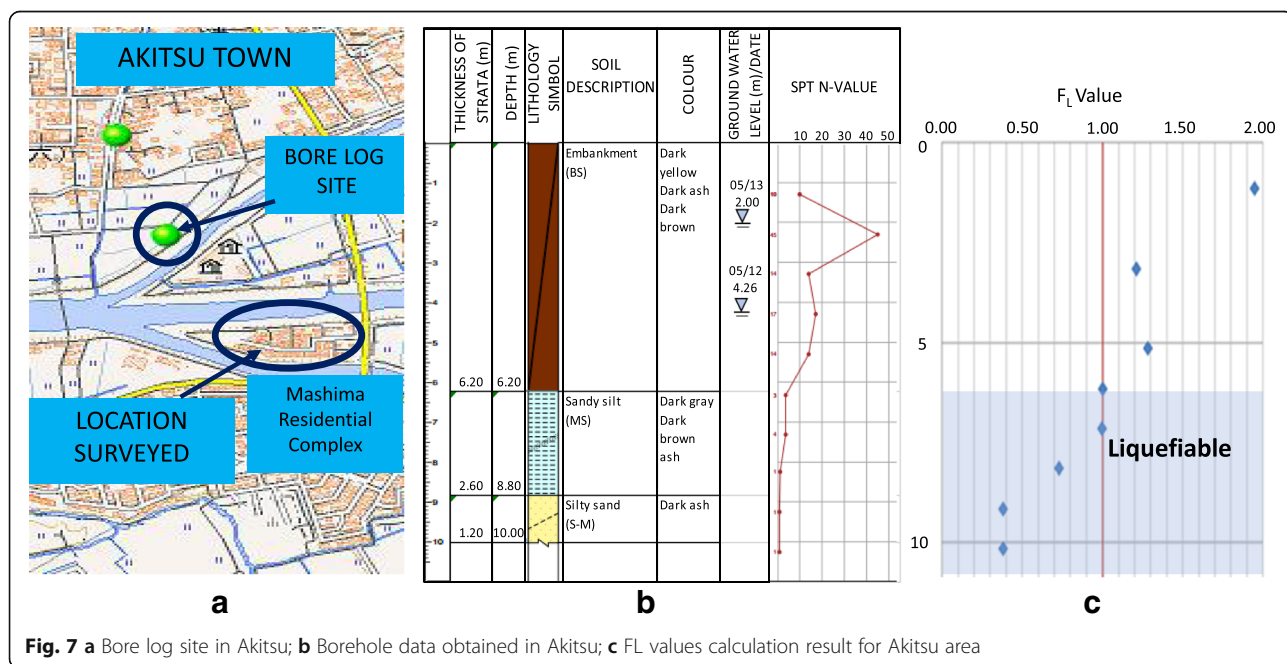
Figure 7a shows the location of the bore log while Fig. 7b presents borehole data obtained at Akitsu. As can be seen in this figure, the groundwater level is 2 m below the ground surface. The embankment layer lies at a depth of 6.2 m and at a depth of more than 6.2 m, the ground is composed of sand and silt layers. Bore data at this site were available only to a depth of 10 m, but this data was sufficient to show that the ground consists of an embankment and sand layers which has the potential to liquefy. The calculated SPT N-value showed that the ground was in a very loose condition. The calculation result of the safety factor against liquefaction, F_L , in Akitsu can be seen in Fig. 7c. Based on the resultant F_L value, the Akitsu area has a low risk of liquefaction to a depth of 5 m, as F_L values are higher than 1. In contrast, it has a high potential for liquefaction at a depth of more than 6 m since it is composed of sand and sandy silt layers with an F_L value lower than 1.

Fig. 7 a Bore log site in Akitsu; b Borehole data obtained in Akitsu; c F_L values calculation result for Akitsu area

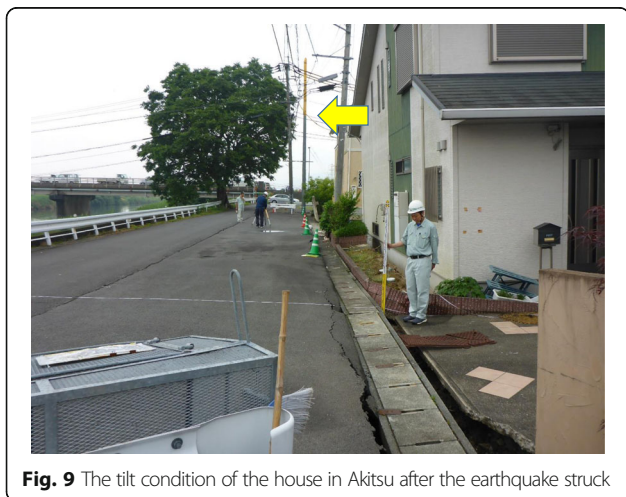
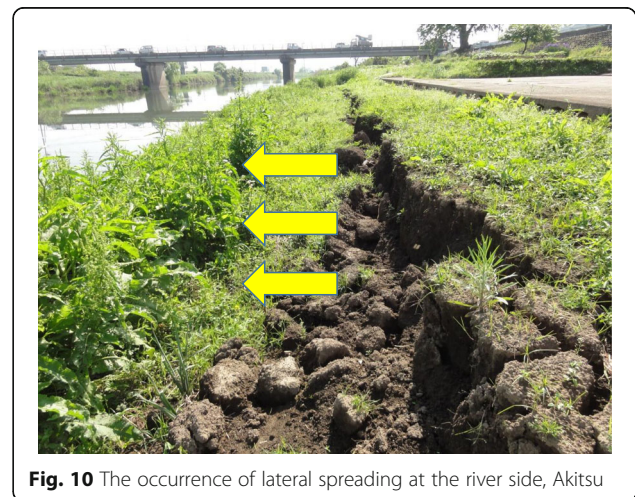
Figure 9 shows the state of the house after the earthquake struck and shows that the house became tilted toward the river. Furthermore, as can be seen in Fig. 10, the lateral movement also occurred toward the river side at this site. As a result, adjacent houses tend to be tilted in the same direction with a lateral spreading direction. Figure 11 presents the summary of the structure types and the damage in this area. As for building A, it was inclined 3.6° to the north and 3.7° to the east as there was substantial ground subsidence on the north side and different settlement of the foundation occurred. Ground subsidence at the north side also occurred in buildings C and D and similarly to building A, these buildings tilted to the north. Although

ground subsidence occurred, building B only experienced minor inclination and minor vertical gap development due to the insignificant differential settlement of its foundation. This is because this building was supported by a foundation of piles. Figure 12 shows the pile foundations that support building B. Based on this result, it is thought that the foundation type also influenced the degree of inclination of building structures.

Structure Type	Wooden frame, 2 storey	Steel frame, 2 storey	Wooden frame, 2 storey	Wooden frame, 2 storey
Inclination damage	3.6° to the North, 3.7° to the East	Minor inclination (less than 1°)	3.6° to the North	1.5° to the North

Fig. 11 The summary of the structure type and damage level (Buildings A, B, C and D in Fig. 8) in Akitsu

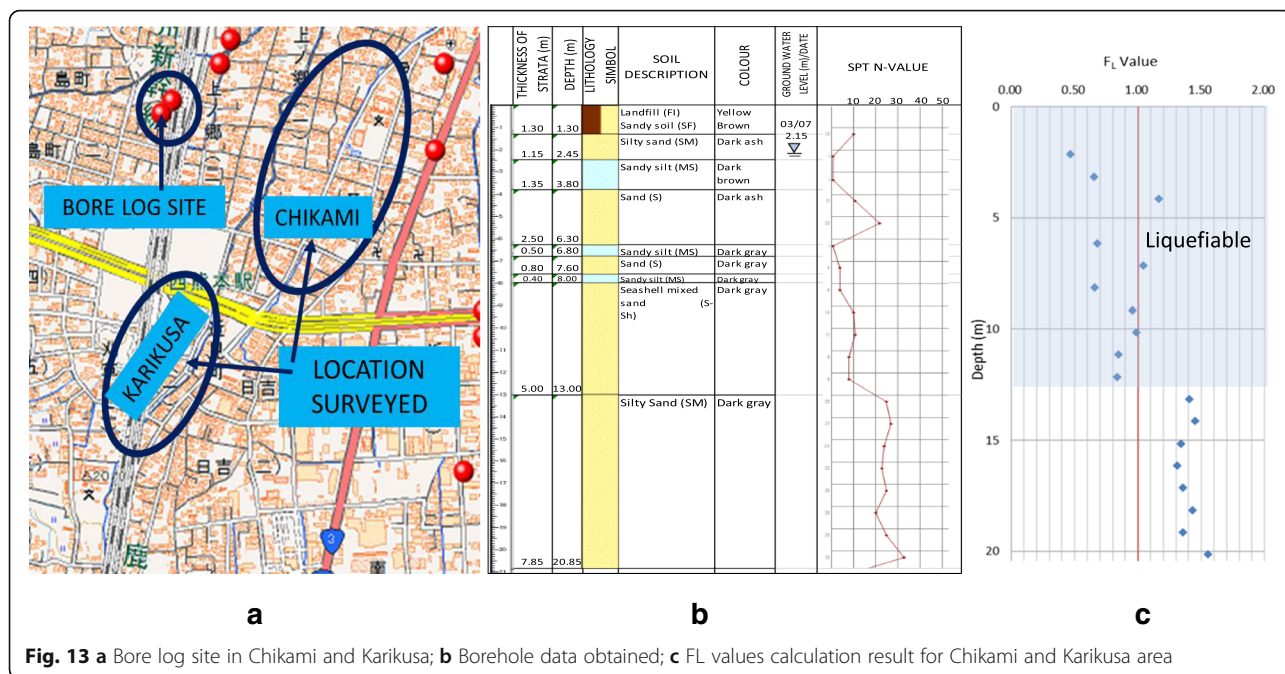
20 m depth below the ground surface. It can be seen that SPT N-value near to the ground surface is also very low, so it can be said that this ground has a high risk of liquefaction, especially from the ground surface down to a depth of around 12.5 m.

Figure 13c gives the F_L values for Chikami and Karikusa areas. Based on calculated F_L value its potential to liquefy is moderately high to a depth of about 12.5 m below the ground surface as it is composed mostly of sand and has F_L values of less than 1, specifically near the surface. Generally, the potentially liquefiable ground surface may lead to structural damage related to differential settlement and structure tilting because sand boiling has a high potential to take place.

Fig. 13 a Bore log site in Chikami and Karikusa; b Borehole data obtained; c FL values calculation result for Chikami and Karikusa area

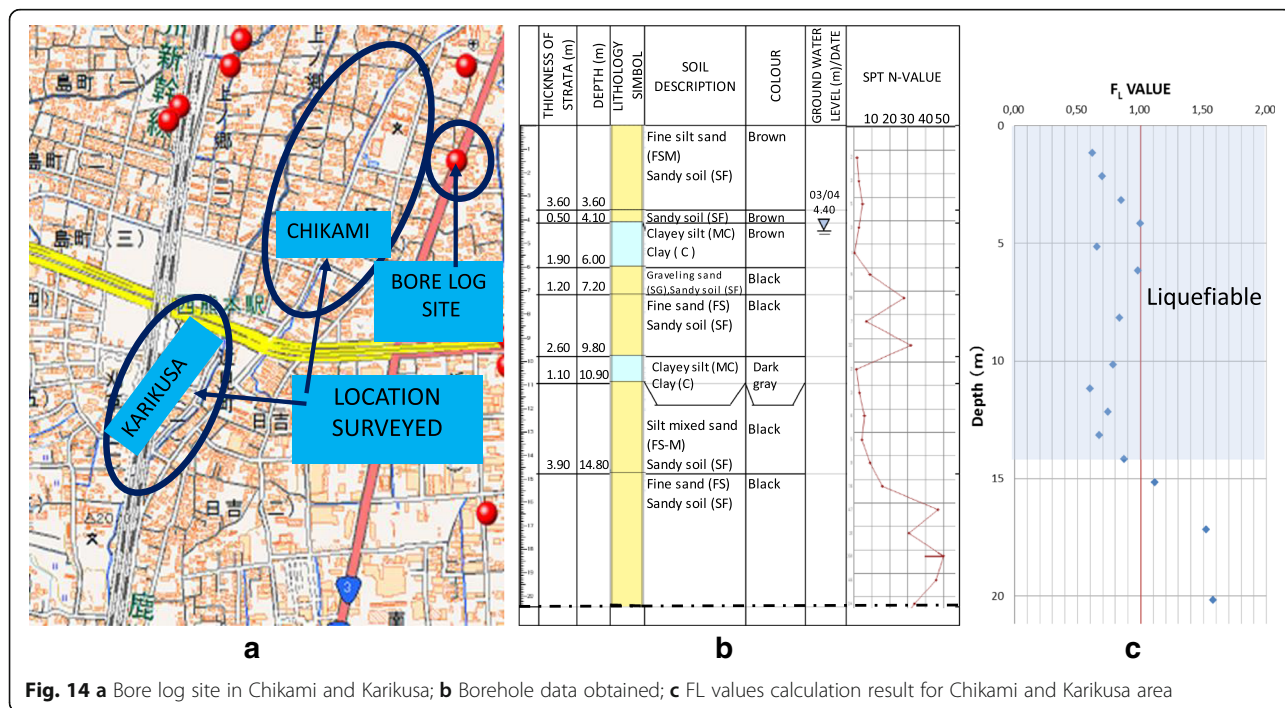
In order to ascertain ground conditions in this area, geological profiles of other two bore logs are observed in the adjacent site. The result obtained were much the same, as shown in Figs. 14 and 15.

Fig. 14 a Bore log site in Chikami and Karikusa; b Borehole data obtained; c FL values calculation result for Chikami and Karikusa area

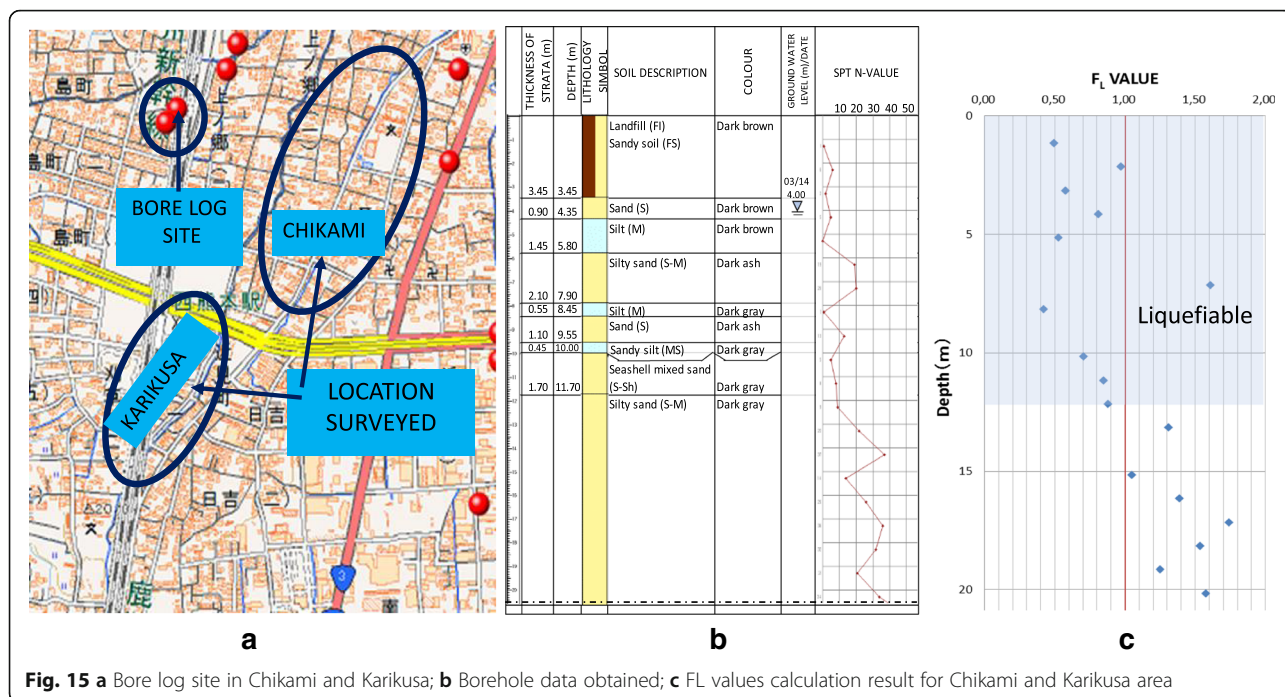
Fig. 15 a Bore log site in Chikami and Karikusa; b Borehole data obtained; c FL values calculation result for Chikami and Karikusa area

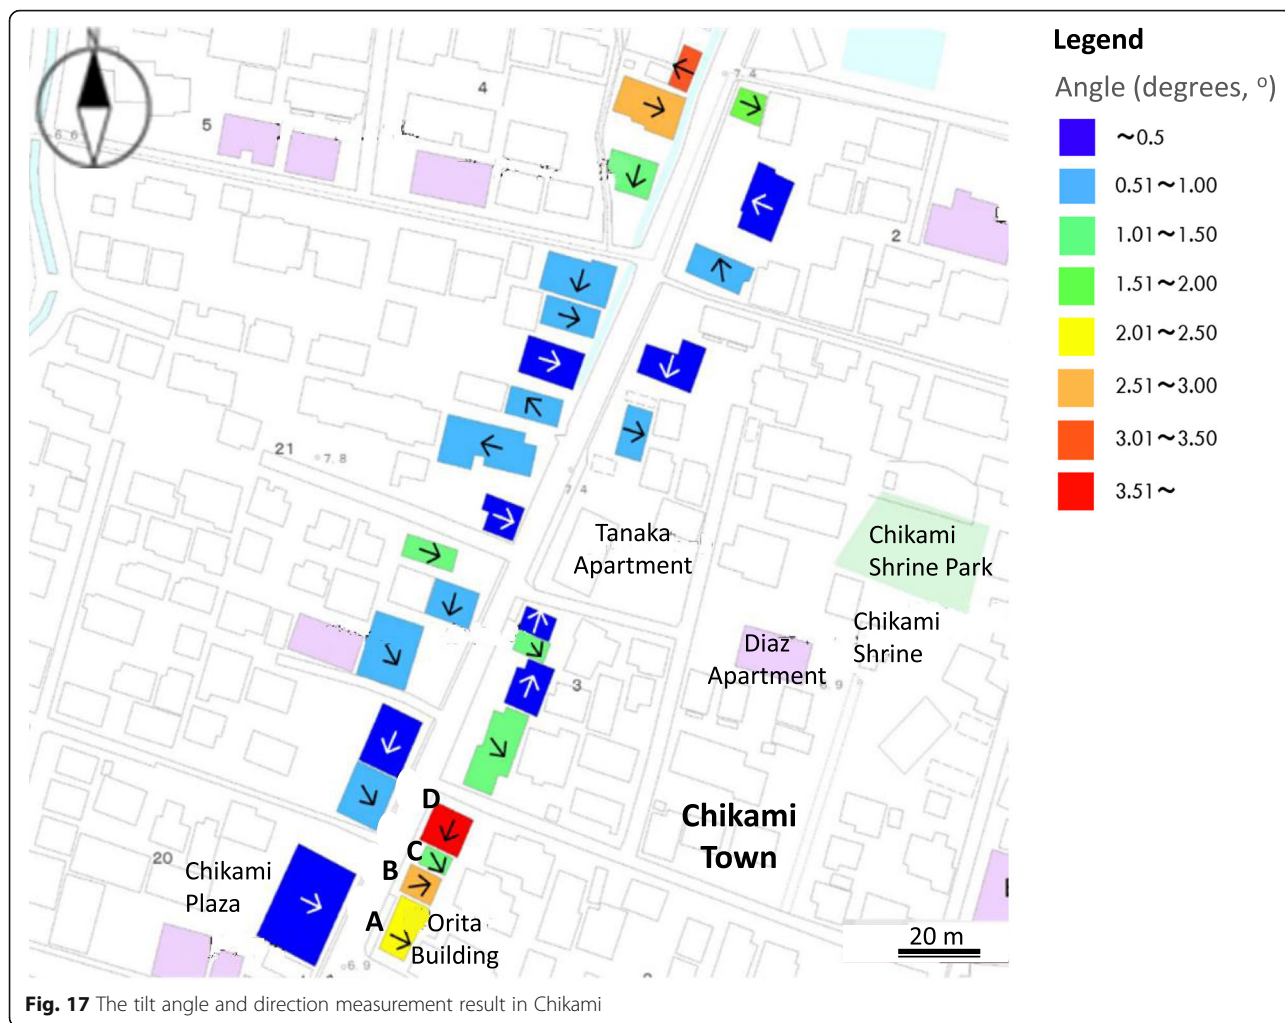
Figure 17 shows the measurement results of the inclination angle and tilt direction of the buildings in Chikami area. There is a tendency for houses experiencing large tilt angles were located on the adjacent site. It can also be seen from this figure that the direction of inclination is to the southeast where the river used to be. Structure types and building damage are summarized in Fig. 18. Differential settlement occurred in both steel framed and wooden framed buildings. The four buildings, A, B, C, and D are taller than other building in their vicinity, as a result, the tilt angle and the damage inflicted were substantial. Buildings B and C were tilted so as to appear to be attracted to each other like magnets. This was probably caused by the combined weight of the two adjacent buildings resulting in a greater settlement on the neighboring side. It also seems that the non-uniform settlements were influenced by the weight of the structure and the position of its center of mass. For building D, the north side wall was severely damaged resulting in a large inclination.

Building	a	b	c	d
Photo				
Structure Type	Steel frame, 3 storey	Wooden frame, 2 storey	Wooden frame, 3 storey	Wooden frame, 2 storey
Inclination damage	1.5° to the East	2.7° to the East, front wall is damaged	1.3° to the East, first floor is damaged	5.7° to the East, North side wall is damaged

Fig. 18 The summary of the structure type and damage level (Buildings A, B, C and D in Fig. 17) in Chikami
