CASE HISTORY—PEER-REVIEWED

Failure of a Dissimilar Metal Braze in an Expansion Joint

Brett A. Miller · Phillip D. Swartzentruber · Justin T. Barnes

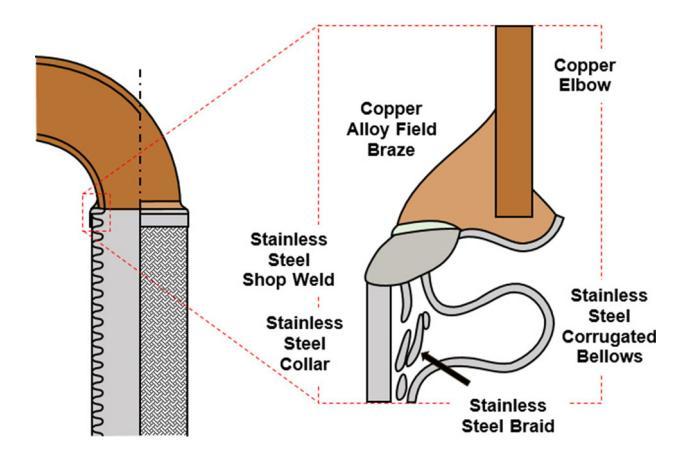
A diagram of the failed end of the expansion joint is provided in Fig. 1. The joint is not a typical braze where a

Fig. 1 Diagram of the failed joint with identifications of the components and materials. Partial cutaway (left) shows the general assembly with the inset image (right) showing the installed braze weld joint

relatively tight joint is filled by capillary action. A large gap was created where the elbow was nested into the last convolution in the assembled bellows. Large volume joints like this are usually called braze welds. Due to the liquidity necessary to fill this braze joint, it is considered likely that it could only be brazed in the horizontal orientation depicted, otherwise the liquefied braze alloy would run out of the joint.

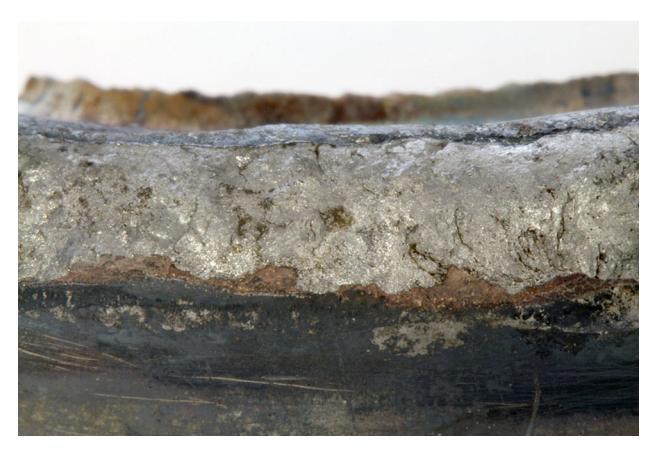
Separation occurred through the brazement adjacent to the stainless steel expansion joint weld. The color of the braze alloy was grayish brown, suggestive of a copper alloy filler metal. The fracture appeared macroscopically brittle, without any permanent plastic deformation. There was no impact evidence or macroscopic brazing or fabrication flaws. A representative region of the fracture is shown in Fig. 2. The features were dull and did not exhibit the normal matte appearance of ductile rupture which would be

Fig. 2 Close-up photograph of a typical region of the fracture surface

expected for a copper alloy braze. Some angular features were evident at low magnification. No gross incomplete braze fusion was identified.

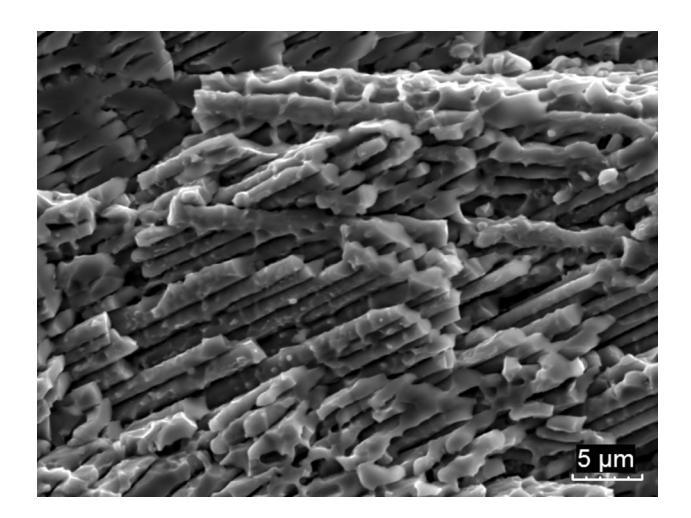
Fig. 3 Electron image of a representative fracture region

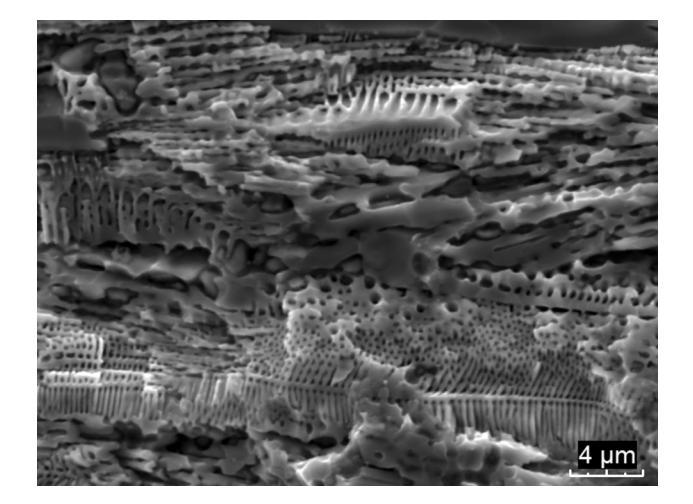
Fig. 4 Electron image of another fracture zone which exhibited different morphologies

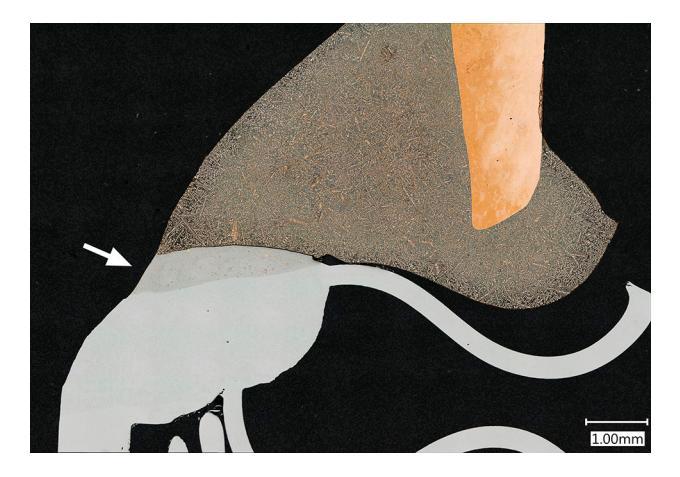
Fig. 5 One cross section of the expansion joint brazement is pictured. An intermetallic phase was identified (arrow) between the braze and the stainless steel weld (potassium dichromate etch)

All of the cross section specimens contained an irregular phase that formed between the braze alloy and the stainless steel weld. This phase was continuous, from the OD to the ID of the joint. The features suggested this was an intermetallic phase rather than trapped flux or slag. Cracking was isolated to this intermetallic phase and did not follow a particular structure. Higher-magnification images of the intermetallic phase are included in Figs. 7–10. Various etchants were used singly and in succession, but Waterless Kallings and 10% oxalic acid (electrolytic) revealed the intermetallic microstructure best. Copper spheres were evident in the intermetallic, a condition which is often observed in brazing intermetallic layers. The unusually thick intermetallic contained both lamellar and somewhat

With regard to prevention, the prohibition of this filler metal for dissimilar metal joints between copper and stainless steel should be strictly observed. Copper and stainless steel base metal combinations may be successfully brazed using silver, nickel or gold-alloyed copper filler metals (with suitable fluxes), where deleterious intermetallic layers do not form [4]. Joining research has shown that interfacial barrier layers of nickel on stainless steel and copper on mild steel can suppress phosphide layer formation when phosphorus-bearing alloys are selected [5].

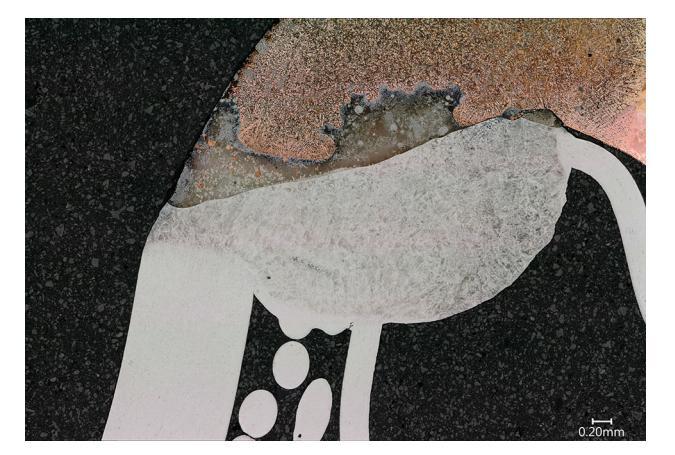
Fig. 6 An additional cross section revealed a more irregularly shaped intermetallic phase (10% oxalic acid electrolytic etch)

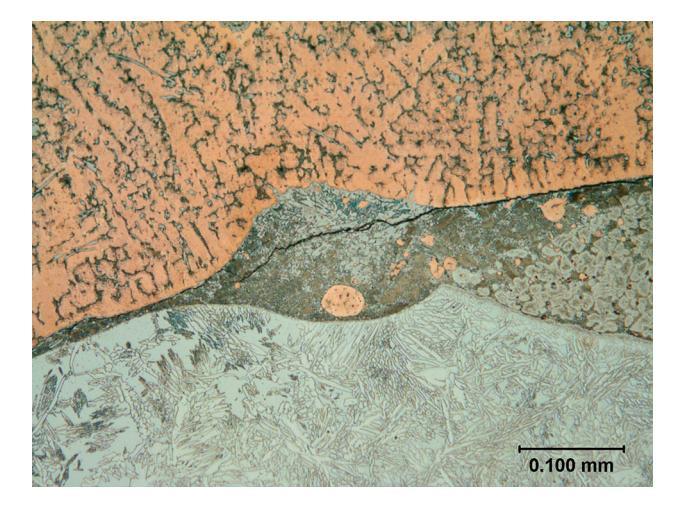
Fig. 7 Photomicrograph of cracking which was isolated to the intermetallic layer between the copper braze (top) and the stainless steel weld (bottom) (Waterless Kalling's reagent etch)

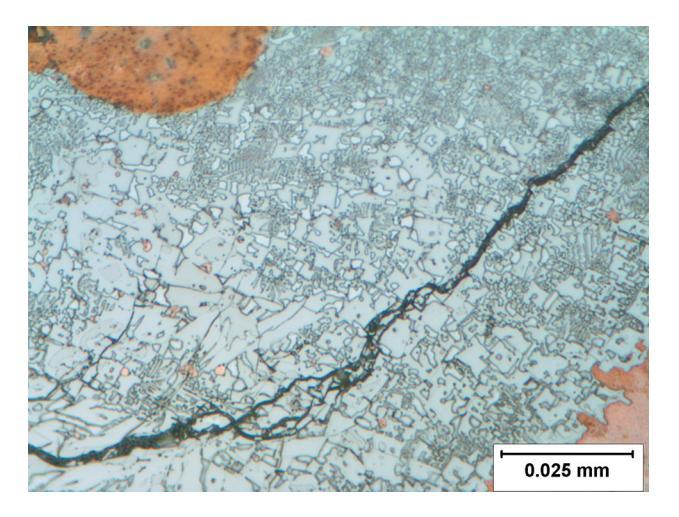
Fig. 8 Additional image of cracking through the intermetallic showing that the cracks did not follow any unique features (Waterless Kalling's reagent etch)

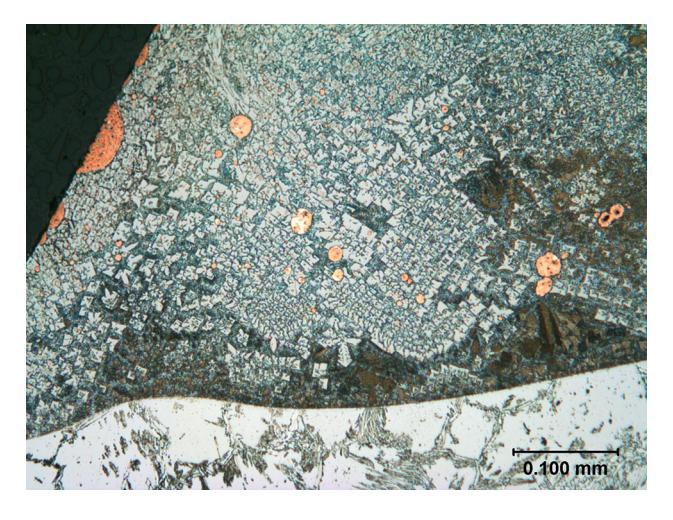
Fig. 9 Moderate magnification image showing the unique microstructure of the intermetallic layer (oxalic acid/Waterless Kalling's reagent etch)

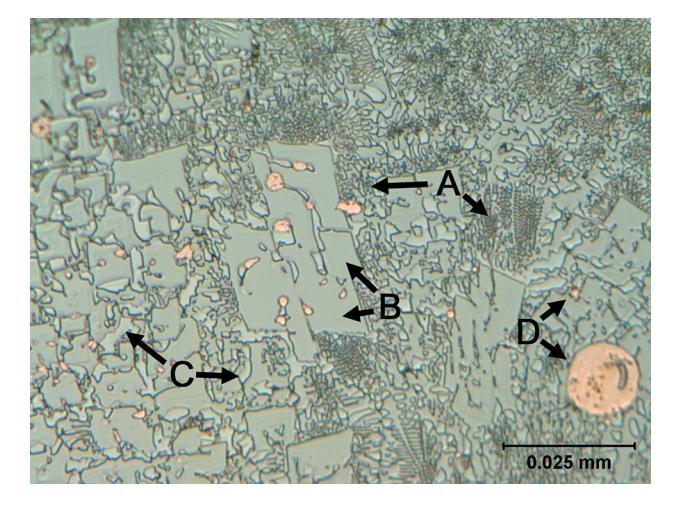
Fig. 10 High-magnification image showing the intermetallic microstructure. A number of phases were apparent, including a lamellar phase (a), a somewhat cubic blocky phase (b), a lighter hued irregular phase (c) and copper spheroids (d) (oxalic acid/Waterless Kalling's reagent etch)

The composition of the intermetallic compound, in Table 1, consisted primarily of iron, chromium, phosphorus, nickel and copper, along with trace levels of silicon and manganese. This layer contained all of the elements from the stainless steel and most of the elements from the braze alloy. However, silver was absent from the intermetallic in the regions that were analyzed. The copper level was relatively low, as much of the copper appeared to have been separated into the copper-colored spheroids in the intermetallic microstructure (Figs. 8 and 9). EDS analysis of a larger spheroid revealed that its composition was greater than 90% copper. SE and BSE SEM examinations showed identifiable boundaries between the cubic-shaped and lamellar structures within the intermetallic layer, but no compositional differences could be quantified by EDS analyses. The intermetallic was likely composed of mixed metal phosphides likely M₃P-M₂P, iron, nickel, chromium and copper phosphides, but this could not be confirmed.
