An unusual failure of cardiac resynchronization therapy

Satoshi Higuchi¹ · Henry H. Hsia¹

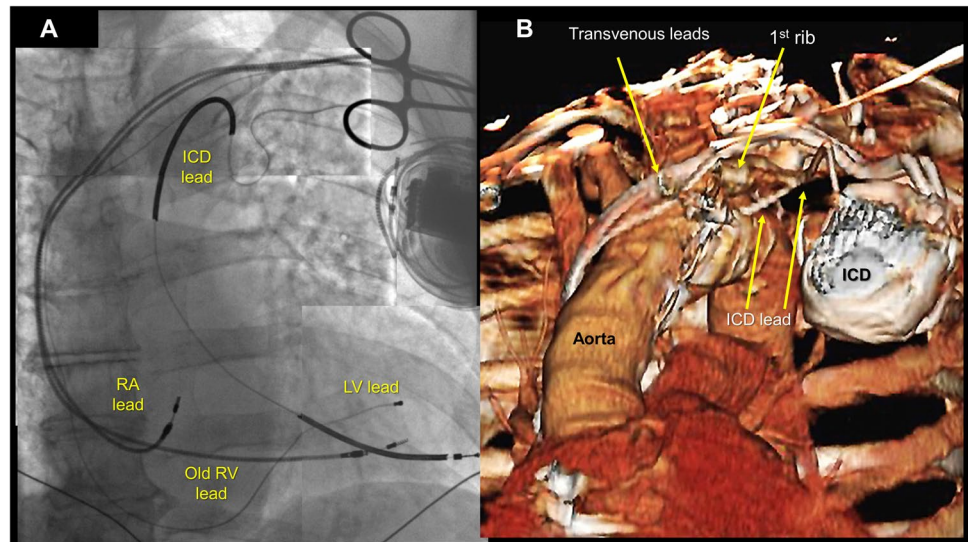
This case illustrated a spectacular complication of a transarterial placement of the ICD lead into the aortic arch and a unique cause of CRT failure, with epicardial and endocardial pacing across the lateral LV wall. Although inadvertent arterial puncture can occur during routine access using the subclavian or proximal axillary vein [1], an LV lead placement can be prevented with a high index of suspicion, marked by an abnormal course of the wire on radiography after accessing the vasculature. A long wire should be advanced to the level of the inferior vena cava, below the right diaphragm before insertion of the sheaths and leads. Moreover, in cases with a challenging access, alternative approaches, such as an ultrasound-guided puncture or cut down of the cephalic vein would be of benefit to obtain access without risk of inadvertent arterial puncture.

Fig. 1 **A** Rightward and inferior displacement of the ICD lead. **B** ICD lead traversing under the first rib

with serial echocardiographic follow-ups. Biventricular pacing and resynchronization therapy was re-established using the original LV epicardial lead as well as the old right ventricular endocardial pacemaker lead. He noted an immediate and marked improvement in his heart failure symptoms, which continued to improve over the subsequent months. A follow-up echocardiogram 5 months later showed a recovered LV ejection fraction of 50%.
