Microstructural Aspects of Premature Pitting Corrosion of Steel Pipe–Case Study

Dorota Tyrała · Bogdan Pawłowski

Abstract A premature pitting corrosion in seam-welded 3-inch L235 steel pipe was reported to occur after 8 years in service. This pipe was part of a closed ice water cooling system, where the inlet water temperature was 6 °C and the outlet water temperature was 11 °C. The present work aimed to investigate the causes of this premature pitting corrosion of the pipe through metallographic investigations. This work comprised a visual examination of the internal surfaces of the pipe and microstructural examinations of the corrosion perforation regions (pitting corrosion areas) using optical and scanning electron microscopy (SEM) with energy dispersive X-ray (EDX) analysis. The investigations showed that the corrosion pits occurred only in areas with a huge number of specific micro-voids that can be associated with the excessive presence of trapped hydrogen dissolved in the steel, probably during steelmaking operations.

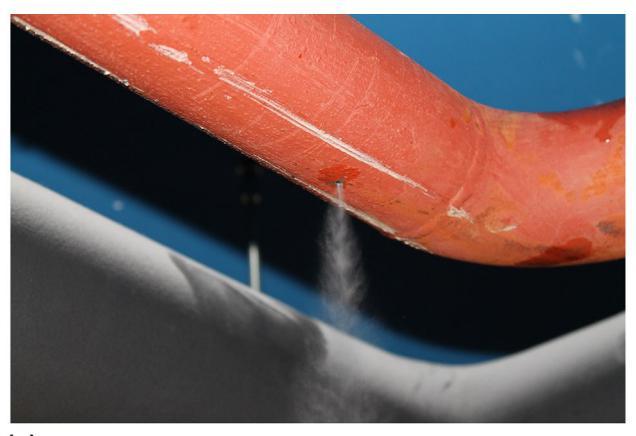
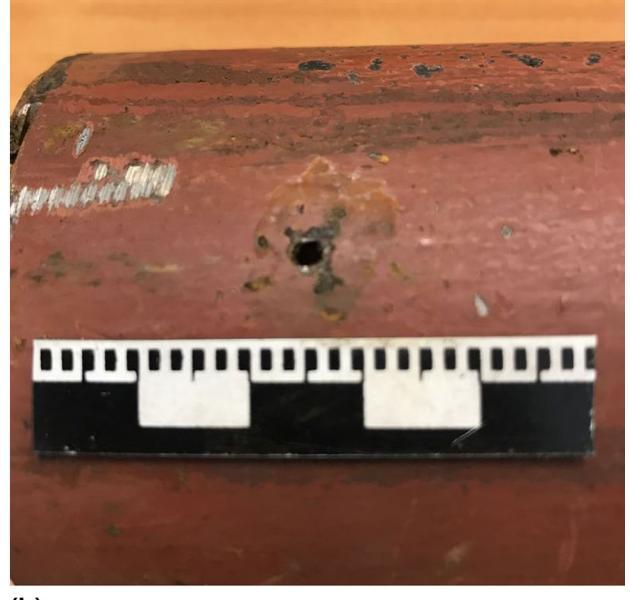
The purpose of this work was to determine the reasons for premature pitting corrosion failure (leakage of coolant occurred at several points) in a seam-welded 3-inch L235 steel pipe, which was reported to occur after 8 years in service (Fig. 1).

Fig. 1 Pitting failure of the pipeline (a) and fragment of pipe taken for testing $\left(b\right)$

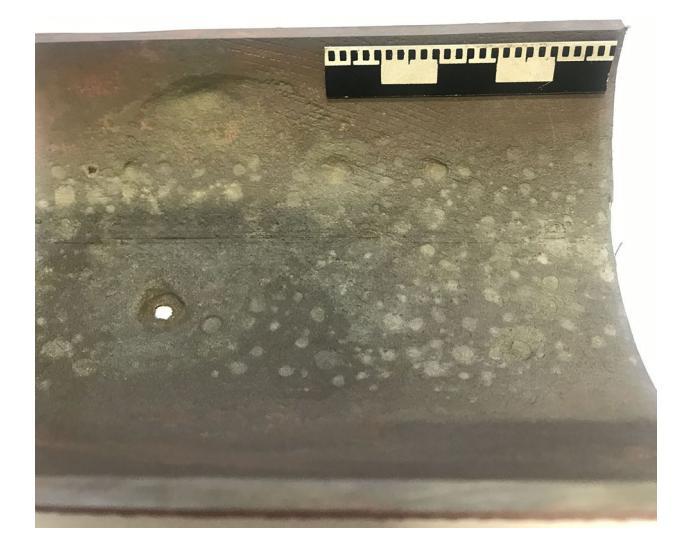
Fig. 2 Macroscopic view of the pitting area (inner surface after corrosion deposits were removed)

Visual examination of the internal surfaces of the pipe near the perforation revealed that there were many corrosion pits of larger and smaller sizes that did not perforate the pipe wall (Fig. 2). This photograph also shows the seam weld line is not the preferred pitting site. It is worth noting that the inner surface of the pipe away from the perforation was free of pitting.

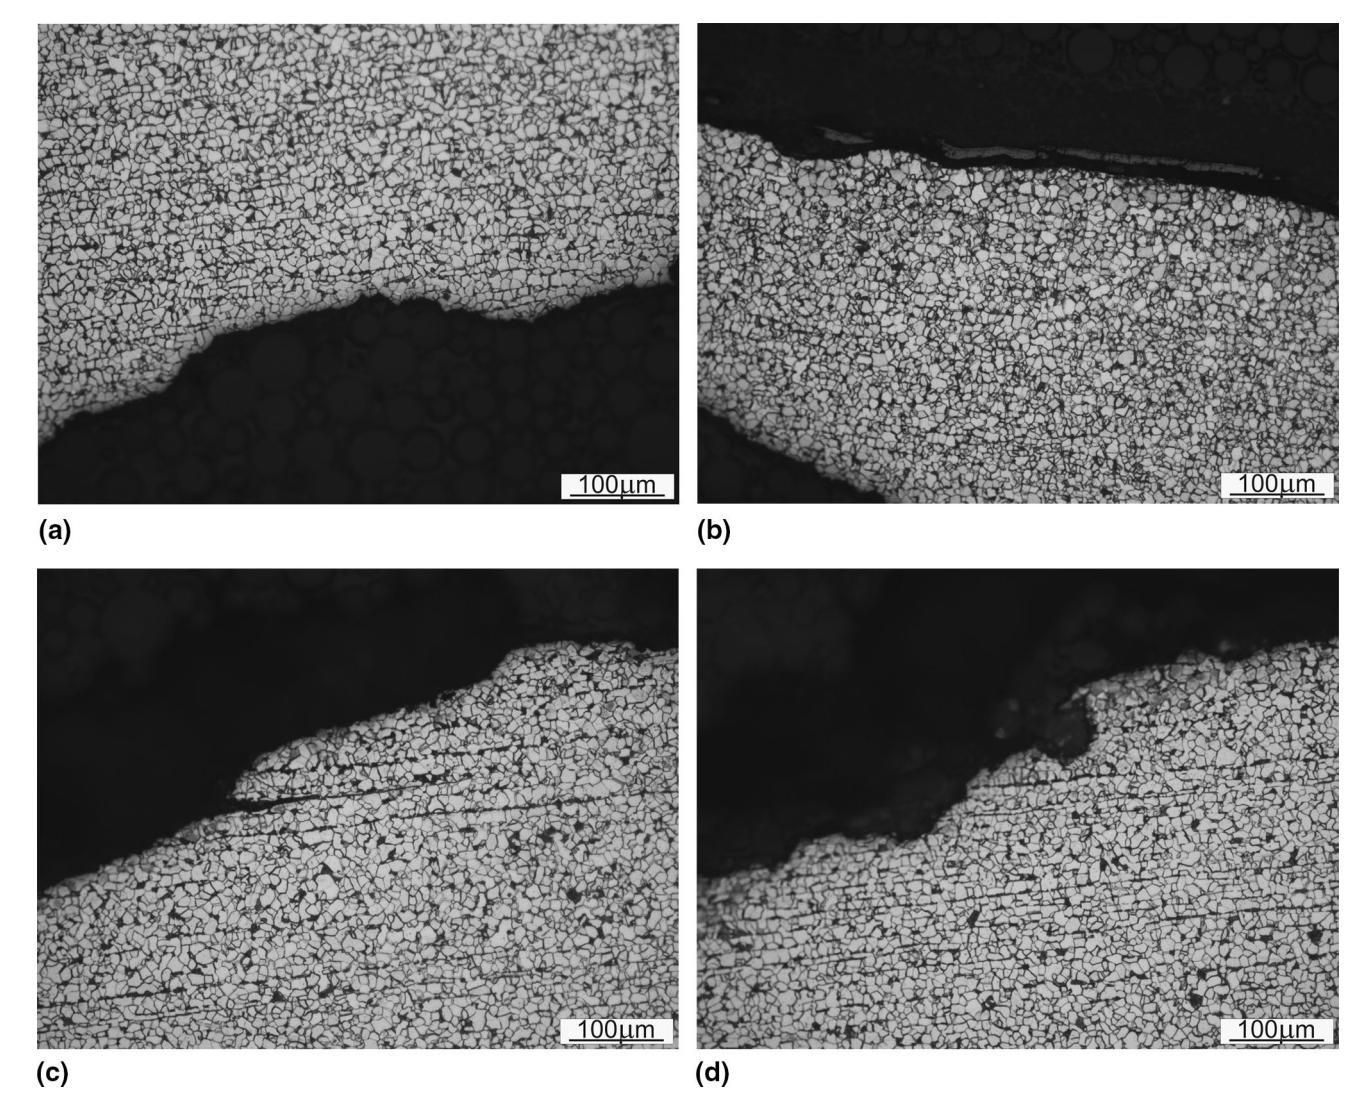
Fig. 3 Microstructures near the corrosive perforation, both transverse (a, b) and longitudinal (c, d) cross section

Metallographic examinations revealed a typical microstructure for this type of steel, consisting of ferrite grains with small islands of perlite. Typical microstructures are shown in Fig. 3.

Apart from the perlite grains (in the photographs of dark areas) arranged most often in bands alternating with bright ferrite grains, several dark areas were also observed which could not be clearly identified in the light microscope. Nothing was observed during the metallographic examinations that could explain the pitting corrosion and perforation of the pipe wall. Therefore, further observations of the microstructure were made using scanning electron microscopy.

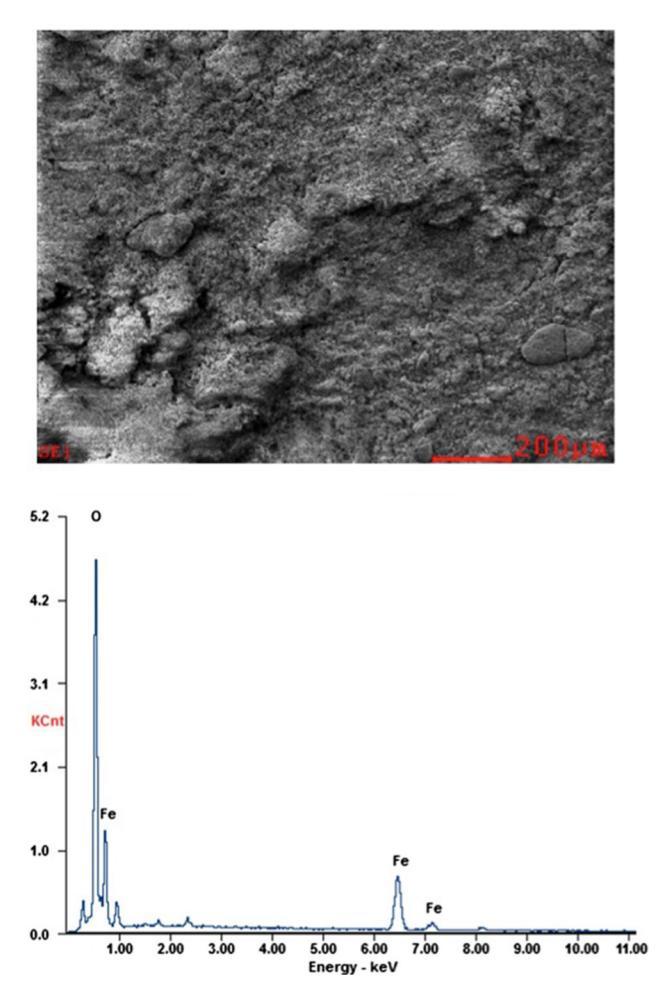
EDS analysis of sediments collected from inside the pipe showed that they are only corrosion products (iron oxides), as shown in Fig. 4.

Fig. 4 EDS area analysis of sediments collected from inside the pipe

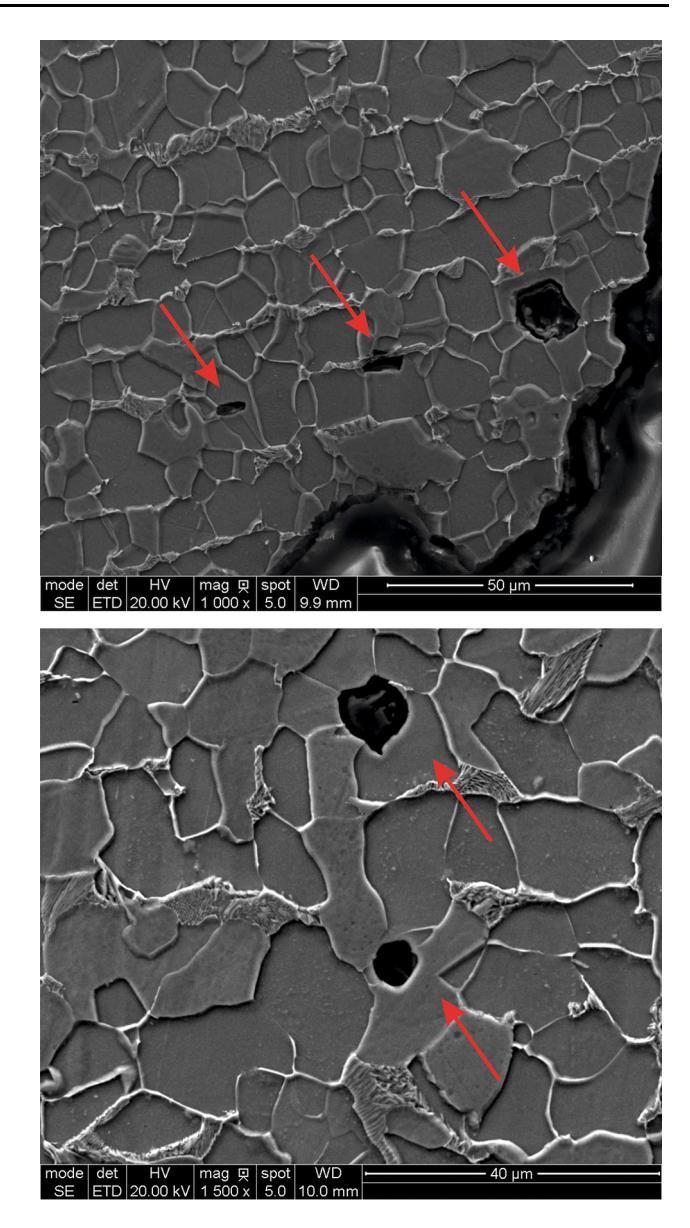
SEM observations of microstructures near the corrosive perforation revealed the presence of three types of microscopic defects. Examples of defects of the first type are in the form of regular voids (micropores), as shown in Fig. 5.

Fig. 5 Micro-voids (micropores)-the first type of observed microdefects

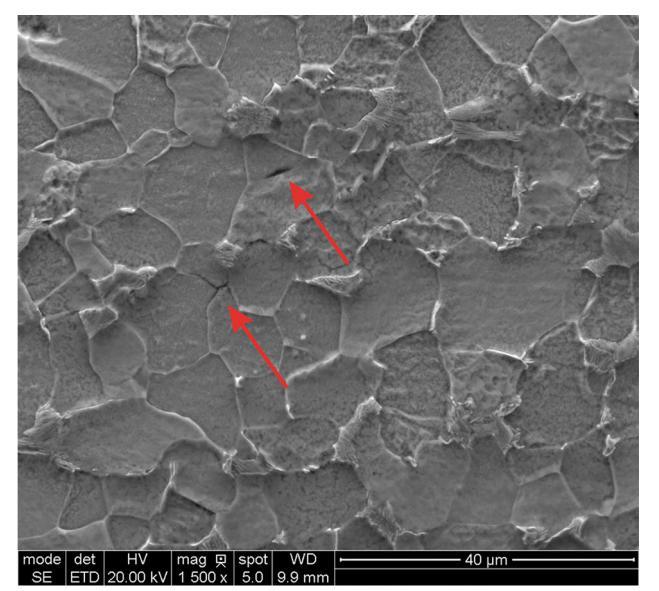
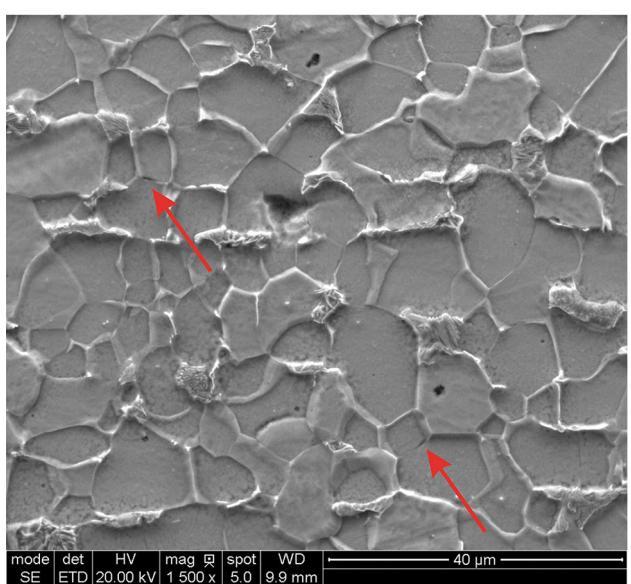
The second type of observed defects are microcracks, mainly at the grain boundaries–Fig. 6

Fig. 6 Microcracks-the second type of observed microdefects

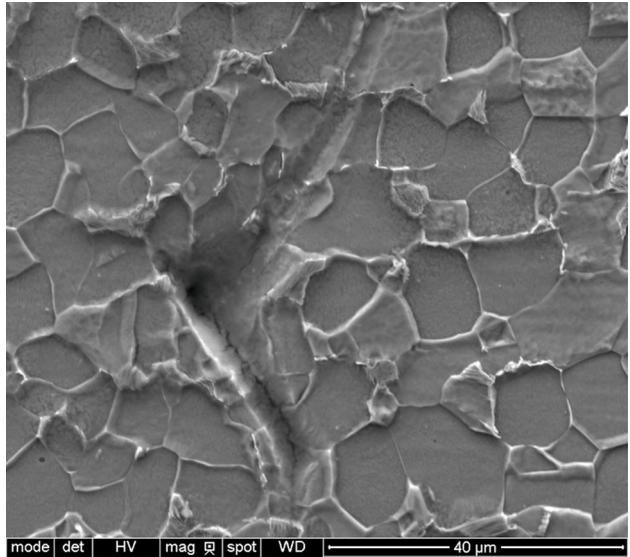
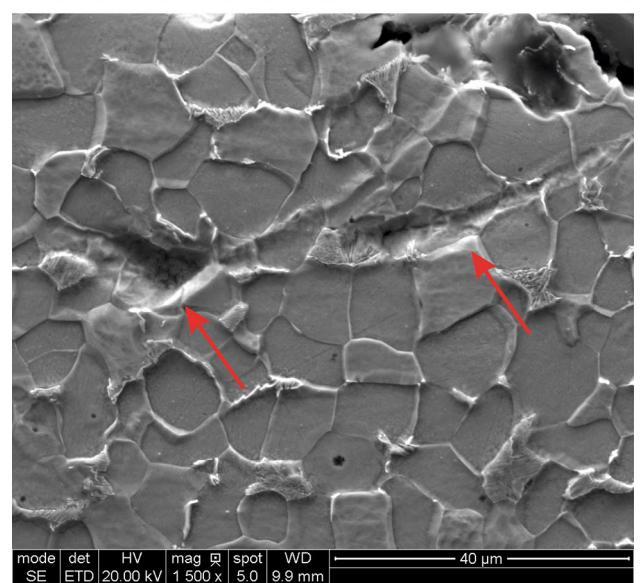
The third type (so-called "rooster feet") was most often observed in the form of local deformation areas at the bottom of which microcracks were visible, as shown in Fig. 7.

Fig. 7 Local deformation areas-third type of observed microdefects
