## Weathering phenomena, rock physical properties and long-term restoration intervention: a case study from the St. Johannis Chapel of Lütgenrode (Lower Saxony, Germany)

Siegfried Siegesmund<sup>1</sup> · Frank Wiese<sup>1,2</sup> · Calvin Klein<sup>1</sup> · Ulrich Huster<sup>3</sup> · Christopher Pötzl<sup>1</sup>

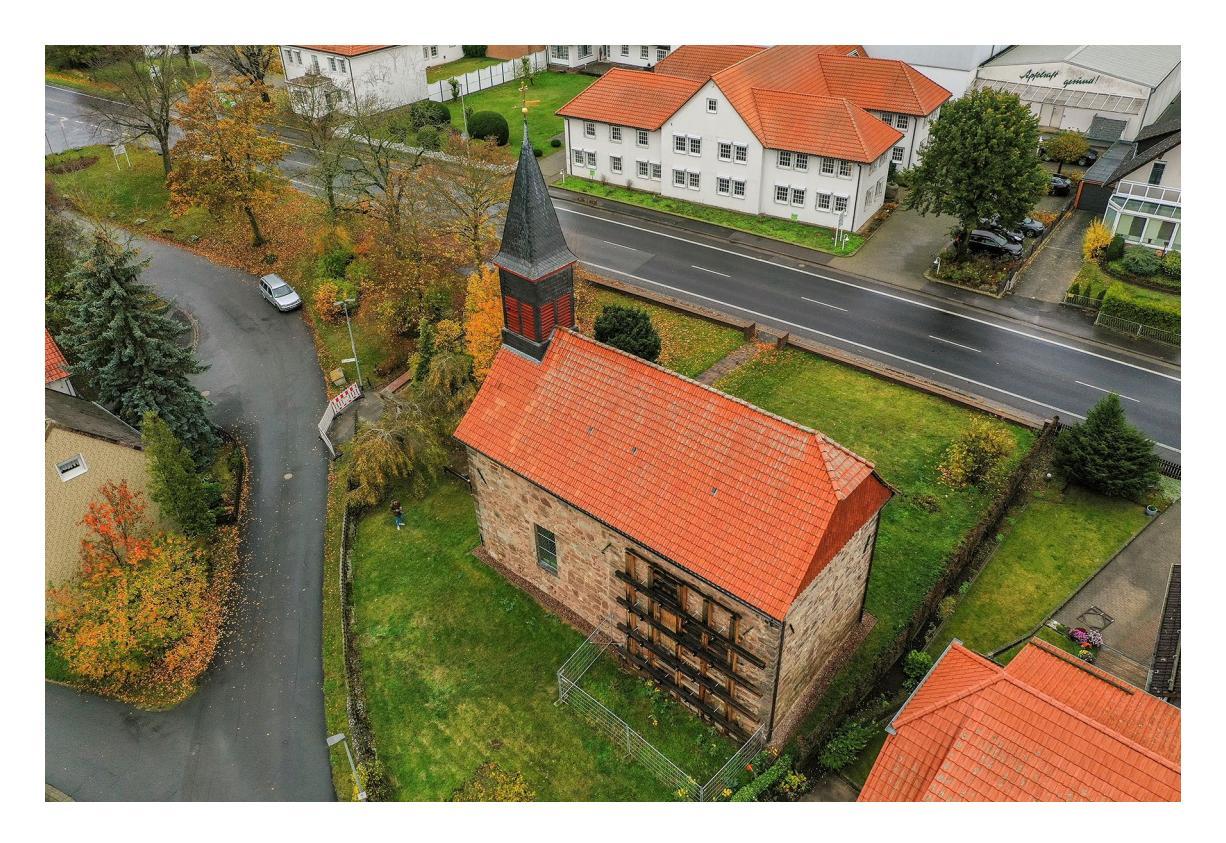
Fig. 1 The St. Johannis Chapel in Lütgenrode with supporting construction on the south side in 2020

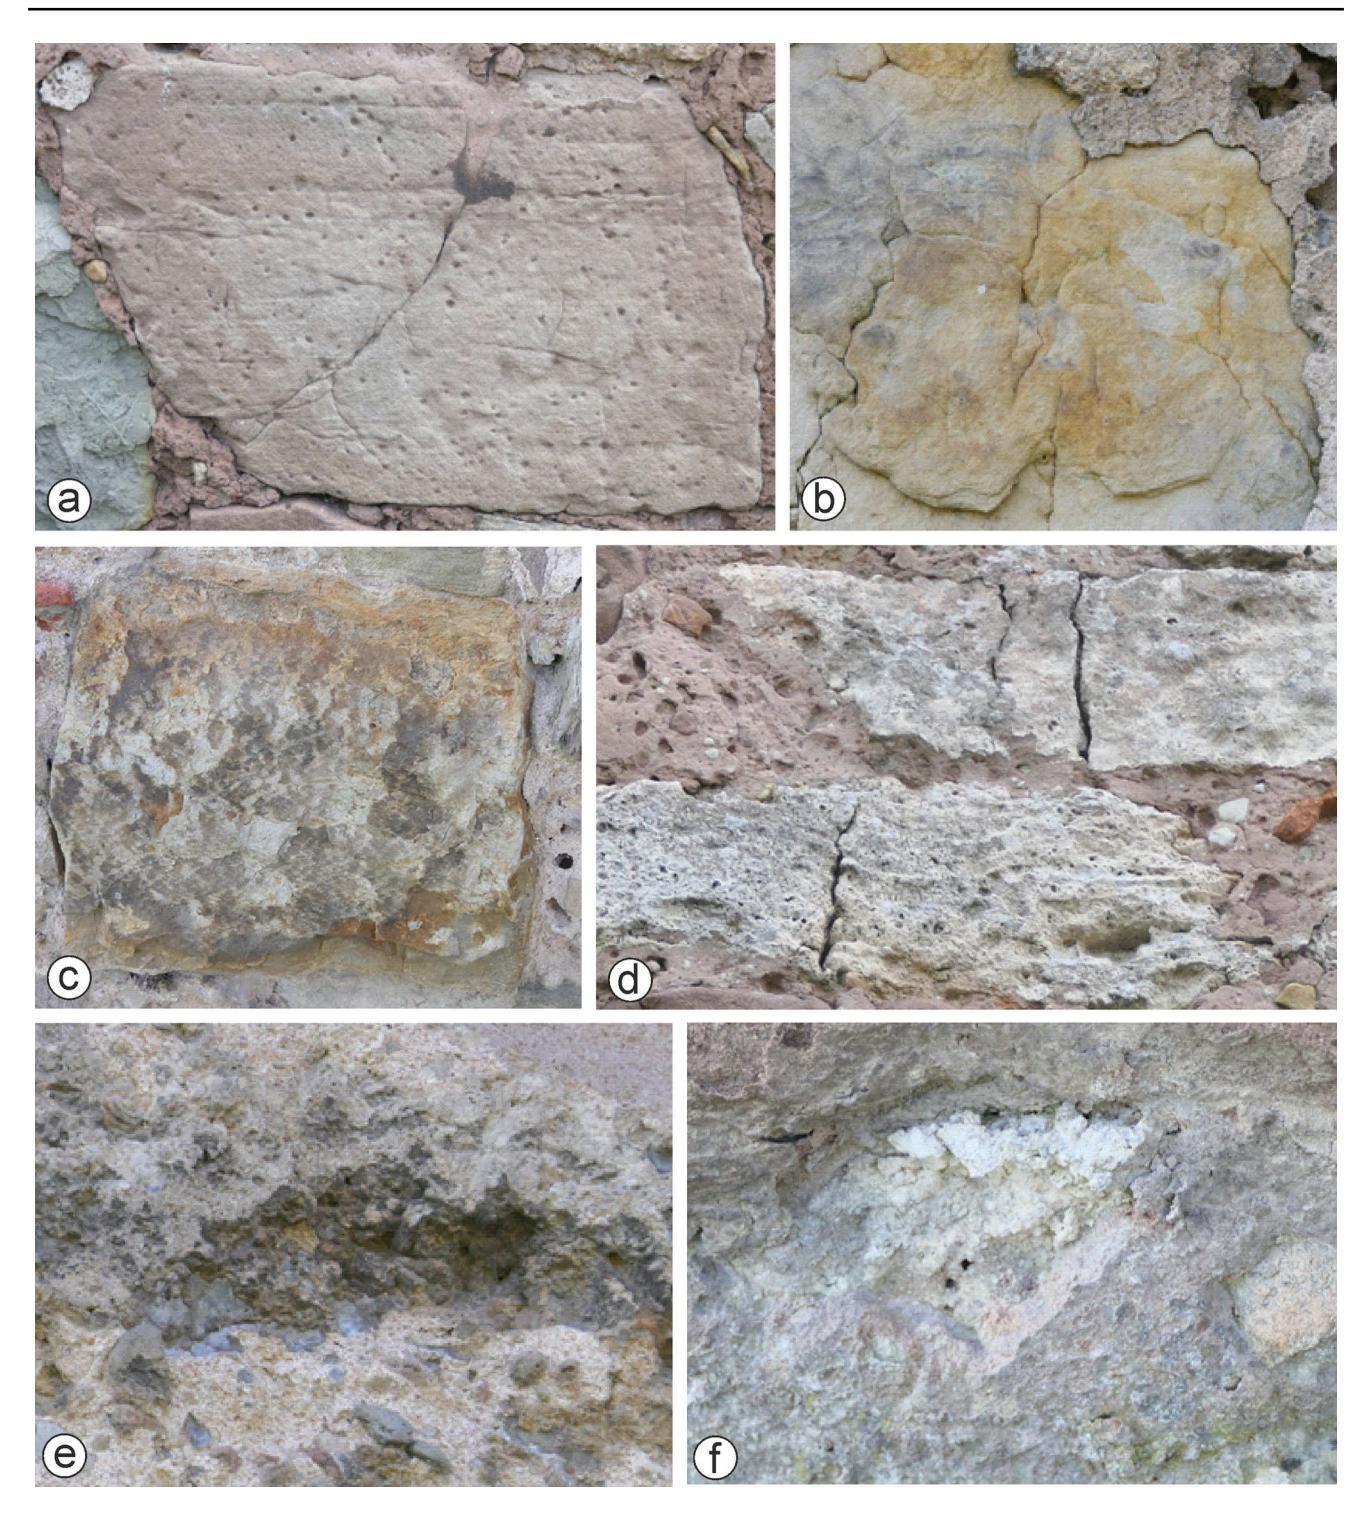
Fig. 15 a Crack formation and rock fragmentation in the grey-green Solling Sandstone (width: 50 cm). b Superficial iron enrichment (width: 30 cm). c Soiling, iron enrichment and biological colonization (width 20 cm). d Vertical fractures as a result of larger crack

structures in the Holocene Duckstein (widht: 50 cm). e Soiling and gypsum crusts on calcareous rocks (width: 10 cm). f Salt efflorescence and loss of material (width: 25 cm)

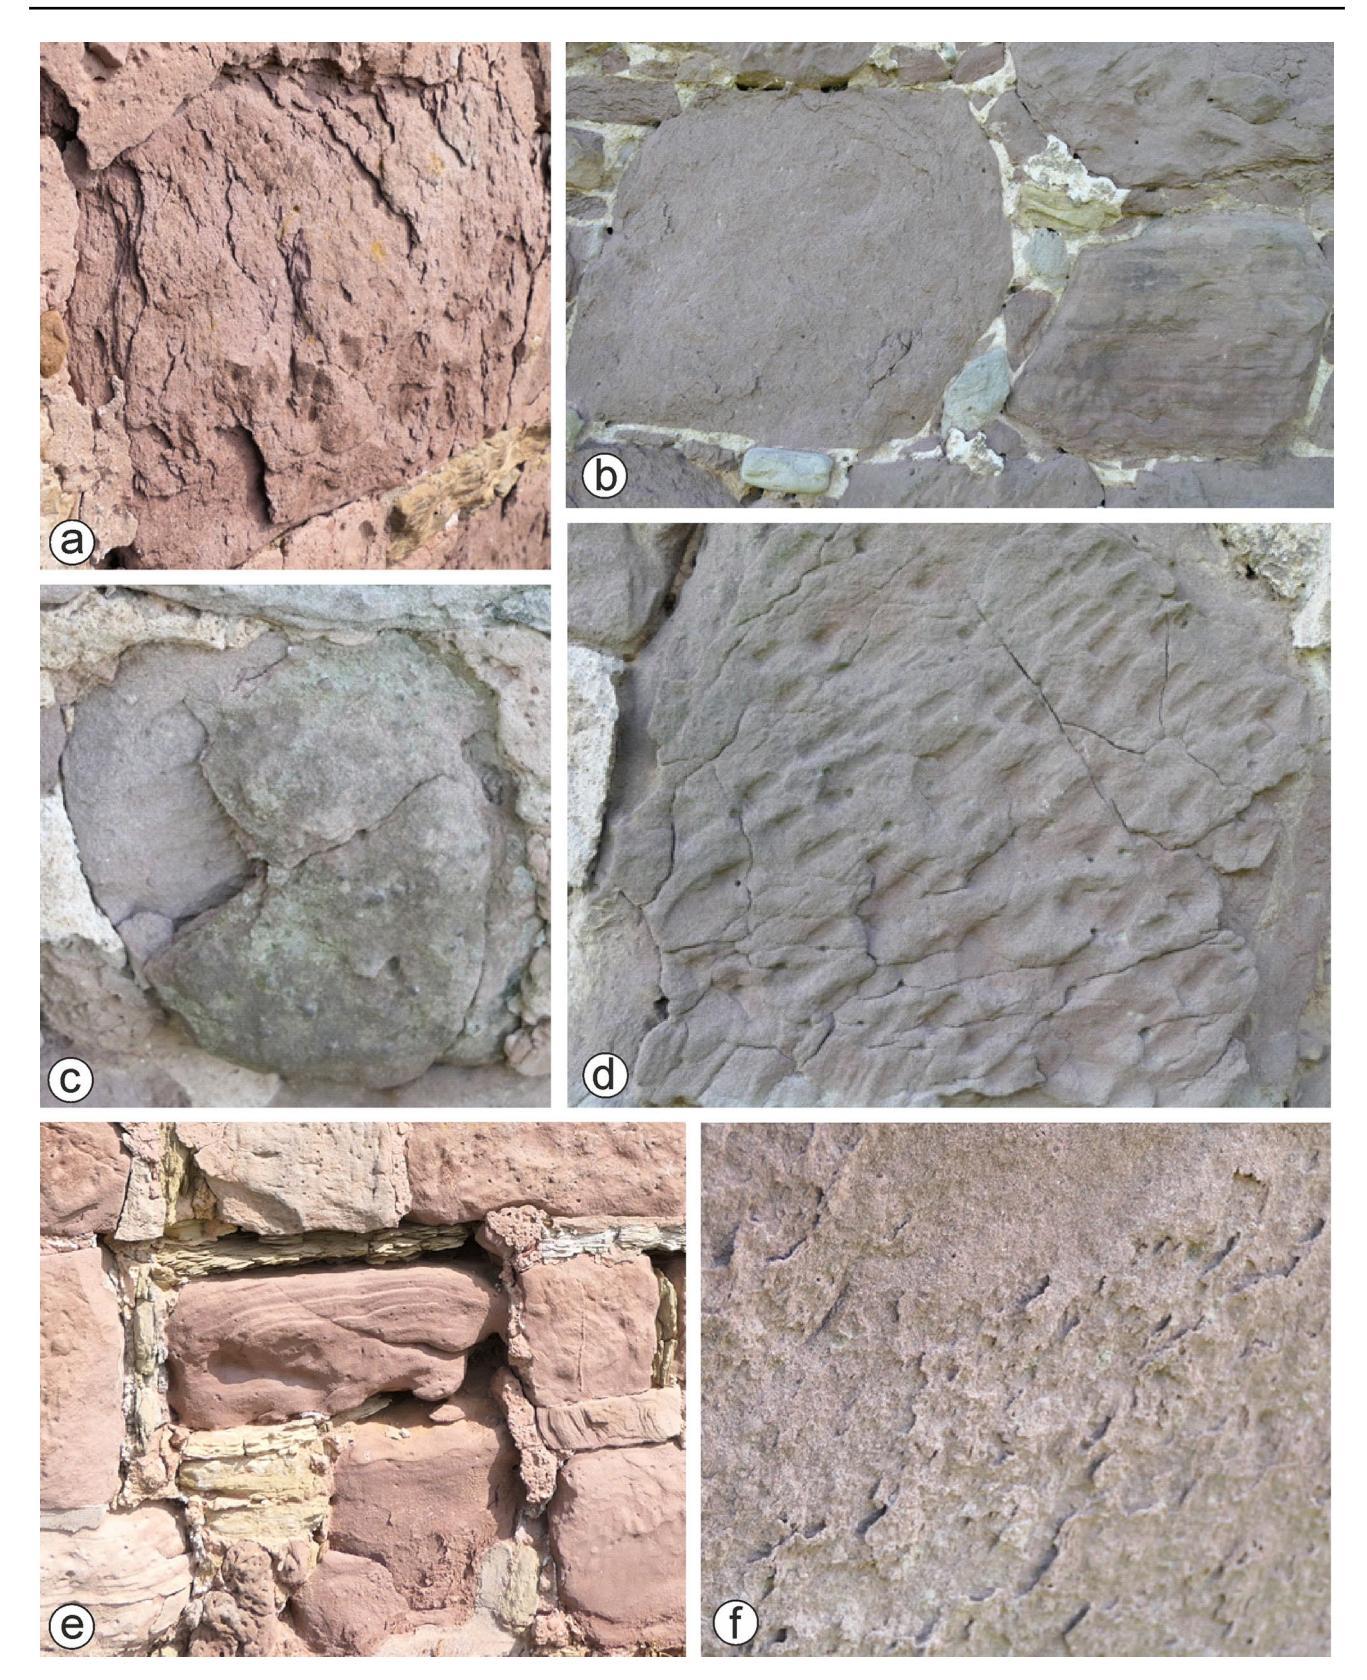
◄Fig. 16 a Scaling of red Solling Sandstone (width 45 cm). b Different orientation of sandstone ashlars; bedding parallel to the surface (left) or vertical to the surface (right) (width: 60 cm). c Large scales are often present if the ashlars are installed parallel to the bedding (width: 19 cm). d Progressive weathering into the core of the stone results in surface parallel scales and cracks (width: 42 cm). e Rounding and sanding of red Solling Sandstone on the southern facade (width 90 cm). f Spalling and flaking phenomena are present on many sandstone surfaces (width: 7 cm)

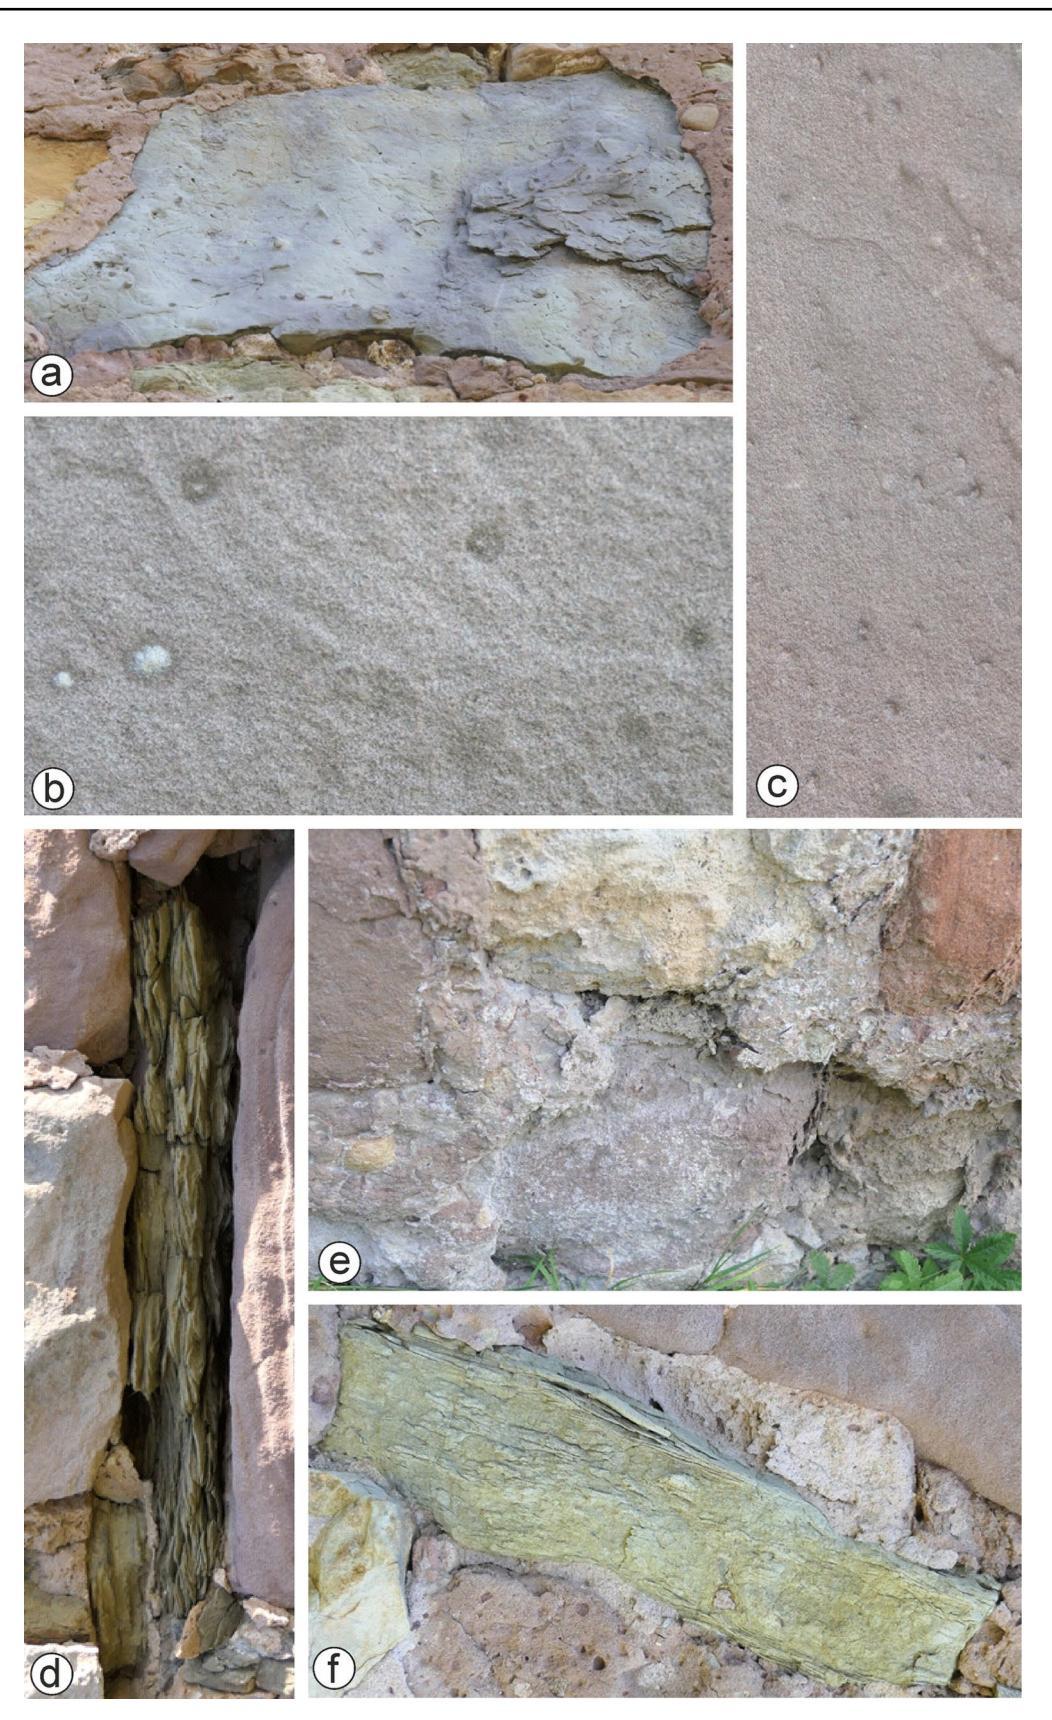
◄Fig. 17 a Surface parallel flaking and scaling on the Schilfsandstein (width: 45 cm). b Selective dissolution of carbonatic concretions (width 13 cm). c Loss of matrix leading to protruding of more resistant components (width 7 cm). d Extreme example of fabriccontrolled back-weathering in the form of splintering (height: 60 cm). e Formation of salt crusts on rocks in the base area of the chapel (width: 55 cm). f Expansion processes leading to scaling parallel to the bedding (width 33 cm) were postponed in favor of cheaper punctual repairs. Often enough, architectonically and historically the most valuable among them are located in structurally weak regions. If such objects are listed as an important cultural heritage, there is hope that something will be done to preserve them. However, the St. Johannis Chapel in Lütgenrode is not the only church which needs an urgent reconstruction belonging to the church office Göttingen–Münden. The funds of the church office for the preservation of all churches, which

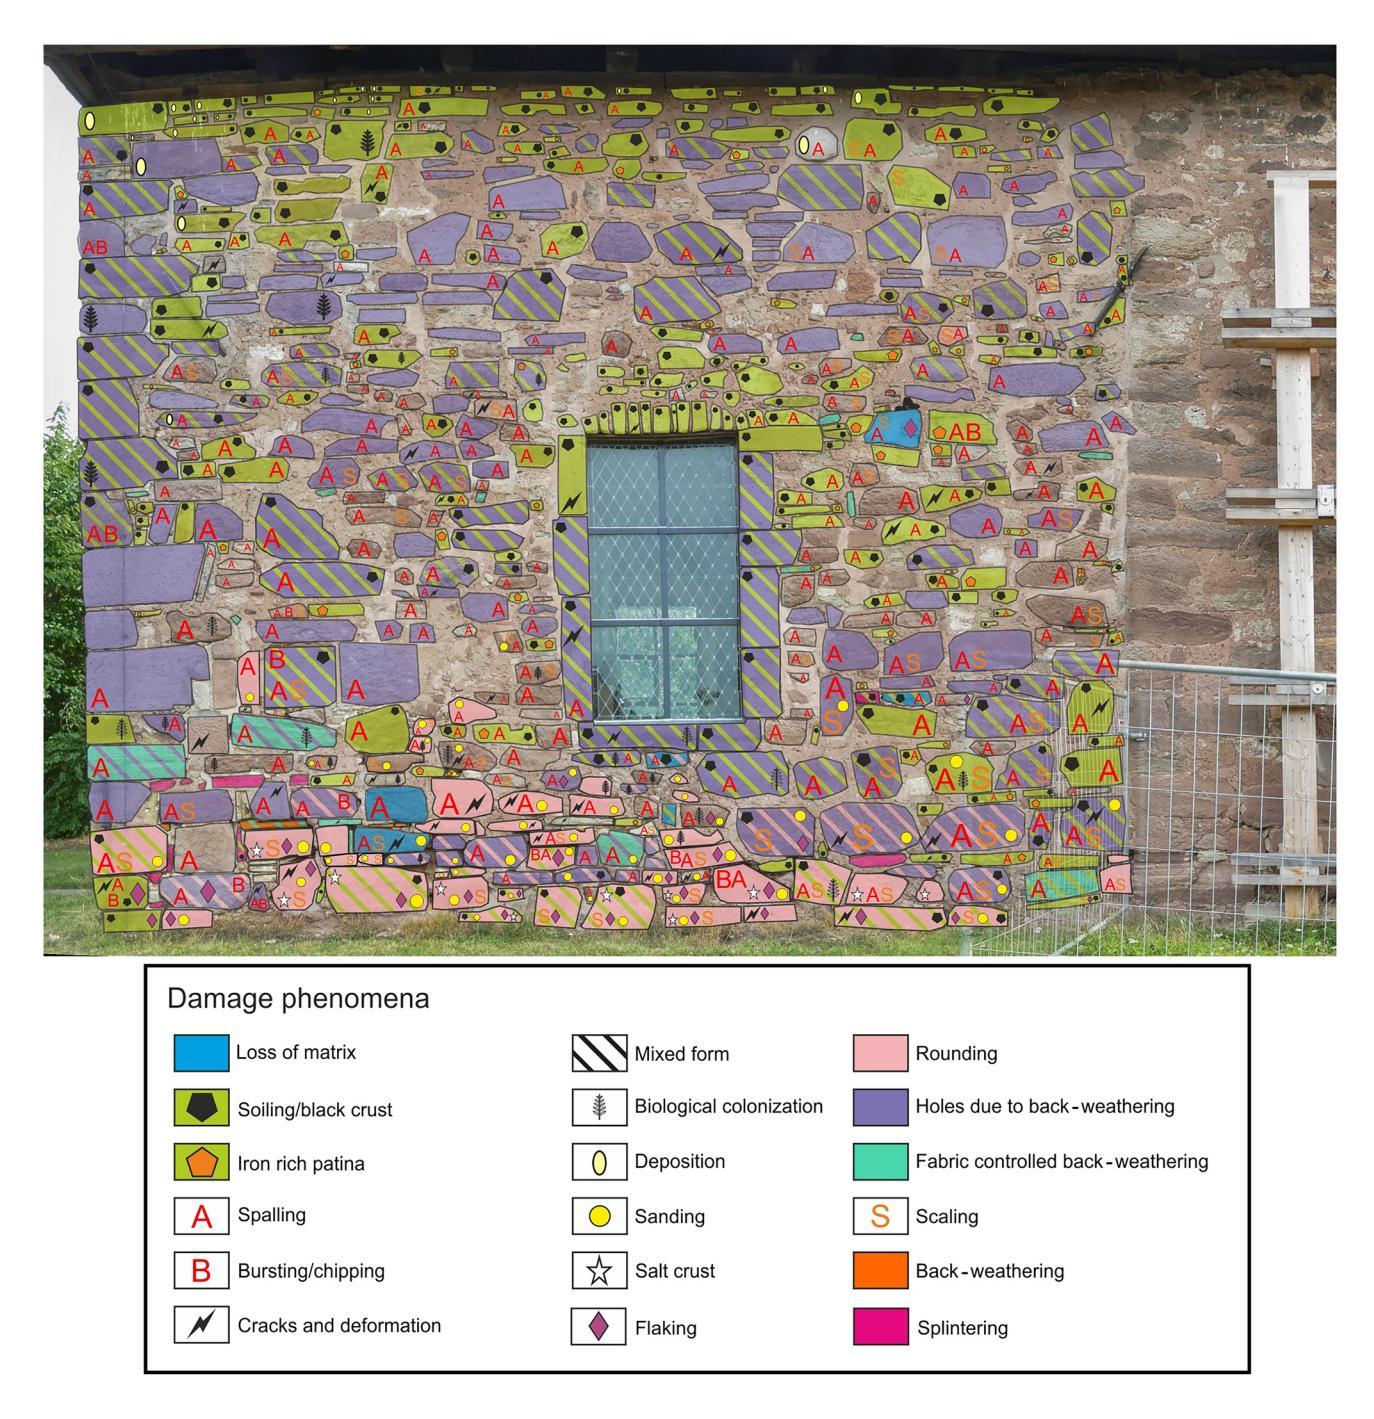
only the western part could be reliably mapped (Fig. 18). The most common damage is minor chipping and spalling (35%), pollution and black crusts (30%) as well as smaller cavities through back-weathering (26%). These three damage groups are distributed over the entire side of the build-ing. However, the intensity of damage that the rocks have

suffered from the three phenomena is quite low. Black crusts are quite rare. Most of the stones are soiled. All other weathering phenomena are significantly less present (< 10%).

In parts, the intensity of damage caused by scaling, sanding and rounding is enormous. Due to the strong rounding of some ashlars, cavities are created in the former corner areas, which can reach down to a decimeter and ultimately may have a potential negative impact on the static of the building. Salt crusts and flaking in the base area damage the masonry. In addition, the replacement and filling of the masonry by silt and fine sandstone of the Exter Formation, which weather back strongly, create additional extensive cavities. On less weathered siltstones and fine sandstone, the weathering phenomenon of splintering can be observed frequently.

Fig. 18 Damage mapping of the eastern part of the south side of the St. Johannis Chapel in Lütgenrode

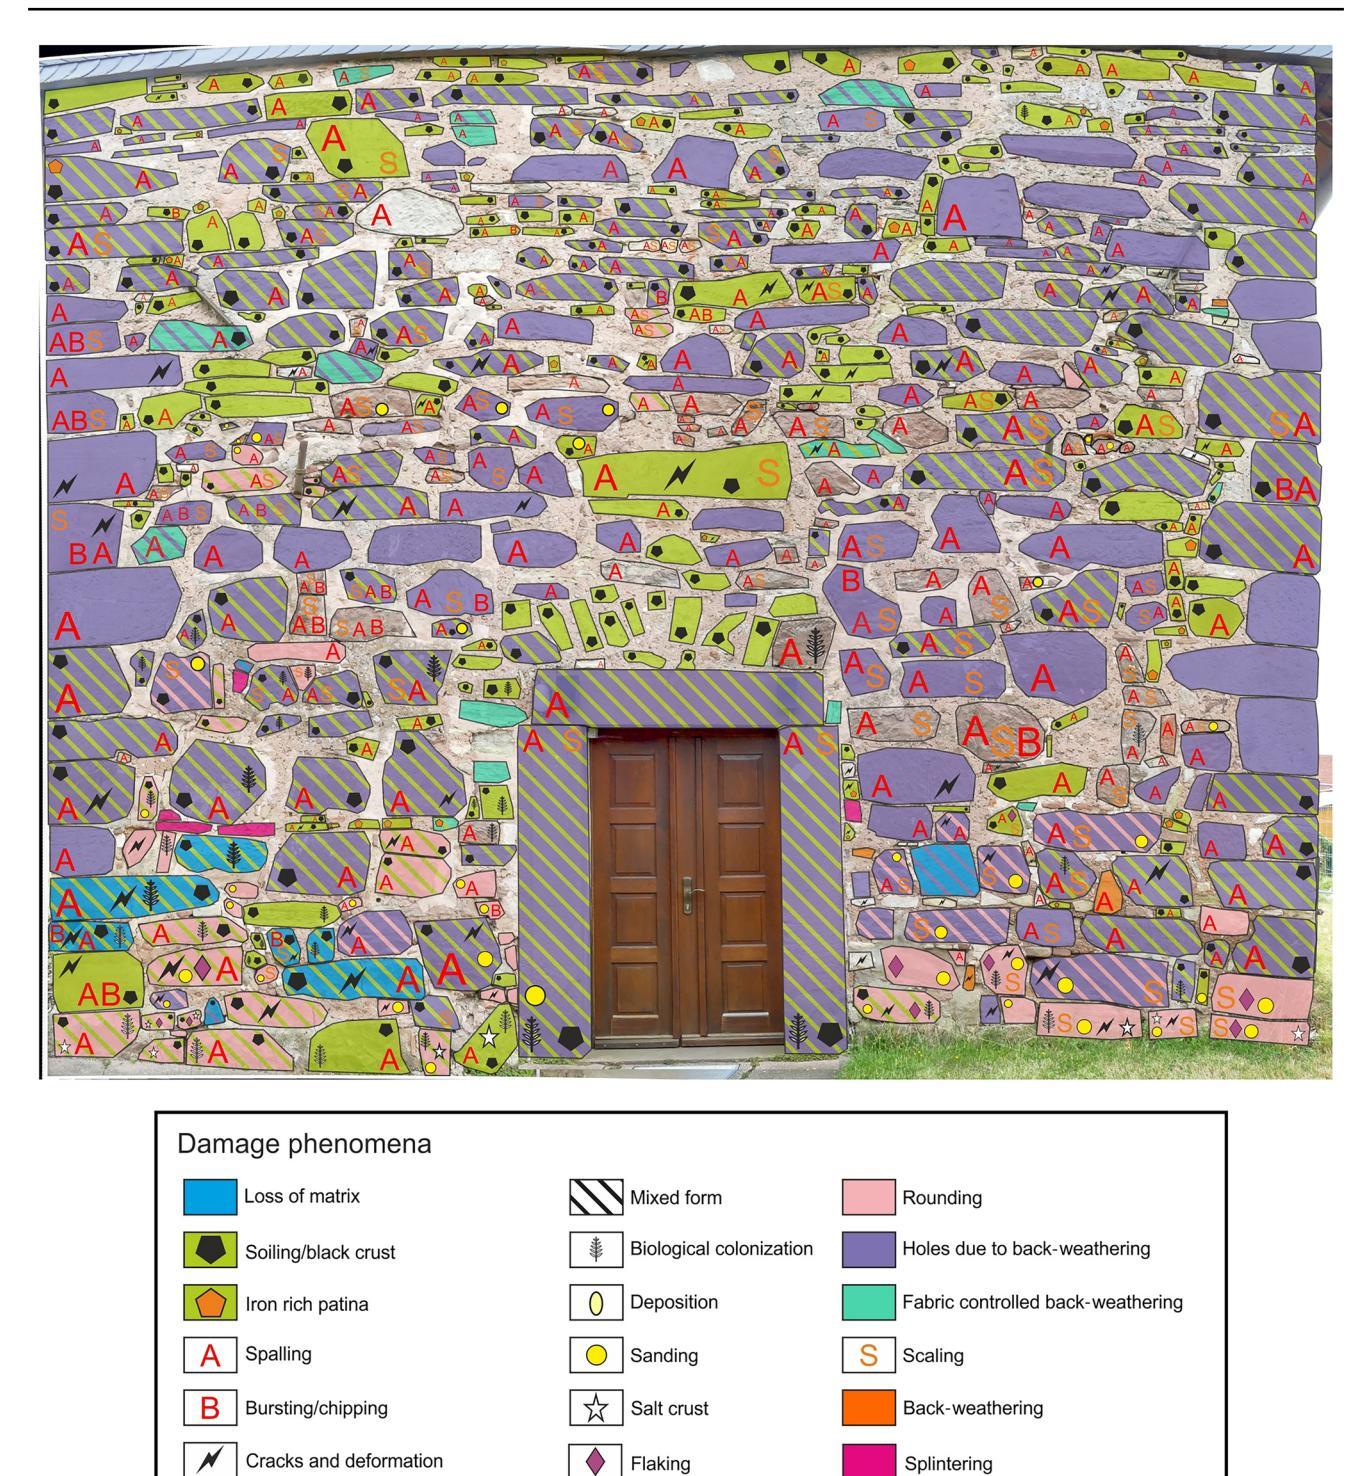
The damage mapping on the western facade is shown in Fig. 19. As on the south side, the highest damage intensity occurs in the lower area of the masonry, where rounded and sanding sandstone dominates. However, also in the higher parts of the facade, some ashlars show the same weathering phenomena. Salt crusts, biological colonization and sometimes very intensive scaling and flaking can be observed near the ground. Cracks and deformations also occur preferentially in the lower area and affect almost 10% of the masonry. Smaller chipping and spalling are the most common weathering phenomena (48%), but do not result in high damage intensities. They are followed by soiling and few

Fig. 19 Damage mapping on the west side of the St. Johannis Chapel in Lütgenrode

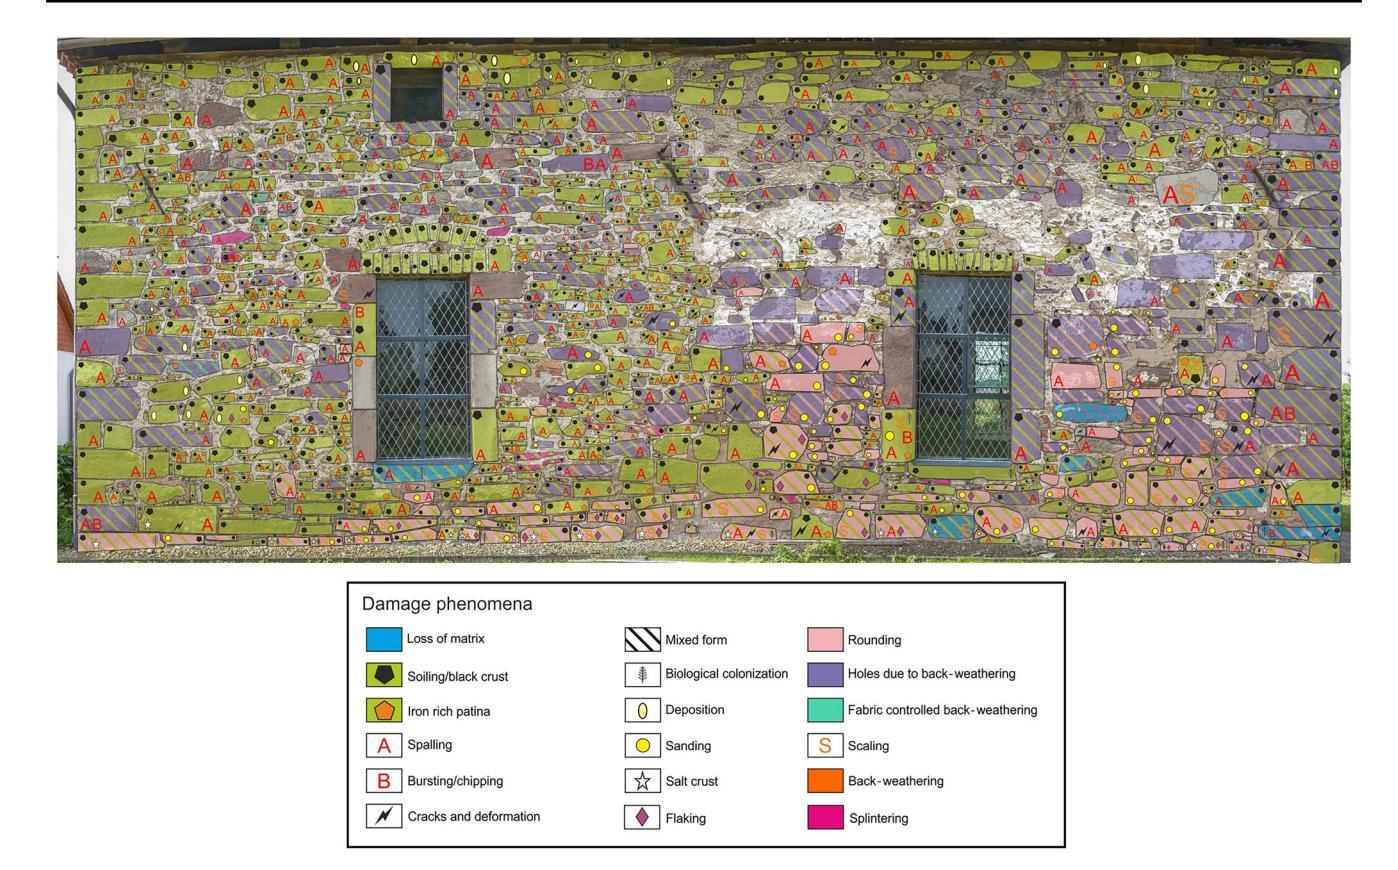
Soiling and black crusts (63%) as well as smaller spalling and chipping (46%) determine the damage pattern on the north side (Fig. 20). The presence of high amounts of black crusts could originate from the north-facing position. As the wind predominantly comes from the west or south all year round, the resulting lower exposure to precipitation leads to an undisturbed adhesion of atmospheric particles that form these crusts.

The sandstone varieties show characteristic cavities as well as clear rounding and sometimes heavy sanding in the lower to middle parts of the facade. In some of the sandstone ashlars of the Solling Formation, weathered rip-up clasts can be found. The red sandstone show particularly high damage intensity due to scaling, when the bedding is oriented parallel to the surface. Looking at the entire north face, scaling has been mapped on around 5% of the ashlars.

Fig. 20 Damage mapping on the north side of the St. Johannis Chapel in Lütgenrode

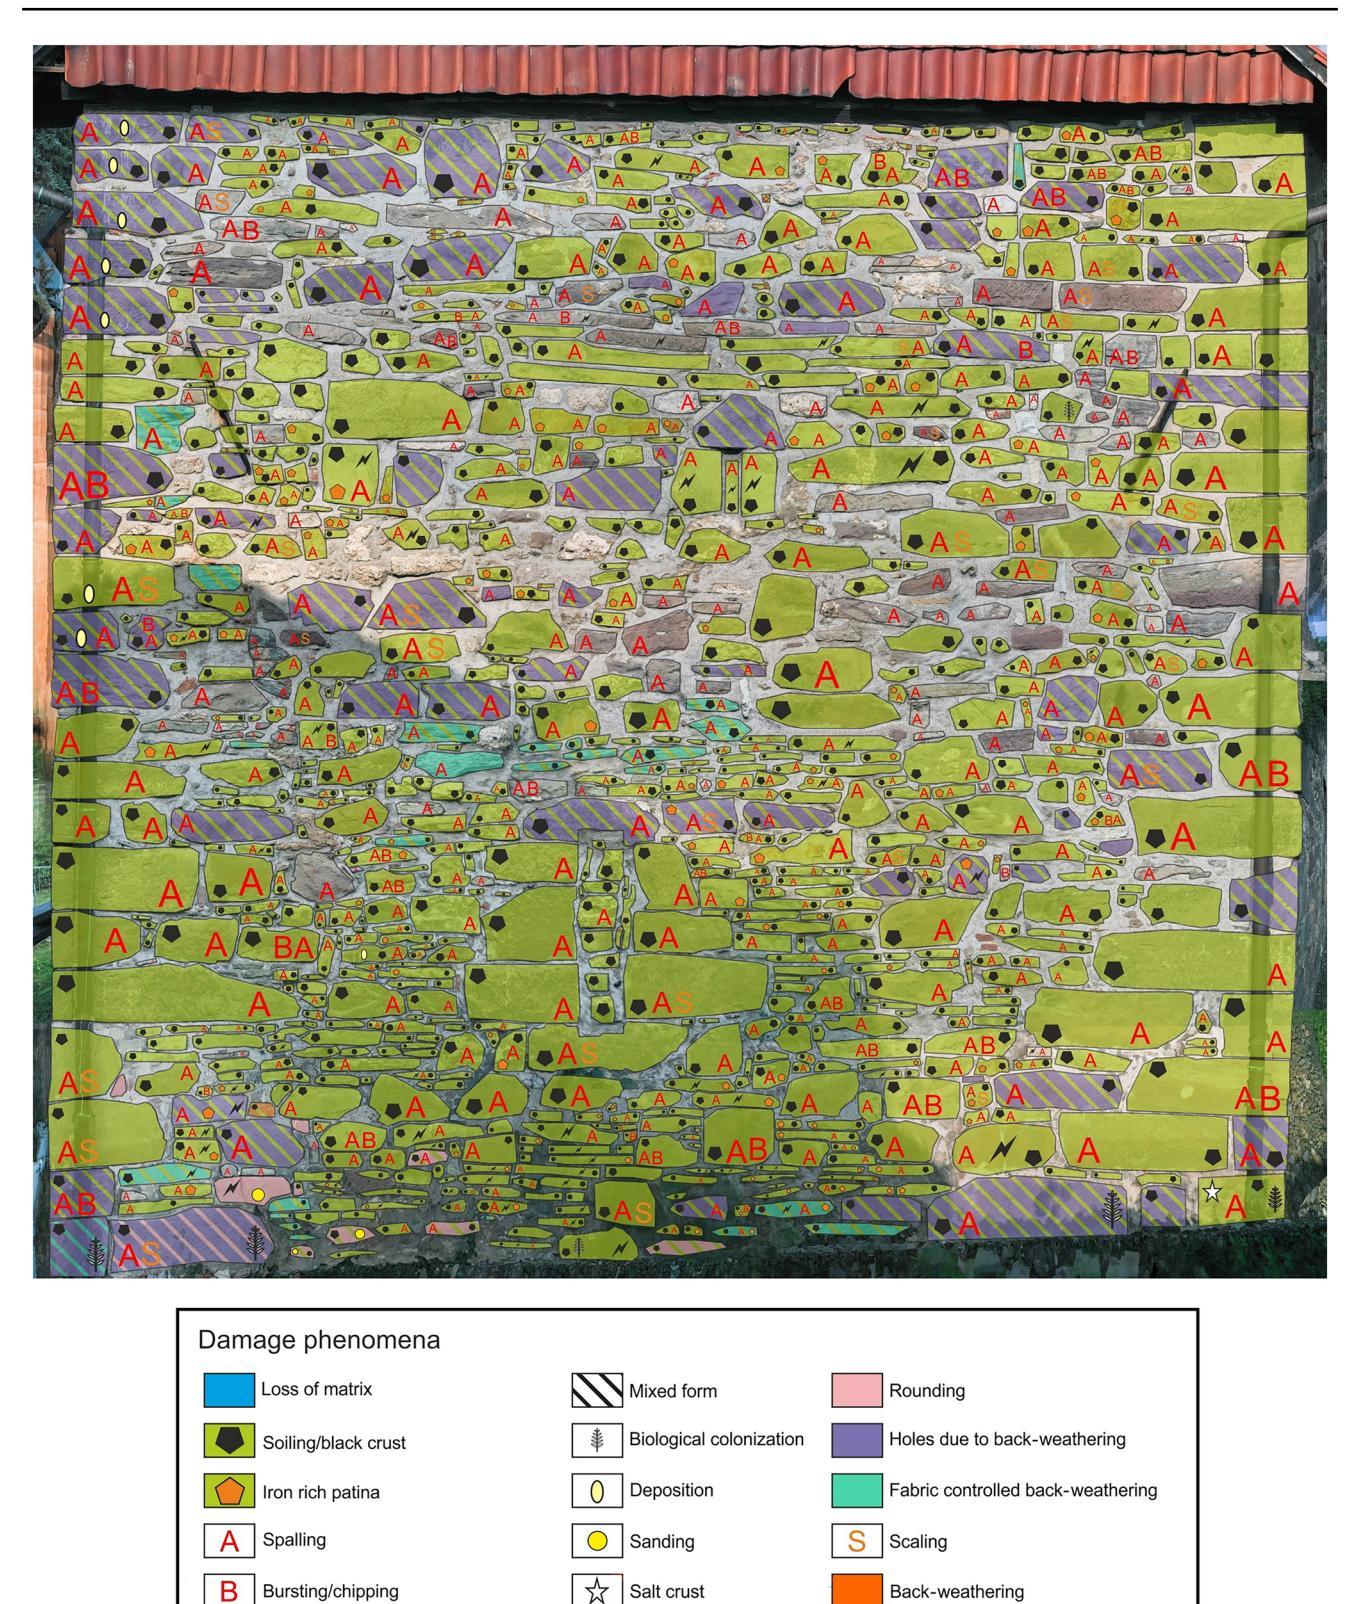
The damage pattern of the masonry of the east side is less diverse than on the other sides of the building. Especially soiling and black crusts dominate the appearance (66%) (Fig. 21). In contrast to the south and west sides, black crusts

are more common than soiling. Most of the rocks have dark crusts, especially in the lower parts. This is probably because a neighboring residential building protects huge parts of the east facade from precipitation. Minor spalling and chipping have been mapped on almost every second ashlar (45%). Iron enrichment and iron crusts are common (12%). The rather high occurrence of iron crusts is due to the increased number of quartzites applied on this side, which are more susceptible to this type of damage. Cracks and deformations occur on around 6% of the ashlars. Elongated cuboids of the silt and fine sandstone and quartzite of the Exter Formation are often broken vertically. In addition, there are vertical crack systems that have resulted in fractures in the mortar and ashlars (Fig. 21). Breakouts and chipping, like the cracks and deformations, are scattered throughout the facade.

Since less sandstone ashlars were used in the east wall compared to the other sides of the building, the rate of holes due to back weathering is comparatively low (6%). In the center of the east side, many siltstone and fine sandstone components are located, which are characterized by fabriccontrolled back weathering. Salt crusts, biological colonization, rounding and sanding are only found sporadically on the east side. Matrix back-weathering, splintering and flaking do not occur. As on the south and north sides, deposits of bird droppings can be found on a few rocks of the upper part.

Fig. 21 Damage mapping on the east side of the St. Johannis chapel in Lütgenrode

For the masonry of the east facade, west facade and north facade, complete de-jointing, masonry protection and reconstruction is inevitable. To prevent the complete exchange of the masonry a stepwise injection method for different cracks widths must be applied. Different resins, resin modified mortars or crack bridging by adhesives are important tools for the reconstruction. Stone replacement or the use of stone replacement mortars are also under discussion. The resulting replacement material has to show similar properties, aesthetics and weathering behavior like the original rock.

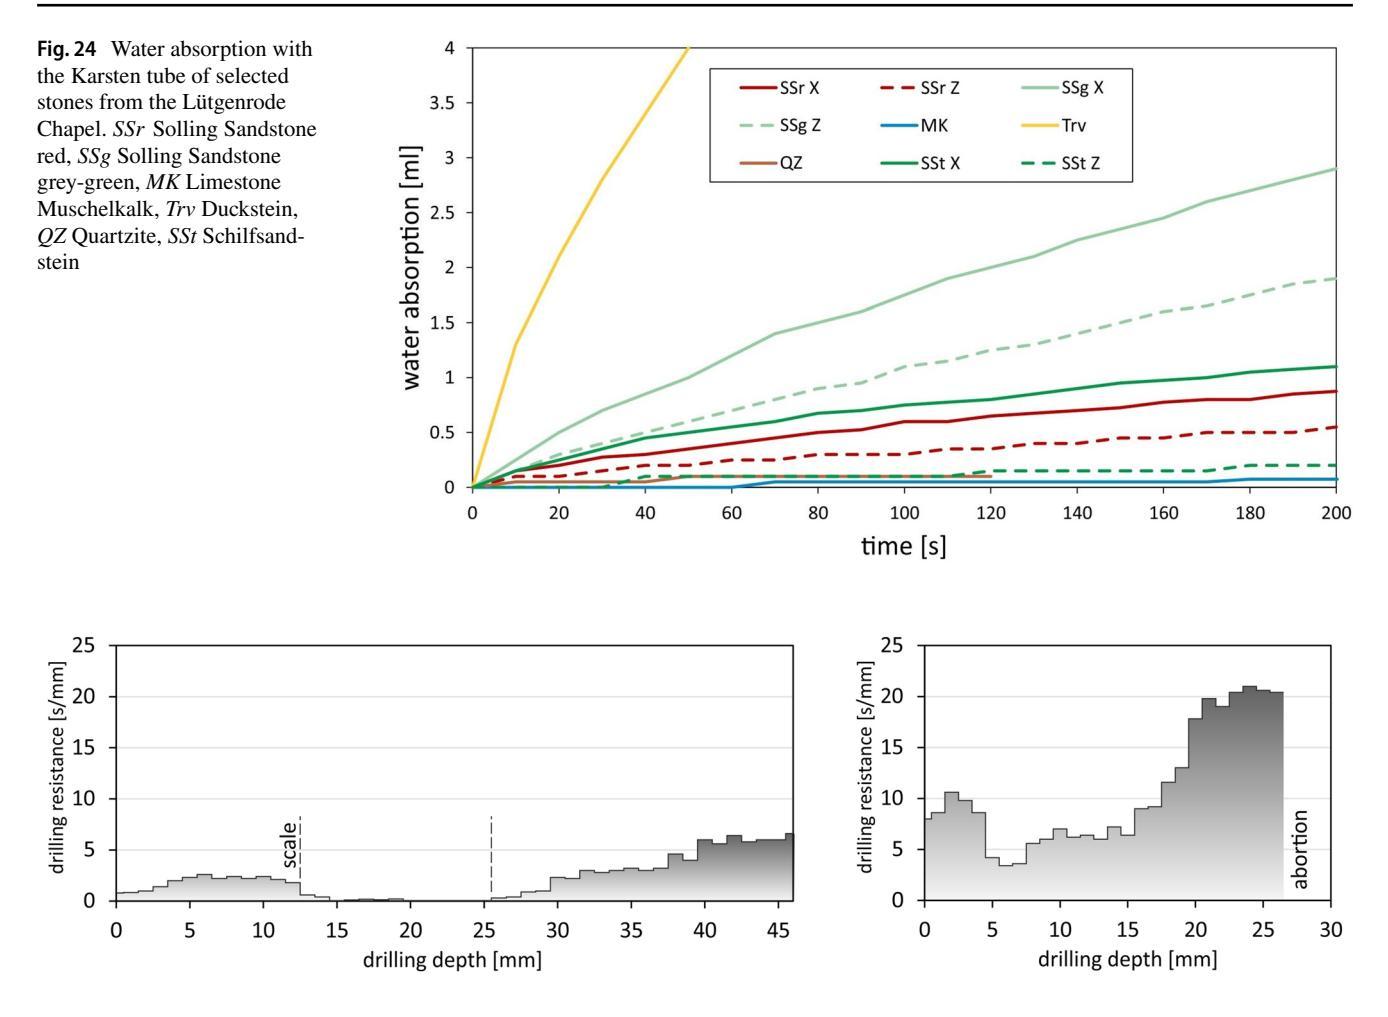
To visualize the weathering profile from the stone surface into its core, the drilling resistance was measured insitu on two selected ashlars from the mainly used Solling Sandstone. The drilling machine drives a 3 mm drilling bit into the stone surface, keeping the rotation and the pressing force constant. A coupled chart recorder continuously registers the penetration depth by drawing a line on a paper running perpendicular to it with a speed of 5 mm/s. Figure 25 illustrates very well the difference in drilling resistance on a healthy and a deteriorated Solling Sandstone. The difference between both ashlars is enormous. A scale of several millimeters on the deteriorated Solling Sandstone could be clearly illustrated. However, even behind the scale the weathering into the core of the stone appears to be progressive, as the increase in drilling resistance is lower compared to the unweathered example.

Fig. 25 Drilling resistance on a deteriorated (left) and unweathered (right) example of Solling Sandstone
