# Sheeting Joints: Characterisation, Shear Strength and Engineering

S. R. Hencher · S. G. Lee · T. G. Carter ·  
L. R. Richards

**Abstract** Sheeting joints are extensive fractures that typically develop parallel to natural slopes. Embryonic sheeting joints initially constitute channels for water flow and then become the focus for weathering and sediment infill accompanied by progressive deterioration and dilation. Slabs of rock fail along them periodically because of their adverse orientation and long persistence. They are however rough and wavy and these characteristics contribute highly to their shear strength and improve their stability. This paper reviews several landslide case histories and on the basis of these provides guidelines for characterising sheeting joints and determining their shear strength. Engineering options for stabilising sheeting joints in natural and cut slope configurations are then examined with reference to case examples.

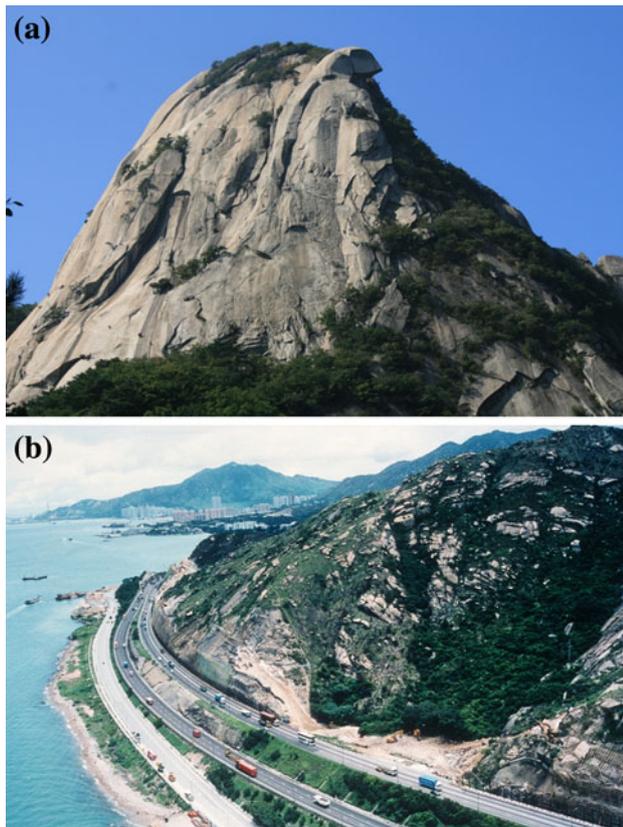
**Fig. 1** Sheeting joints in granite: **a** Mt. Bukhansan, near Seoul, Korea; **b** Tuen Mun Highway, Hong Kong

Sheeting joints are a striking feature of many landscapes (Fig. 1a, b) and they have been studied for more than two centuries (Twidale 1973). They run roughly parallel to the ground surface in flat-lying and steeply inclined terrain and generally occur close to the surface, typically at less than 30 m depth. They can often be traced laterally for hundreds of metres. Most sheeting joints are young geologically and some have been observed to develop explosively and rapidly as tensile fractures in response to unloading (Nichols 1980). Others are propagated to assist in quarrying using heat or hydraulic pressure (Holzhausen 1989). Their recent origins and long persistence without rock bridges differentiates them from most other joints many of which develop following pre-imposed, geological weakness directions during weathering and unloading as illustrated in Fig. 2a, b and discussed by Wise (1964) and Hencher and Knipe (2007). These characteristics of sheeting joints (especially their long persistence and lack of intact rock bridges) also distinguish them from most bedding, cleavage or schistosity-parallel discontinuities.

A modern approach to assessing the need for preventive measures is to use quantified risk assessment as described by Pine and Roberds (2005) for the widening of the Tuen Mun Highway in Hong Kong (Fig. 1b). This project involved remediation and stabilisation of several sections of high cut and natural slopes dominated by potential sheeting joint failures and by the potential for failure of rock blocks and boulders bouncing down exposed sheeting joints to impact the road below. Design of the slope cut backs and stabilisation measures was based on a combination of reliability criteria and conventional Hong Kong standard factor of safety design targets aimed at achieving an ALARP (as low as reasonably possible) risk target which, in actuarial terms, translated to less than 0.01 fatalities per year per 500 m section of the slopes under remediation.

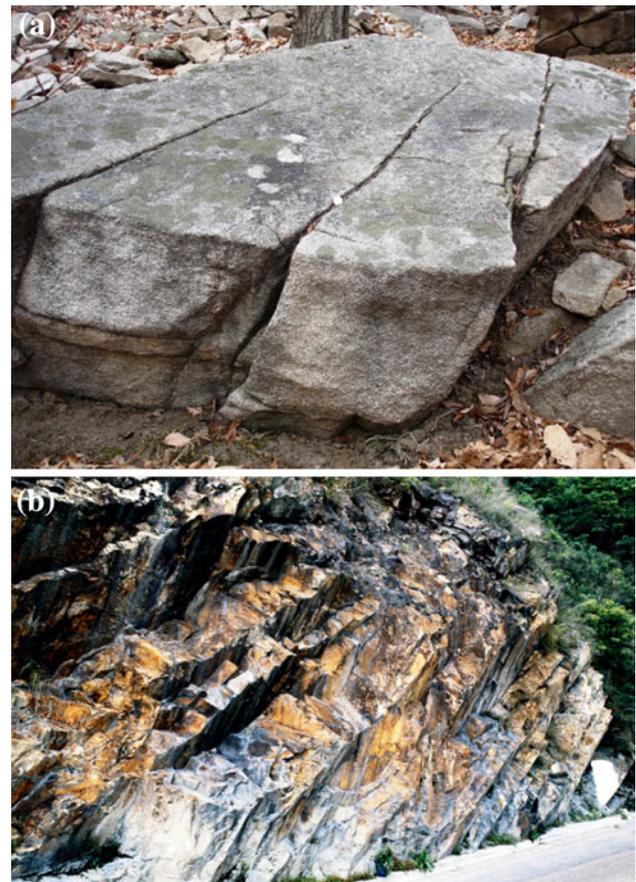
**Fig. 2** Parallel set traces of proto-joints in the process of developing as full mechanical fractures but maintaining considerable true cohesion **a** Jurassic granite, Bukansan, Seoul; **b** Tuff, Island Road, Hong Kong

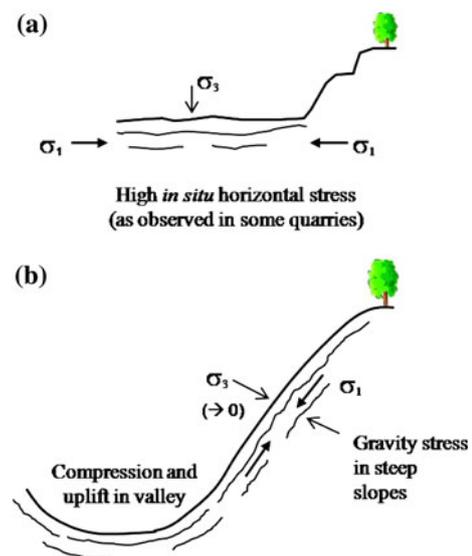
**Fig. 3** Stress conditions for the formation of sheeting joints **a** in regions with very high horizontal in situ stresses and **b** in steep slopes and relatively strong, unfractured rock

compressive stresses are locked in at shallow depths (Fig. 3a). In Southern Ontario, Canada, for example, high horizontal stresses locked in following glacial unloading often give rise to quarry floor heave and pop-up structures accompanied by opening up of pre-existing incipient discontinuities such as bedding planes and schistose cleavage (Roorda et al. 1982). Where there are no pre-existing weakness directions, new sub-horizontal fractures may develop in otherwise unfractured rock. Holzhausen (1989) describes propagation of new sheeting joints under a horizontal stress of about 17 MPa at a depth of only 4 m where the vertical confining stress due to self weight of the rock is only about 100 kPa. The mechanism is similar to a uniaxial compressive strength test where tensile fracture propagates parallel to the maximum principal stress ( $\sigma_1$ ). Such exfoliation and tensile development of sheeting joints is analogous to the sometimes explosive spalling and slabbing often seen in deep mines (Diederichs 2003; Hoek 1968).

the slope as illustrated in Fig. 3b, demonstrated by numerical models (Yu and Coates 1970; Selby 1993) and discussed in detail by Bahat et al. (1999). Sheeting joints also develop parallel to the stress trajectories that curve under valleys where there has been rapid glacial unloading or valley down cutting as illustrated in Fig. 4. Failure and erosion is a continuing process with the formation of new sheeting joints following the failure of sheet-bounded slabs. Wakasa et al. (2006) calculated an average erosion rate of 56 m in 1 million years from measurements of exposed sheeting joints in granite in Korea which is significantly higher than erosion rates on other slopes without sheeting joints. Whilst many exposed sheeting joints are evidently very recent, others are much older. Jahns (1943) and Martel (2006) note the apparent dissection of landscapes post-dating sheet joint formation. Antiquity is also indicated by preferential and thick weathering as illustrated in Fig. 5a, which shows a segment of core through a sheet joint infilled with completely decomposed granite (CDG) with the joint infill material abutting directly against almost fresh rock; Fig. 5b shows a similar thick band of highly decomposed granite (HDG) between the walls of a sheeting joint at North Point, Hong Kong. Weathering grades used

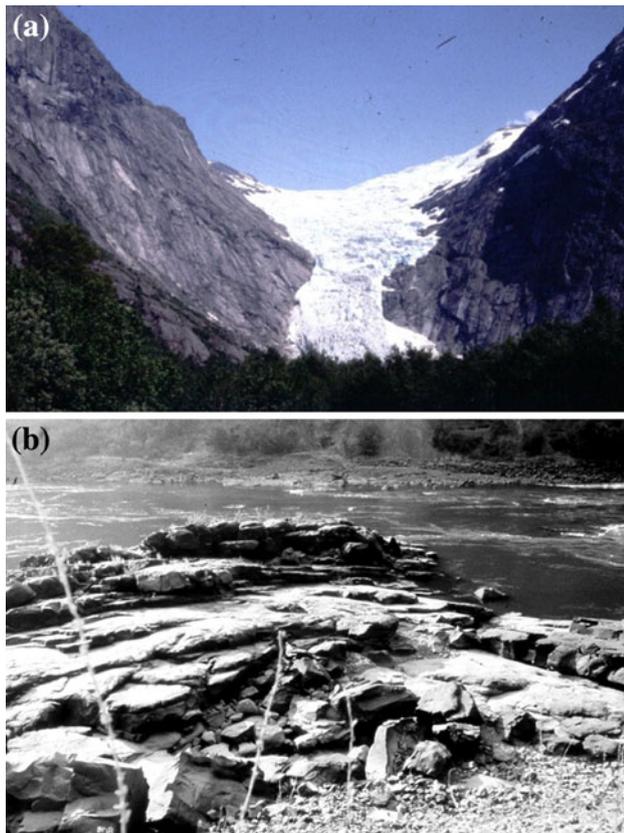
**Fig. 4** Sheeting joints under valleys **a** Norway; **b** Zambezi River at Batoka Gorge, Zimbabwe. The sheeting joints are in otherwise massive basalt

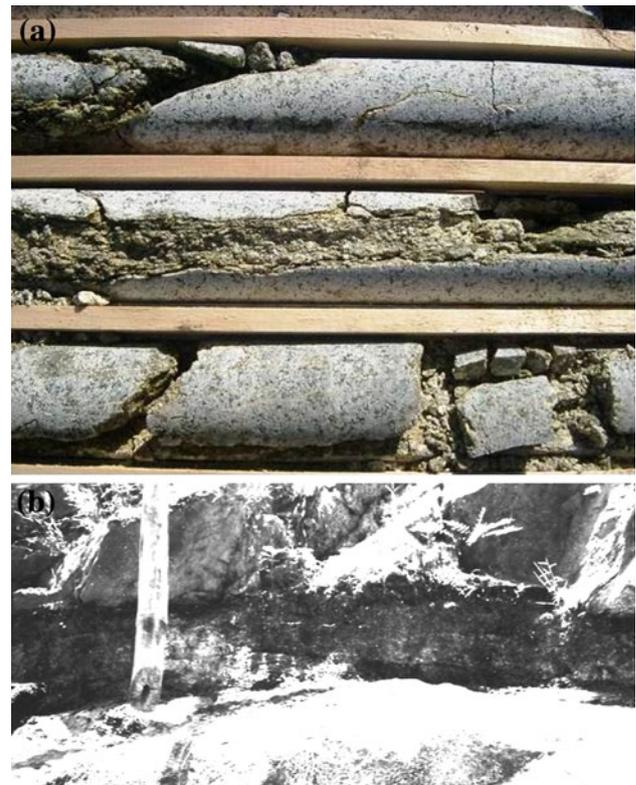
**Fig. 5** **a** Completely decomposed granite in sheeting joint (horizontal borehole for tunnel). **b** Thick (300 mm) continuous layer of grade IV granite sandwiched between grade II wall rock. Note sharp contacts and rough nature of lower exposed sheet joint surface. *Bamboo scaffold pole* in foreground

Richards and Cowland (1982) suggest that where there is a thick band of weathered rock along a joint (say grades IV and V) as shown in Fig. 5, zero dilation should be allowed

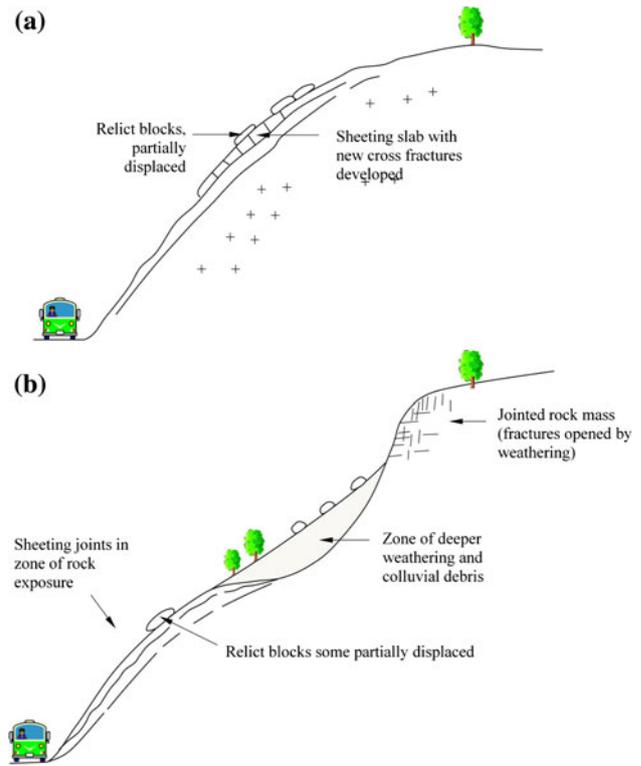
**Fig. 6** Typical sheeting joint terrains. **a** Sheeting joints dominate landscape; **b** sheeting joints only in areas of rock exposure where erosion rate is higher than accumulation of weathering and colluvial deposits

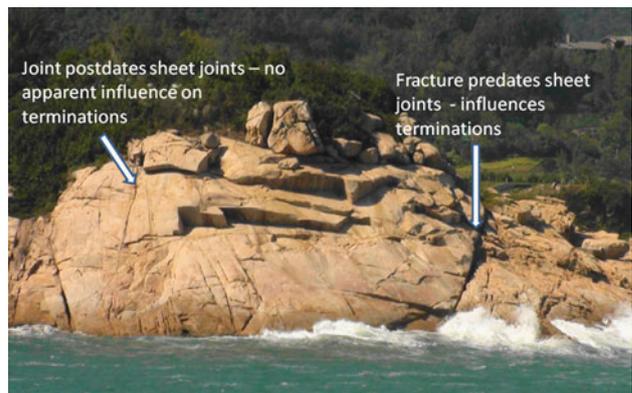
**Fig. 7** Cross fractures influencing sheet joint development, Shek O, Hong Kong

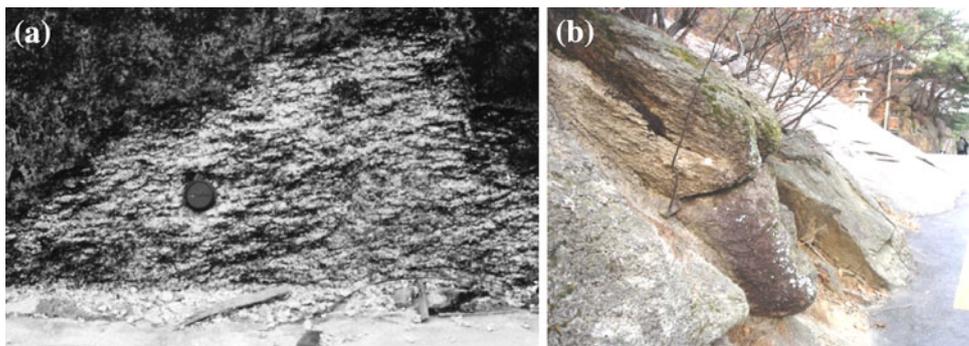
**Fig. 8** Parallel unloading microfractures throughout hillside. **a** Lion Rock Tunnel portal, Hong Kong. Lens cap for scale. **b** Near Doseonsa temple, nr. Seoul. Note microfracture disintegration is parallel to discrete sheeting joint in background

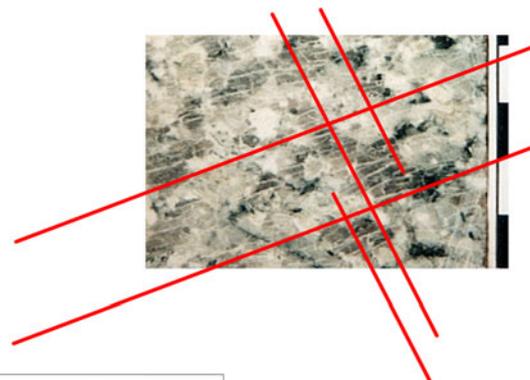
**Fig. 9** Main set of microfractures dipping to left run parallel to main discrete sheeting joints seen elsewhere in slope (see stereo plot). Cross fractures run roughly parallel to cross joints dipping back into slope and acting as release joints to the sheeting joints

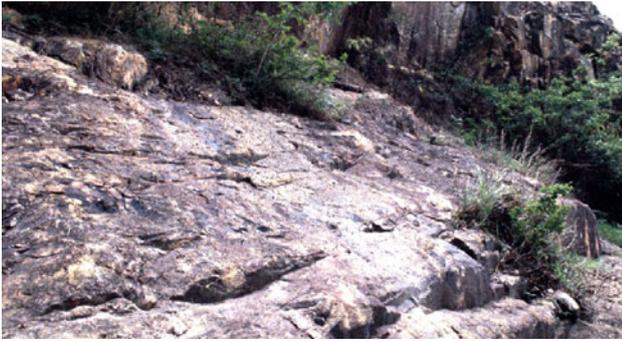
**Fig. 10** Wavy and stepped surface through volcanic tuff, Hong Kong

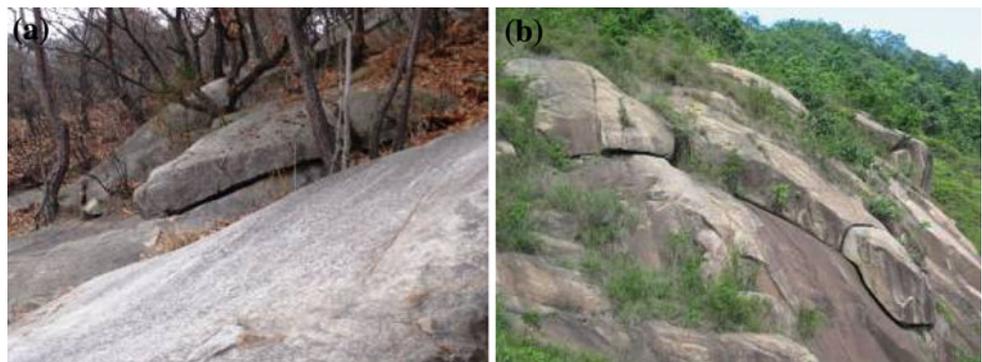
**Fig. 11** Partial movement and dilation of sheeting slabs: typical of early stage of failure **a** Korea, **b** Hong Kong

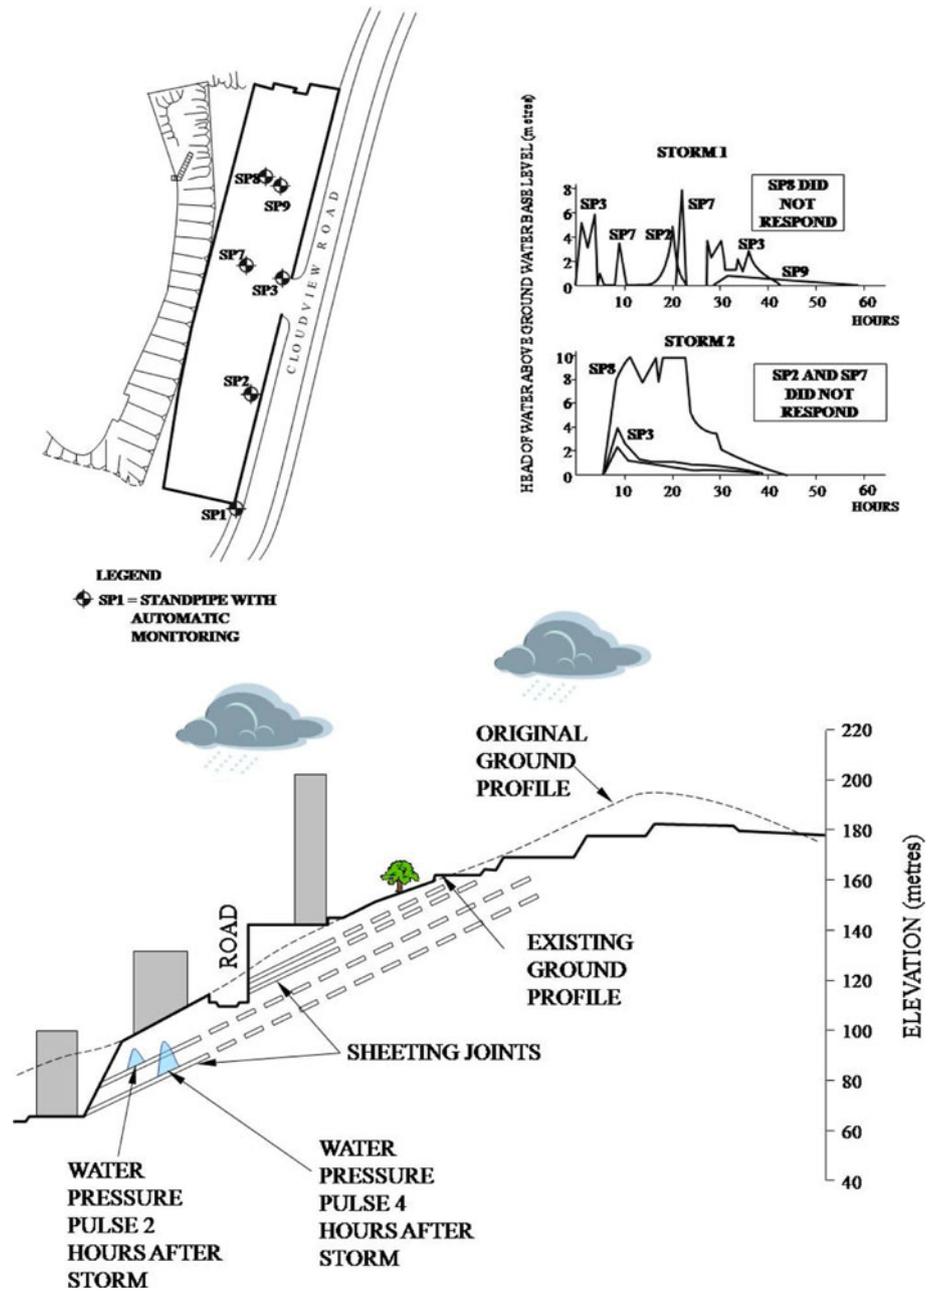
**Fig. 12** Storm response of piezometers installed in sheeting joints (after Richards and Cowland 1986)

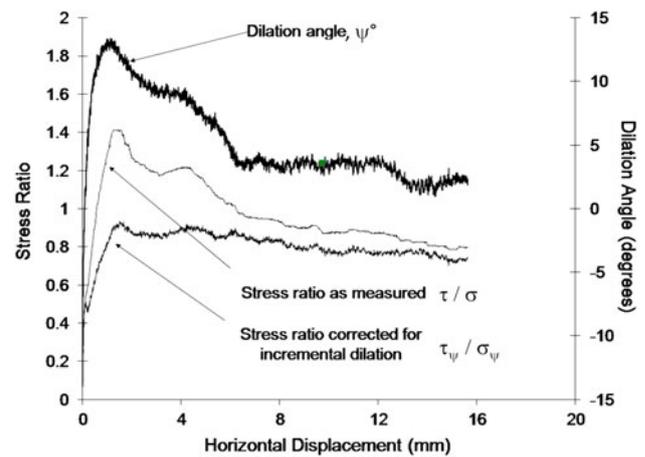
**Fig. 13** Typical test from single direct shear test run on a joint sample. Note how the measured strength strongly reflects the incremental dilation angle and how the corrected strength (*lower line*) is essentially constant once the influence of major, sample-specific roughness has been accounted for

Typically, because of the complex nature of shearing, with damage being caused to some roughness asperities whilst others are overridden, the dilation angle,  $\psi^\circ$ , is difficult to predict for an irregularly rough sample although numerous efforts have been made to do so with some limited success (e.g. Archambault et al. 1999; Kulatilake et al. 1995). In practice, rather than trying to predict dilation which will be unique to each sample, stress level and testing direction, it is a parameter that needs to be measured carefully during direct shear tests so that corrections can be made to derive a normalised basic friction angle for use in design. Figure 13 shows the result from a well instrumented direct shear test on a rough interlocking joint. It can be seen that the peak measured ratio between shear stress and normal stress ( $\tau/\sigma$ ) is about 1.4 corresponding to a peak uncorrected friction angle,  $\phi_p = 54^\circ$ , given that  $\tau = \sigma \tan(\phi_p)$ . This peak strength however includes the effect of the upper block having to override the roughness as the joint dilates and work is done against the confining pressure. The dilation contribution is specific to this sample, this stage of the test, stress level and direction of shearing so cannot be taken as representative or even indicative of the roughness component of the joint,  $i^\circ$ , at field scale. The measured dilation angle,  $\psi^\circ$  (which equals  $\tan^{-1} dv/dh$  where  $dv$  is the vertical displacement

increment over horizontal displacement increment,  $dh$ ), and which varies throughout the test, can however be used to correct (normalise) the shear strength incrementally using the following equations:

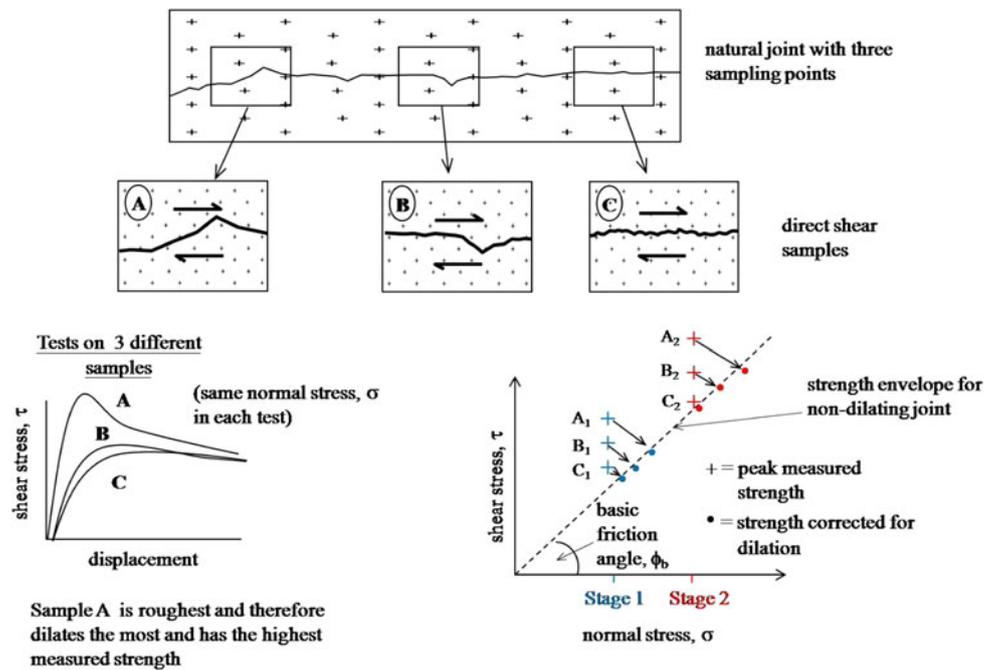
**Fig. 14** Series of direct shear tests carried out on three samples taken from different locations along the same joint. Different roughnesses will result in different peak strengths for the same normal stress but dilation correction will reduce scatter considerably and give a basic friction for naturally textured, non-dilatant joints. The same samples can be tested repeatedly at increasing or decreasing normal stress stages. Peak strengths will vary with amount of damage and normal stress level but the corrected strength envelope for basic friction,  $\phi_b$ , is usually well defined

the same joint set (with similar surface mineralogy and textures) provide a reasonably well-defined dilation-corrected strength envelope as illustrated in Fig. 14. That strength is frictional (obeys Amontons's laws) and comprises an adhesional component plus a non-dilatant damage component that varies with textural and second order roughness (Hencher 1995).

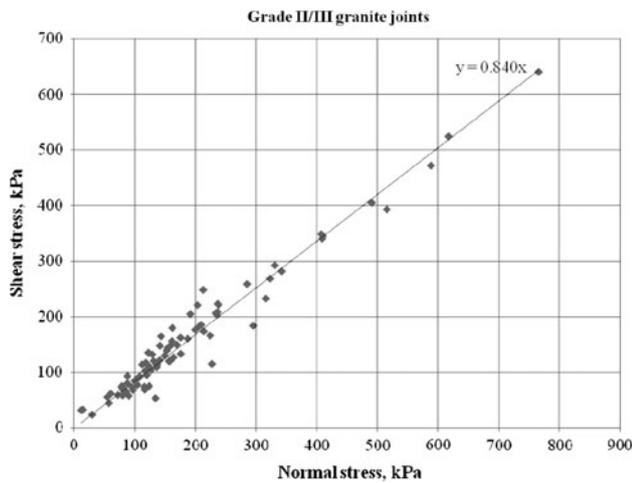
**Fig. 15** Dilation-corrected tests on sheeting joint samples through grades II and III rock, many samples iron- or manganese dioxide stained and with some patchy clay

(Hencher and Richards 1982). Figure 15 shows dilation-corrected data for joints through grades II and III granite and Fig. 16 shows similar data for joints through friable, grade IV rock. These data define essentially the same strength envelope with  $\phi_b \approx 40^\circ$ . Similar values for dilation-corrected basic friction angle are reported for other silicate rocks (Papaliangas et al. 1995) and Byerlee (1978) found the same strength envelope ( $\tau = 0.85\sigma$ ) for a large number of direct shear tests on various rock types where dilation was constrained by using high confining stresses. Similar strengths have been reported as a mean value generally even for more weathered grades IV and V granite in Hong Kong (El-Ramly et al. 2005). Papaliangas et al. 1995 suggest, on the basis of these sort of results, that a friction value of about  $40^\circ$  for granite joints may mark a transition from dilatational to purely frictional behaviour and may relate to a change from brittle to ductile behaviour within highly stressed asperities. Empirically it seems to be about the highest value for basic friction achievable for natural joints through many silicate rocks and applicable specifically to joints that are forced because of small-scale roughness to dilate, which includes most sheeting joints. That said, even higher dilation-corrected values can sometimes be measured for tightly interlocking, rough textured, tensile fractures through very strong rock, at least for several stages of testing (Hencher 1995, 2006). Conversely, it must be remembered that where joints are smoother so that they do not dilate during shear and where the surface texture is fine, polished or coated with low friction minerals such as chlorite, much lower basic friction angles can be measured for natural joints (Brand et al.

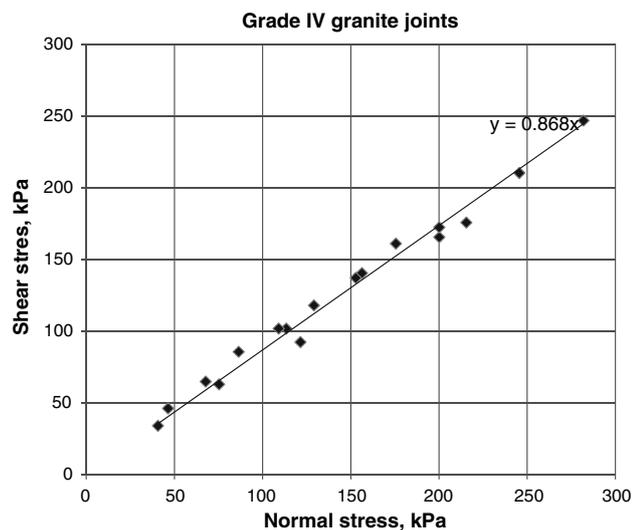
**Fig. 16** Dilation corrected data for grade IV material from sheeting joints, North Point, Hong Kong

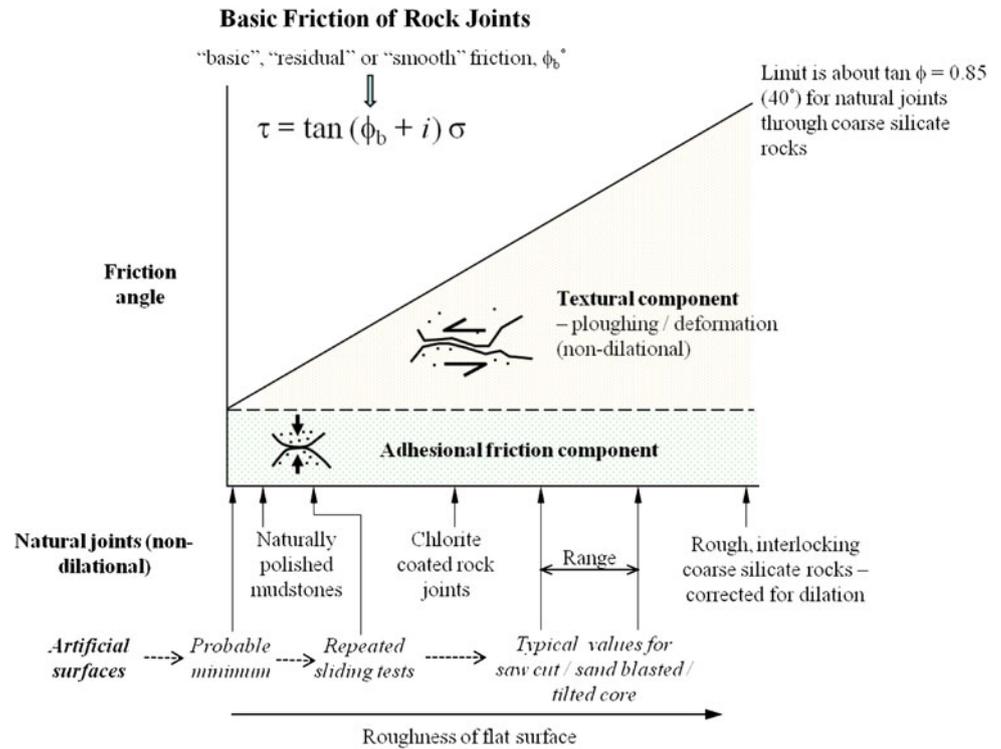
**Fig. 17** Components of basic friction for natural joints and artificial surfaces

1983). This means that there is a marked variation between basic friction measured for artificially prepared (saw-cut and lapped) joints and for natural joints with different surface textures, as illustrated in Fig. 17.

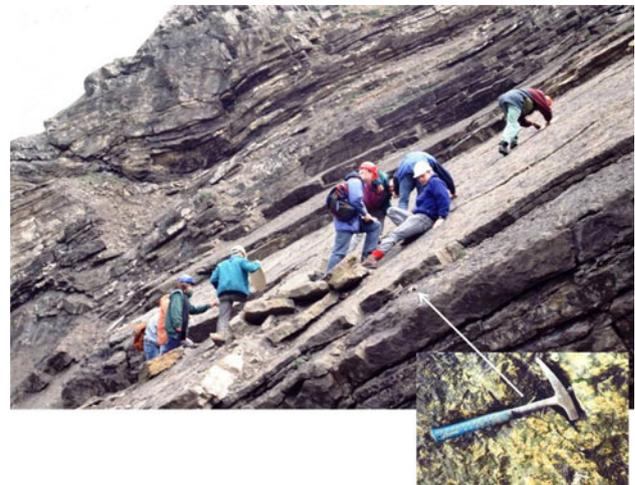
**Fig. 18** Roughness survey under way using plates of different diameter on a bedding plane discontinuity in shaley limestone (Skipton, Yorkshire). At the small scale (*hammer*) the joint is rough but at larger scale the joint is effectively flat

In practice, the best way of characterising roughness is by measurement on a grid pattern in the way originally described by Fecker and Rengers (1971) and adopted in the ISRM recommended methods (1978) although spatial variability may be an important issue for sheeting joints; the important first order roughness represented by major wave features may vary considerably from one area to another. At one location a slab might be prevented from sliding by a wave in the joint surface causing a reduction in the effective down-dip angle along the sliding direction; elsewhere, a slab of perhaps several metres length may have a dip angle steeper than the mean angle for the joint as a whole because it sits on the down slope section of one of the major waves as illustrated by a case example later. For the Tuen Mun highway stability studies (Carter et al. 2002) numerous true scale survey profiles down the plunge line of exposed sheet structures were collected using EDM surveying techniques, with abseil approaches being utilised to achieve profiles down even the steepest of the slope gradients. These detailed profiles of the exposed surfaces were assumed to be representative of adjacent hidden joints that were candidates for potential failure. The level of roughness/asperity surface detail that is attainable by this sort of survey profiling is illustrated for an extensive discontinuity in Fig. 18.

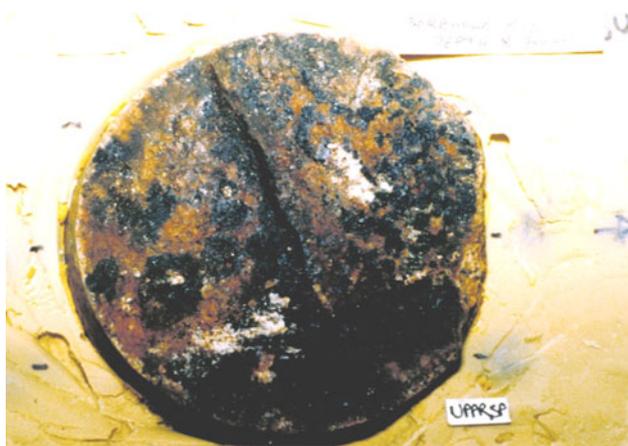
**Fig. 19** Sample V13, 8.7 m (North Point Study, Hong Kong) following 5 stage, repeated direct shear test up to normal stress 285 kPa equivalent of more than 10 m confining stress. Note the localised nature of damage (*white areas*) on the weathered, stepped surface coated in brown iron and black manganese dioxide. Note that main step feature has survived intact (and was responsible for dilating the joint) at that stress level

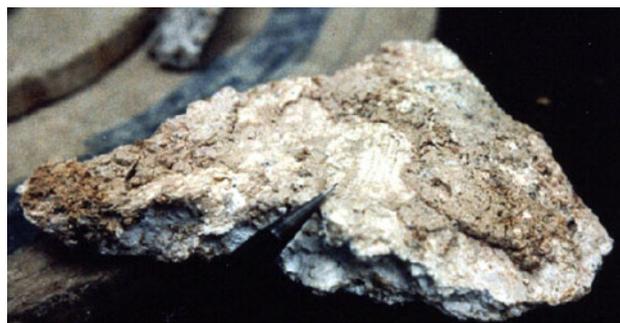
**Fig. 20** Hard, slickensided kaolinite infill from downwarp on failed sheeting joint (Hencher 1983). *Pencil for scale*

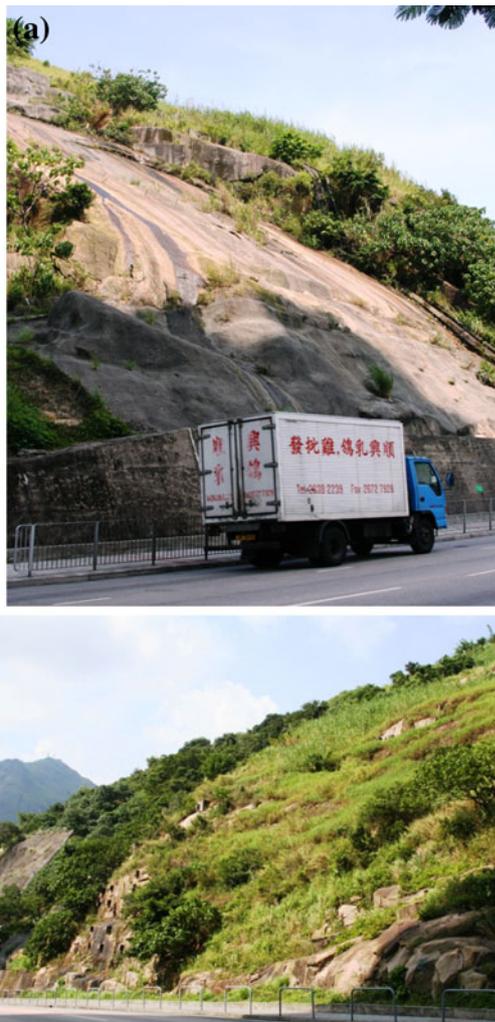
**Fig. 21** **a** View of sheeting joint (2007) pictured in Hoek (2009); **b** picture of the slope analysed and then cut back as discussed in detail in Hoek (2009)

An example of an in-depth study of slope stability governed by potential sliding on sheeting joint is presented by Hoek (2009) and Wyllie and Mah (2004). Figure 21a shows a section of the slope as it is today, little changed from the slope photographed in the early 1970s, with an extensive section of exposed sheeting joint following a failure during blasting to construct the road. It was anticipated that the exposed sheeting joint would extend through the adjacent 60-m-high slope with an overall angle of  $50^\circ$  and individual batters 20 m high and inclined at  $70^\circ$ . The slope that was of concern has now been cut back as illustrated in Fig. 21b (compare to Hoek’s Fig. 4). Hoek goes through a reasoned series of sensitivity calculations based on various assumptions, culminating in the decision to cut back rather than drain or reinforce the slope. The interpretation at the time was that the additional strength offered by dilation in overcoming roughness could be expressed as apparent cohesion. If these analyses and calculations were repeated today probably a slightly different approach would be taken in the way that shear strength was dealt with and consequently on the measures adopted. In particular a cohesive component of strength is insensitive to water pressure assumptions, whereas if strength is expressed as friction plus dilation angle, both of these are dependent on effective stress and a different answer would ensue. Apparent cohesion is clearly a good concept for jointed rock masses (e.g. Brown 2008) but not for the shear strength of persistent rock joints. The result and conclusions might still be the same (cutting back the slope to the dip angle of the sheeting joint is certainly a pragmatic

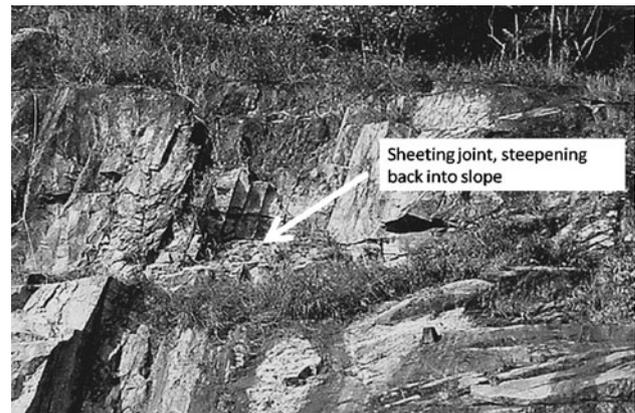
**Fig. 22** Location of rock fall at Hui Min Street, 2000

In 2000 a block of rock with volume of  $15 \text{ m}^3$  fell close to a playground after sliding on a sheeting joint. The source of the rock fall is shown in Fig. 22. A nearby previous failure of a 20-m-wide section of slope in 1993 was re-examined as part of the study into the 2000 landslide Halcrow China Ltd (2002a). The basal surface of the 2000 rockfall dipped out of the slope at about  $35^\circ$ – $38^\circ$ . Using a 420-mm-diameter plate on a 200-mm grid across the failure surface a dilation angle,  $i^\circ$  of  $8^\circ$ , was determined and for an 80-mm plate, between  $12^\circ$  and  $14^\circ$  which is consistent with measurements on other sheeting joints in Hong Kong. The section of sheeting joint below the failed block that would have been exposed prior to failure, dipped more shallowly

at less than  $30^\circ$ . This case illustrates that significant block failures can occur on unexposed steep sections of sheeting joint. Back analysis showed that for an effective friction angle ( $\phi_b + i$ ) of  $43^\circ$  the factor of safety was 1.2 under dry conditions and reduced to 1.0 with water pressure of about 10 kPa. The nearby, much larger 1993 failure surface was investigated by cutting trial trenches through shotcrete that had been placed over the landslide scar. The mean dip of the lower part of the failure surface was only about  $22^\circ$  but steepened to about  $45^\circ$  over the rear half of the failure surface. Roughness values (deviation from mean dip) were measured as  $16^\circ$  using an 80-mm plate and  $12^\circ$  for a 210-mm plate. Much of the basal surface was however coated with completely and highly decomposed granite which would have reduced the effective dilation angle.

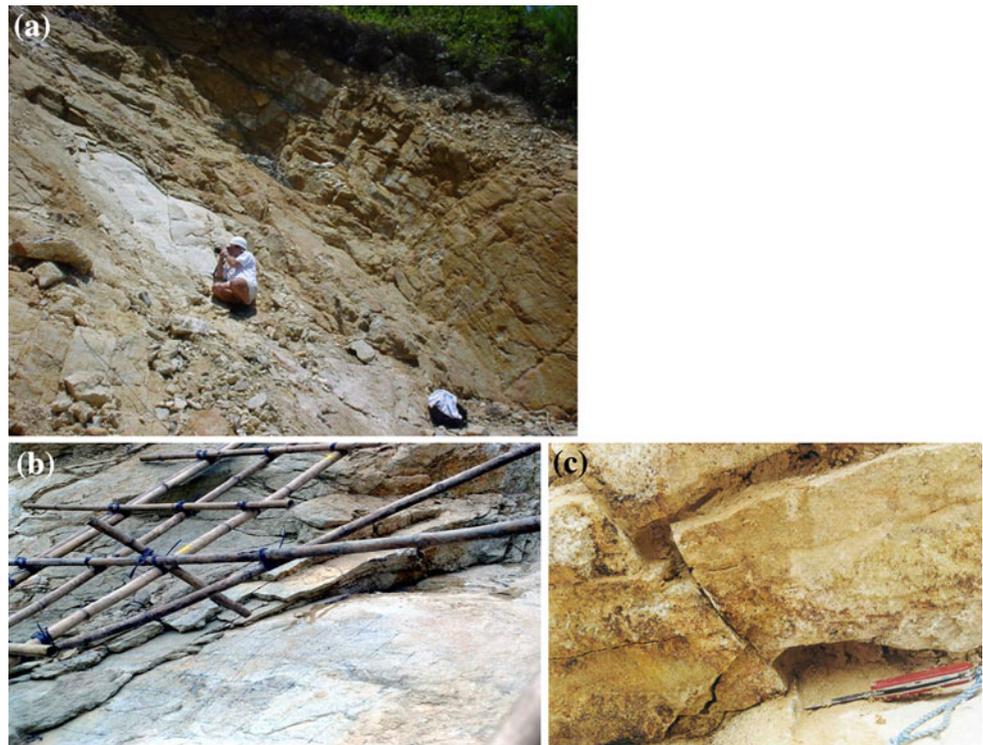
**Fig. 23** Landslide above Leung King Estate, Hong Kong.  
**a** Below the detachment surface the rock is light coloured and joints are rare; above, the rock is fractured and discoloured.  
**b** Lower wavy surface with grid for roughness measurements using plates.  
**c** Side view with evidence of long-term displacement including dilation and deposition of sediments in voids

The progressive nature of failures associated with sheeting joints is illustrated well by a landslide that occurred above Leung King Estate, Hong Kong (Halcrow China Limited 2002b; Hencher 2006). Features of this landslide are illustrated in Fig. 23. Surviving remnants of the rock mass above the main sheeting joint along which detachment finally took place showed signs of long-term movement, growth of fractures and sediment infill prior to failure. The stages prior to failure are shown schematically in Fig. 24.

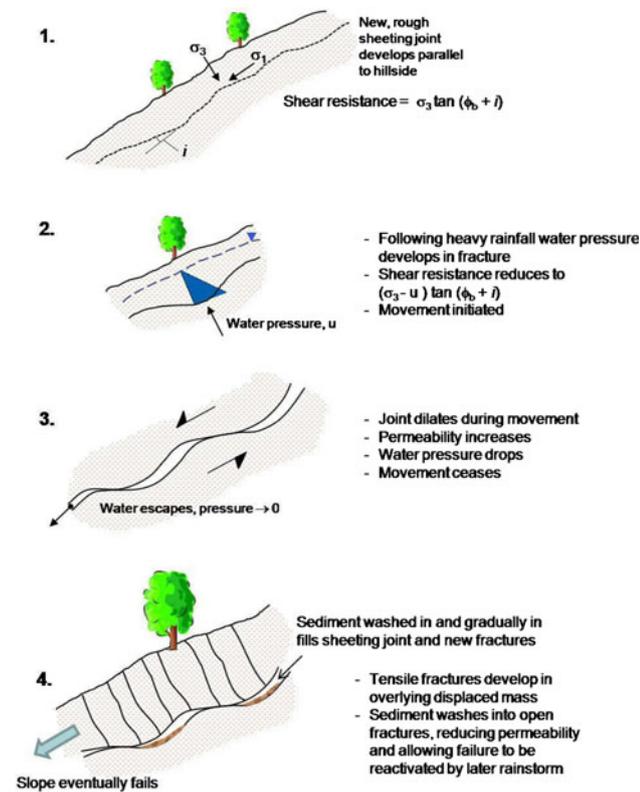
**Fig. 24** Schematic representation of history of Leung King landslide prior to detachment

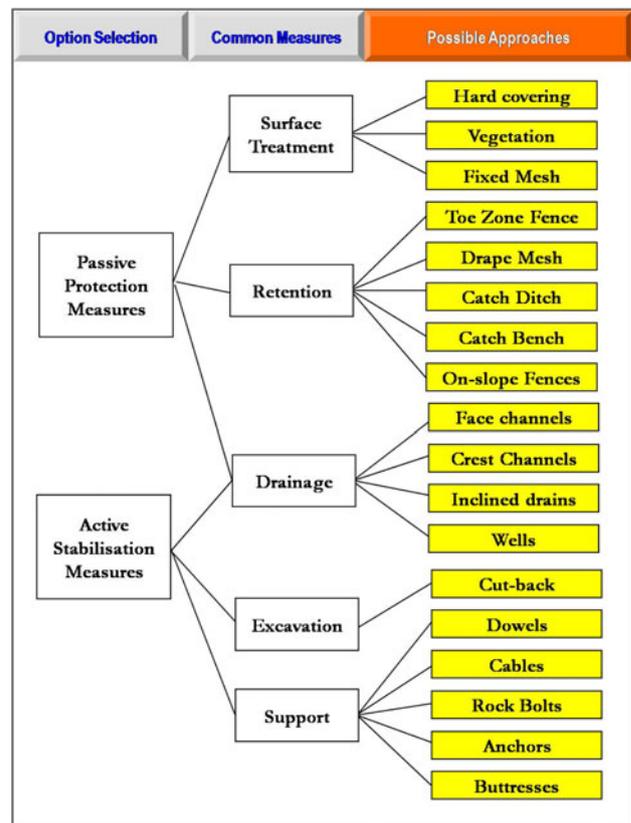
**Fig. 25** Engineering options for stabilising slopes in sheeting joint terrain

Some of the options for improving the stability of slopes are listed in Fig. 25 and illustrated in Fig. 26. These can be split into *passive* options that either deal with the possible failure by controlling surface deterioration at source or installing preventative reinforcement to increase local factors of safety, or adding walls or buttresses to restrain detached debris before it causes injury or damage and *active* measures that enhance overall factors of safety of larger sections of slope by major engineering works including cut backs or buttresses or heavy tie-back cabling.

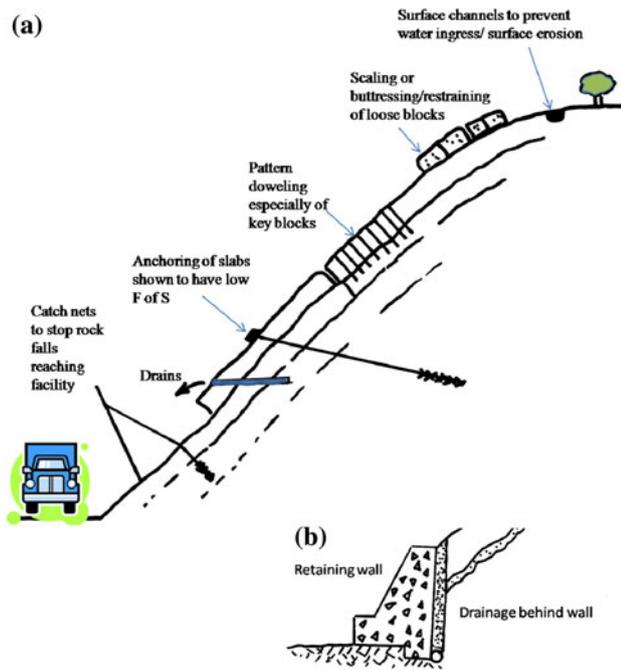
**Fig. 26** **a** Main engineering options for stabilising slopes in sheeting joint terrain; **b** retaining wall used to buttress large section of slope

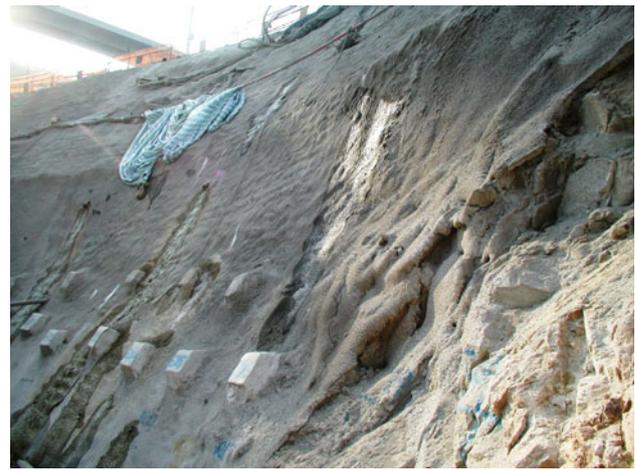
**Fig. 27** Use of shotcrete on broken rock face together with anchorages (nails). Disadvantages include damming water, hiding what is going on and the shotcrete itself will form a hazard as it deteriorates

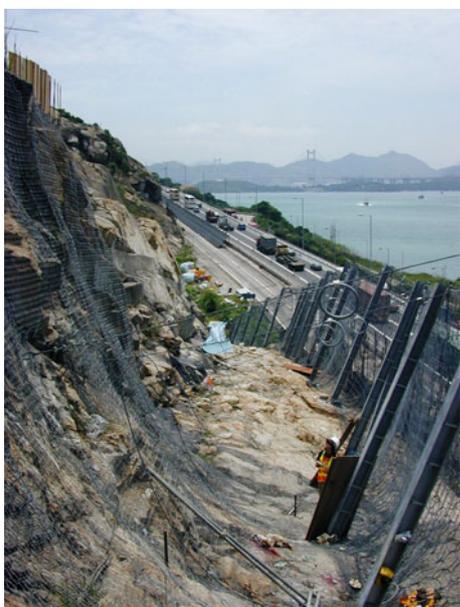
**Fig. 28** Catch net to stop rock falls, above Tuen Mun Highway, Hong Kong

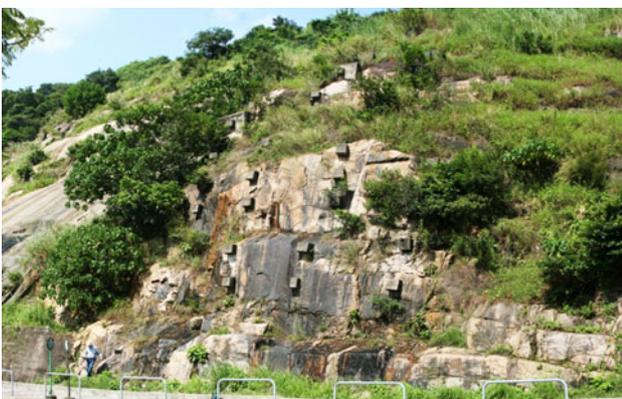
**Fig. 29** Spot bolting of sheeting joint slabs

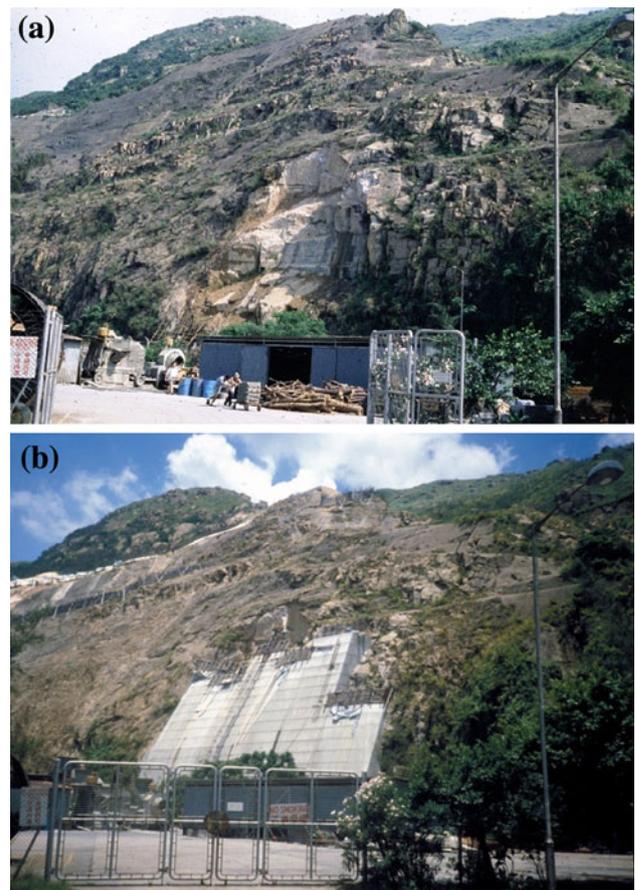
**Fig. 30** Tsing Yi Island, Hong Kong.  $500 \text{ m}^3$  rock fall from sheeting joints: **a** debris cleared off and showing the extent of problem with extensive sheeting joints through the hillside; **b** the solution: a huge concrete buttress

Where earlier failure or cutting exposes sheeting joints or detached blocks resting on a sheet structure then buttressing using a reinforced concrete wall or a raked structural prop may be an economic option and offer some certainty of solving potential sliding or toppling instability problems. One example is shown in Fig. 30. Much of the slope illustrated has sheeting joints running through it. The slope

failed progressively over a period of 2 years and the eventual solution was to fill the failed zone with a very large concrete buttress wall.

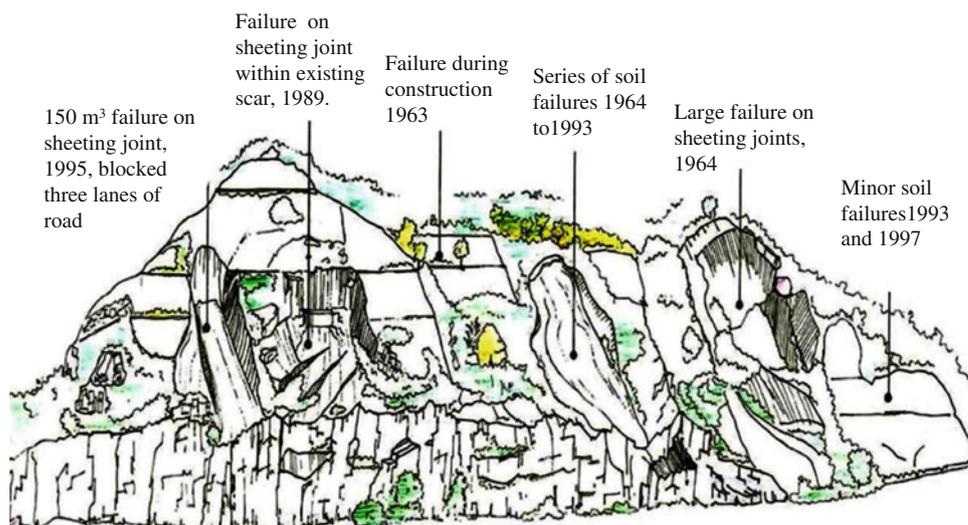
**Fig. 31** Sketch of large section of rock slope along Kwun Tong Road (slopes up to 30 m high) with history of failures dominated by sliding on sheeting joints and selected for engineering upgrading work

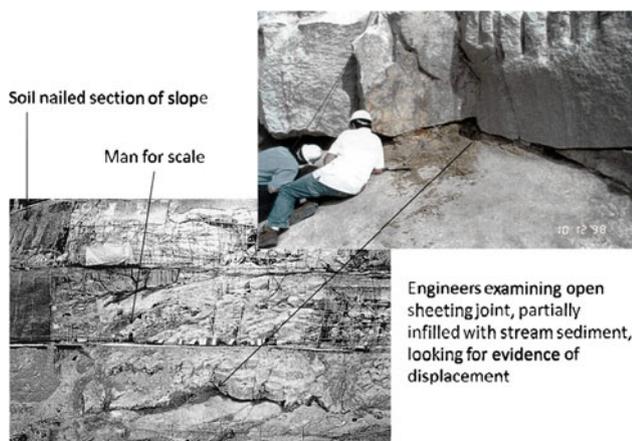
**Fig. 32** Landslide preventive works underway at Kwun Tong, Hong Kong
