Landslides (2013) 10:219–230  
 DOI 10.1007/s10346-012-0362-4  
 Received: 11 April 2012  
 Accepted: 2 October 2012  
 Published online: 17 October 2012  
 © The Author(s) 2012. This article is published with open access at Springerlink.com

Do Minh Duc

## Rainfall-triggered large landslides on 15 December 2005 in Van Canh District, Binh Dinh Province, Vietnam

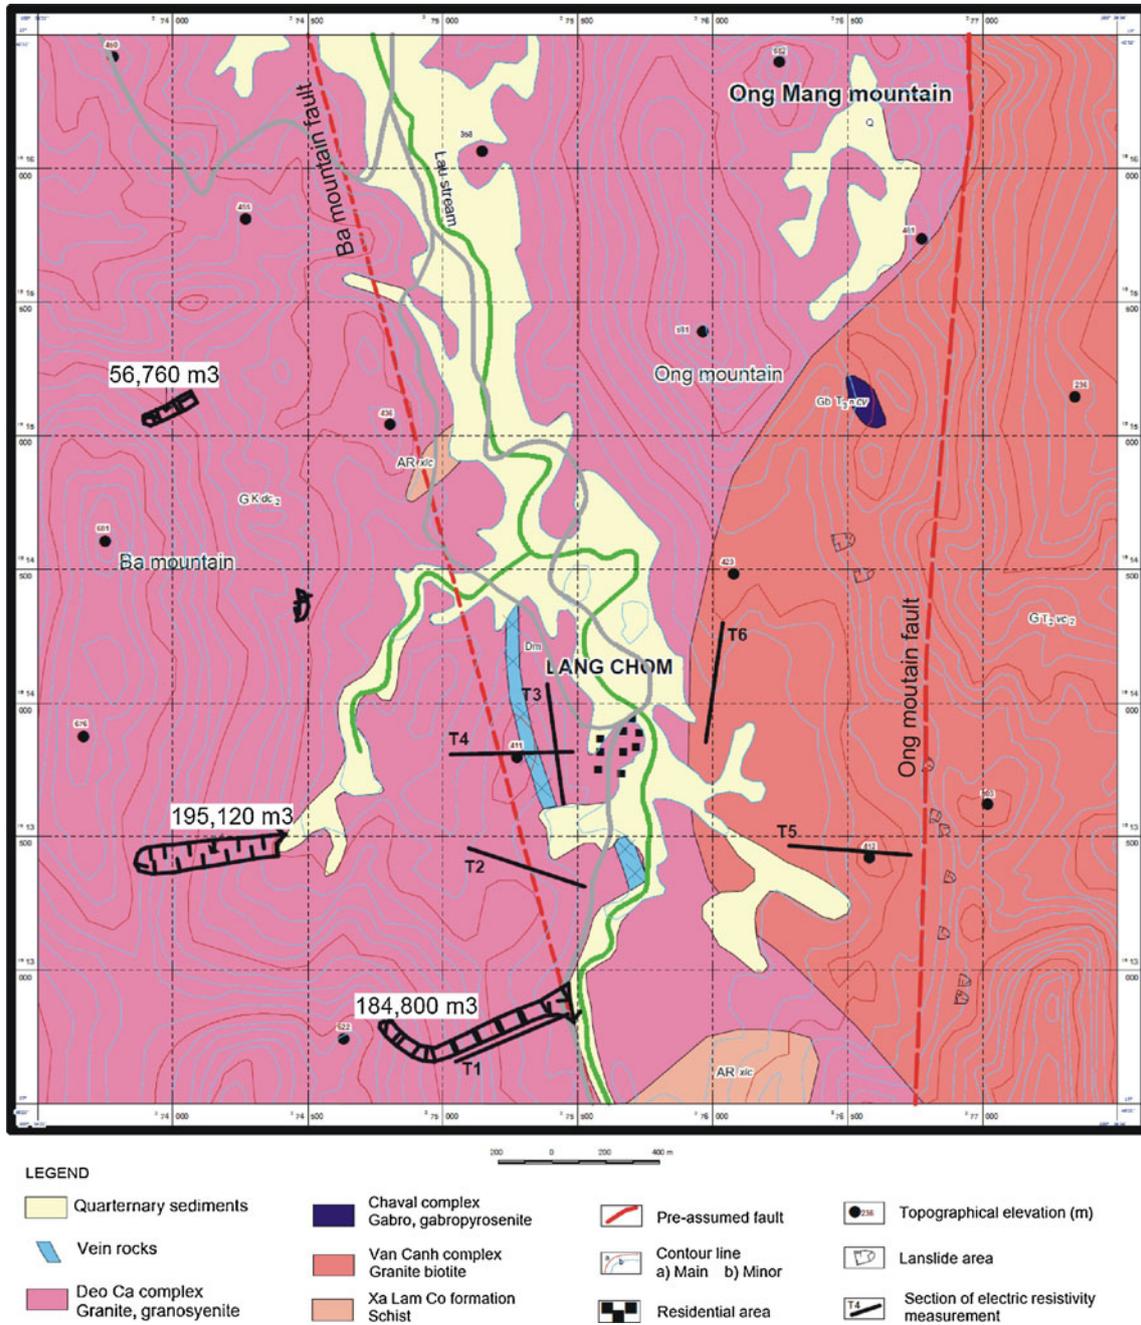
Fig. 2 Geological map of Lang Chom commune (detail investigation)

distance of electrodes (ABmax) is 140 m, which allowed us to investigate materials up to a depth of about 50 m. Six sections were measured, which are abbreviated as T.1, T.2, T.3, T.4, T.5, and T.6, respectively (Fig. 2). Each section is 450 m long. A total of 60 measuring points were included. Sections T1, T2, and T3 are designed to cut through the Ba mountain fault. Section T2, together with T3 and T4, are also for assessing landslide hazard at the hillside close to the main residential area of Lang Chom commune. T5 and T6 are for landslide hazard assessment in the tentative resettlement areas.

Faults of north–south and northeast–southwest oriented are dominant. The northeast–southwest oriented Ong mountain fault is a normal fault. A new fault was discovered during the detail investigation of geological settings, named the Ba mountain fault. It is a normal fault with strike of 165–345° and dip angle of 45° (Fig. 2). The fault system, especially the 165–345° fault leads to many cracked blocks of bedrock which accelerates the weathering process that can make conditions suitable for the sliding of large rock and soil masses. Fault planes even form the slip surfaces of some large landslides (details in “Landslide properties”).

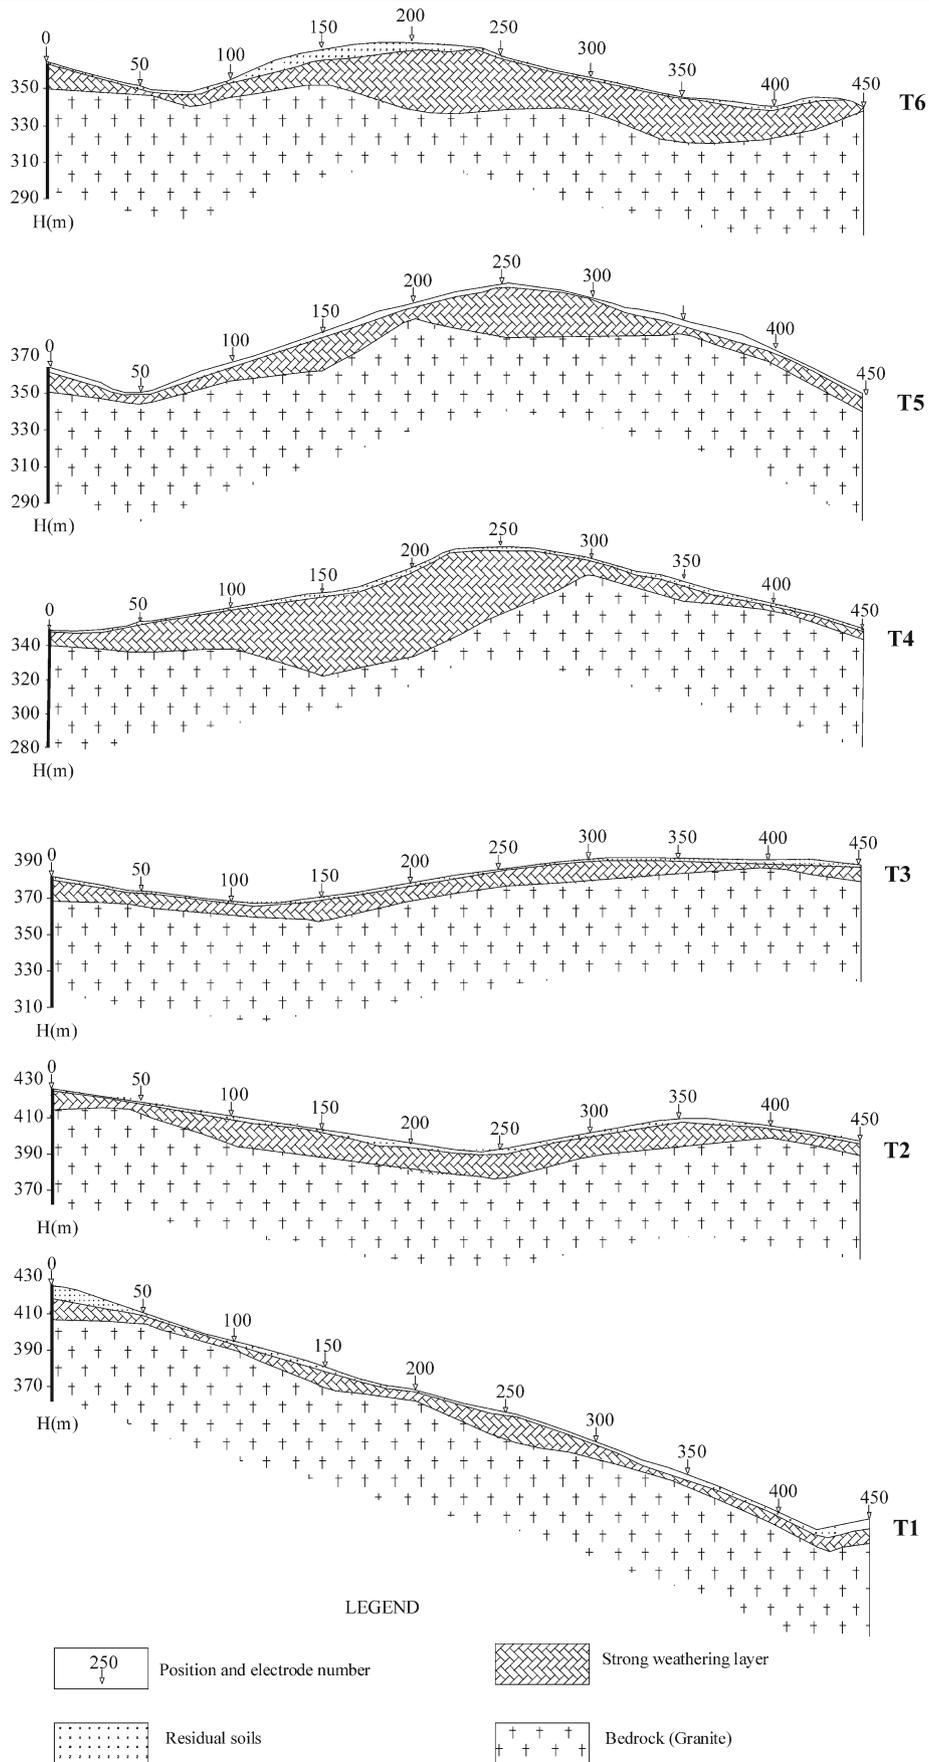
Fig. 4 Weathering crust (defined by electric resistivity measurement)

Deo Ca complex. The crust has three layers of soils and rocks (Fig. 4).

- The upper layer is residual soils which are classified as silt (ML), clayey sand (SC), and well-graded sand (SW). The thickness varies from 0.5 to 6.2 m. The layer has resistivity ranging from 174 to 4,136  $\Omega$ m. This layer is covered by trees, *Acacia mangium*, at a medium density. The trees are cut and re-planted every 3 years for the paper industry.

- The second layer is fractured and strongly weathered bedrock with a resistivity of 62–6,318  $\Omega$ m. The thickness varies over a large range: from 1.2 to 50.6 m (Fig. 4), greater thicknesses occur at fault zones and above vein rocks.
- The lower layer is intact bedrock with a resistivity of 1,168–50,175  $\Omega$ m.

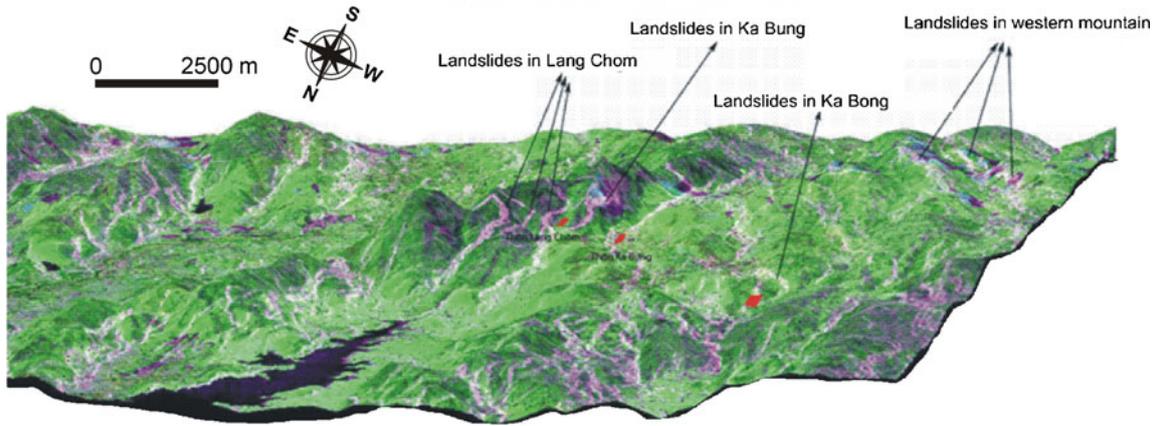
**Fig. 5** Landslides in Van Canh district in December 2005 (interpretation of PALSAR satellite image on the third of November 2009) (revised from Ha 2011)

The three largest landslides took place in Lang Chom commune and had volumes of 56,760, 184,800, and 195,120 m<sup>3</sup>, respectively (Figs. 5 and 6). The landslides were accompanied by remarkable loud noises. The landslide slip surface has two parts. The upper surface is in residual soils and has an arc shape. The height of this part is 3–6 m. The main part of slip surface is the fault plane of the Ba mountain fault (Fig. 6). The figure shows that fault plane is the interface between intact rocks and weathering soils, sheared rocks in the landslide body. Residual soils are weathered from rocks of the Deo Ca complex and have a thickness of 4–6 m. The slope angles are 27–32°. Numerous granite boulders of about 10 m<sup>3</sup> were transported downslope along a distance of hundreds of meters (Fig. 6). Sliding debris from the landslides destroyed a local road segment and filled up the Lau stream, causing an increase of

At the same time, in Ka Bung commune (the opposite site of the mountain), there was a series of large landslides (Figs. 5 and 7). The thickness of residual soils in these landslides is 6–9 m and slope angles are 28–32°. The average volume of these landslides is 20,500 m<sup>3</sup>. The landslides took place far from residential areas and did not cause any fatalities. Many other landslides and rockfalls were also triggered by rainfall along local routes and on rocky mountains with steep slopes on 15 December 2005.

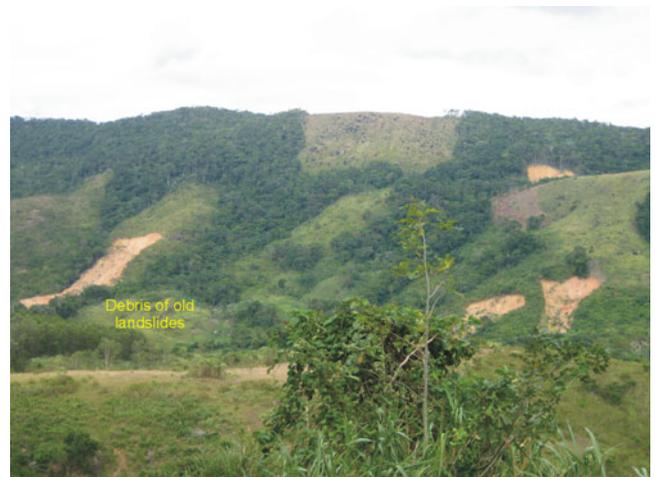
**Fig. 7** Landslides in Ka Bung commune

At the slip surfaces of landslides, some fractures were recognized in the intact bedrock (Fig. 7d). Although the initial loud noises emanated from the sliding areas, they were not followed by rolling rocks or dust clouds. These sounds may have been the result of intact brittle rock fracturing in the slope. A similar event was recorded in the Afternoon Creek rockslide in the state of Washington, USA (Strouth et al. 2006) and in a catastrophic rockslide–debris avalanche at St. Bernard, Southern Leyte, the Philippines (Catane et al. 2007). The noises that followed may be due to the falling and rolling of rock boulders.

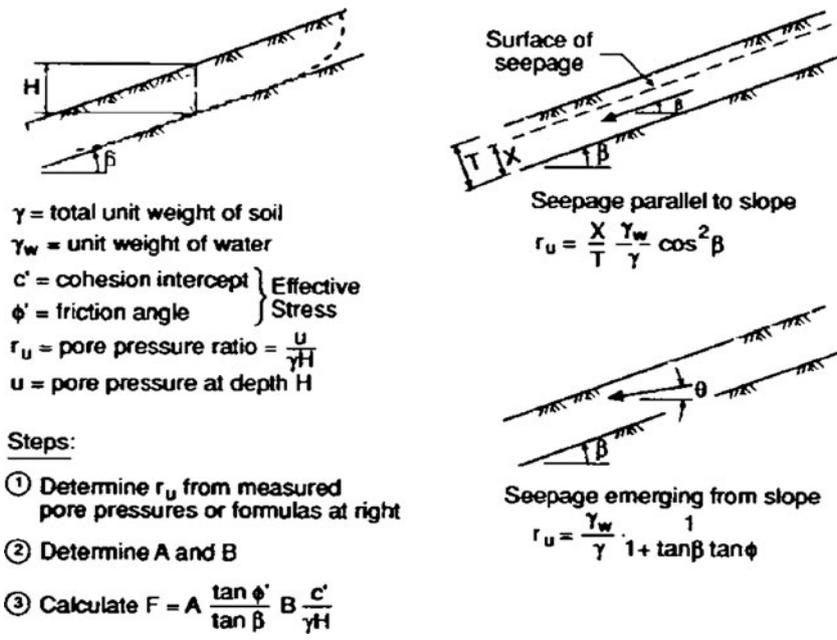
**Fig. 8** Illustration of infinite-slope-analysis method (taken from Duncan 1996)

The infinite-slope-analysis method was employed for the stability analysis. It quantitatively analyzes the effect of soil saturation on the stability of those slopes where potential for translational slides exists (Duncan 1996). The analysis assumes the slip surfaces are long compared to their depth, and it ignores the driving force at the upper end of the sliding mass and the resisting force at the lower end (Fig. 8). The method requires a procedure with three steps:

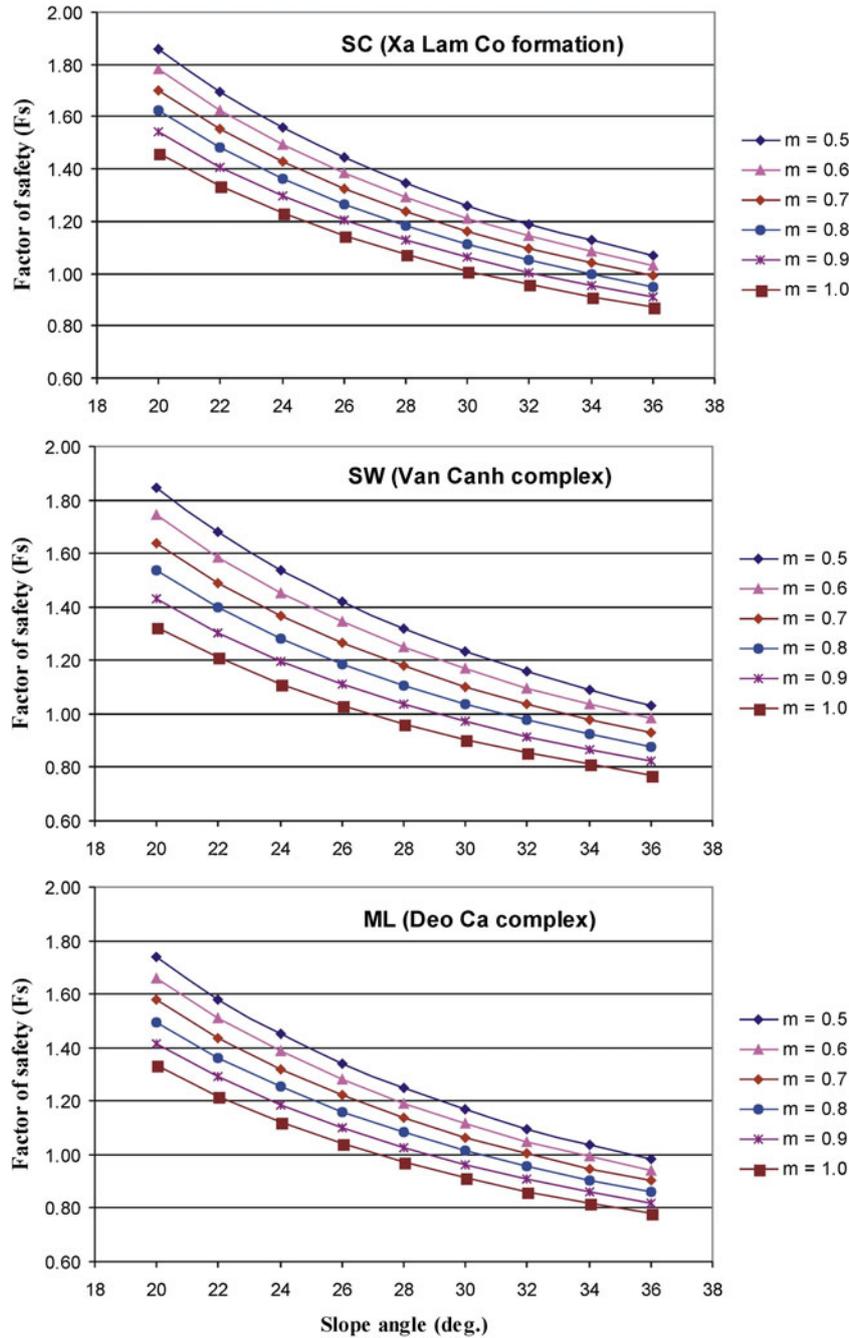
Fig. 9 Relationships between slope angle, saturated fraction, and factor of safety for various residual soils

The results are shown in Fig. 9 and display the relationships between  $F_s$  and slope angle at various values of saturated fraction (m). As can be seen in Fig. 9, a slope of well-graded sand and silt at an angle of more than 28° is unstable when fully saturated, meanwhile a 36° slope can fail if half of the soil mantle is saturated. Meanwhile, a saturated slope of

clayey sand is unstable at an angle of more than 30°. The results match well with actual observations, where failures occurred at slope angles of 28–31°. However, the phenomenon of rainfall-induced slope failure depends not only on soil properties but also on topographical and geological characteristics which contribute to the existence of a potential sliding surface.

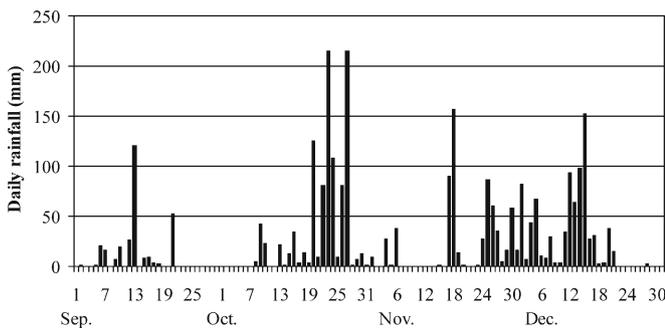
**Fig. 10** Rainfall from 01 September 2005 to 31 December 2005

To determine an empirical relationship between rainfall and landslides, the daily rainfall data from September to December 2005 was taken into account. Total rainfall in September 2005 was 287.3 mm, a normal figure in comparison to other years. In October 2005, the figure was 1,016.8 mm which is larger than the normalized rainfall with a frequency of 5 % (1,015 mm, Table 3). Therefore the rainfall in October 2005 was above the value for a 20-year return period. The number of rainy days in this month was 20 days continuously. In particular, the rainfall in 3 days (23–25 October) reached to a total of 566.5 mm (Fig. 10). However, no large landslides occurred during that month. The rainfall in November and December 2005 was 627.6 and 829.0 mm, respectively (Fig. 11). The rainfall in November 2005 is also a normal event. But the rainfall for December 2005 is very remarkable, and has a return period of 50 years. Therefore, all of the large landslides occurred in a month with an extraordinary high amount of rainfall. The unusual high amounts of rainfall in October and December make a total rainfall of 2,766 mm in the fourth quarter of 2005 which is likely to have a return period of 100 years.

The above results show that the landslides occurred after 3 months of heavy rain from September to December 2005. Heavy rainfall at the beginning of wet season (September and October) increased the water content of the soils but could not trigger landslides. In fact, the rainfall in October 2005 was even larger than in December 2005. As the results of slope stability analysis, we can predict that landslides were triggered when the slopes were almost saturated. The antecedent rainfall in October and November made soils and rock joint surfaces wetter, conditions that are more favorable for later showers to induce landslides. The total rainfall that triggered landslides was 1,260 mm, which occurred after about 1 month (17 November–15 December 2005) of heavy rains.

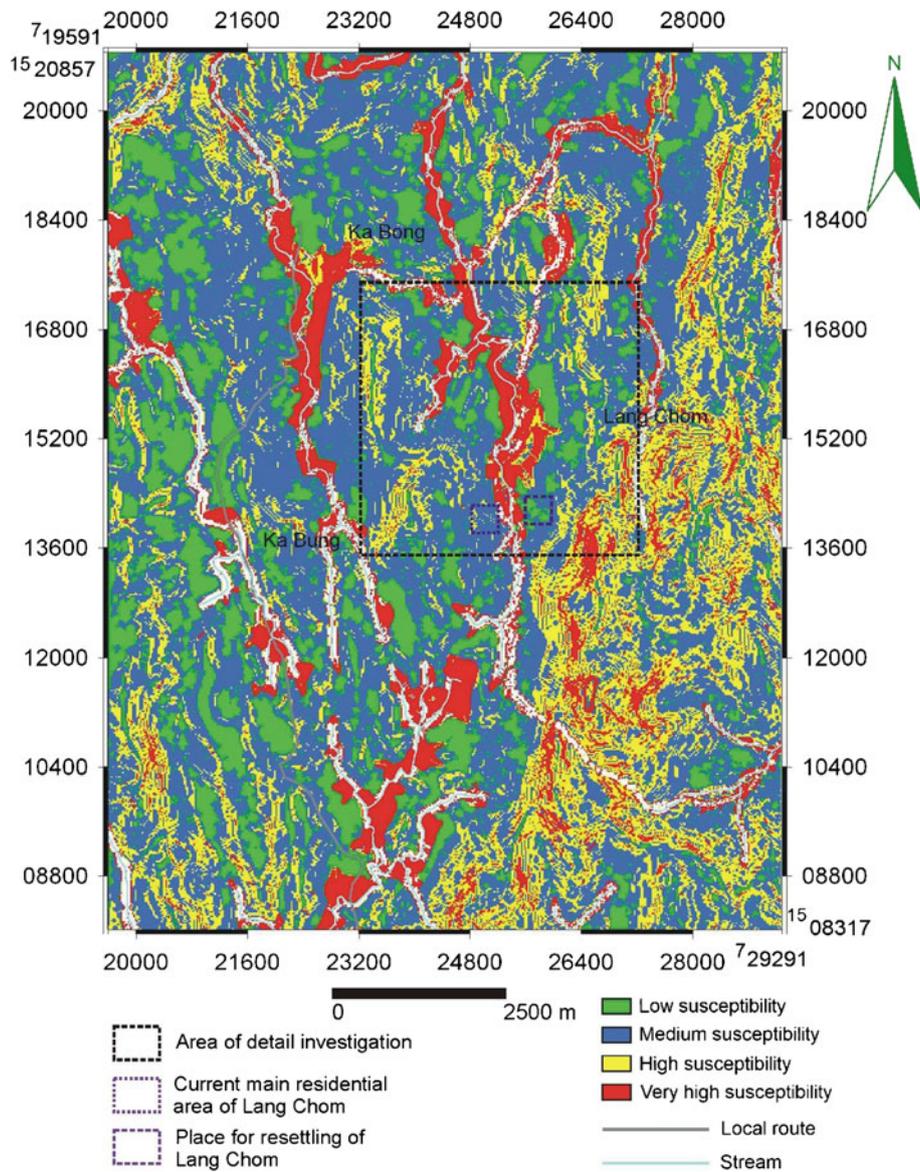
**Fig. 12** Landslide susceptibility

Thematic maps of slope angle, aspect, and geology were overlaid by using ILWIS software. Pixels with size of 10×10 m were used. Based on the total score of these three factors, landslide susceptibility was divided into four levels with scores of 0–2, 3–4, 5–6, and 7–8 (Table 4). The results are shown in Fig. 12. It showed that areas of very high and high landslide susceptibility occupied only small portions of the area. However, a major proportion was distributed along streams and some routes because of steep excavated slopes. The map also provided an orientation and initial information for selection of resettlement sites.

To define suitable places for resettlement in the whole study area, a score-based method was applied to assess landslide susceptibility. It included four levels of low, medium, high, and very high susceptibility. The study results showed that main factors affecting landslide susceptibility include slope angle and faults. Based on the results of stability analysis (a fully saturated slope can fail at an angle of 28–30°), slope angles are classified into four categories with angles of less than 20°, 20–30°, 30–40°, and more than 40°, respectively (Table 4). The influence of faults includes two aspects. Firstly, the actual distance from the investigated point to a fault, which is categorized into four levels (Table 4). The second aspect was the difference between the strikes of the slope face and the fault plane. Plane failures were considered to occur if the slope face strikes parallel or nearly parallel to the fault plane ( $\pm 20^\circ$ ) (Wyllie and Mah 2004). It has been called here “slope aspect” and was categorized into three levels, with the absolute value of difference of more than 20°, 10–20°, and less than 10°, respectively.

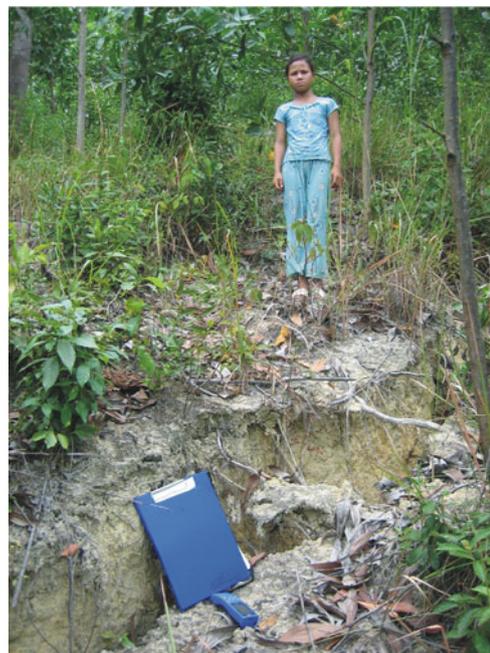
Fig. 13 Signs of potential landslides in Van Canh district (tension crack and scarp at the top)

Natural slope failure is normally a long-time process. The first sign of instability is a tension crack or scarp at the top of the potential slip surface. It is easy to recognize these signs (Fig. 13) because the local people usually carry out many activities on the slopes such as planting trees and feeding cattle. The signs can help to give an early warning of potential landslides and dangerous areas.
