Performance of EVA-Based Membranes for SCL in Hard Rock

Abstract The bonded property of multi-layered sprayed concrete tunnel linings (SCL) waterproofed with sprayed membranes means that the constituent materials will be exposed to the groundwater without any draining or mechanically separating measures. Moisture properties of the sprayed concrete and membrane materials are therefore important in order to establish the system properties of such linings. Ethyl-vinyl-acetate based sprayed membranes exhibit high water absorption potential under direct exposure to water, but are found to be significantly less hygroscopic and exhibit lower sorptivity (water absorption rate) than sprayed concrete. This material behavior explains the relatively dry in situ condition of the membrane that was observed. Measured in situ moisture content levels of the membrane material in tunnel linings have been found to vary within the range of 30–40 % of the maximum water absorption potential, and show a decreasing trend over the first 4 years after construction has been completed. A model for the mechanical loading, moisture condition and thermal exposure of the membrane and the resulting realistic param

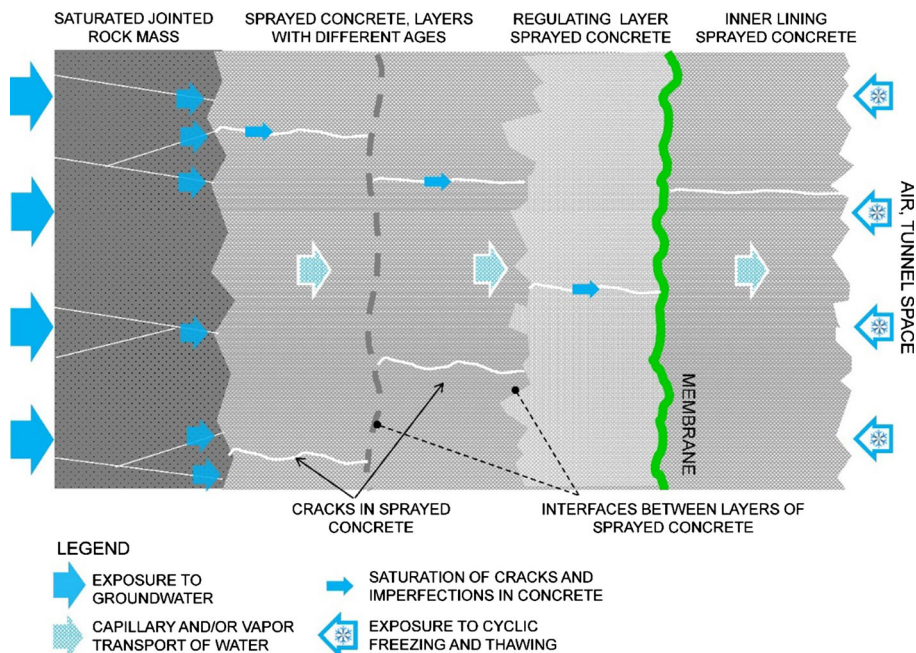
Fig. 2 Detail of waterproof SCL. Conceptual model with section of the lining structure with the constituent materials, moisture transport processes and exposure to freezing

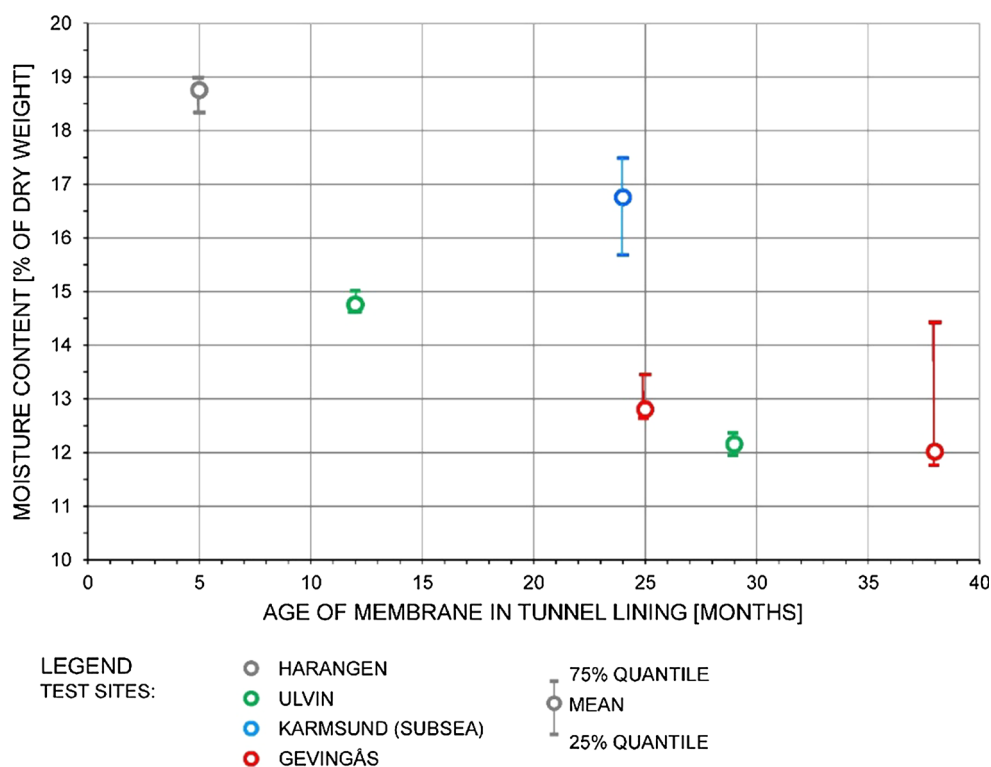
Fig. 4 Measured development of in situ moisture content in sprayed membrane material in tunnel linings

A trend with decreasing moisture content in the membrane material with increasing time after construction can be observed, in spite of high degrees of capillary saturation of the concrete on either side of the membrane. These data refer to four different hard rock tunnel projects indicated with the different colors. The tunnel linings in all four cases were constructed with drained invert and waterproof undrained SCL in the walls and crown. The Karmsund case is a subsea road tunnel located at approximately 70 m below the groundwater table. Hence a complete saturation under hydrostatic pressure of the rock mass, and higher saturation of the imperfections of the concrete is likely to have taken place.

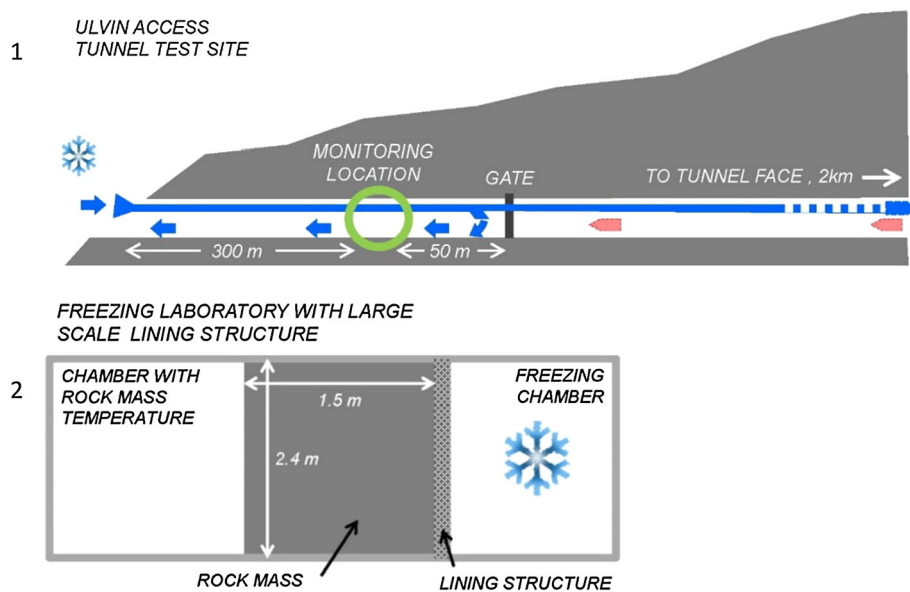
Fig. 5 Longitudinal vertical sections with configuration of the Ulvin test site for in situ measurements (case 1) and the laboratory lining structure (case 2) for controlled thermal exposure

Thermal monitoring with freezing exposure was carried out in the full scale lining section at the Ulvin test site and the lining structure in the freezing laboratory. The main goal of this monitoring was to measure temperature profiles under realistic conditions. The temperature at the location of the membrane can then be assessed. The two monitoring cases are explained in Fig. 5.

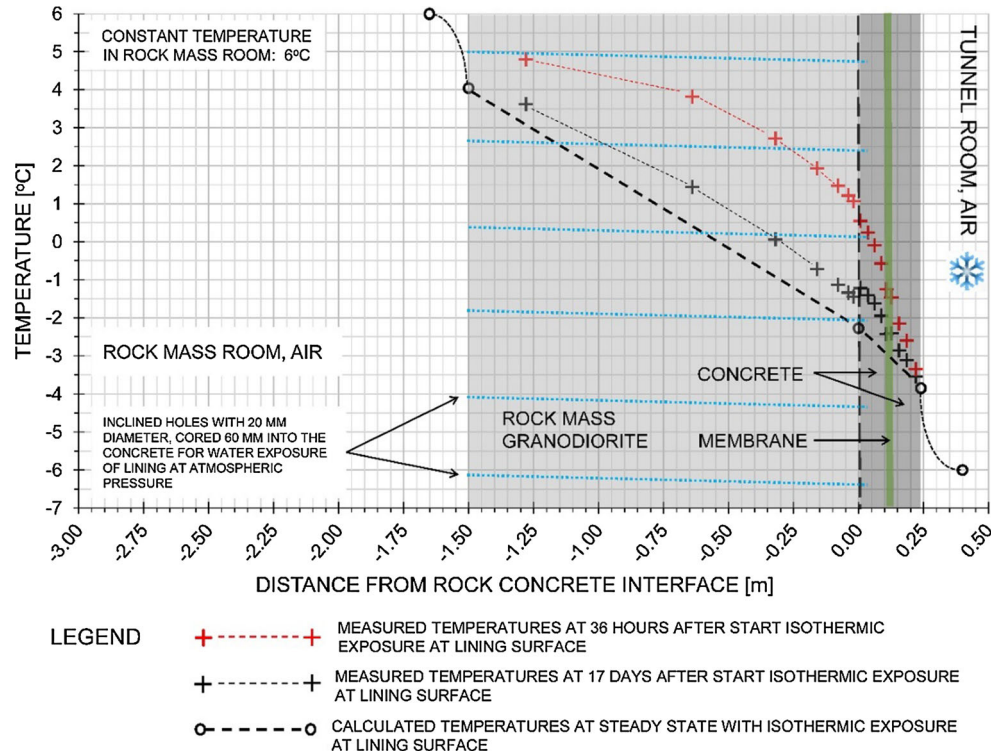
Fig. 6 Large scale laboratory simulation: measured and calculated temperature profiles through rock mass and lining structure

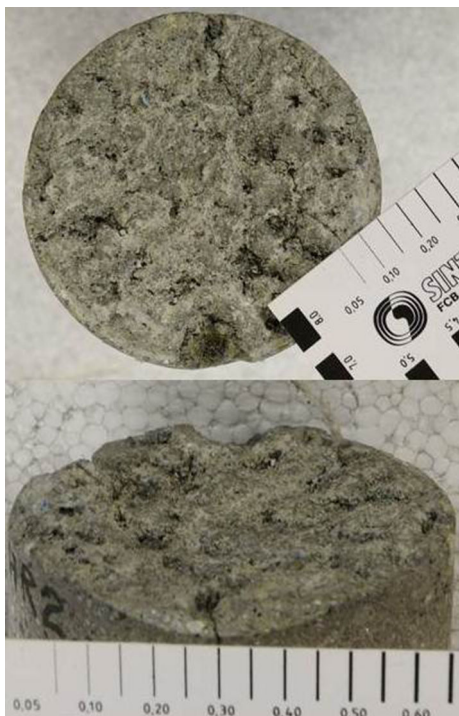
Fig. 8 Example of recordings of cracks in a sprayed concrete surface using a concrete crack measurement gauge

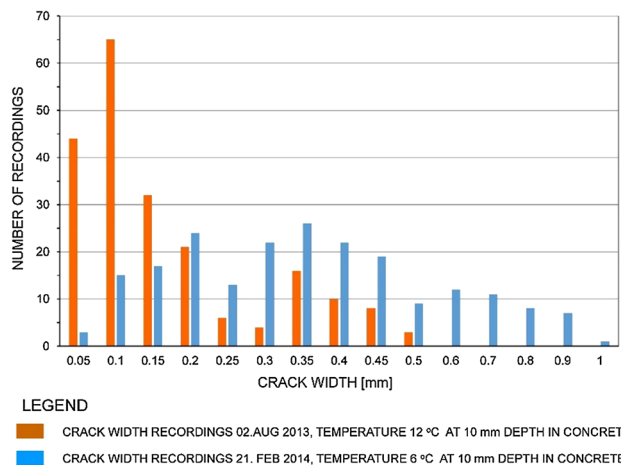
Fig. 9 Measured crack widths in the sprayed concrete lining surface at the same location in August 2013 and February 2014

the recorded cracks for the measurements done in August 2013. The crack measurements in February 2014 show an increase in crack width, and a larger scatter of the

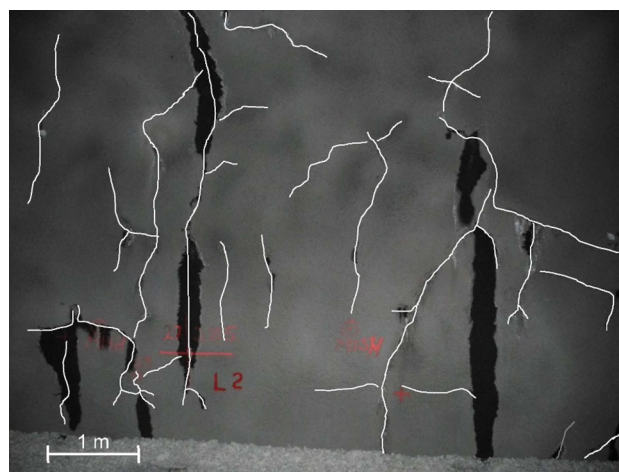
Fig. 10 Surface observations of cracks in sprayed concrete

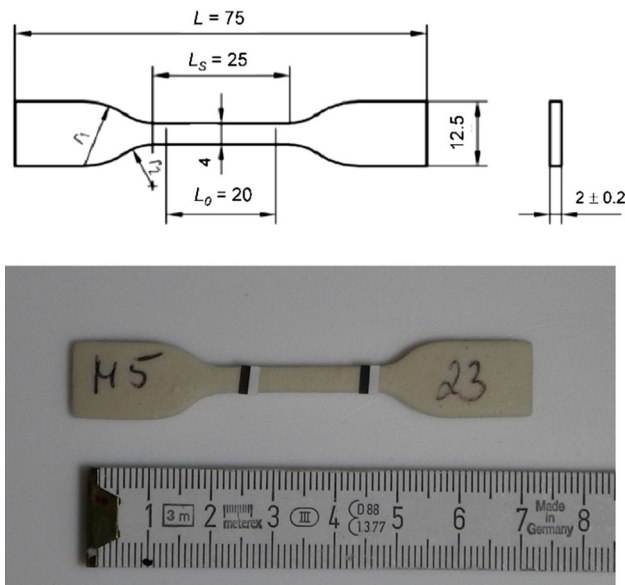
Fig. 11 Specimen for elasticity test according to DIN 53504. *Top* dimensions of the S2-type dog bone shaped specimen used for this purpose, with figures in mm. *Bottom* photo of specimen with markings of the length L_0 area for precise elongation measurement with video-extensometer

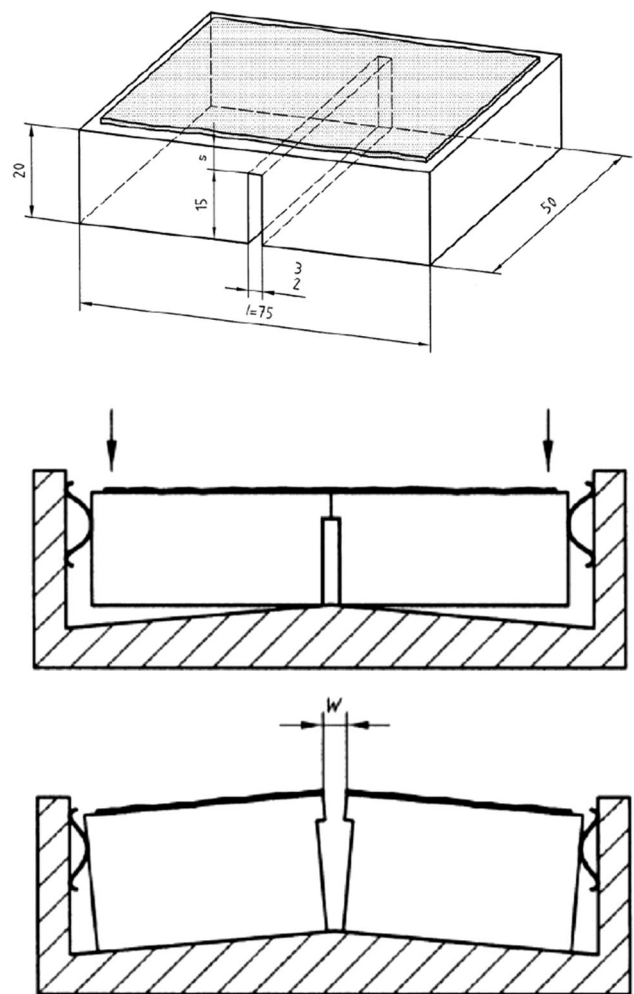
Fig. 12 Conceptual illustrations showing the static crack bridging test procedure according to DIN EN 1062-7 Annex C1, proposed by ITA/AITES 2013

The proposed test method for crack bridging performance according to ITA/AITES (ITA/AITES 2013) is a static crack bridging test and is designed for the testing of coating materials on exterior surfaces of masonry and concrete (DIN EN 1062-7:2004). With this test method one can basically test only one crack width, although it would be possible to include a few increments in the crack width

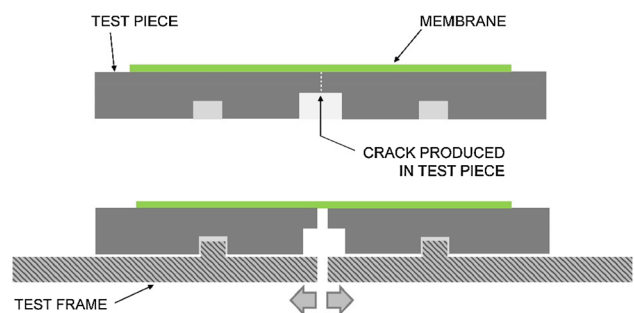
Fig. 13 Conceptual illustrations showing the loading mode during the adopted version of the dynamic crack bridging test

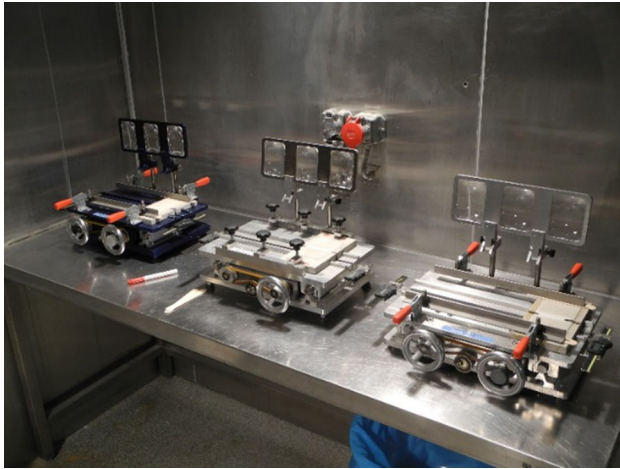
Fig. 14 Crack bridging testing with adopted procedure in progress in climate chamber. (Courtesy by Wacker Chemie AG)

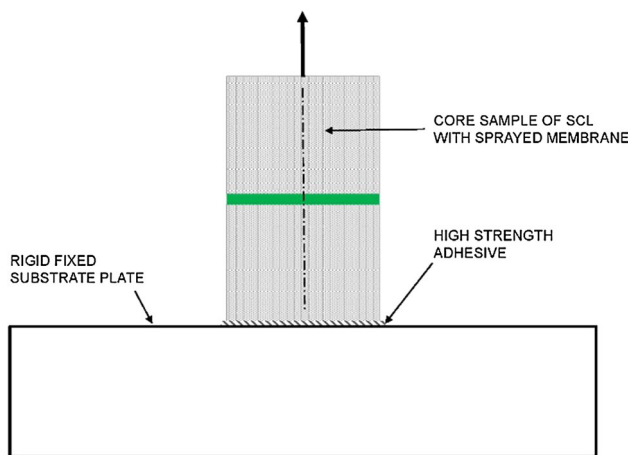
Fig. 15 Testing of tensile bonding strength according to EN-ISO 4624

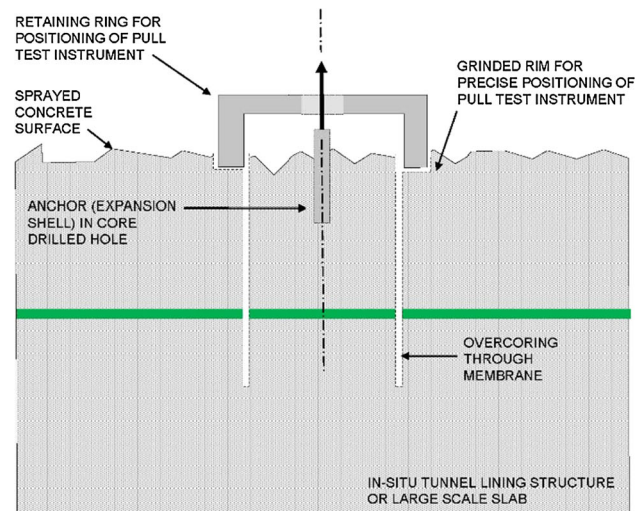
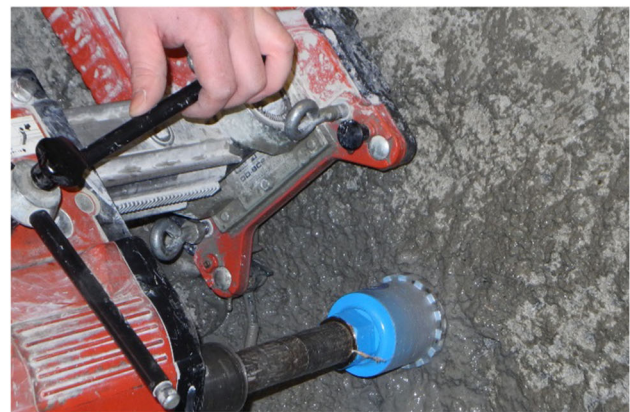
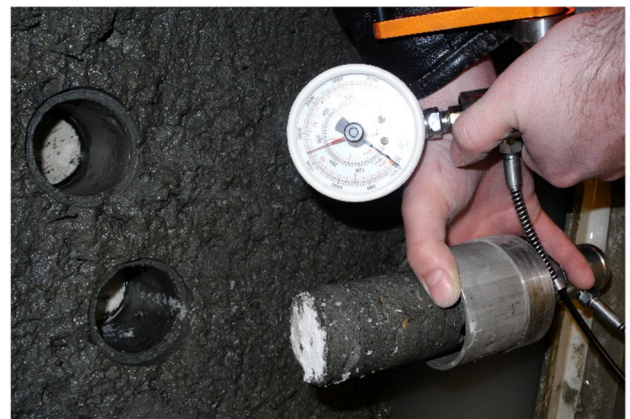
Fig. 16 Adopted procedure for in situ measurements of tensile bonding strength. *Top* conceptual diagram showing the layout of the test. *Middle* Preparation with over-coring with grinding of the test specimen. *Bottom* in situ specimen after testing

A procedure to measure tensile bond strength without extracting core samples was adopted. The main purpose of this procedure was to test the tensile bond strength under as

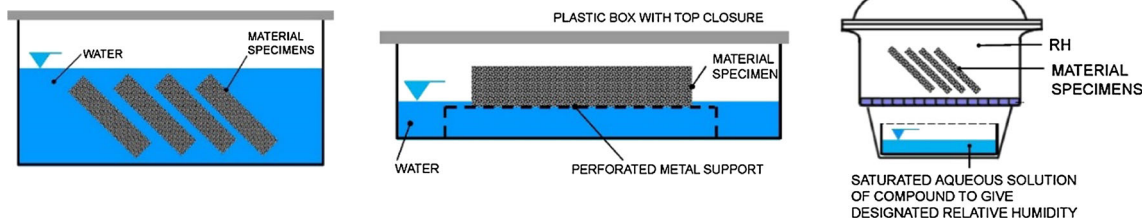
Fig. 17 Sketches of the three water absorption modes which have been tested in the laboratory. *Left* water content at complete immersion. *Middle* sorptivity (water absorption rate) at unidirectional

water exposure. *Right* moisture bearing capacity at equilibrium in the hygroscopic range

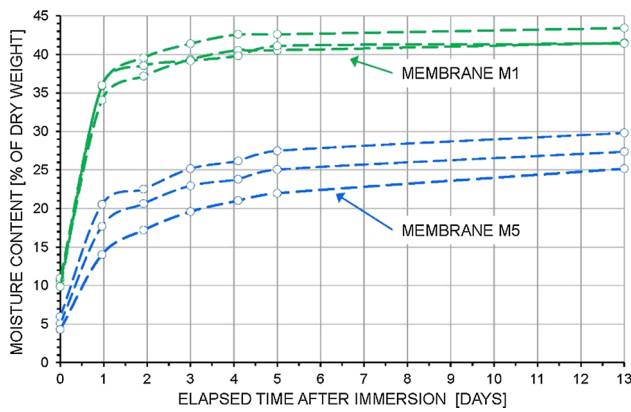
Fig. 18 Moisture content of membranes measured after complete immersion at atmospheric pressure for sprayed specimens of membranes M1 and M5

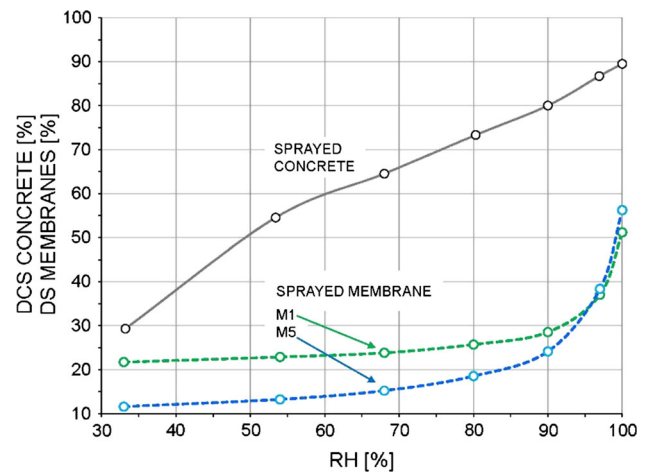
Fig. 20 Desorption isotherms obtained at 25 °C for sprayed concrete and sprayed membrane, showing the moisture content represented as degrees of saturation at equilibrium versus different values for RH

The investigation of the moisture content at equilibrium for concrete was presented by Holter and Geving (2015). Testing of the membranes M1 and M5 with moisture content at equilibrium obtained by isothermic desorption has been added in this study. The desorption isotherms show moisture content represented as degree of saturation at immersion for the materials versus relative humidity. A compilation of the results is shown in Fig. 20. The difference in behavior when

taking the material from immersion to RH 100 % is noteworthy. Concrete loses approximately 10 % of its moisture content, whereas the membranes lose approximately 50 %

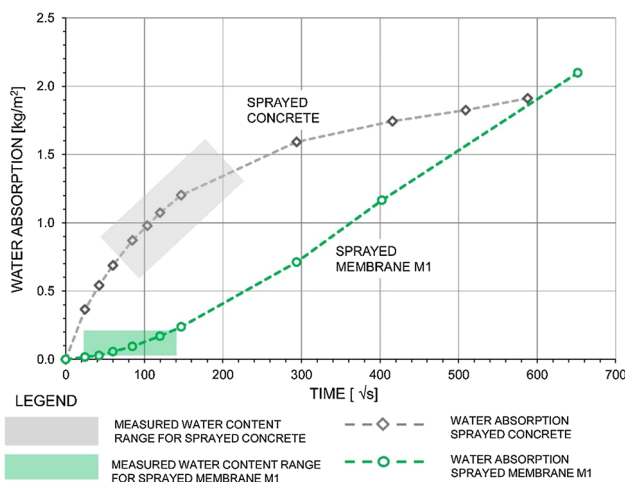
Fig. 19 Water absorption rate (sorptivity) of sprayed concrete and sprayed membrane (M1) represented as water absorption versus square root of time (compiled from Holter and Geving 2015)

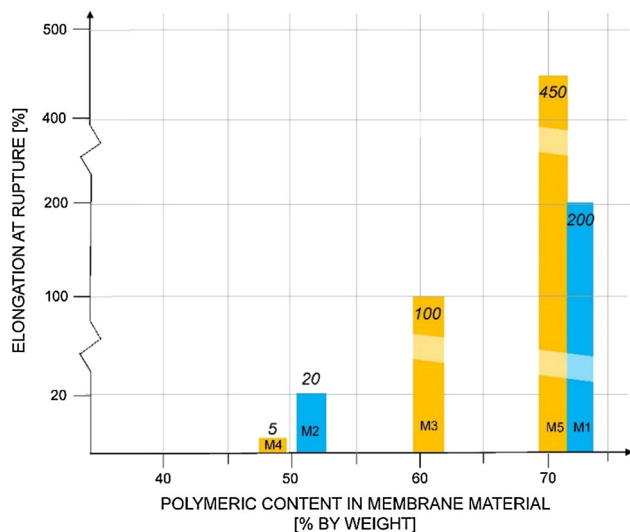
Fig. 21 Elongation performance of sprayed membrane samples versus polymeric content in the base (powder) membrane products M1–M5 measured by thermo-gravimetric analysis (TGA) with argon as test gas. The elongation was measured in one single test series (laboratory 1) with specimens which had undergone identical treatment from application to testing

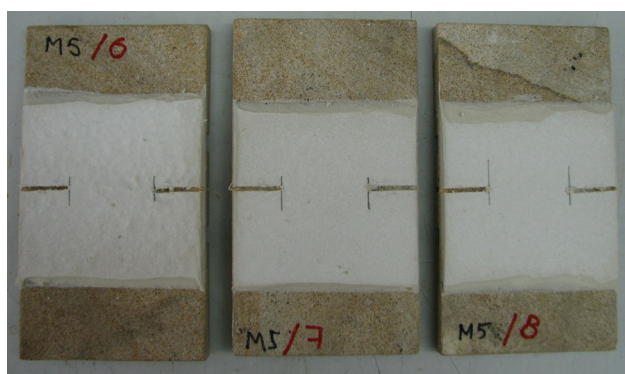
Fig. 22 Specimens for crack bridging test with membrane applied on the surface of test pieces. The dimensions of the test pieces are 100 mm × 200 mm

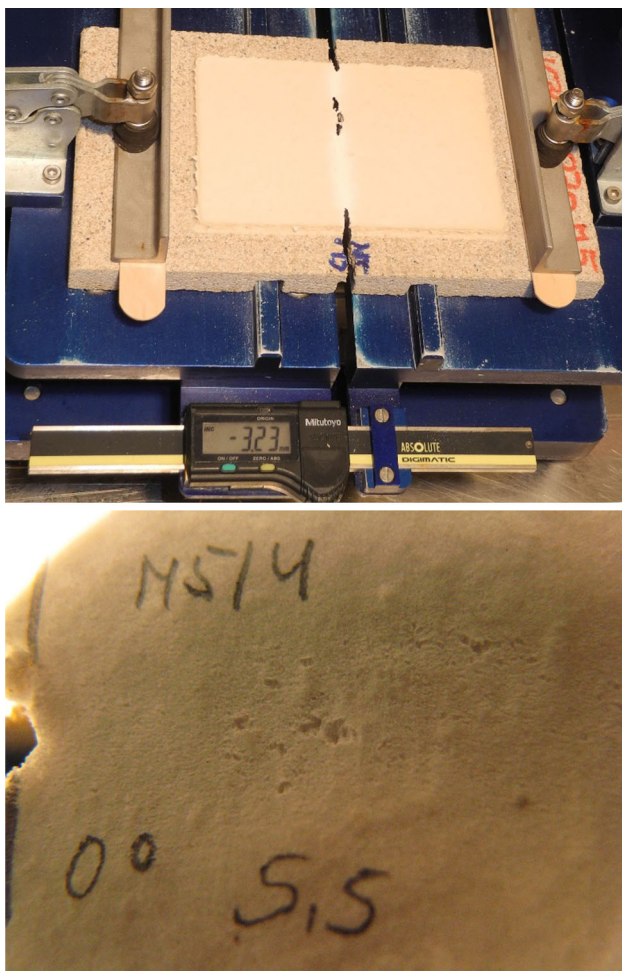
Fig. 23 Crack bridging testing in progress. *Top* specimen in testing apparatus for precise measurement of crack aperture at rupture. *Bottom* definition of rupture with visible initial damage of the membrane

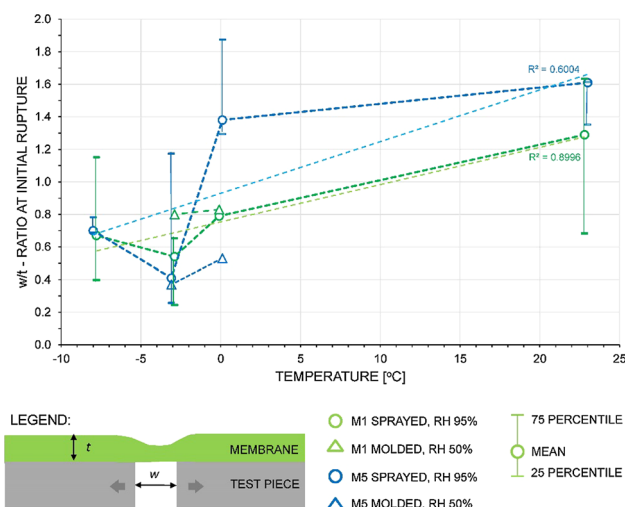
Fig. 24 Results from crack-bridging testing for membranes M1 and M5 conducted at different temperatures and pre-conditioned at RH 50 and 95 %

The results of test series 1 and 2 are shown in Fig. 24. For the specimens with spray applied membrane (series 1) values are shown as mean with 25 and 75 % percentiles. For the molded specimens (series 2) only average values are shown, since there were too few satisfactory readings to obtain statistical data. The specimens had slightly differing membrane thicknesses. Therefore the value for rupture was given as the ratio between crack width at rupture and the membrane thickness which varied from 1.9 to 5.5 mm. The variation of the membrane thicknesses was largest for the specimens with spray applied membrane. The results (Fig. 24) show that the crack bridging capacity decreases with decreasing temperature with the given conditioning of the specimens. Both membrane products M1 and M5 were found to bridge cracks with an aperture in the range of 0.4–0.8 times the thickness of the membrane at −8 °C. At

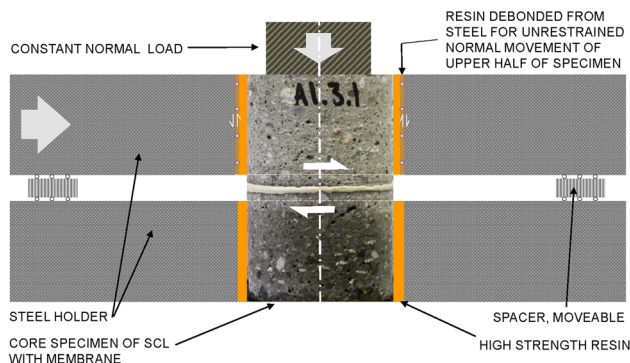
Fig. 25 Conceptual diagram showing a section of the assembly with core specimen mounted in the steel frame used for direct shear testing

After water storage the specimens were prepared for shear testing by mounting them in a steel frame assembly. The process of preparing a series of three specimens in the test assembly and conducting the shear tests could be undertaken in 1 day. The assembly of the specimens is shown in Fig. 25 and the steps in the procedure are shown in Fig. 26.

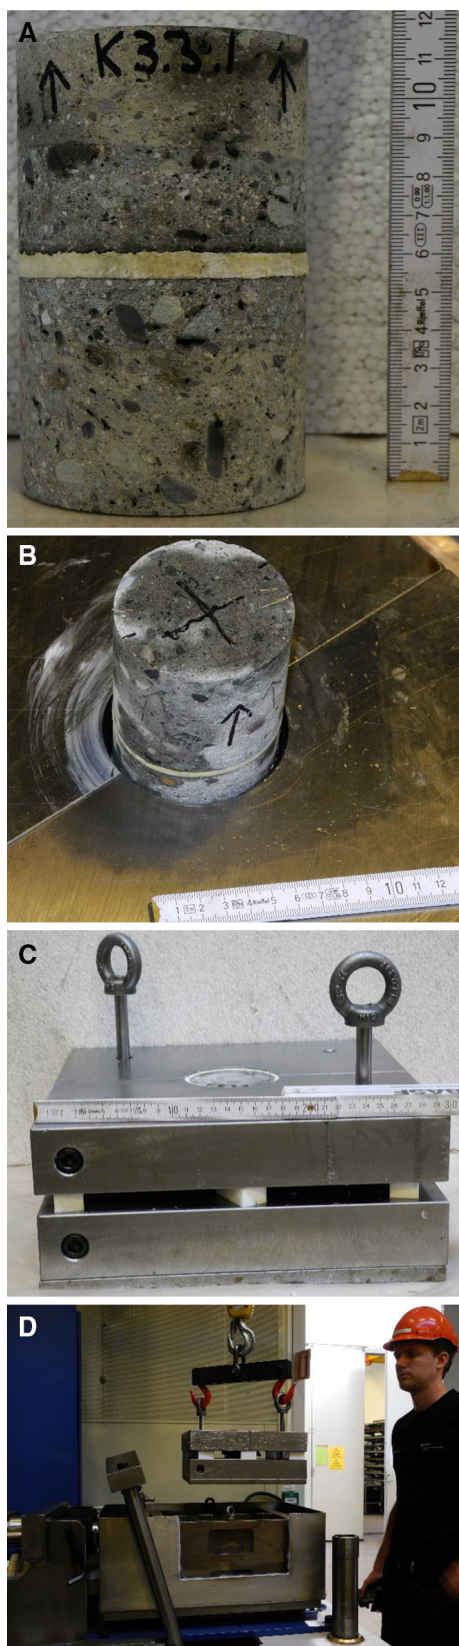
◀**Fig. 26** Direct shear testing of SCL structure. **a** Typical core specimen with 74 mm diameter. **b** Specimens placed in steel holder ready for fixing with high strength resin. **c** Specimen in complete assembly ready for testing. **d** Placement of test assembly into shear box

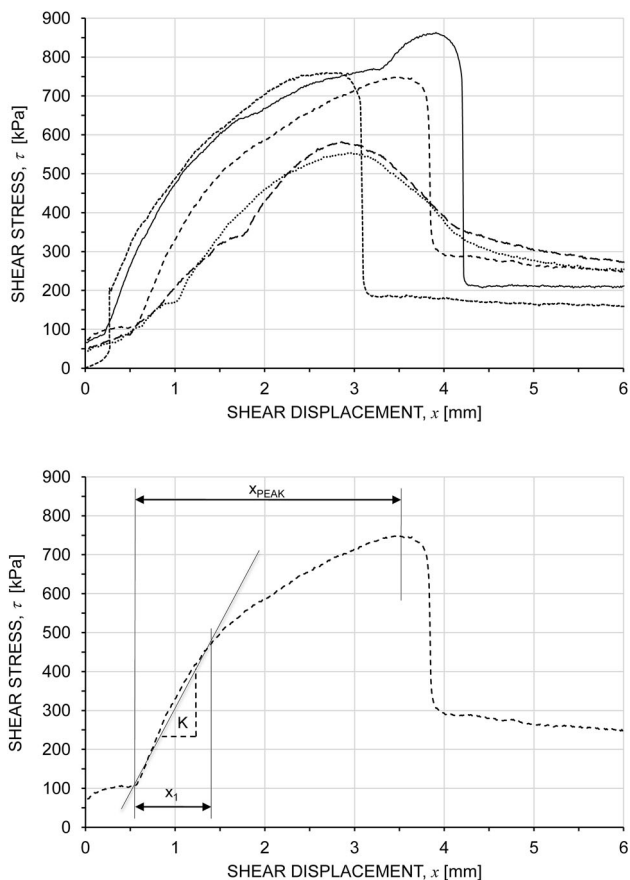
Fig. 27 Results from shear testing for membrane M1 represented as shear stress versus shear displacement. *Top* diagram showing results for all five specimens. *Bottom* results for one specimen with recorded parameters, shown in Table 16

Both membranes exhibit almost the same behavior within the initial deformation, showing linear shear elasticity up to approximately 1 mm shear deformation. Membrane M1 exhibits a slightly higher shear stress at this point, corresponding to the higher shear stiffness K_1 compared to M5. M1 exhibits a clear bonding (adhesive) failure (Fig. 28) with peak shear stresses in the range of 0.55–0.85 MPa, after approximately 3–4 mm shear deformation. After the initial zone of shear elasticity, the two membranes have very different behavior. Membrane M1 exhibits increasing strain softening behavior and membrane M5 exhibits a bi-linear behavior with increased displacement. In the latter phase a lower shear stiffness can be observed. After approximately 7–8 mm horizontal displacement membrane M5 exhibits almost

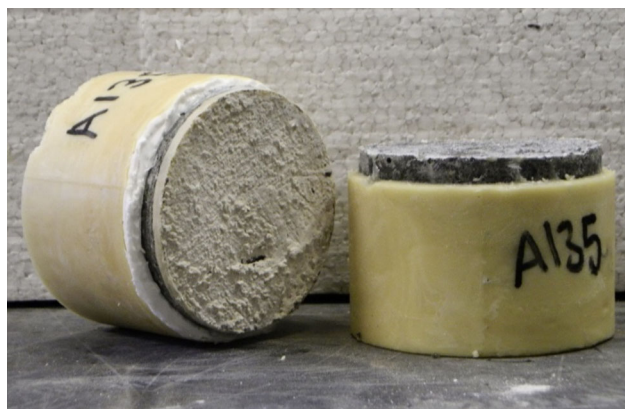
Fig. 28 Specimen of membrane M1 after shear testing exhibiting a debonding (adhesive) failure between membrane and the substrate concrete

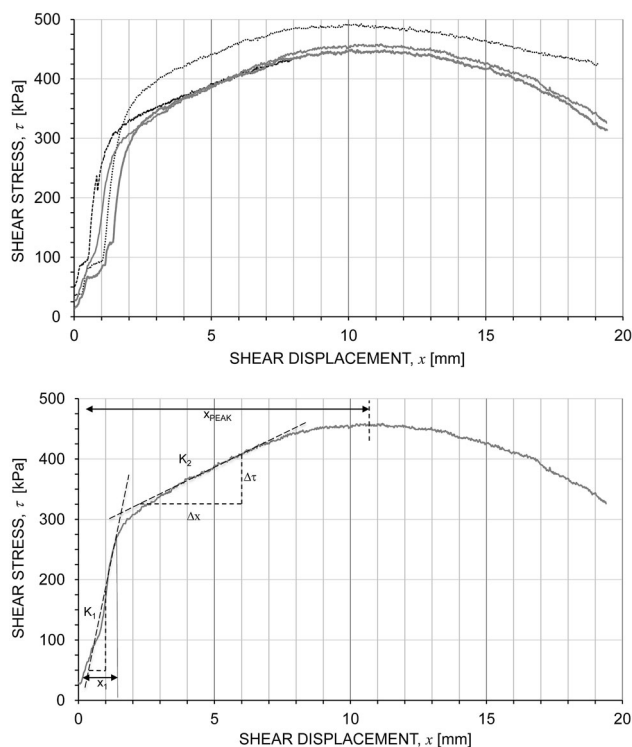
Fig. 29 Results from shear testing for membrane M5 represented as shear stress versus shear displacement. *Top* diagram showing results for all five specimens. *Bottom* results for one specimen with recorded parameters, shown in Table 15

perfect plasticity and reaches a peak shear stress of approximately 0.45–0.5 MPa. No clear failure could be observed during the shear testing with the M5

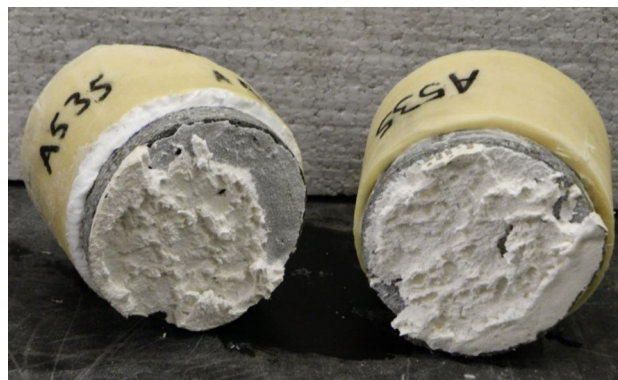
Fig. 30 Specimen of membrane M5 after shear testing exhibiting shear (cohesive) failure in the membrane material

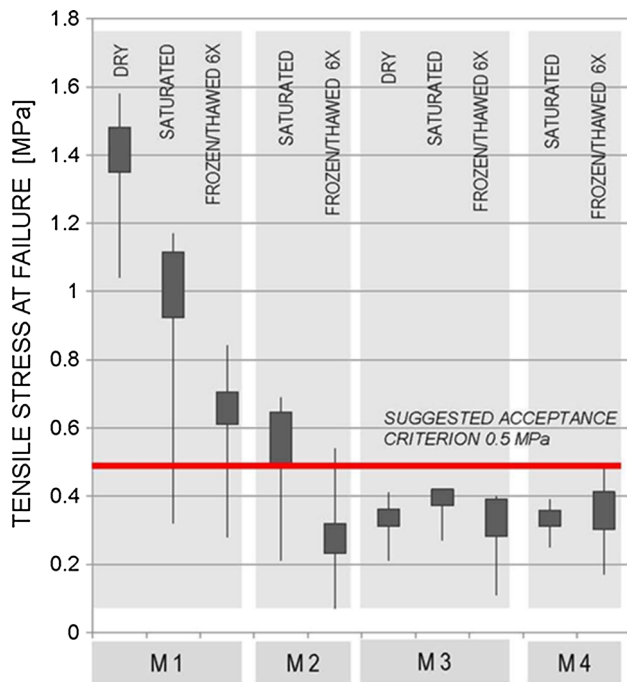
Fig. 31 Results from tensile bond tests for test series 1 (Table 15), drill core specimens with diameter 74 mm. Membrane numbers M1–M4 are explained in Sect. 6.3.2

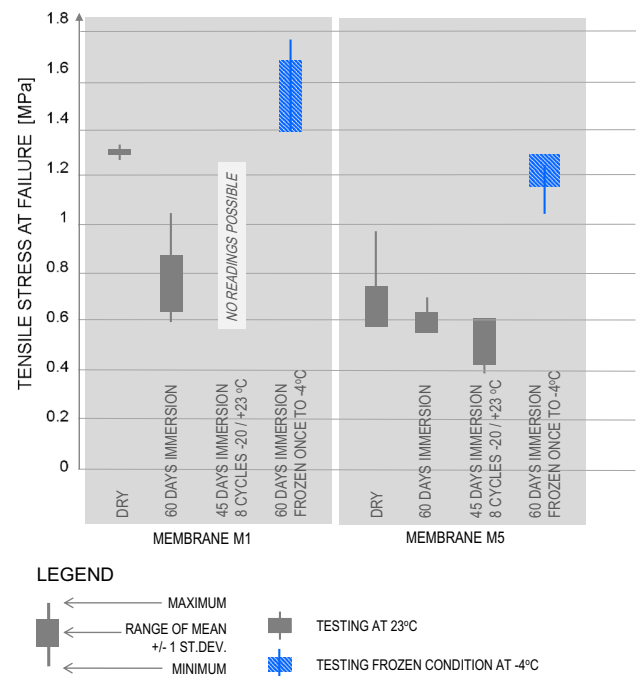
Fig. 32 Results from tensile bond tests for test series 2 (Table 15), in situ pull test method

The membrane M5 was introduced as a substitute for M1 and M2. M3 was discontinued for further testing. The results for series 2 which only includes membranes M1 and M5 are shown in Fig. 32. This testing context shows that saturation through 60 days immersion of the entire slab gives a significant reduction of the tensile strength for M1 and a slight reduction of tensile strength for M5 compared to dry specimens. Eight freeze–thaw cycles to -20°C result in a reduction of tensile strength from approximately 0.7–0.5 MPa for M5. For M1 no readings were possible after the freeze–thaw cycles due to jamming of the drilling equipment at the membrane. For both membranes the

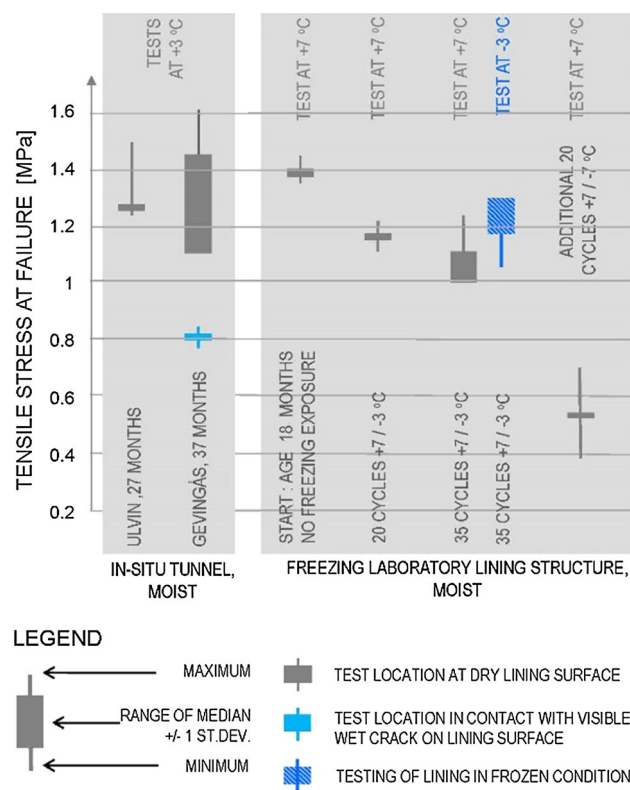
Fig. 33 Results from tensile bond tests for membrane M1, test series 3 and 4 (Table 15), in situ pull test method

Series 3 and 4 (Table 15) represent in situ readings conducted with horizontal drilling on tunnel walls in different lining sections ranging from complete tunnel to large scale lining structure in a laboratory (Fig. 7). Exposure to moisture took place through the substrate sprayed concrete. Results from the tunnel test sites exhibit high tensile strengths in the range 1.1–1.6 MPa, with 1.3 MPa as the mean value (Fig. 33, left part). Two readings could be made at a wet crack (defect) in the inner lining, at which 0.8 MPa tensile bond strength was measured. Since realistic moisture contents were achieved in the lining structure at the SINTEF freezing laboratory, the effect of cyclic freezing and thawing on tensile bond strength could be measured (Fig. 33, right part). An initial tensile bond strength of 1.4 MPa at realistic moisture content was measured. After 20 and 35 freeze–thaw cycles with -3°C minimum temperature at the membrane during each cycle, a slight reduction to respectively 1.15 and 1.1 MPa tensile strength could be measured. A tensile strength in the range of 1.1 to 1.3 MPa was measured in frozen condition at -3°C at the membrane. An additional freeze–thaw exposure with 20 cycles with a minimum temperature of -7°C at the membrane was conducted after the first 35 cycles to -3°C . Tensile strengths ranging from 0.4 to 0.7 MPa were measured after this exposure. Difficulty in

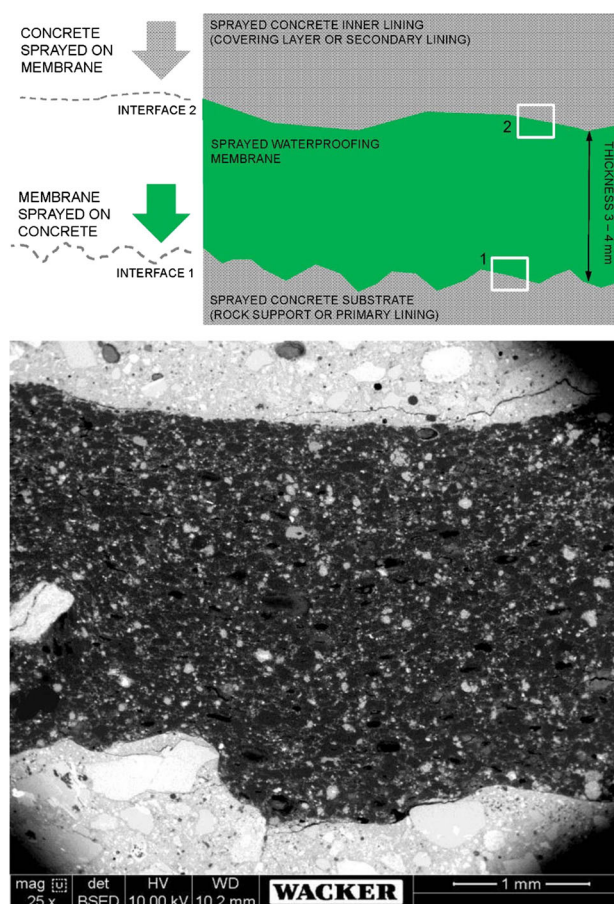
Fig. 34 Principle sketch and photo of the two interfaces between membrane and sprayed concrete. The interfaces 1 and 2 are shown respectively in Figs. 35 and 36 (courtesy by Wacker Chemie AG)

The interface on which the secondary lining concrete has been applied onto the membrane (interface 2) shown in
