Slope stability modelling and landslide hazard zonation at the Seymarch dam and power plant project, west of Iran

Abstract The Zagros Mountains Range is an important structural unit in south western Iran and accommodates a significant portion of the 2.5 cm/year convergence between Arabia and Eurasia. This structural unit includes folds, thrusts, strike-slip faults and salt diapirs. There is evidence of past failures in the area, probably some 11,000 years ago. In the order of 30 million cubic metres of rock debris was moved from the Kabir Kuh Anticline as well as rock failures from the Ravandi Anticline. Investigations indicated 4.5 m of landslide/rock fall debris underlying about 28 m of lake deposits and 5.5 m of recent river alluvium upstream of the Seymareh Dam area. The direction of the Seymareh River bed was displaced by about 1,000 m to the northeast, forming a sharp river meander near the entrance to the gorge of the Ravandi Anticline where the Seymareh Dam is being constructed. The paper reports the rock slope instability modelling, kinematic analysis of slope faces and landslide hazard zoning undertaken.

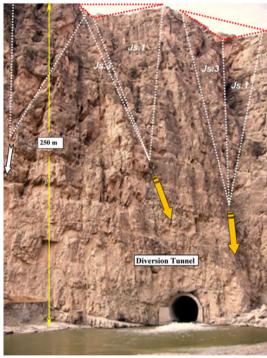
Fig. 18 Wedge failure along intersection of Js.1, Js.3 at right bank downstream of Seymareh River valley, some of which are historic. *Yellow arrows* show the direction of sliding toward the river valley; *white arrows* indicate probable wedge failures in the future

the potential for wedge failures on the right bank and toppling on the left, such as has clearly occurred in the past (Fig. 18). Field investigations indicated up to 60,000 m³ was moved, which now shows evidence of weathering and surface erosion. Figure 19 shows an example of slope instability on the left bank of the Seymareh River valley due to toppling failure.

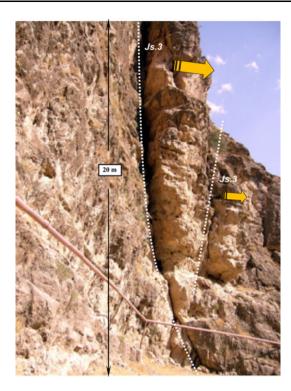
Fig. 19 Toppling failure along joint set.3 on the *left* bank of the Seymareh River valley
