A procedure for the identification of the seismic vulnerability at territorial scale. Application to the Casbah of Algiers

V. I. Novelli · D. D'Ayala · N. Makhloufi ·
D. Benouar · A. Zekagh

Keywords Seismic vulnerability · Masonry buildings · Historical buildings · Building cluster · Territorial scale

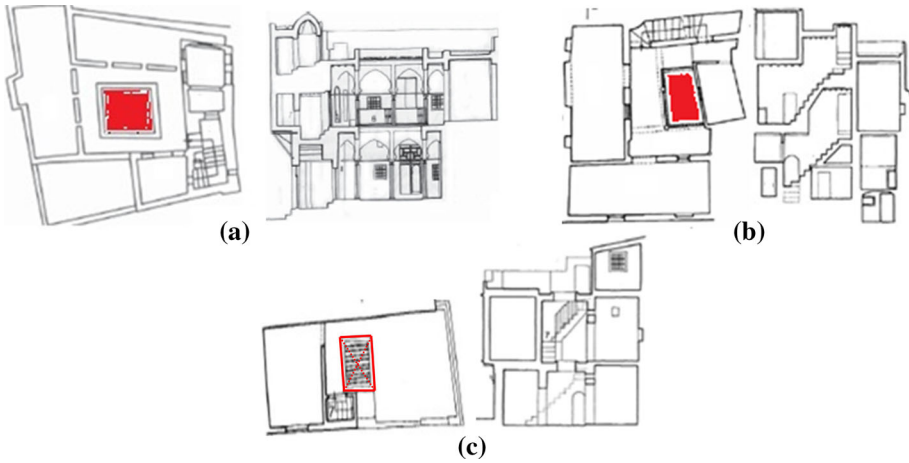
Fig. 1 Plan and section view of traditional house **a** “Dar shebbak” with “wast Al-dar”, **b** “Dar shebbak” with “shebak and **c** “Al –Alwi” (images adapted from Missoum 2003)

According to Amina et al. (2010), three main buildings typologies can be identified within an urban block in the Casbah: (1) “Dar shebbak” with “wast Al-dar”, patio, highlighted in red in Fig. 1a, positioned in the centre of the house, (2) “Dar shebbak” with “shebak” in which the “wast Al-Dar” the big large patio of Fig. 1a becomes a “shebak”, a small internal patio covered by a grid, highlighted in red, Fig. 1b, created for ensuring ventilation and illumination to the house and for providing access to the rooms, (3) “Al-Alwi”, house without patio, distributed in elevation around a staircase, highlighted in red in Fig. 1c.

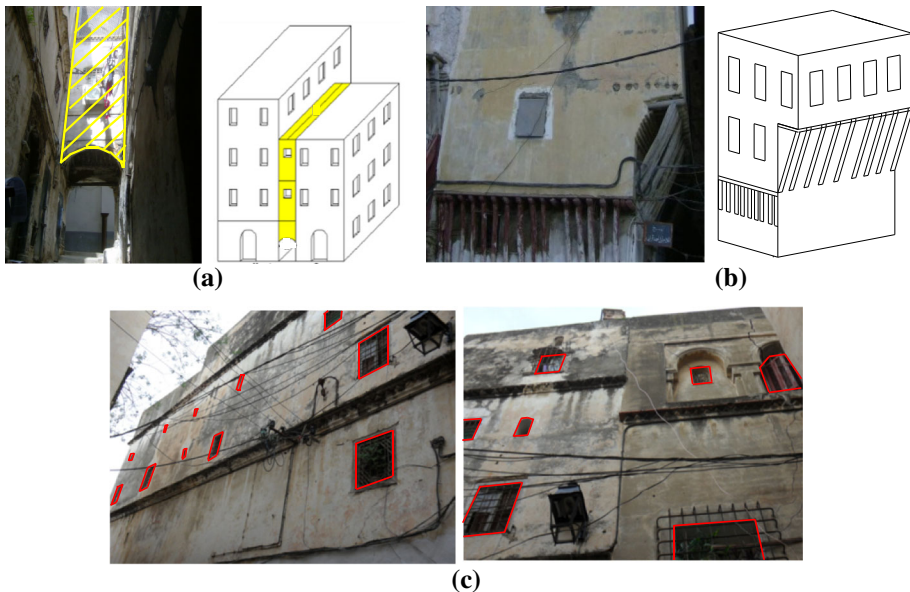
Fig. 2 **a** Sabat and **b** “q ‘bû”, **c** opening layout of the façades in the Casbah of Algiers

alignment, since several modifications are brought to the structures throughout the years, is frequently altered, indeed this is particularly evident from the irregular opening layout (Fig. 2c). Typical alterations to the original structures are the frequent addition of one or two storeys above the original roof level. The original horizontal structures are timber floors and roofs, replaced in the early twentieth century by jack arches (steel profiles with shallow brick arches) and in more recently refurbished buildings by concrete slabs. In summary, four major groups of construction typologies have been identified in the Casbah of Algiers and they can be classified using the WHE-PAGER project taxonomy (Jaiswal et al. 2011) as follows: unreinforced fired brick masonry with timber floors (UFB3); dressed stones and bricks with timber floors (DS2); dressed stones and bricks with reinforced concrete floors (DS4); poorly hewn stone stones and bricks with jack arches (RS4).

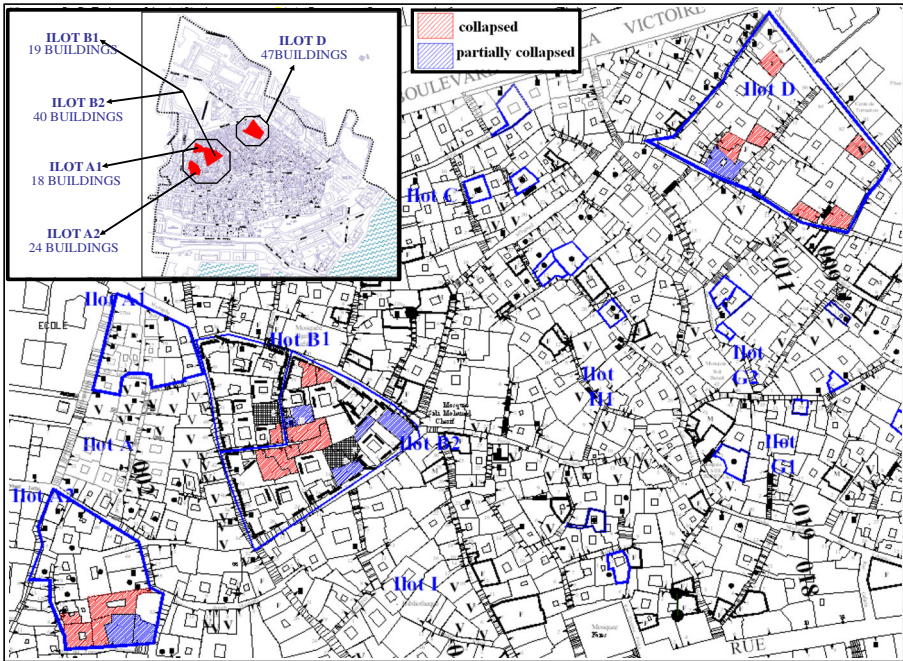
Fig. 3 The most representative blocks of the urban fabric of the Casbah (reference to the official map: Groupe CNERU, Plan de Recollament, and Codification: ES1/DEG/01/09/CA)

Given the conditions above, the most representative blocks of the observed urban fabric were identified with the blocks A1 and A2, B1 and B2 and D, in Fig. 3 which includes around 150 buildings from the Ottoman regency to the French colonial period. The most common building typology is DS2 with a percentage of 87 % against the 5 % for the classes DS4 and RS4 and 3 % for UFB3.

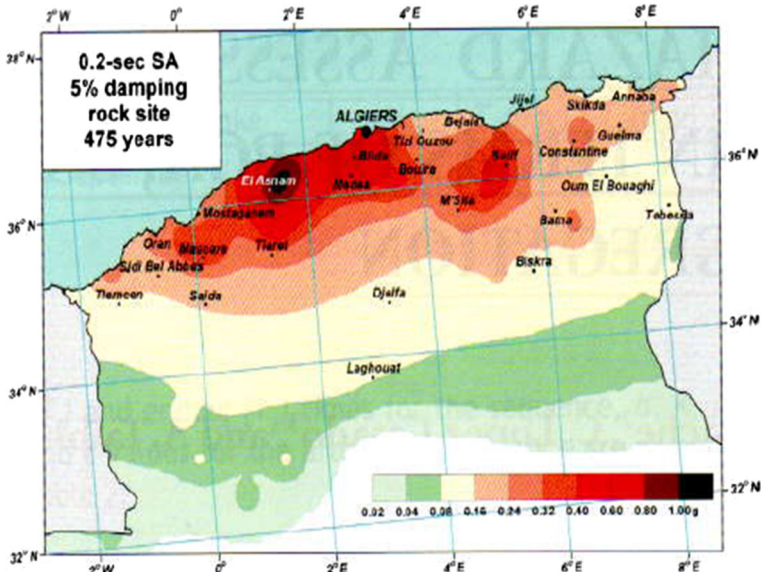
Fig. 4 Probabilistic SA values for roc, 0.2 s, damped at% 5 and a return period of 475 years [Ref: Peláez et al. (2006)]

Studies conducted by Olivera et al. (2005), shows that the region of Algiers is exposed to values of PGA greater than 0.24 g for a 10 % probability of exceedence in 50 years as shown in Fig. 4 (Peláez et al. 2006). Based on seismogenic studies and ground motion models defined by Meghraoui et al. (1988), Boudiaf (1996) and Geomatrix (2006), Ait Meziane (2012) developed a standard PSHA for rock site conditions with focus on the historical site of the Casbah in Algiers (reference coordinate 3.05E–36.78N). Local site amplifications were not considered, due to the lack of detailed stratigraphic information. Figure 5 shows the hazard curves for each ground motion prediction models and Fig. 6 shows the computed mean hazard curves for PGA and spectral acceleration at various natural periods, at the considered site. These curves reflect the high seismicity of the region of Algiers and indicate that for the commonly-used return period of 475 years the expected mean ground motions are: PGA = 0.37 g, SA(0.2 s) = 0.90 g, SA(0.5 s) = 0.57 g, SA(1.0 s) = 0.28 g, SA(2.0 s) = 0.11 g.

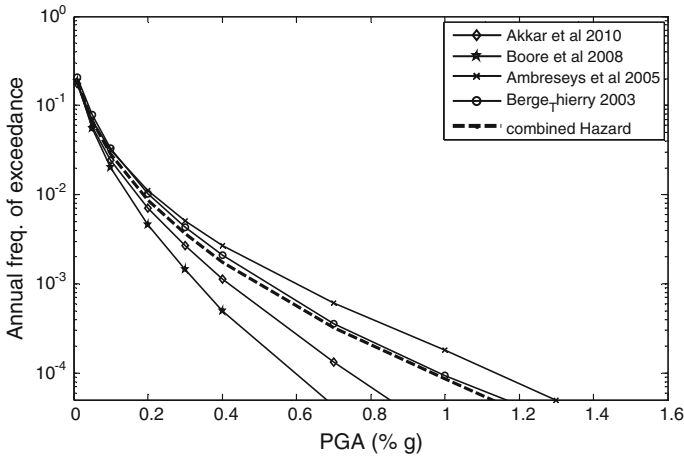
Fig. 5 Mean hazard curves for different GMPEs

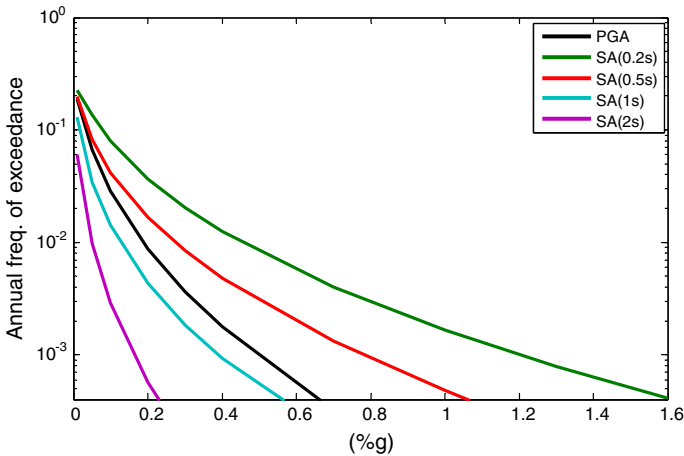
Fig. 6 Mean hazard curves at the considered site for PGA, SA ($T = 0.2\text{ s}$), SA ($T = 0.5\text{ s}$), SA ($T = 1\text{ s}$) and SA ($T = 2\text{ s}$)

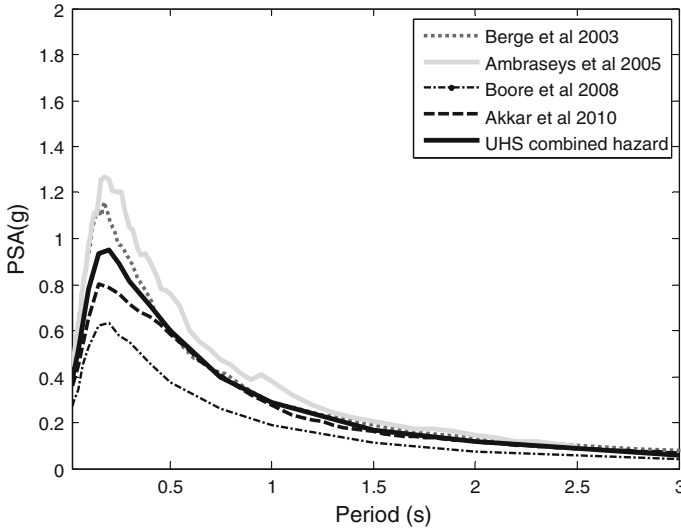
Fig. 7 Uniform hazard spectra for different GMPMs

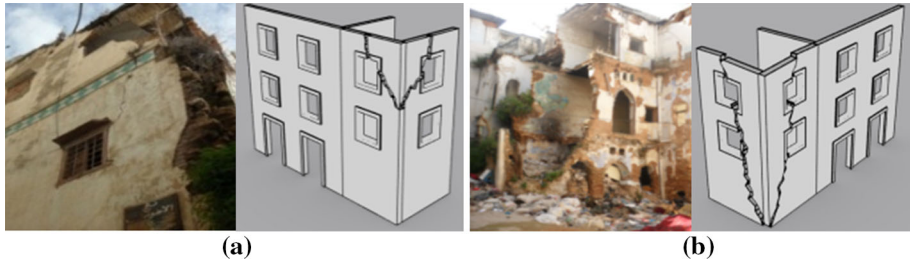
Fig. 9 Overturning **a** partial combined mechanism, **b** total combined mechanism

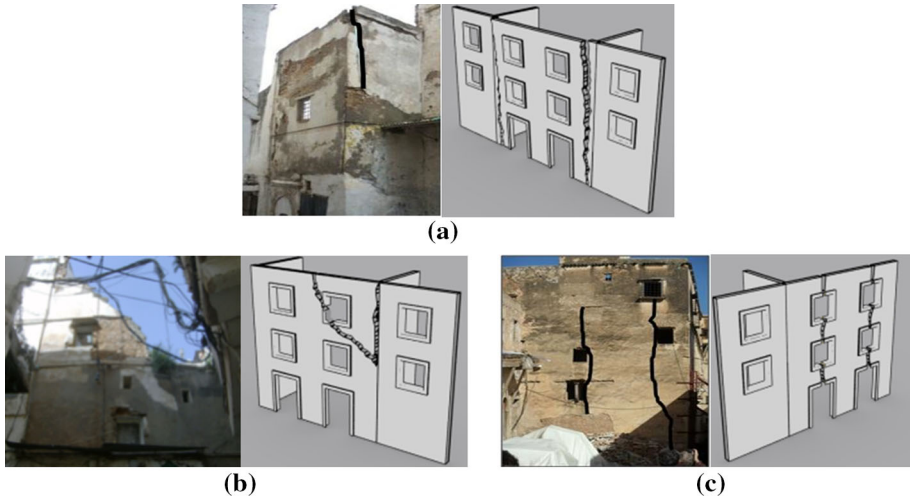
Fig. 10 Overturning due to **a** bad connection between facades, **b** bad connection between facades and bad connection between facades and horizontal structures, **c** bad connection between facades and internal bearing walls

- Good connections between façades and bad connections between facades and horizontal structures (Fig. 10a, b), leading to the development of mechanisms which involve sets of orthogonal walls and are defined as combined mechanisms in Sect. 9;
- Bad connections between orthogonal façades (Fig. 10a), or between façades and horizontal structures (Fig. 10b), or between façades and internal bearing walls (Fig. 10c), leading to mechanisms which involve the failure of one façade only, defined as out of plane mechanisms in Sect. 9.

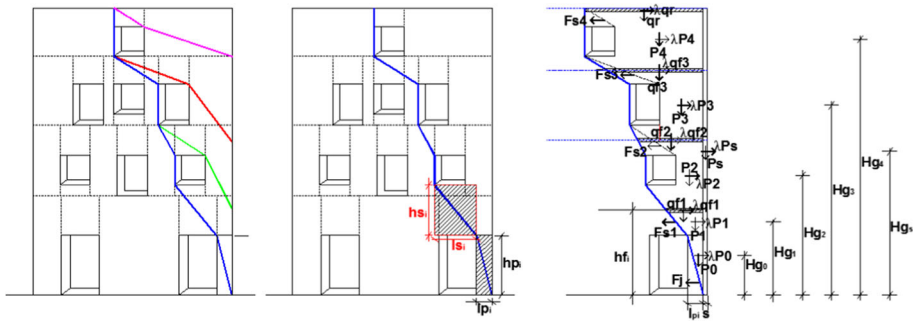
Fig. 14 Geometric variables, crack initiation points and forces involved in a façade with irregular opening layout where $\alpha_b \geq \alpha_c \geq \alpha_f$. Adapted from Novelli and D’Ayala (2012b)

The geometric quantities used in the virtual work equations for the computation of the load factor multiplier for the in plane mechanism are shown in Fig. 14: l_{si} and l_{pi} are the spandrel and pier width respectively; h_{fi} and h_{si} are the interstorey and spandrel height respectively, while h_{pi} is the height of the pier over which a crack will develop and H_{gi} is the distance between the centre of gravity of the pier and the point where the cylindrical hinge forms, which coincides with the crack initiation point; q_{fi} (or q_r) is the i th floor (or roof) load resultant, taken from the horizontal structures acting upon the portion of wall involved in the mechanism. The frictional behaviour of the masonry along the crack is given by frictional restraint from the pier, and frictional restraint from the spandrels. The frictional forces along

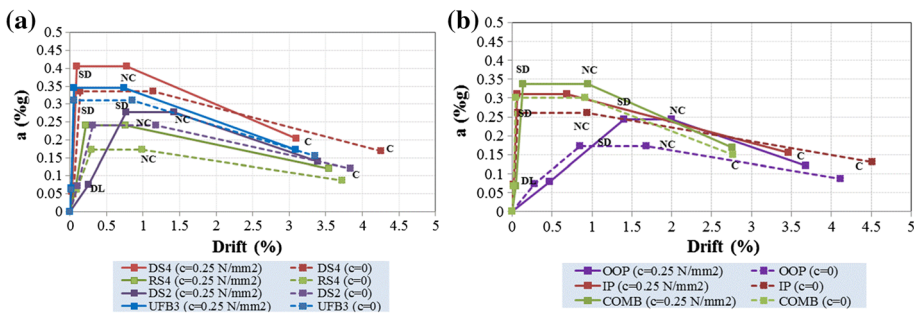
Fig. 15 a Comparison between the capacity curves for (DS2); (DS4); (UFB3) and (RS4) for the condition of $c = 0$ and $c = 0.25 \text{ N/mm}^2$; b comparison between the capacity curves for in plane, out of plane and combined mechanisms for the total samples for the condition of $c = 0$ and $c = 0.25 \text{ N/mm}^2$

The capacity curves in Fig. 15a, b are computed for two cases, one by neglecting the contribution of the material’s cohesion ($c = 0$ in Fig. 15) and the second by assuming that the cohesion of the original material has been increased to 0.25 N/mm^2 ($c = 0.25 \text{ N/mm}^2$) by using grout injections. It should be noted that although the increase in cohesion is the same for all building types, the average increase of base shear for each building typology is not the same, as the base shear depends on the distribution of collapse modes in each building class. For instance, the increase in cohesion benefits DS4 and RS4 more than the other two typologies (see Fig. 15a). As it can be seen from Fig. 15b, the increase in cohesion, in average terms, seems to have a greater effect on OOP failure modes and IP failure modes than on COMB failure modes. The increase in lateral capacity does not necessarily imply an increase in ductility.

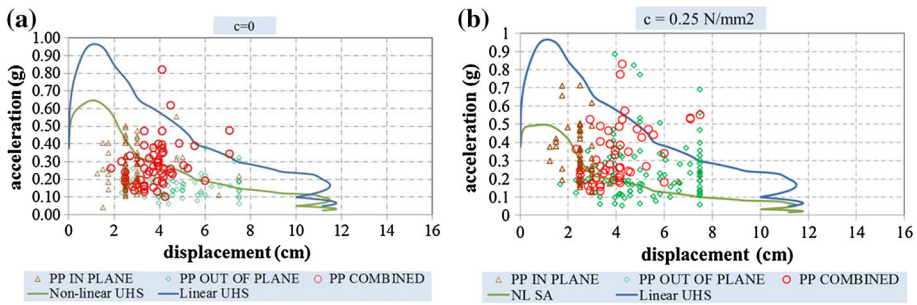
Fig. 16 Comparison between the performance points for the limit state of structural damage, associated to the significant damage condition in EC8 and the response spectrum linear and non-linear obtained from the UHS spectrum: **a** for building samples with $c = 0$ and **b** and for building samples with $c = 0.25 \text{ N/mm}^2$

The benefit of the increase in cohesion is more evident, when the performance points for each façade are compared. In Fig. 16a for $c = 0$, and Fig. 16b for $c = 0.25 \text{ N/mm}^2$ the performance point for the limit state of structural damage, defined according to EC8 definition, is compared with the response spectrum obtained from the average UHS of Fig. 7. The nonlinear spectrum for a ductility value of 2 is also provided for reference. This is calculated using the N2 method approach (Fajfar 2000). Comparing the two diagrams the improvement in lateral capacity for the IP cases is evident as well as the improvement in performance of the COMB mechanisms affected façades, while many of the OOP facades representative points remain below the ductility spectrum, and hence in the unsafe zone. Although an increase in cohesion results also in an increase in tensile strength of the masonry (with the current friction model and tension cut-off the tensile strength is assumed as $f_t = 0.75 \tau_0$, with τ_0 representing pure cohesion) the major benefit is felt by the in-plane mechanism. The resulting increase in ultimate collapse load for the IP modes it means that there is a shift in critical mechanisms, corresponding to an increase in the number of OOP failure within the sample. The shift is approximately 33% from in-plane failure to out-of plane failure, while the occurrence of combined mechanisms reduces by 8% on the total number of buildings as the other two modes of failure become more critical.

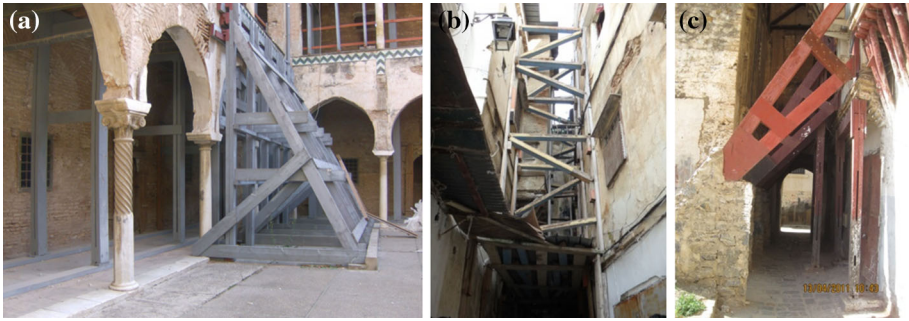
Fig. 17 **a** Shoring system made of wooden trusses used to prevent out of plane failure of masonry walls in The Casbah of Algiers, **b** shoring system applied to buildings facing a narrow street and **c** system of shoring also supporting the q'bu

In many historic centres in seismic prone areas, cross ties, inserted into the walls of the buildings, just below the floor level or above the openings, are a common feature to improve the connections between vertical adjacent walls or between walls and floors and to guarantee in plane failure to buildings. In the Casbah of Algiers only few buildings, 2% of the surveyed sample, are restrained with anchors. On the other hand, up to 10% of the total building stock of the Casbah is restrained by temporary wooden truss systems which form a buttress, preventing the overturning of the entire façade (Fig. 17a). For building facing on narrow streets an alternative shoring system, comprising a series of vertical composite posts connected transversally at every meter or so depending on the geometry of the façade, and contrasted to a twin system on the other side of the street, shown in Fig. 17b, is also frequently observed. The objective is to prevent overturning of opposite façades facing the same street while maintaining access by creating a safe passageway (Fig. 17c).

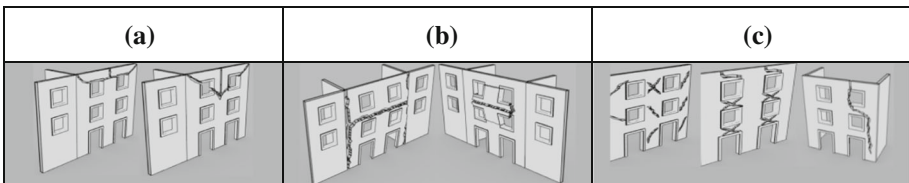
Fig. 18 Typical seismic failures occurring on buildings restrained by anchors **a** out of plane mechanisms: arch failure, **b** combined mechanism due to the presence of anchors, **c** in plane mechanisms

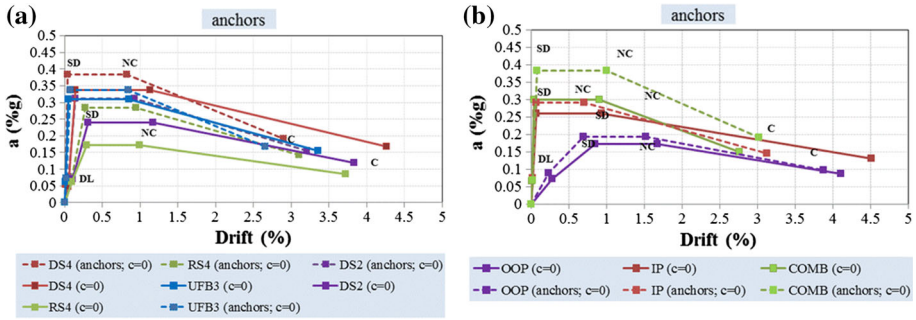
Fig. 19 **a** Comparison between the capacity curves for (DS2); (DS4); (UFB3) and (RS4) with and without anchors for the condition of $c = 0$; **b** comparison between the capacity curves for in plane, out of plane and combined mechanisms for the building samples with anchors for the $c = 0$

The effect of the ties is first investigated in the hypothesis of $c = 0$, Fig. 19, and then in the hypothesis of $c = 0.25 \text{ N/mm}^2$, Fig. 20. The use of anchors, as shown in Fig. 19a, produces a very noticeable increase in lateral capacity on average for buildings type RS4 and DS2, which had a majority of out-of-plane mechanisms, now prevented. However as seen in Fig. 19b, the comparison of the lateral capacity for the three types of failures shows a very modest average increase for OOP and IP, while the increase in lateral capacity for the COMB mechanism is quite substantial. It should be noted that, in average terms, there is a slight increase in stiffness for the elastic range and a decrease in ductility.

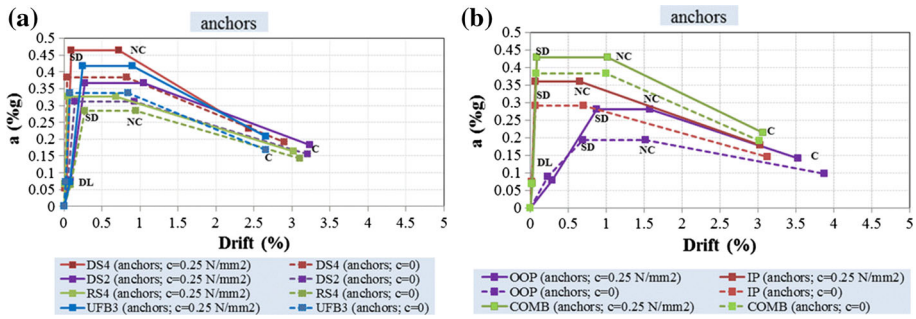
Fig. 20 **a** Comparison between the capacity curves for (DS2); (DS4); (UFB3) and (RS4) with anchors for the condition of $c = 0$ and $c = 0.25 \text{ N/mm}^2$; **b** comparison between the capacity curves for in plane, out of plane and combined mechanisms for the building samples with anchors for the condition of $c = 0$ and $c = 0.25 \text{ N/mm}^2$

The grout injections in walls strengthened by ties further increase the lateral capacity of the building stock by an average of 30 %, as it is pointed out in Fig. 20, whether the sample is grouped in terms of typology or in terms of class of mechanism. Figure 21 shows the shift in mechanism types, first by introducing the anchors, with a clear decrease of OOP failure modes and increase of COMB failure modes, then with a decrease of IP failure and slight increase of OOP failure modes, when an increase in cohesion is also considered. The improvement of behaviour in the sample is clearly visible by the shift of points above the green line representative of the response spectrum for ductility of 2, and an increase of points above the blue line representative of the elastic spectrum and hence representative of buildings, which will have an elastic behaviour for the considered scenario. It is however clear that a still considerable number of buildings will develop significant damage leading to in-plane mechanism, as denounced by the array of brown triangles.

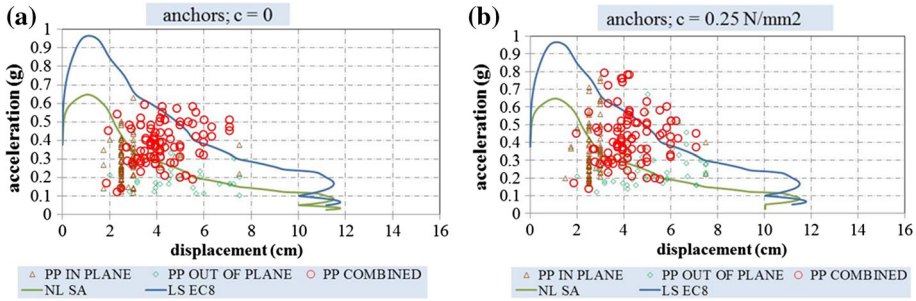
Fig. 21 Comparison between the performance points for the limit state of structural damage, associated to the significant damage condition in EC8 and the response spectrum linear and non-linear obtained from the UHS spectrum: **a** for building samples with $c = 0$ and anchors and **b** for building samples $c = 0.25 \text{ N/mm}^2$ and anchors

The use of ties decreases the percentage of buildings failing for overturning from 32 to 13%, as it is highlighted in Fig. 21a, where the number of green rhombi are considerably reduced, respect to Fig. 16b. The percentage of buildings failing for COM collapses increase of 37.5%, while the percentage of buildings failing for IP collapses increase only of 6%, as a result of the overturning of entire facades being prevented. This points out that the use of

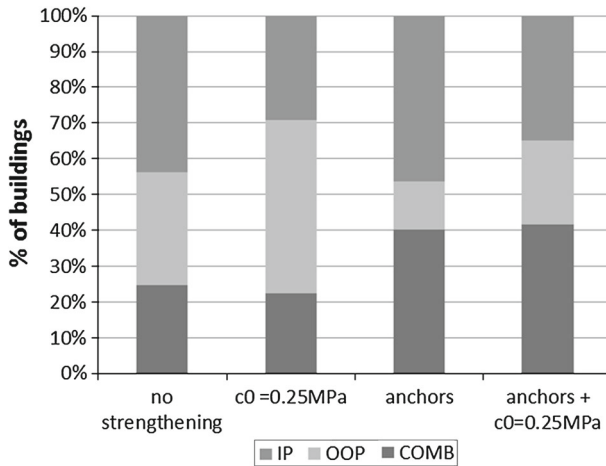
Fig. 22 Percentage of damaged buildings in combined (COMB), out of plane (OOP) and in plane (IP) mechanisms, in the hypothesis of $c = 0$, $c = 0.25 \text{ N/mm}^2$, $c = 0 + \text{anchors}$ and $c = 0.25 \text{ N/mm}^2 + \text{anchors}$

occurrence and types of mechanism. The variation in occurrence of failure modes associated with the various strengthening strategies is shown in Fig. 22. It can be seen that the grouting resulting in an increase of cohesion, would minimise the number of in-plane failures, vis-à-vis an increase of overturning modes. On the other hand, the insertion of anchors, while minimises the occurrence of out-of-planes, results in an increase of in plane failure modes. A better balance is obtained, when both strengthening intervention are considered. Increasing the quality of the materials and improving connections in the walls, still leaves 23 % of the total number of buildings prone to local out-of plane failures of the upper part of the façade, if unrestrained by connection to the roof’s structures. To mitigate this vulnerability timber wall’s plate and timber lacing might be adopted.

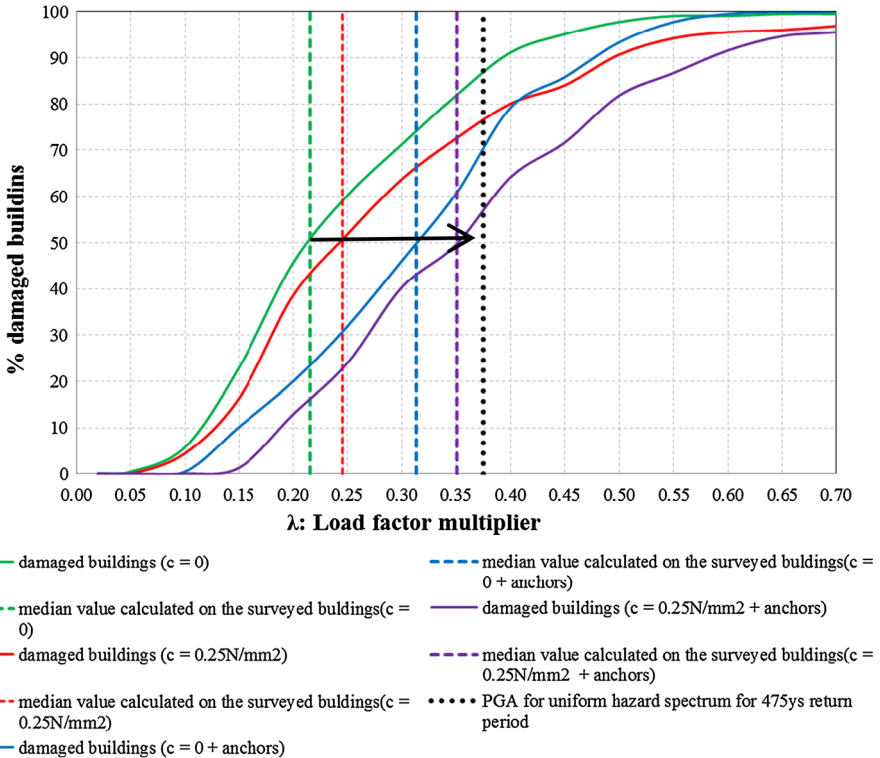
Fig. 23 Load factor multiplier (λ) distribution in the surveyed sample
