Composition of weathering crusts on sandstones from natural outcrops and architectonic elements in an urban environment

Mariola Marszałek · Zofia Alexandrowicz ·
Grzegorz Rzepa

Keywords Sandstones · Tors · Monuments · Weathering crust · Air pollution

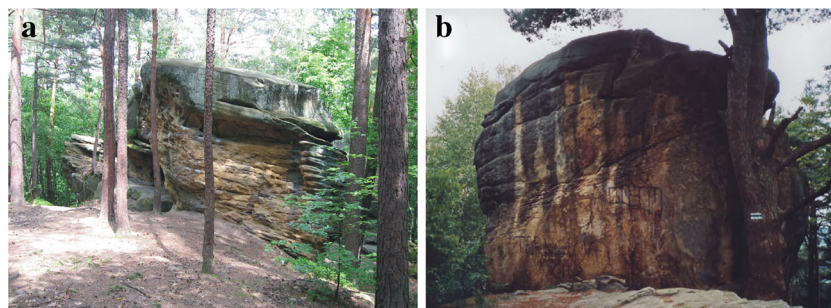
Fig. 2 **a** The Brodziński Stones Natural Monument in the Carpathian Foothill. Thick bedding of the massive sandstone facilitated the exploitation. **b** Sandstone tower rock in the Stone Town Nature Reserve in the

Carpathian Foothill. The exposed surfaces of the rock are covered with black crusts. Photos by Z. Alexandrowicz

transported in large blocks (Fig. 2a). Therefore, they were widely used in Kraków in the Romanesque, Gothic, Renaissance and nineteenth-century constructions (Rajchel 2004).

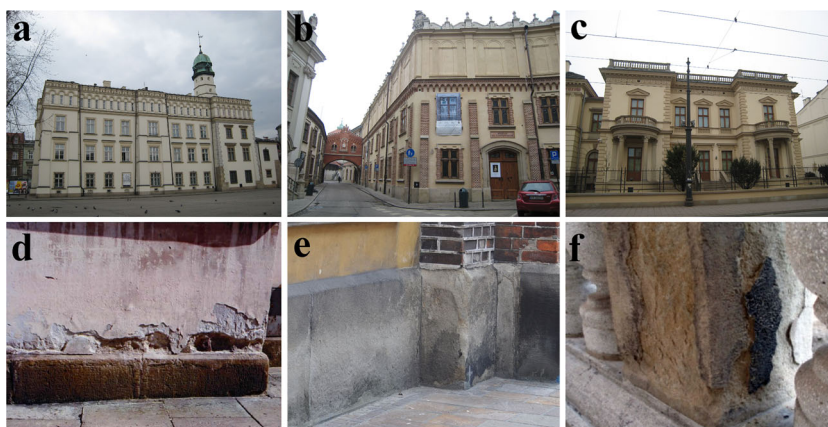
Fig. 3 General view and examples of black crust development of: **a, d** the Ethnographic Museum, **b, e** the Czartoryski Museum and **c, f** the Czapski Palace. Photos: **d** by T. Sokal, **e** by A. Bohan-Strumińska, **f** by A. Orzechowska

The samples of grey and black weathering crusts on sandstone architectural elements were collected from three historical buildings situated near the centre of Kraków: the Ethnographic Museum, the Czartoryski Museum and the Czapski Palace (Fig. 3).

The samples of sandstone weathering crusts from the Ethnographic Museum (three specimens) were collected from the portal of the main entrance to the building and from the plinth (at a height of up to 1 m above the ground). The samples from the Czartoryski Museum (seven specimens) were collected from plinths and window sills at a similar height, whereas those from the Czapski Palace (four specimens) from columns of a balcony. The samples were collected during the dry season, in June and July of 2011, utilizing a restoration campaign.

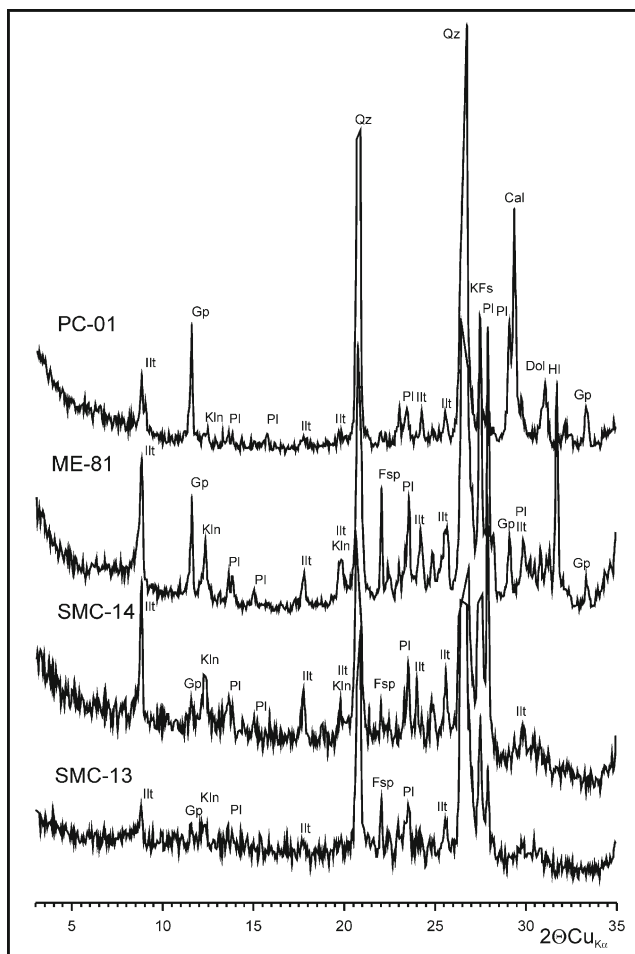
Fig. 4 XRD patterns—weathering crusts from natural outcrops (SMC-13, SMC-14) and architectural details of the Ethnographic Museum (ME-81) and the Czapski Palace (PC-01). *Illt* illite, *Kln* kaolinite, *Pl* plagioclase, *Gp* gypsum, *Fsp* feldspar, *KFs* K-feldspar, *Qz* quartz, *Cal* calcite, *Dol* dolomite, *Hl* halite

All the rocks examined are medium-grained sandstones with very similar lithological characteristics. Their grain framework comprises quartz, feldspars, rock fragments, micas (biotite and muscovite) and accessory minerals (e.g. rutile, ilmenite, zircon, tourmaline and opaques, including pyrite). Feldspars are significantly altered by kaolinitisation and sericitisation. Also altered are the remaining, albeit less resistant aluminosilicates. The contact-porous cement is composed chiefly of clay minerals and iron (oxyhydr)oxides. It is locally enriched in carbonates, while glauconite aggregates were also found in some places. The XRD analysis has revealed among clay components kaolinite, illite and probably illite-smectite mixed-layer minerals (Fig. 4).

The XRD analyses confirmed the presence of quartz, feldspars, clay and carbonate minerals (Fig. 4). No salt minerals identified in the SEM-EDS examinations were noted, except for gypsum but only in single samples. It is a proof of minor amounts of the salt-group phases in the overall composition of the crust.

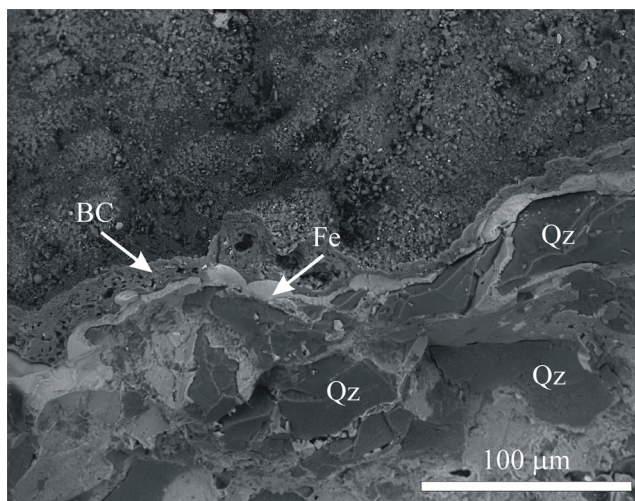
Fig. 5 Scanning electron microscope image of the weathering crust developed on the sandstone surface (sample KB-9). *BC* black crust, *Fe* iron (oxyhydr)oxides incrustation between quartz grains, *Qz* quartz

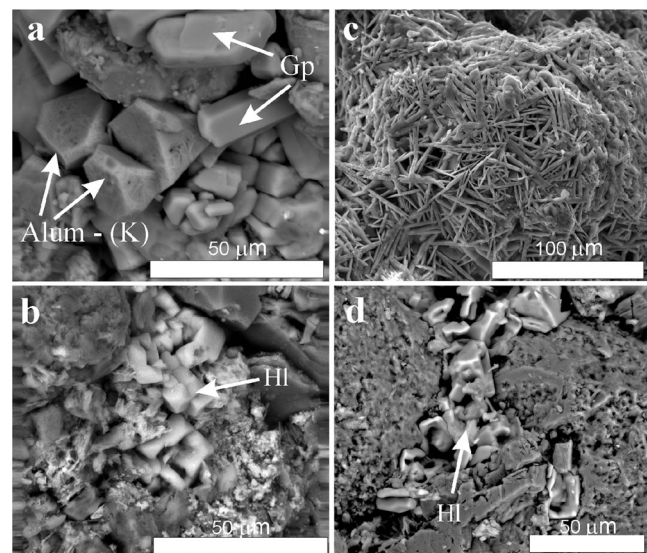
Fig. 6 Scanning electron microscope images of the sandstone surface: **a**, **b** from natural outcrops (sample SMC-13) and **c**, **d** from architectural details (sample ME-81). *Gp* gypsum, *Alum-(K)* potassium alum, *Hl* halite, partial dissolution of mineral grains is also visible (**d**)

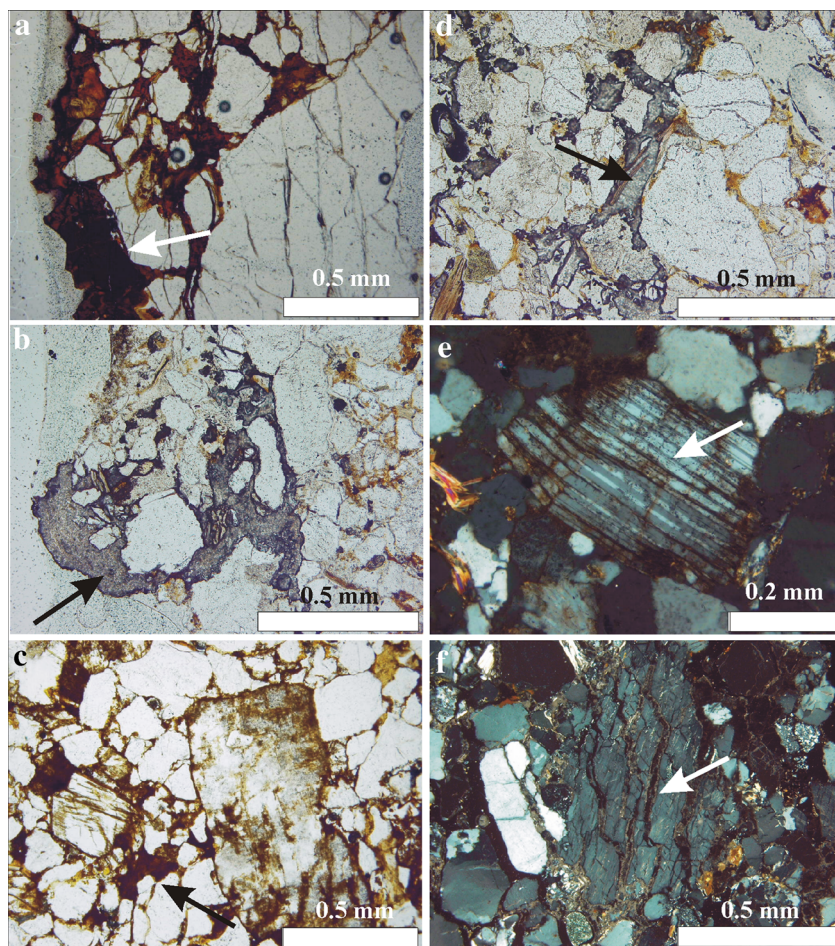
Fig. 7 Microphotographs: sandstone from natural outcrops—**a** outer layer covered by ferruginous compounds (sample SMC-14, 1P), **b** iron oxides between mineral grains (sample SMC-12, 1P), and **c** iron compounds occurring in cleavage fissures of feldspar (sample SMC-14, XP); sandstone from architectural detail—**d** black crust composed of gypsum covering the outer layer of the detail (sample MC-001, 1P), **e** gypsum crystals filling pores and cracks, replacing stone cement (sample MC-001, 1P), and **f** gypsum filling cleavage on feldspar (sample MC-011, XP). Optical microscope, thin sections cut perpendicular to the stone surface. *1P* one polar, *XP* crossed polars

Immediately beneath the above described hard and black crust, there is a zone of sandstone altered by weathering (Fig. 7a, b), which differs from the inner parts of the rock due to the presence of variably coloured zones running parallel to the surface. Alexandrowicz et al. (2012, 2014) have found that the darker layers contain more iron compounds than the lighter ones, whereas their colour depends on the prevailing type of the Fe-bearing minerals. The red and pink zones contain mostly an oxide—hematite ($\alpha\text{-Fe}_2\text{O}_3$), whilst the yellow and brown zones are characterised by the presence of an oxyhydroxide—goethite ($\alpha\text{-FeOOH}$). The layers closer to the surface of the weathering crust contain often major hematite and are richer in iron (Fig. 7a), whereas the deeper layers are richer in goethite (Fig. 7b). Such stratification is a result of redistribution of iron during weathering. Iron released during the decomposition of primary aluminosilicates, and—to a lesser extent—of carbonates and sulphides, is transported towards the rock surface, where it precipitates and can undergo further transformations (Alexandrowicz et al. 2012, 2014). Additionally, physical changes of rock-forming minerals have been noted in the weathering crust in the form of cracks in quartz grains and fissures running along the cleavage surfaces

of feldspars. These cracks and fissures are filled with iron compounds, principally goethite and hematite, whose particles were also found within other minerals (Fig. 7c).

The sandstones of the outer zones of architectonic details are generally loose and friable. Their surface is covered by a discontinuous, grey or black crust up to 0.5-mm thick. Optical microscopy has revealed only opaque and/or translucent grains of variable morphology, probably iron (oxyhydr)oxides and carbon particles, and transparent gypsum crystals that are usually very fine. Gypsum also fills the cracks in quartz grains and the fissures along the cleavage surfaces of feldspars, as well as spaces between flakes of micas. In some places, it also replaces rock cement (Fig. 7d–f).

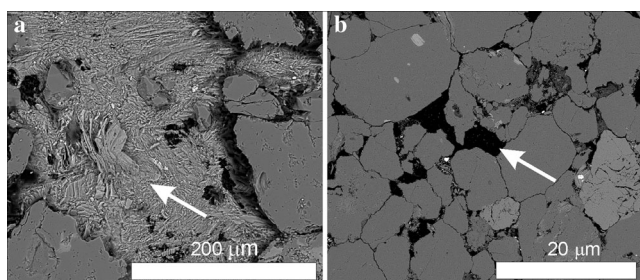
Fig. 8 Scanning electron microscope images of sandstone samples from architectonic detail: **a** gypsum replacing cement of the stone (sample MC-010) and **b** empties after leaching the sandstone cement (sample ME-81)

In SEM-EDS examinations, the near-surface framework minerals of sandstones are covered by a thin layer rich in C, Si, Al, Fe, P, Cl, K and Ba. Grain components include iron oxides, along with local occurrences of barite and carbon particles (soot). Above all, however, discontinuous accumulations, containing chiefly salt minerals, mainly gypsum and halite (Fig. 6c, d), spherical particles of aluminosilicate glass and spherules of iron oxides (magnetite and hematite), were observed. The properties and composition of the latter components indicate them to originate from industrial emissions (Marszałek 2008). Another significant component of this layer is organic matter (confirmed in TG/DTA analyses). SEM observations corroborated that numerous laths of gypsum cover the crust surface and also occur within pores of the sandstones, where they replace a primary cement (Fig. 8a).

Sometimes, however, the intergranular spaces after leaching the cement remain empty (Fig. 8b) and increase the porosity of the stone. The framework components commonly show traces of chemical corrosion (Fig. 6d). In samples from the Czartoryski Museum and the Ethnographic Museum collected at a small distance from the ground level, halite and gypsum are frequent secondary minerals. They precipitated primarily in the intergranular spaces (Fig. 6d) and in some areas densely cover the surface. Halite is absent, however, in the samples collected from the balcony columns of the Czapski Palace.

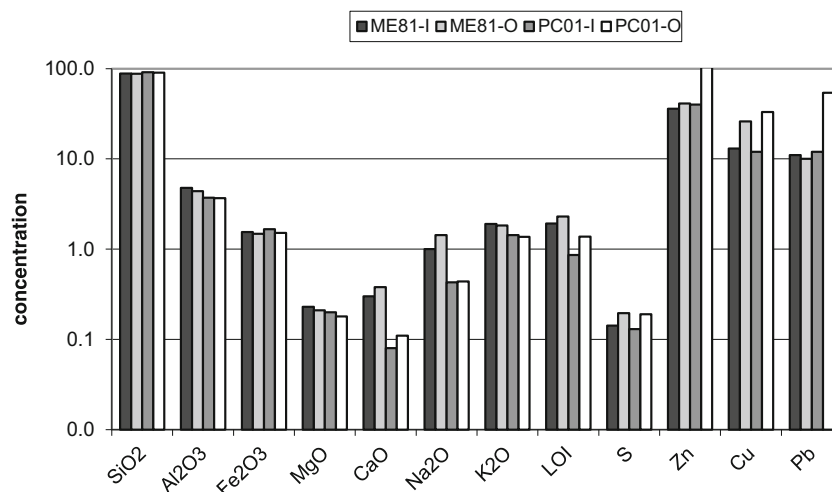
Fig. 9 Bulk chemical composition (combined ICP-OES, ICP-MS and INAA analyses) of inner and outer layers of the sandstones crusts from architectural details (major elements and sulphur in wt%, trace metals in ppm). *ME-81* the Ethnographic Museum, *PC-01* the Czapski Palace, *I* inner layer, *O* outer layer

Comparing the chemical compositions of crusts on the sandstones from natural outcrops and those from architectonic elements, higher concentrations of MgO, CaO, Na₂O, S, Cu and Zn were found in the latter (Table 2). The samples represent outermost layers, ca. 0.5-cm thick, and may contain a certain admixture of a material from below as it was not always possible to separate the crust layer alone. In the case of samples collected in Kraków, these results do not differ considerably from those of the layers situated deeper, ca. 2 cm below the crust surface, which probably reflects advanced changes reaching deep into the sandstones. Nevertheless, in the inner layers of the sandstones from the architectonic elements the assays for CaO, Na₂O and losses on ignition (LOI), and also the contents of sulphur and some trace elements (Zn, Cu) slightly decrease, whereas the contents of SiO₂, Al₂O₃, Fe₂O₃, MgO and K₂O slightly increase in comparison with the outer layer (Fig. 9). Such a trend manifests
