Erratum to: Composition of weathering crusts on sandstones from natural outcrops and architectonic elements in an urban environment

Erratum to: Environ Sci Pollut Res (2014) 21:14023–14036
DOI 10.1007/s11356-014-3312-y

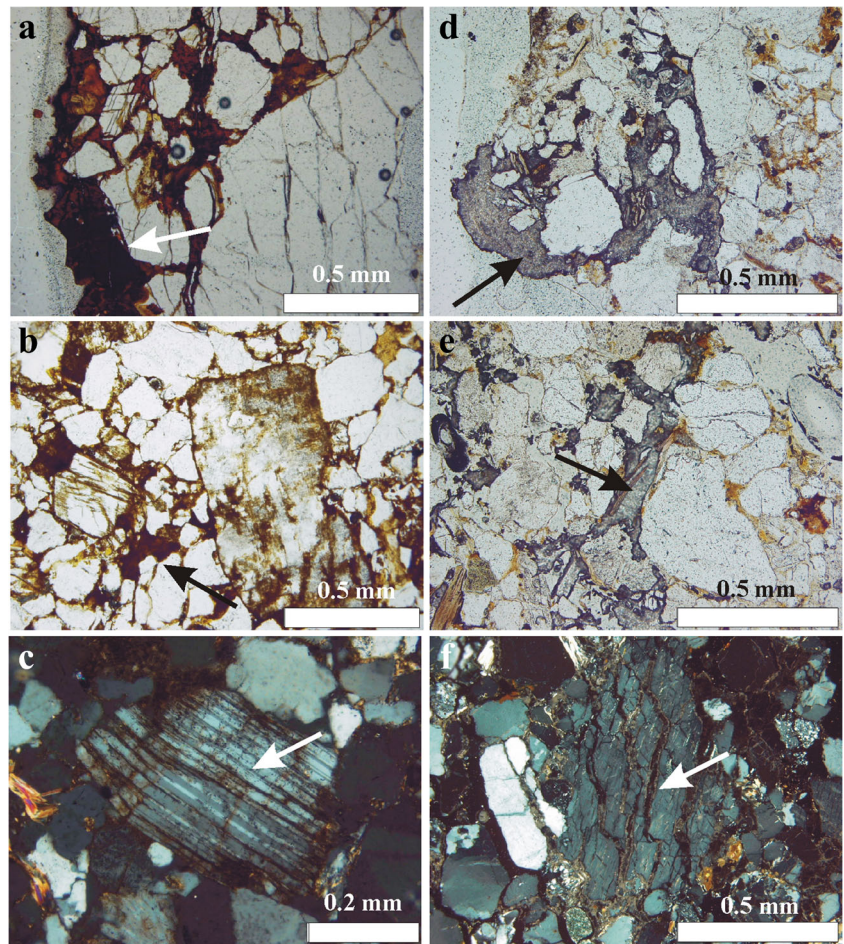
Fig. 7 Microphotographs: sandstone from natural outcrops—**a** outer layer covered by ferruginous compounds (sample SMC-14, 1P), **b** iron oxides between mineral grains (sample SMC-12, 1P), and **c** iron compounds occurring in cleavage fissures of feldspar (sample SMC-14, XP); sandstone from architectural detail—**d** black crust composed of gypsum covering the outer layer of the detail (sample MC-001, 1P), **e** gypsum crystals filling pores and cracks, replacing stone cement (sample MC-001, 1P), and **f** gypsum filling cleavage on feldspar (sample MC-011, XP). Optical microscope, thin sections cut perpendicular to the stone surface. 1P one polar, XP crossed polars. Scale bars: 0.5 mm for a, b, d, e, f; 0.2 mm for c.

The original publication of this article contains a mistake. The correct image for Fig. 7 is shown below:
