Bypassing and tightening of an underground water retention system in permeable karst: case study of the hydropower plant (HPP) Bribin, Indonesia

Abstract In the framework of the Integrated Water Resources Management (IWRM) joint research project in the karst area of Gunung Kidul, Province of Yogyakarta Special Region on the Java Island, Indonesia, an underground hydropower driven water extraction facility in the cave “Bribin” was developed using pump-as-turbine-driven systems for freshwater supply of the rural area. As numerous other caves in the Gunung Kidul area, Bribin is part of a ramified system of all-season water-bearing subterranean rivers and natural caves in karstic limestone. The elliptic cross section of the cave was completely closed with a concrete barrage, thus creating a year-round underground retention volume with an operational storage level of approx. 15 m. This contribution highlights the geotechnical and geohydraulic challenges handled within the sub-project “Short-time and long-time behaviour of karst rock surrounding pressure-bearing underground water-retaining structures”. One key to the feasibility of an artificial water retention scheme in a natural cave

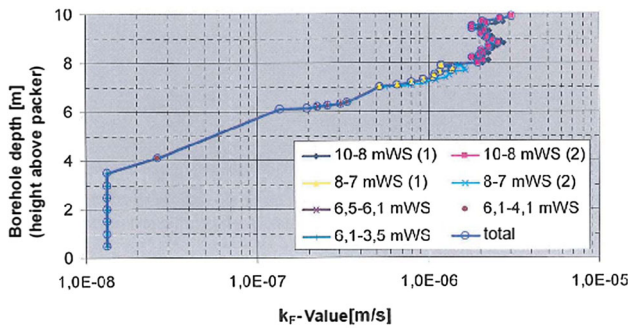
Fig. 2 Permeabilities measured above cave roof

Rock mass stability was addressed at an early planning state already. A vertical 100 m deep borehole had been drilled from the surface down to the later construction site as a preliminary investigation for the access shaft. In this borehole, falling head slug tests above the cave revealed a permeability varying over three orders of magnitude from 2×10^{-8} to 5×10^{-6} m/s, due to intense variability of the more or less porous limestone (Fig. 2).

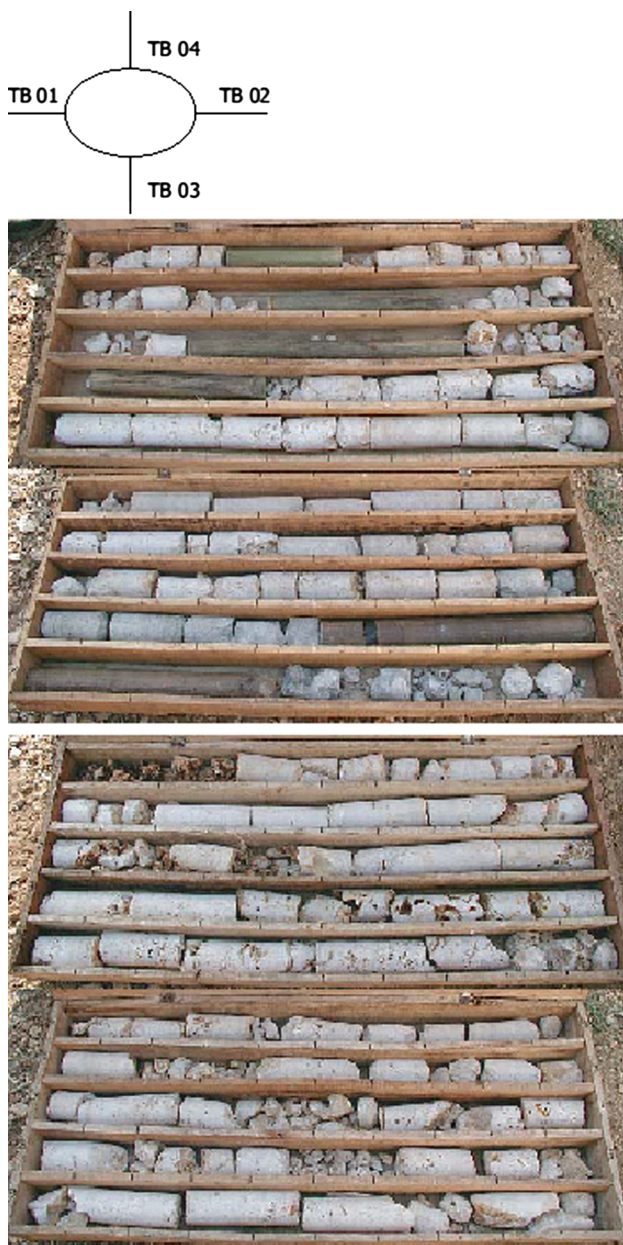
Fig. 3 Borehole orientation at the barrage site and cores from TB03 (floor) and TB04 (roof) in comparison

Investigation boreholes TB 01–TB 04 (length 10 m) were cored from the machinery platform into roof, floor and sidewalls of the cave (Fig. 3). These drillings were arranged in a vertical plane in the cross section where the barrage later was built. While the rock quality in TB 01

and TB 04 proved to be sufficient ($RQD = 49$), boreholes TB 02 and TB 03 in the floor showed very poor conditions ($RQD = 28$). These findings were confirmed by four supplementary vertical boreholes TB 03-1 to TB 03-4 in the floor (next to TB 03). At that time, these results gave reasons to concerns regarding the stability and permeability of the right cave wall and the floor.

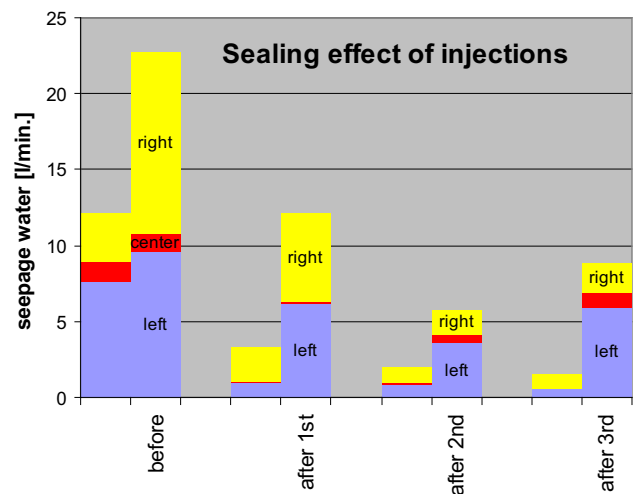
Fig. 13 Reduction of bypassing water from right, left and center seepage area, *left column*: minimum, *right column*: mean value

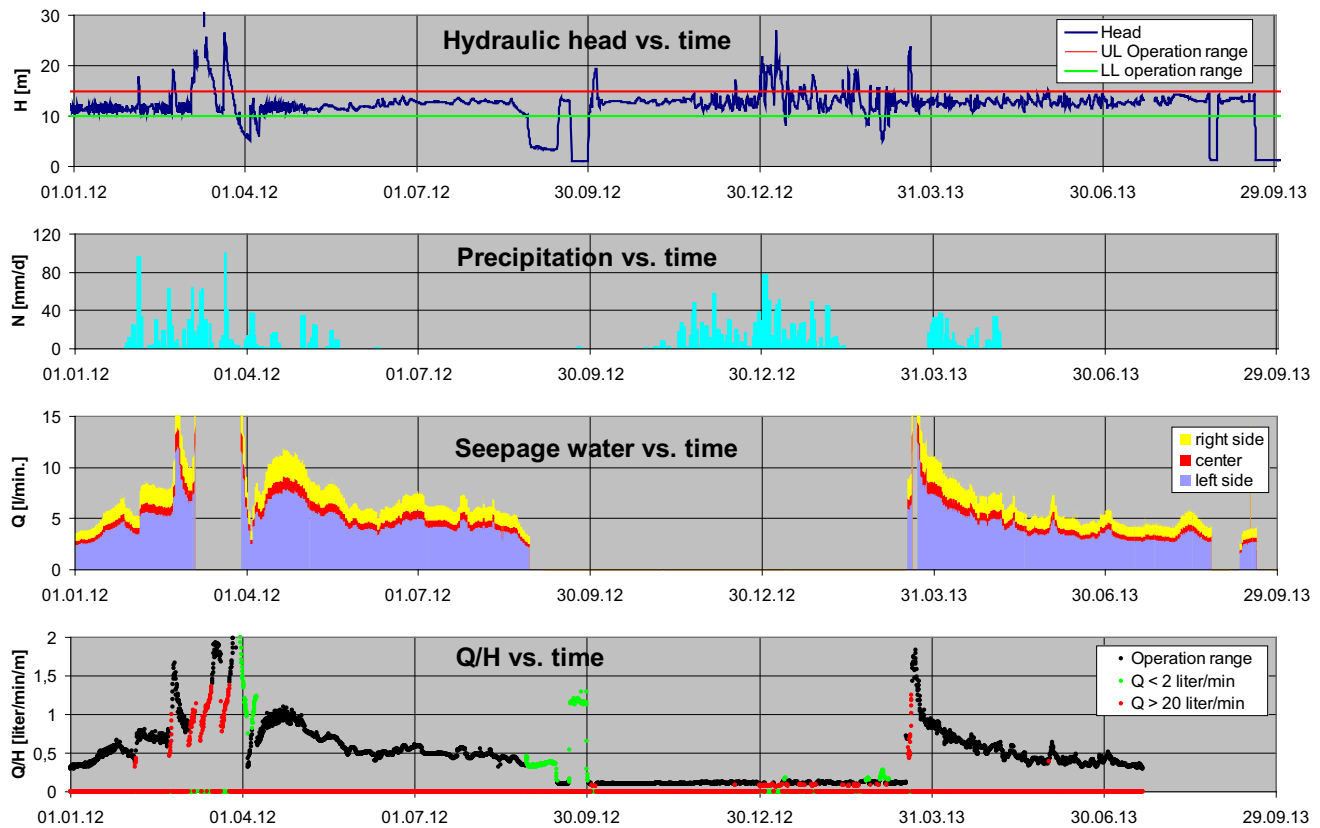
Fig. 15 Seepage monitoring data including rainfall and Q/H evaluation over 21 consecutive months

over time. A quotient Q/h (amount of seepage water divided by hydraulic head) was introduced as a measure for the relative change of the overall rock mass permeability (Fig. 15). Q/h should remain approximately constant as long as the permeabilities and hydraulic boundaries in the system remain unchanged. This, however, is not the case and demonstrates that the flow conditions change with time.
