Seismic performance of existing water tank after condition ranking using non-destructive testing

Abstract

Keywords Condition ranking · Strengthening · Retrofitting · Non-destructive · Seismic response · Elevated water tank

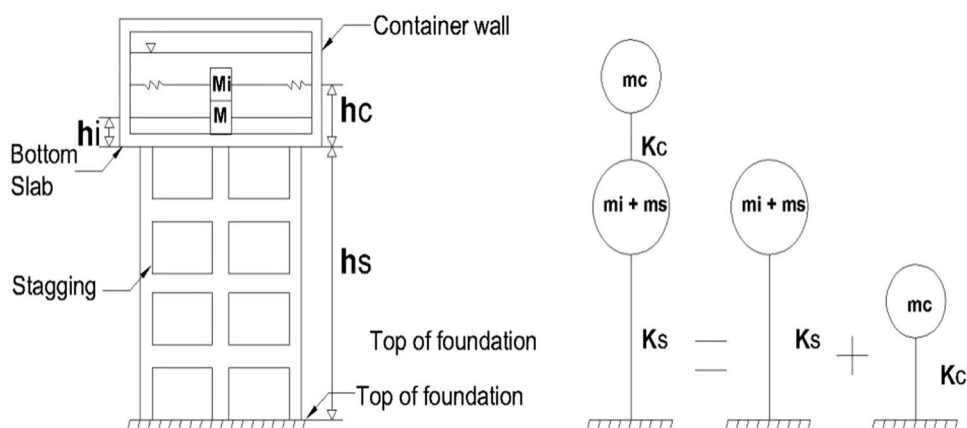
Fig. 1 Spring mass model and two mass idealizations for elevated tank

After the Chilean earthquake of 1960, two mass–spring models were proposed to distinguish the basic dynamic properties of the elevated tank. The dynamic motion of the tank can be divided into two parts, viz convective and impulsive when the pressure is generated within the fluid. Horizontal acceleration developed on the tank wall and liquid when the tank was subjected to horizontal earthquake ground motion when containing a liquid with a free surface (Housner 1963).

Lower region liquid mass, i.e., impulsive mass (m_i), is rigidly attached to the tank wall. The upper region liquid, i.e., convective mass (m_c), is attached to the tank wall by the spring having stiffness (K_c) in the spring–mass model. Instead of the spring–mass model, elevated tanks are considered as two-mass model systems with two degrees of freedom because two-mass model idealization is nearer to actuality. Figure 1 shows a two-mass model of an elevated water tank. The response can be obtained using elementary structural dynamics for two degrees of freedom systems. However, it is observed that both the time periods are well separated in most of the cases. Hence, two uncoupled single degrees of freedom system can be used for two mass idealizations. The stiffness (k_s) and mass (m_s) is lateral stiffness of the staging and structural mass of an elevated tank respectively. Structural mass (m_s) includes one-third mass of staging and the container mass acts as a lateral spring.

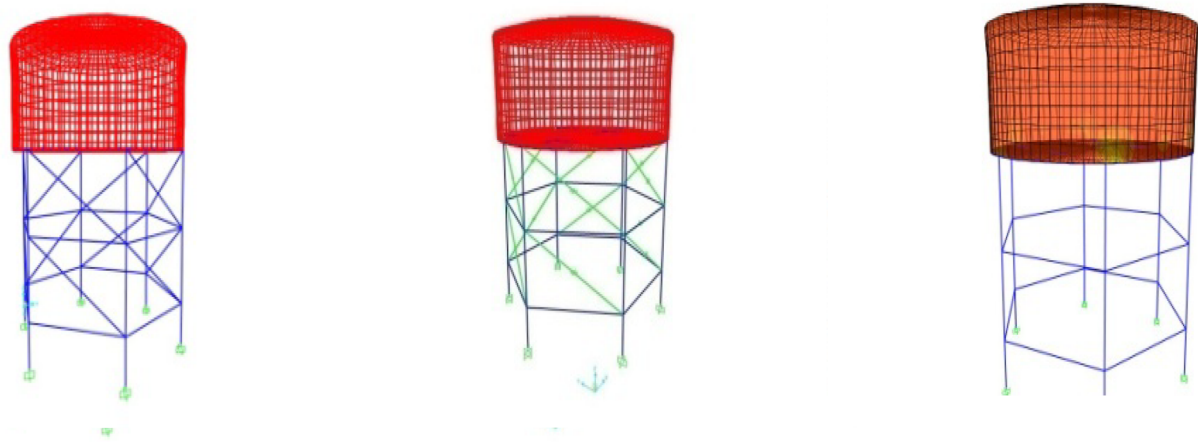
(a) Modeling with bracings

(b) Modeling with damper

(c) Modeling with FRP

Fig. 2 Modeling of water tank with different retrofitting techniques**Table 10** Salient features of ESR

In this seismic retrofit method, diagonal braces are installed on ESR to be retrofitted to absorb earthquake energy input to the ERS and thereby enhance its seismic performance. Figure 2a shows the SAP 2000 model with the addition of the diagonal braces. The material properties of bracing are the size of bracing 0.2 m × 0.6 m and stiffness of bracing 100 kN/mm, with 5% damping as tension and compression member. Figure 2b shows that the configuration of a damper improves the seismic resistance performance of the existing ESR by giving damping. The damper properties are stiffness 200 kN/mm, 5% of critical damping (damper properties are worked out for targeted displacement or permissible displacement or to control the displacement), damping coefficient 200 and damping exponent 1. Wrapping around the surfaces of concrete structures increases the durability and the ductility of the structural members. Figure 2c shows the SAP 2000 model retrofitted with FRP. The material properties of FRP are specific gravity 1.75 g/cm³, tensile strength 3100 N/mm², and modulus of elasticity 220,000 N/mm².

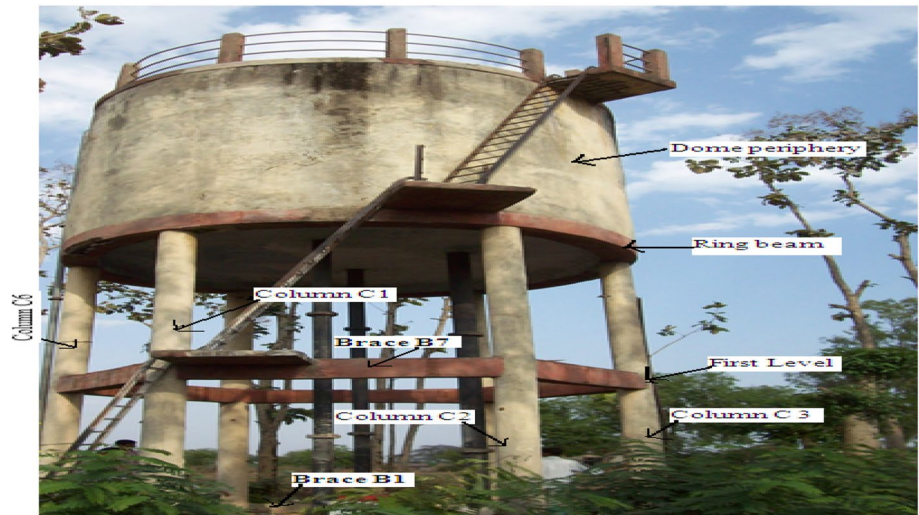
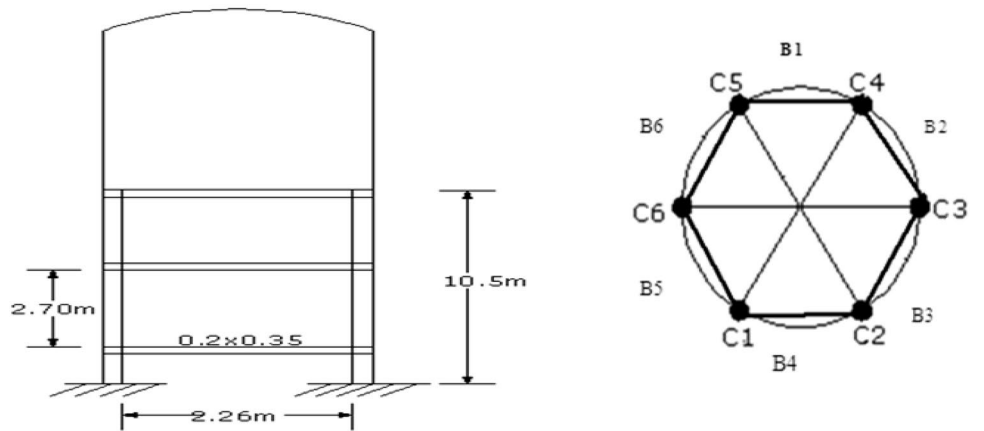
Fig. 3 Examined structure

(a) Real image

(b) Plan and elevation

The following are the details of the water tank located in Baramati. The salient features are given in Table 10 and the overall view in Fig. 3.

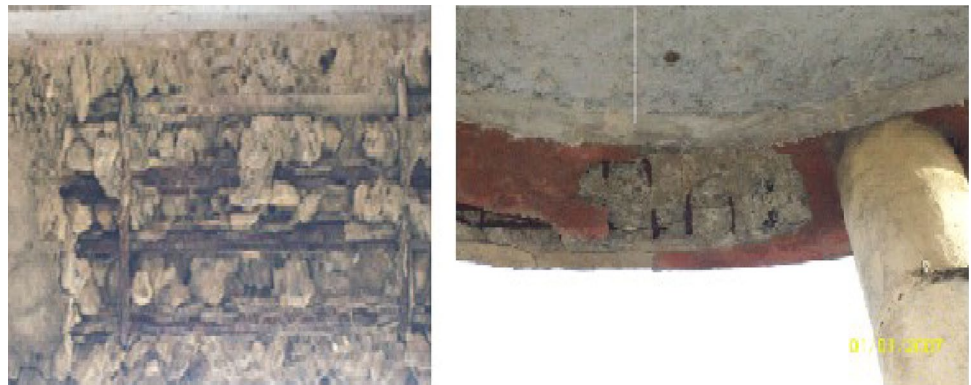
Fig. 4 Corrosion damage on ring beam inner side

The degree of corrosion can be inspected visually by the human eye without any accompanying aids. Figure 4 shows some damages in the water tank and some observations are listed below after visual inspection. Blackish patches were seen on the dome periphery, corrosion damage of ring beam

on the inner side of the ESR, and bottom the reinforcement of bracings exposed and corroded.

A detailed visual inspection was carried out on almost all assessable location, including several visually damaged members. Cracks developed on column and braces of water tank were up to 15 cm in length and 2–3 mm in width. Cracks were observed in the top dome, and the tank wall was of 1.0 cm length and 1 mm width. The maximum portion of rebars of the tank has been exposed and also corroded.

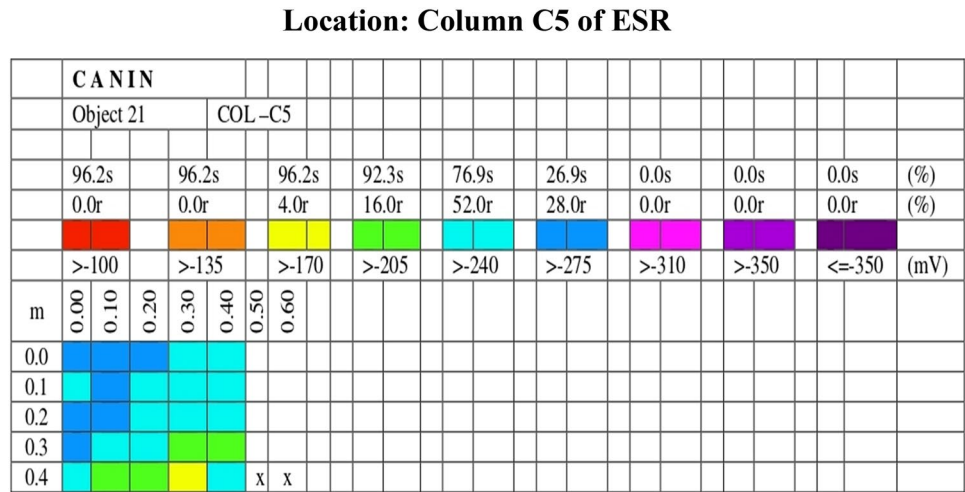
Fig. 5 Corrosion mapping of column C5

Half-cell potential testing was carried out at representative locations on braces, column, and container of ESR. For this test, exposed reinforcement bars were either located or sometimes chiseled out to provide connectivity to the instrument. The surface was cleared of any dust and deposition. Tests were conducted in a grid of 150 × 150 mm using the procedure mentioned in ASTM 876. From Figs. 5 and 6, the average potential difference is in the range of –240 mV and –250 mV for column C5 and beam B2, respectively.

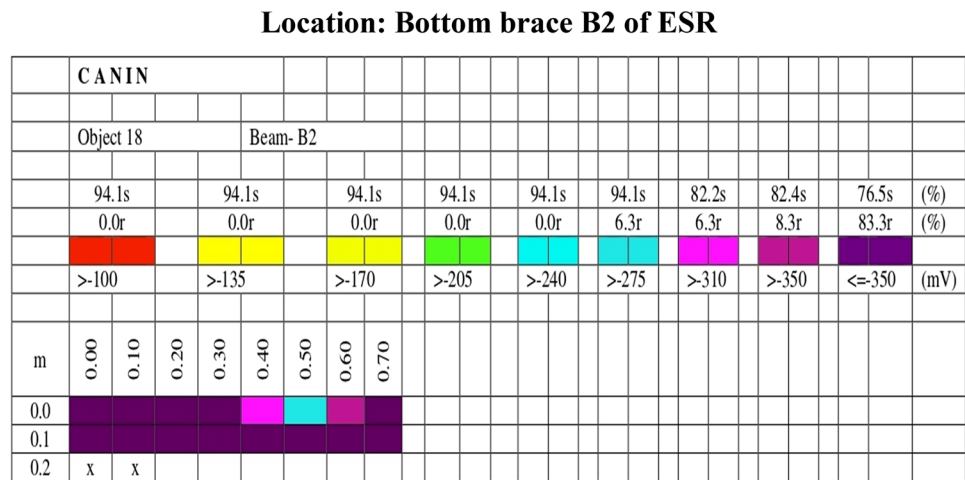
Fig. 6 Corrosion mapping of beam B2

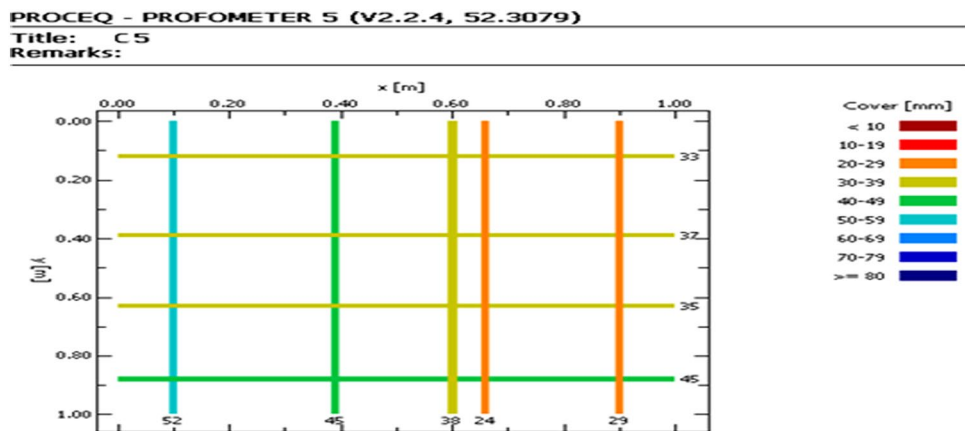
Fig. 7 Details of reinforcement in column C5

Tables 11 and 12 show the various parameters, statistical and measured cover for column C5 and beam B2, respectively. The concrete cover along the X-direction was 37.6 mm and along Y-direction 37.5 mm for column C5. A number of bars were measured in column C5, five in the

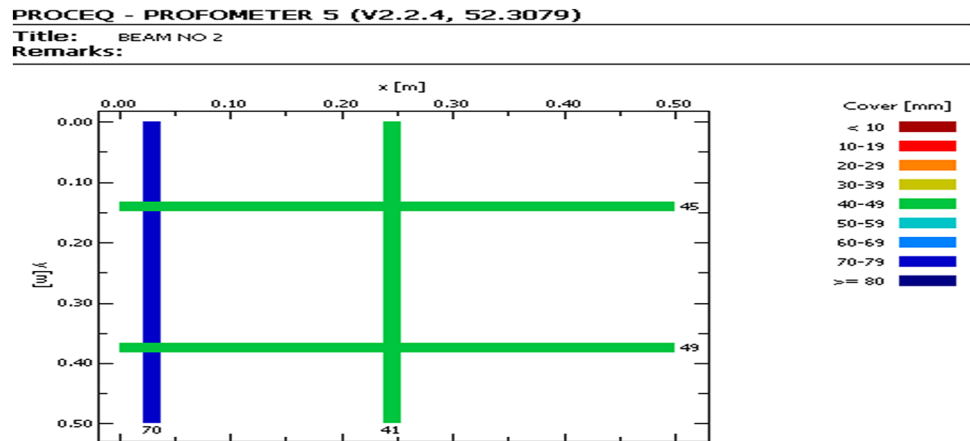
Fig. 8 Details of reinforcement in beam B2

X-direction and four in the Y-direction. The profometer rebar locator test on beam B2 gives an average concrete cover along X-direction 55.5 mm and along Y-direction 47.0 mm. The number of bars measured in beam B2 of ESRs was two in the X-direction and two in the Y-direction.

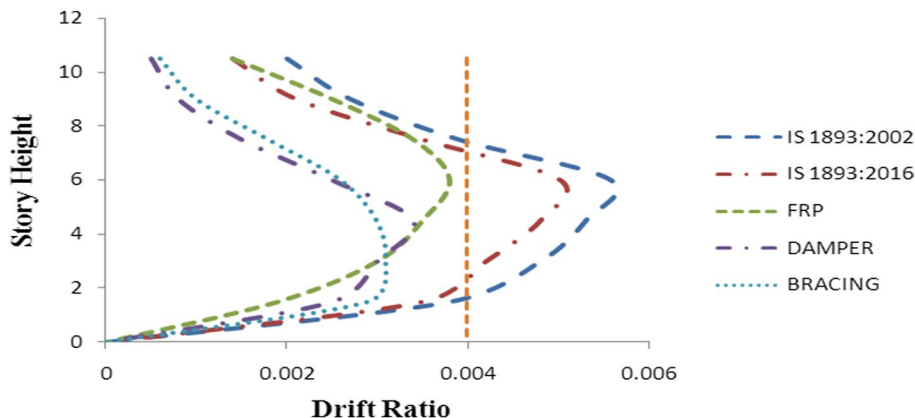
Fig. 9 Comparison drift ratio of ESR

maximum as per IS code as compared to other retrofitting cases. The lowest drift was observed for the bracing system.

4. The value of story drift was reduced 9.50%, 30.01%, 39.06%, and 44.45% by the provision of IS 1893-2016, for FRP, damper, and bracing, respectively, as compared to IS 1893-2002. The lowest drift was observed for the bracing system.

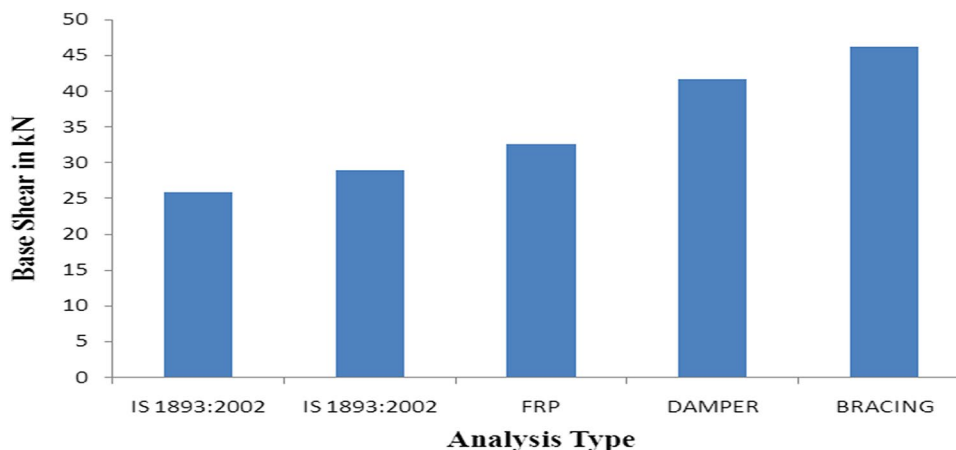
Fig. 10 Comparison of base shear

From Fig. 10, it can be said that the value of the base shear was increased by 11.66%, 25.67%, 60.86%, and 78.88% by the provision of IS 1893-2016, for FRP, damper and bracing, respectively, as compared to IS 1893-2002.

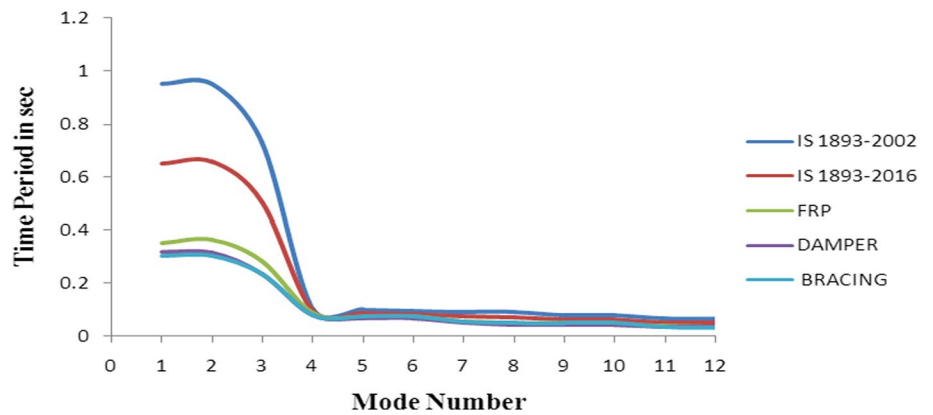
Fig. 11 Comparison between time period vs mode number

Any assumed deflection profile can be built up by a combination of modal shapes. It has been observed that the shape of higher mode for all cases is quite similar. However, the shape of the lower mode tends to differ more. It is observed in Fig. 11 that the time period for each successive mode decreases as the mode number increases.

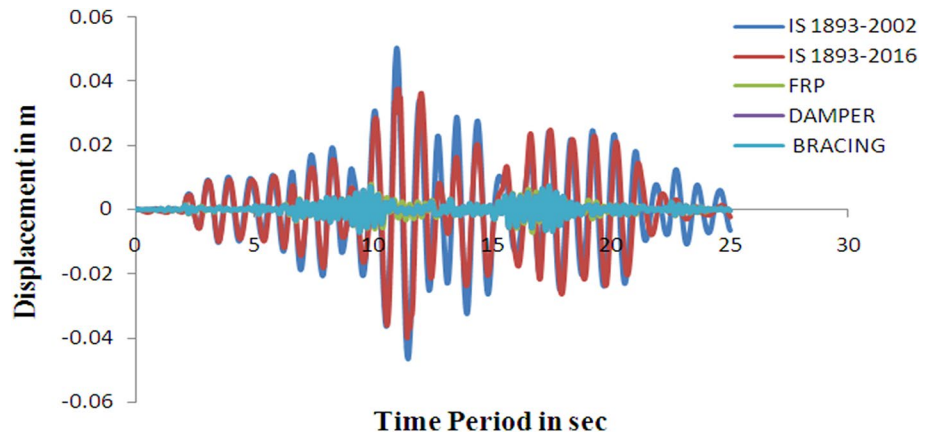
Fig. 12 Comparison between displacement vs time period

From Fig. 12, it can be said that the displacement of the water tank was reduced 21.33%, 84.89%, 88.28%, and 92.89.45% by the provision of IS 1893-2016, for FRP, damper and bracing, respectively, as compared to IS 1893-2002.

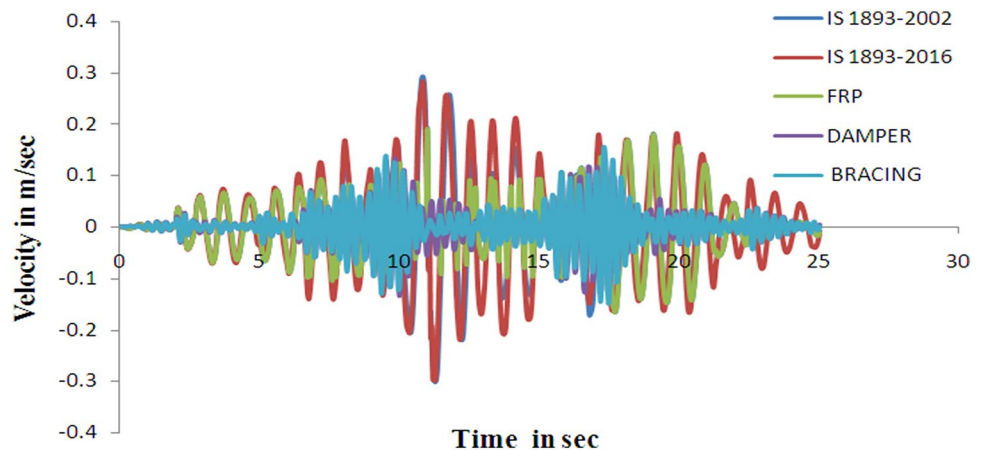
Fig. 13 Comparison between velocity vs time period

A graph was plotted taking time as an abscissa and velocity as ordinate for the different types of cases. It was observed that the velocity was less in retrofitting cases than that of the IS code.

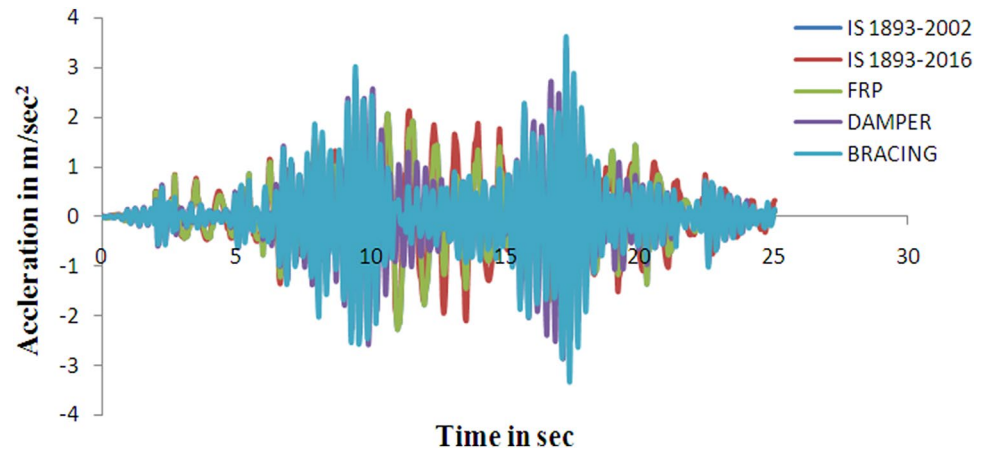
Fig. 14 Comparison between acceleration vs time period
