# Influence of competing notches on the fatigue strength of cut plate edges

P. Diekhoff<sup>1</sup> · J. Drebing<sup>1</sup> · J. Hensel<sup>1</sup> · Th. Nitschke-Pagel<sup>1</sup> · K. Dilger<sup>1</sup>

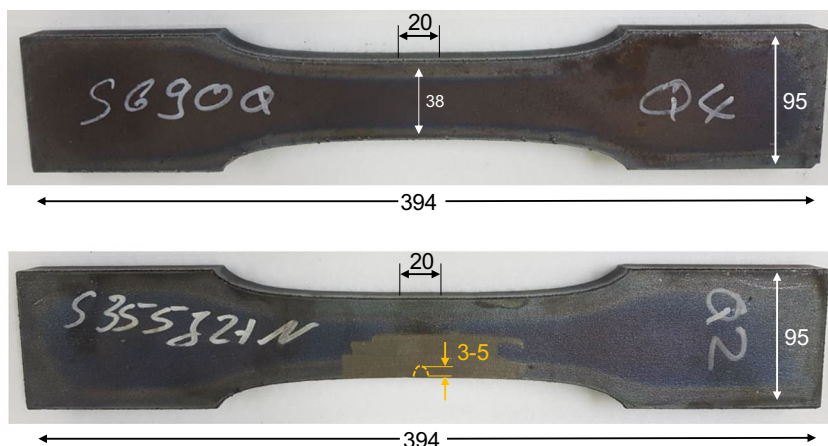
**Fig. 1** Dimensions of fatigue test samples in millimeters, top: S690Q cutting speed high quality 4, bottom: S355N cutting speed low quality 2 + repaired notch

The specimens used for fatigue tests were cut using thermal cutting processes. In this study, oxygen cutting was used. Steel plates had a thickness of 20 mm. The geometry of the specimens was similar to previous work [6]. The samples were 394 mm long, and in the center, the specimens had a parallel length of 20 mm with a width of 38 mm in the critical cross section (Fig. 1). To analyze competing notches on the fatigue strength of cut plate edges, two series, one of each material, were purposely cut with defects in order to reproduce process dysfunctions of the industry. The resulting notches by the flame penetration were subsequently welded using metal-active gas welding GMAW135 with filler wire G3Si1 in welding position flat 1G [21], cf. MAG135 (PA) [22]. Therefore, samples were rotated 90 ° around the y-axis (Fig. 2). The depth of the notch on the cut edge varies over the thickness of the specimen. At the top (entrance of the beam) the depth of the notch was about 5 mm, and at the bottom (beam exit), it was about 3 mm. Weld reinforcements were ground to a plane cut edge surface to recondition the specimen dimensions. Location of the notch is shown on the second specimen schematically at the bottom of Fig. 1.

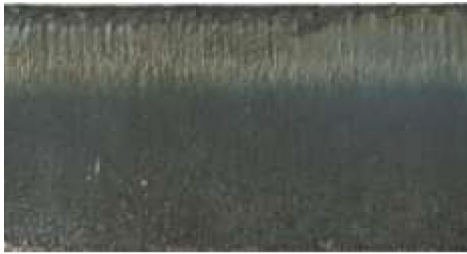
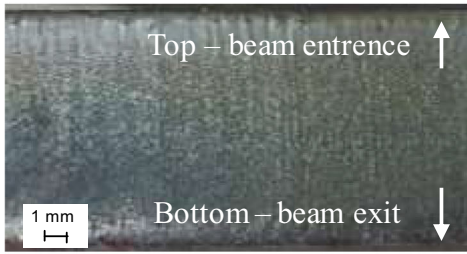
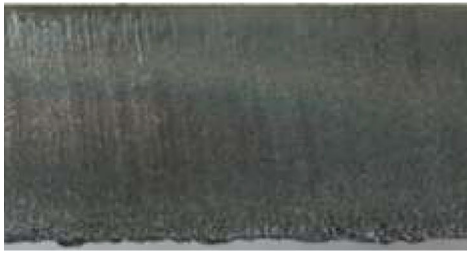
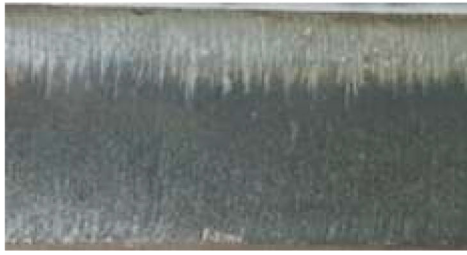
**Table 4** Macroscopic surface analysis of the different series

Base metal	Velocity 420 mm/min	Velocity 390 mm/min
S355N

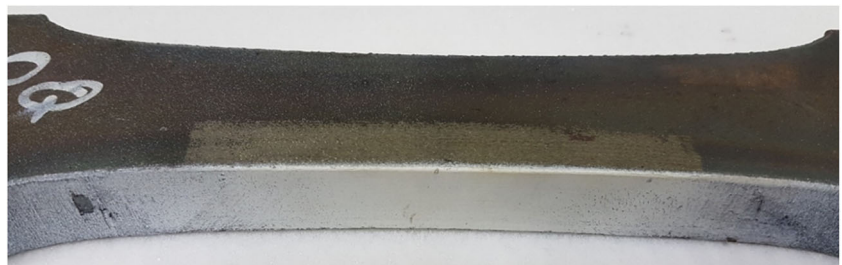
**Fig. 3** Repaired specimen after grinding the weld reinforcements

measurements are shown in Fig. 2. Hardness measurements were made at the cross section for the heat-affected zone (HAZ) as well as the base material (BM), see below. Further, cross-sectional A-A was defined to analyze the repaired notch in terms of hardness mapping and metallography analysis (Table 4). Notch was repaired using metal-active gas welding in 1G position (Fig. 3).

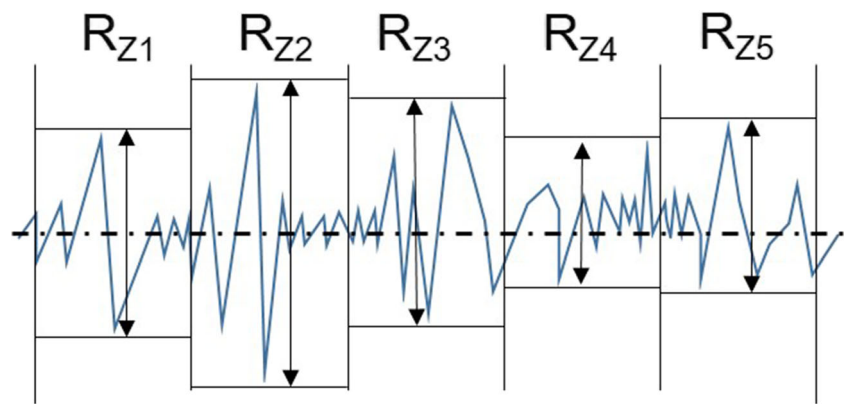
**Fig. 4** Determination of the average surface roughness  $R_Z$

To determine the surface condition, roughness measurements were made on the surface of each specimens in accordance with ISO 4288 [23]. Using the MarSurf M 400 surface measuring instrument, measurements were carried out with the profile method over a length of 17.5 mm. From each series, at least three specimens were measured. To include the roughness distribution over the specimen thickness, measurements were made at the top (entrance of the beam), in the middle, and at the bottom side (beam exit) of the cut edges. The maximum difference between the profile peak and the profile valley is averaged over five individual measuring sections;  $R_z$  is calculated of the five different  $R_{z(i)}$  as follows (Fig. 4) (Eq. 1) [17]:

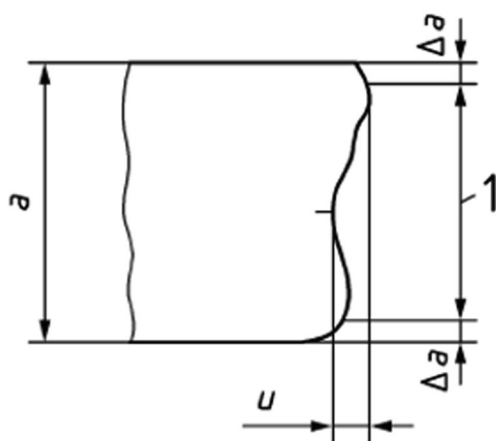
**Fig. 5** Perpendicularity

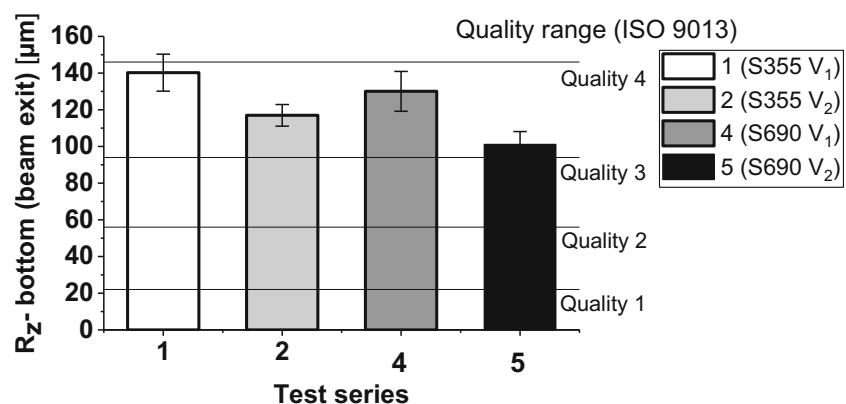
**Fig. 6**  $R_z$  values at the bottom of the cut edge surface

The bar graph in Fig. 6 compares the different roughness values  $R_Z$  at the bottom of the cut edge surface, because highest values were determined. Further, the limits of the

maximum  $R_Z$  value for the specific plate thickness of 20 mm for the different quality groups are added. The roughness of the repaired section A-A was smoother than on the cut edge due to grinding of the weld reinforcements.

It is observed that all mean values of the series have to be classified in quality group 4. The base metal has no influence of the roughness values. Contrary to the base metal, the velocity affects the roughness. Decreasing the cutting speed decreases the roughness at the cut edge as well, and therefore, the quality increases. Even though a higher quality range in the ISO 9013 is not reached.

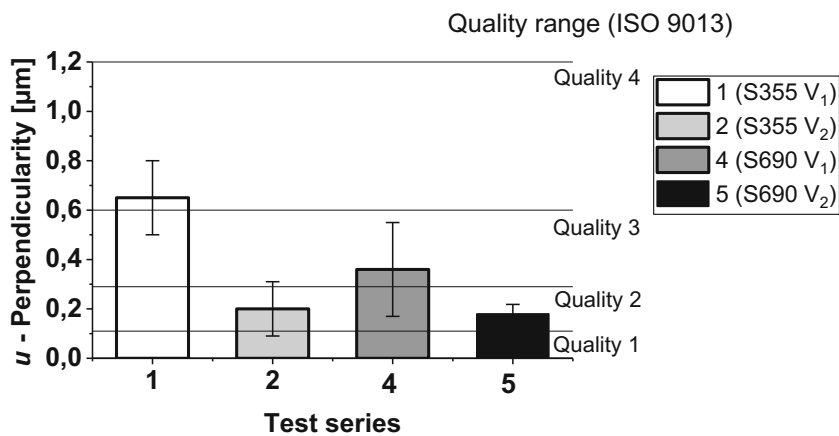
**Fig. 7** Perpendicularity of the cut edges of the different series

The perpendicularity show also the same tendency. Series 1 (S355,  $u = 0.65 \mu\text{m}$ ) and 4 (S690,  $u = 0.36 \mu\text{m}$ ) with a velocity of 420 mm/min have higher  $u$  values compared with series 2 (S355,  $u = 0.2 \mu\text{m}$ ) and 5 (S690,  $u = 0.18 \mu\text{m}$ ) with a velocity of 390 mm/min. With the high cutting speed, S355N is classified in quality group 4 and S690Q in quality group 3. Decreasing the cutting speed decreases the perpendicularity at the cut edge as well, and therefore, the quality increases. Both materials are ranged in quality group 2 with the low velocity (Fig. 7).

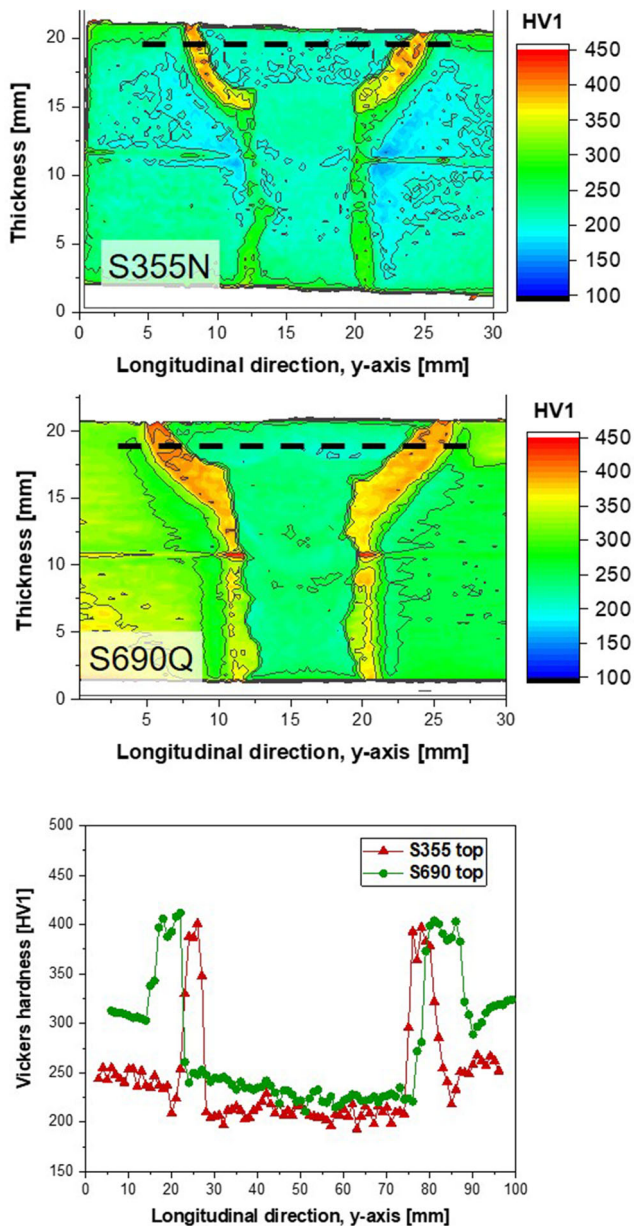
**Fig. 9** Hardness mapping of the repaired notch from S355N (top) and S690Q (middle). Vickers hardness profile 1 mm under the surface (bottom)

To determine the heat-affected area and the hardness increase due to repair welding process, hardness mappings of the cross-sectional A-A (Fig. 2) were carried out with Vickers hardness (HV1) for both materials. Figure 9 shows the hardness mapping of the repaired notch from S355N (top) and S690Q (middle). Further, a hardness profile over the weld seam 1 mm under the surface is carried out of both materials. The different values of the base material of S355N—approx. 200 HV1—and

S690Q—approx. 300 HV1—are visible. Also, the weld seam and the HAZ are well seen. At the top of both specimens, the weld seam is significantly wider than in the middle and at the bottom. The inserted notch by the oxy-fuel flame seems to be larger at the top. The maximum hardness values on the cross section are 436 HV1 for S355N and 449 HV1 for S690Q.

The hardness profiles show similar curves of both measurements except the location and width of the HAZ and the values of the base material. The maximum hardness value is also similar about 410 HV1.

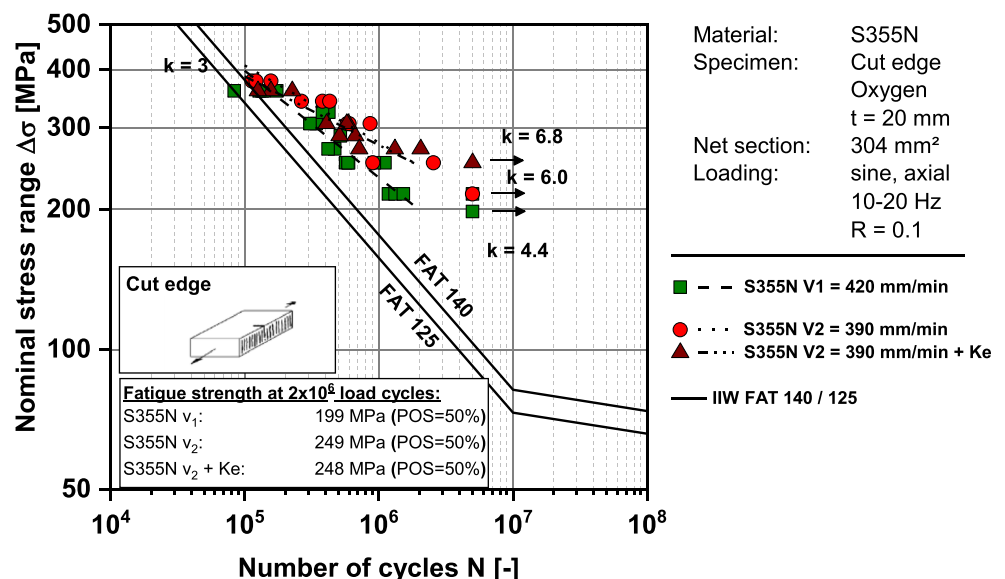
**Fig. 10** Fatigue test data of oxy-fuel cut plate edges, S355N, 20 mm thick with varies velocities and repaired notch (Ke)

Fig. 10 shows the test data from oxy-fuel cut specimens made from S355N plates. Fatigue strength is sum up at the bottom left of the diagrams. Test data of S355N  $v_1$  as well as S690Q  $v_1$  was merged with data of previous studies with the same cutting parameters [6].

Fatigue strength at 2 million load cycles of S355N  $v_1$  was determined to  $\Delta\sigma = 199$  MPa with a survival possibility (POS) of 50%. The regression line was calculated to  $k = 4.4$  without considering run outs. The benefit of a low cutting speed is primary at higher numbers of load cycles. The fatigue strength increase was determined to  $\Delta\sigma = 249$  MPa at 2 million load cycles with a slope of  $k = 6.0$ . It is an increase of 25% of fatigue strength compared with the fast velocity  $v_1 = 420$  mm/min. No significant decrease of the repaired notch series was observed. Fatigue strength results show similar values of  $\Delta\sigma = 248$  MPa and a slope of  $k = 6.8$ .

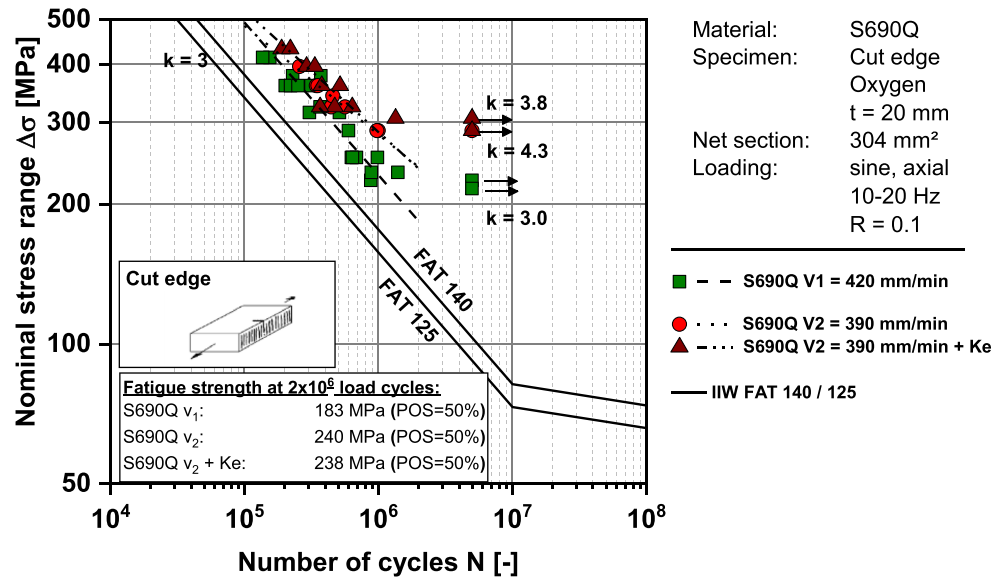
**Fig. 11** Fatigue test data of oxy-fuel cut plate edges, S690Q, 20 mm thick with varies velocities and repaired notch (Ke)

The test data of the material S690Q are shown in Fig. 11. Fatigue strength at 2 million load cycles of S690Q  $v_1$  was determined to  $\Delta\sigma = 183$  MPa (POS = 50%). The slope was calculated to  $k = 3.0$ . The fatigue strength of the series with the low velocity increased to  $\Delta\sigma = 240$  MPa at 2 million load cycles with a slope of  $k = 4.3$ . It is an increase of 31% of fatigue strength compared with the fast velocity  $v_1 = 420$  mm/min. No significant decrease of the repaired notch series was observed. Fatigue strength results show similar values of  $\Delta\sigma = 238$  MPa and a slope of  $k = 3.8$ .

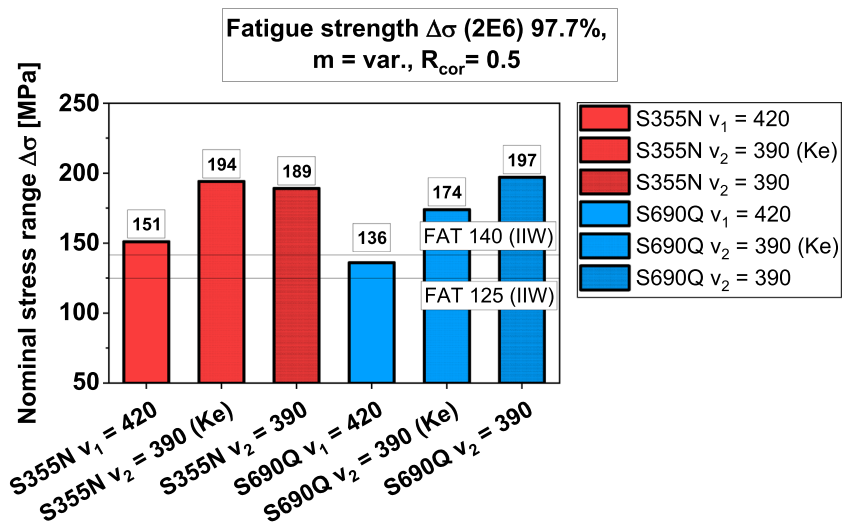
**Fig. 12** Fatigue strength  $\Delta\sigma$  ( $2E6$ ) 97.7%,  $m = \text{var.}$ ,  $R_{\text{cor}} = 0.5$

Fig. 12 shows the fatigue strength results  $\Delta\sigma$  (2E6) 97.7%, *m* = var., *R*<sub>cor</sub> = 0.5. All series exceed FAT 125. The cutting speed affects the roughness and the perpendicularity on the cut edge. Due to reduced cutting speeds, the roughness and the perpendicularity decrease also. This results in an increase of the fatigue strength in all tested series in this study. The defect on the cut edges is reduced as critical details were the cracks

might start. Series with the low velocity achieve FAT 160 in all cases equal to base material samples.
