# Dynamic Behaviour of a High-Strength Structural Steel at Low Temperatures

The main objective of this experimental study is to determine the effect of low temperatures on the mechanical behaviour of Strenx 960 Plus high-strength structural steel at different strain rates and stress triaxialities. For this purpose, a comprehensive experimental campaign was designed to characterise the material at a wide range of temperatures and loading rates. The stress triaxiality was varied by testing specimens with different geometry. First, to determine the ductile-to-brittle transition temperature, instrumented Charpy V-notch impact tests were carried out at a range of temperatures from +20 °C down to –90 °C. The impact energy dropped gradually with decreasing temperature, but a clear transition temperature could not be identified. A fractography study exhibited a clear dimple structure, revealing predominantly ductile fracture at all temperatures. Then, uniaxial tension tests on smooth and pre-notched axisymmetric specimens under both quasi-static and dynamic loading rates were carried out at room temperature and low temperatures. These tests were conducted to characterise the rate-dependen

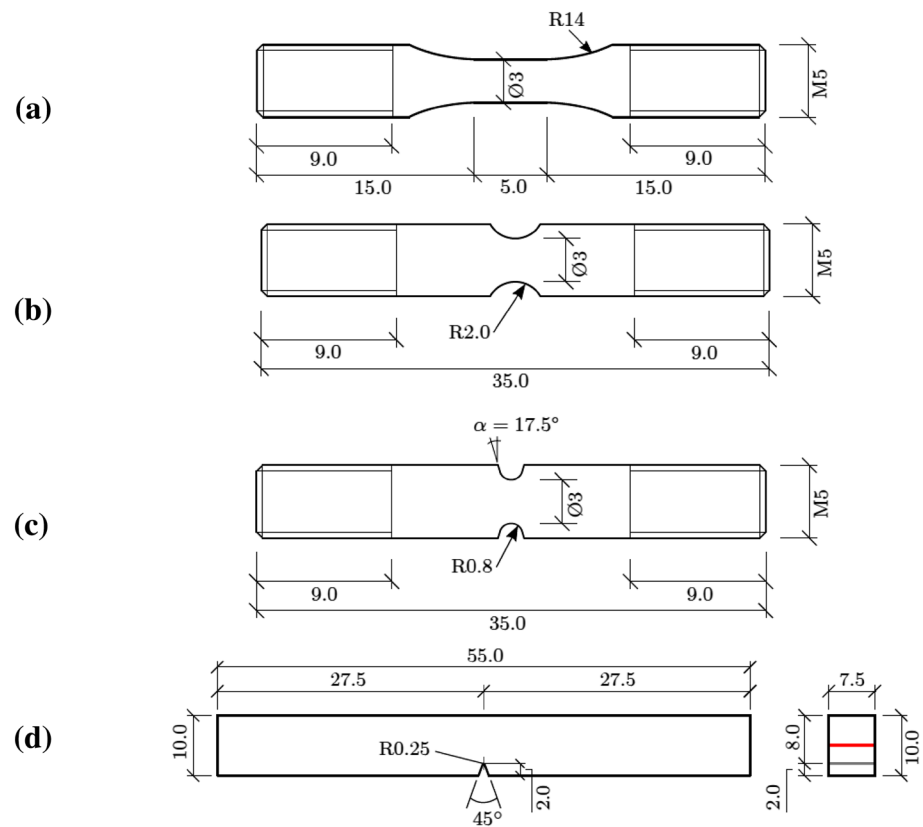
**Fig. 1** Geometries of the **a** smooth and pre-notched tension specimens with radius, **b**  $R=2.0$  mm and **c**  $R=0.8$  mm, and **d** the Charpy V-notch specimen

Smooth round bars and axisymmetric notched tensile specimens were machined from an 8 mm thick Strenx 960 Plus steel plate. The geometries of the smooth and pre-notched specimens with different notch-root radii are shown in Fig. 1a–c. To study the anisotropy of the material, the smooth specimens were extracted from three different orientations with respect to the rolling direction of the plate:  $0^\circ$ ,  $45^\circ$  and  $90^\circ$ , with  $0^\circ$  being the rolling direction. The pre-notched specimens, with radius  $R = 2.0$  mm (R2.0) and  $R = 0.8$  mm (R0.8), were only extracted from

The geometry of the Charpy V-notch specimens is shown in Fig. 1d. The red line on the cross-section indicates the thickness direction of the 8 mm thick steel plate. The substandard geometry of the specimens was in accordance with the relevant standards [15].

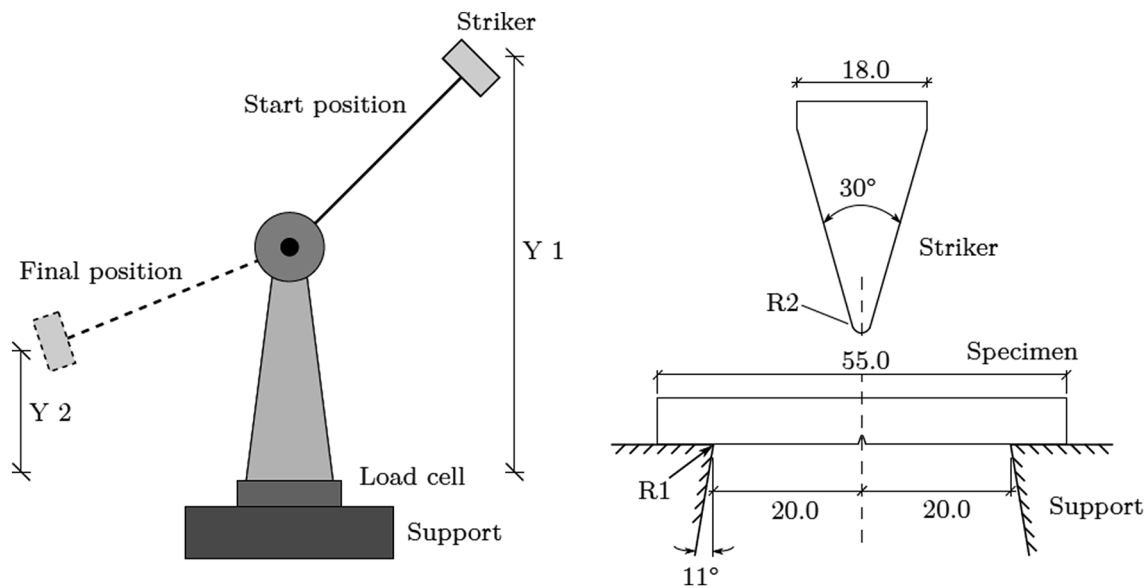
**Fig. 2** Scheme of the pendulum device and the inverse set-up used for the Charpy V-notch impact tests

Charpy V-notch tests were carried out according to the ISO 148-1:2016 standard using an inverse setup (see Fig. 2) [16]. In an inverse setup, the specimen is attached to a 21 kg pendulum with an 800 mm long arm that impacts what is usually known as the striker. Before testing, the specimens were cooled down in an alcohol bath to the desired test temperatures of  $+20$  °C,  $-20$  °C,  $-40$  °C,  $-60$  °C,  $-75$  °C or  $-90$  °C for at least 10 min. Then, each specimen was rapidly transferred to the impact position and impacted by the striker, the elapsed time being not more than 5 s.

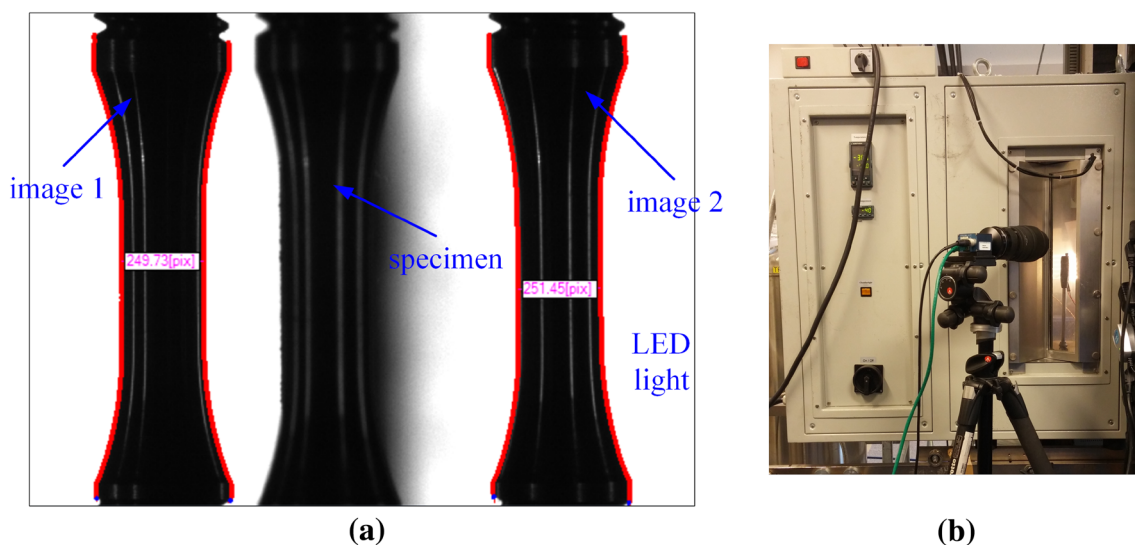
**Fig. 3** **a** Illustration of the edge tracing technique used to monitor the minimum cross-section diameter of the specimen in two perpendicular directions. **b** Environmental chamber used for the low temperature tests in quasi-static regime

a LED light system to improve the grey-scale gradient between the specimen and the background. An optical edge-tracing technique [17, 18], implemented in the software eCorr [19], was used to monitor the minimum cross-section diameter of the specimen in two perpendicular directions (see Fig. 3a). With this technique, the gradient in grey-scale value of the specimen towards the background is used to define the edge and subsequently the minimum diameter of the specimen during loading. The edge-tracing technique was validated against DIC in [17], showing good agreement.

To study the in-plane anisotropy of the material, smooth tension specimens extracted at  $0^\circ$ ,  $45^\circ$  and  $90^\circ$  with respect to the rolling direction of the steel plate were tested at room temperature. Tensile tests of smooth and pre-notched ( $R=2.0$  mm and  $R=0.8$  mm) specimens extracted from the rolling direction were performed at  $+20^\circ\text{C}$  and  $-40^\circ\text{C}$ . The tests at low temperature were conducted in a temperature chamber where the specimens were cooled down using liquid nitrogen. The chamber was equipped with a window through which the test specimen could be recorded (see Fig. 3b). After having reached the desired level, the

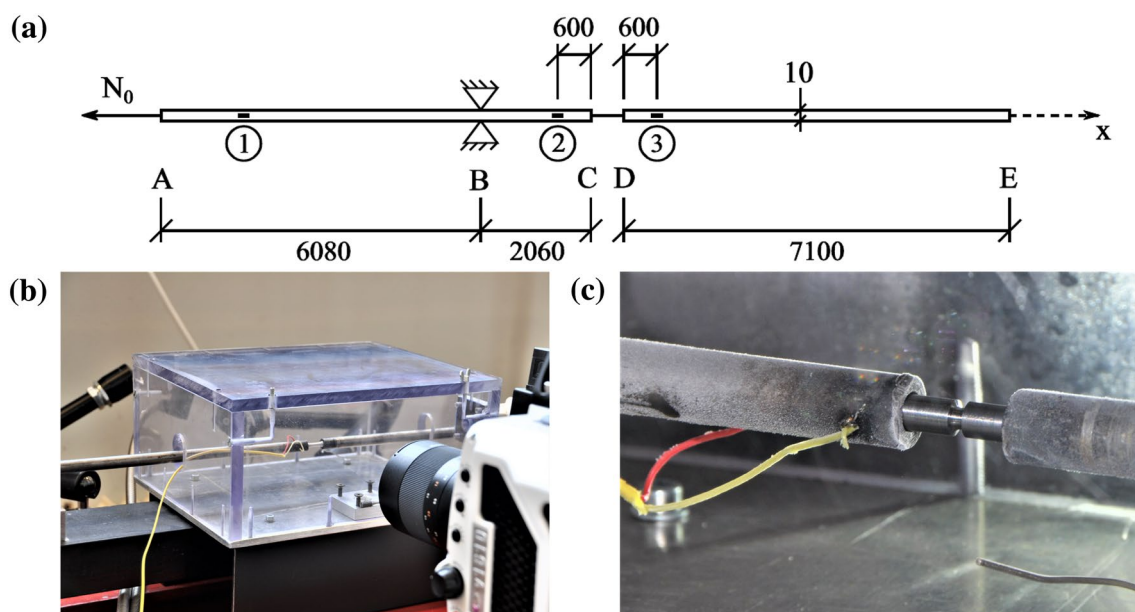
**Fig. 4** Experimental set-up of the dynamic tensile tests. **a** Schematic view of the SHTB (dimensions in mm). **b** Polycarbonate temperature chamber. **c** Specimen located in testing position. Thermocouples attached to the bars to control the sub-zero temperature

Dynamic tensile tests using the same specimen geometries as in the quasi-static tests were conducted in a split Hopkinson tension bar (SHTB) at  $+20\text{ }^{\circ}\text{C}$  and  $-40\text{ }^{\circ}\text{C}$ . The experimental set-up [20], schematically illustrated in Fig. 4a, was composed of an input bar (AC) and an output bar (DE), both made of steel quality Tibnor 52SiCrNi5. A friction locking mechanism (B), which clamped the input bar, allowed the stress wave to be generated. The specimen was mounted between C and D. The SHTB was equipped with strain gauges at each of the positions ①, ② and ③. Strain gauges ② and ③ were used to determine the stress in the specimen, while gauge ① was used to monitor the tension force  $N_0$  used to strain the input bar. Using the signals from the strain gauge measurements, the nominal stress, nominal strain and nominal strain rate in the sample can be obtained based on one-dimensional stress wave theory (see [20] for details).

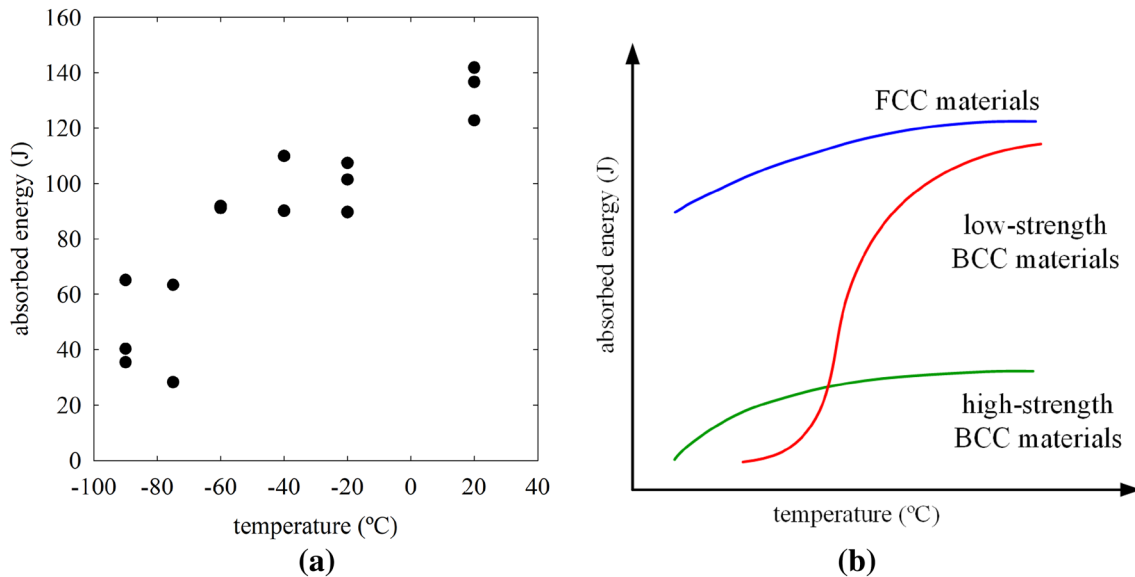
**Fig. 5** Charpy V-notch tests: **a** The absorbed energy as a function of temperature, from +20 °C down to −90 °C. **b** Illustration of the theoretical temperature-transition curve for different materials, adapted from Dieter [9]

The absorbed energy in the Charpy V-notch tests as a function of temperature, from  $+20\text{ }^{\circ}\text{C}$  down to  $-90\text{ }^{\circ}\text{C}$ , is shown in Fig. 5a. Note that the measured absorbed energy at  $-40\text{ }^{\circ}\text{C}$  is significantly higher than the minimum value given by the material certificate (see Table 1). The results

revealed that the absorbed energy gradually decreased with decreasing temperature. However, contrary to what one would expect to observe in a typical steel with a DBTT, no clear drop in energy absorption at a specific temperature could be identified. According to Dieter [9], the shape of the temperature-transition curve highly depends on the material (see Fig. 5b). FCC and most HCP materials have such high notch toughness that brittle fracture is normally not a problem. On the contrary, BCC materials (such as steels) have much lower notch toughness. Thus, brittle fracture is in principle possible at all temperatures and strain rates. The notch toughness of low- and medium-strength BCC materials is strongly dependent on the temperature. At low temperature, fracture occurs by cleavage while at high temperature the fracture occurs by ductile rupture, and the temperature-transition curve may be abrupt. Furthermore, important changes in the transition temperature can be produced by changes in the chemical composition or the microstructure of mild steels. For high-strength steels, such as the Strenx 960 Plus investigated here, the transition temperature is as seen less distinct.

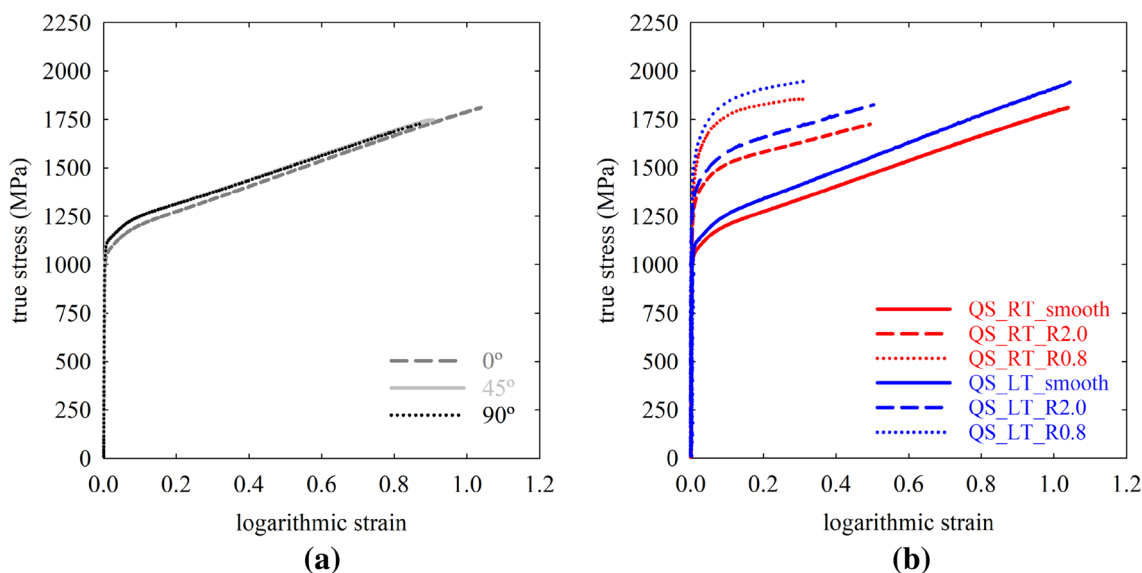
**Fig. 6** True stress–strain curves of quasi-static tests: **a** Smooth specimens extracted from 0°, 45° and 90° orientations at room temperature. **b** Smooth and pre-notched specimens from 0° orientation at +20 °C (in red, RT) and -40 °C (in blue, LT) (Color figure online)

Obtained true stress–strain curves corresponding to the smooth specimens extracted from three different orientations (0°, 45° and 90° with respect to the rolling direction) and tested at room temperature are shown in Fig. 6a. These experimental results confirm that the stress–strain response is rather isotropic, even though minor differences in both flow stress and strain to failure are seen between the different specimen orientations.

Figure 6b shows true stress–strain curves of smooth and pre-notched specimens extracted from the rolling direction and tested at both +20 °C and −40 °C. The results revealed that for all the specimen geometries the flow stress increased with decreasing temperature, while the failure strain remained almost the same. Similar results on a 420 MPa structural steel were found by Tu et al. [14], where the fracture strain did not deteriorate when the temperature decreased from room temperature down to −60 °C.

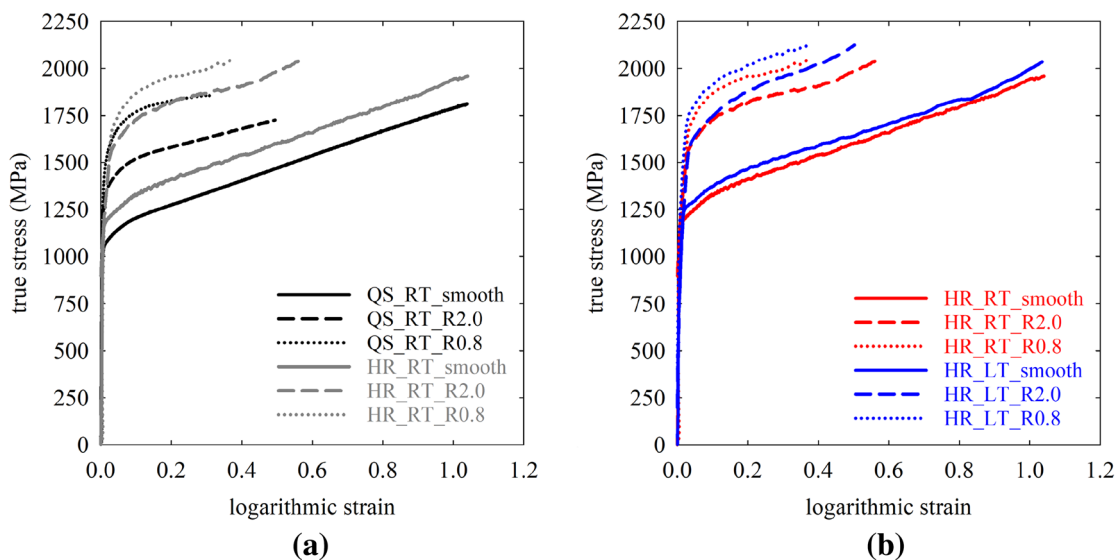
**Fig. 7 a** True stress–strain curves of both quasi-static (LR) and dynamic (HR) tensile tests at room temperature. **b** Effect of temperature on the dynamic tensile test, +20 °C (in red, RT) and -40 °C (in blue, LT) (Color figure online)

As it can be seen in Fig. 7a, the stress level increased with increasing strain rate, being slightly higher at low temperature, i.e., -40 °C, than at room temperature (see Fig. 7b). The Strenx 960 Plus exhibited positive strain rate sensitivity, which was roughly the same at room temperature and low temperature. It should be noted that, although two or three repetitions within each test series were performed, only a representative stress–strain curve for each geometry is shown in Figs. 6 and 7.

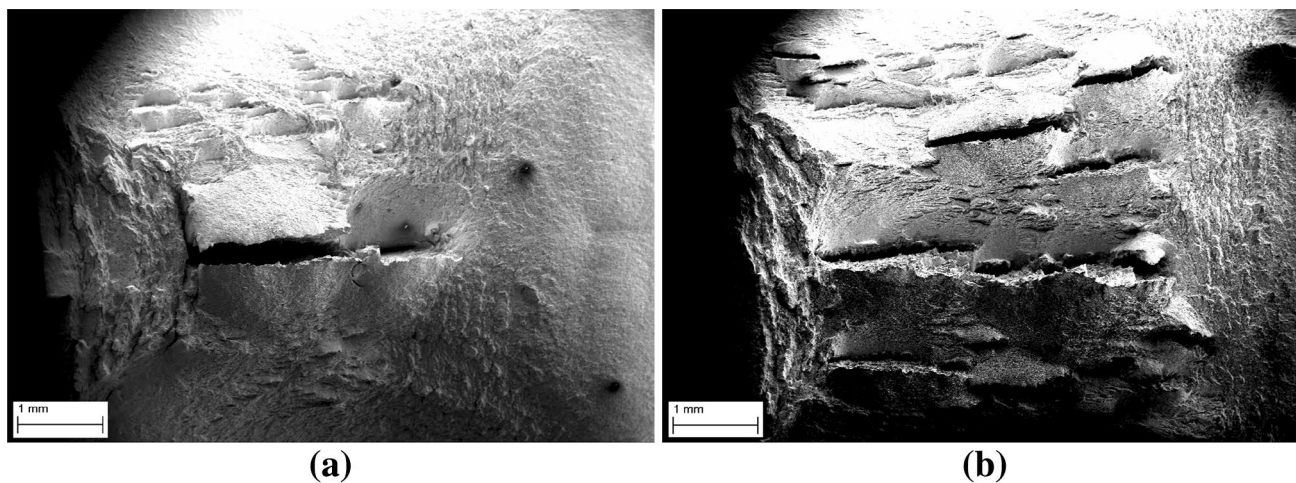
**Fig. 8** Charpy V-notch specimens: **a** room temperature test. **b**  $-40\text{ }^{\circ}\text{C}$  test

Cleavage fracture is typically represented by a multifaceted surface and ‘river patterns’ on each facet of the Charpy specimen [10]. None of these characteristics were observed on the fracture surfaces resulting from the Charpy tests. A clear dimple structure was seen on the fracture surface of the Charpy V-notch specimens; although delamination was more prominent at lower temperatures, as can be observed in Fig. 8. It is believed that the higher stress level in the

material at  $-40\text{ }^{\circ}\text{C}$  is the main contributing factor to the greater tendency of delamination.

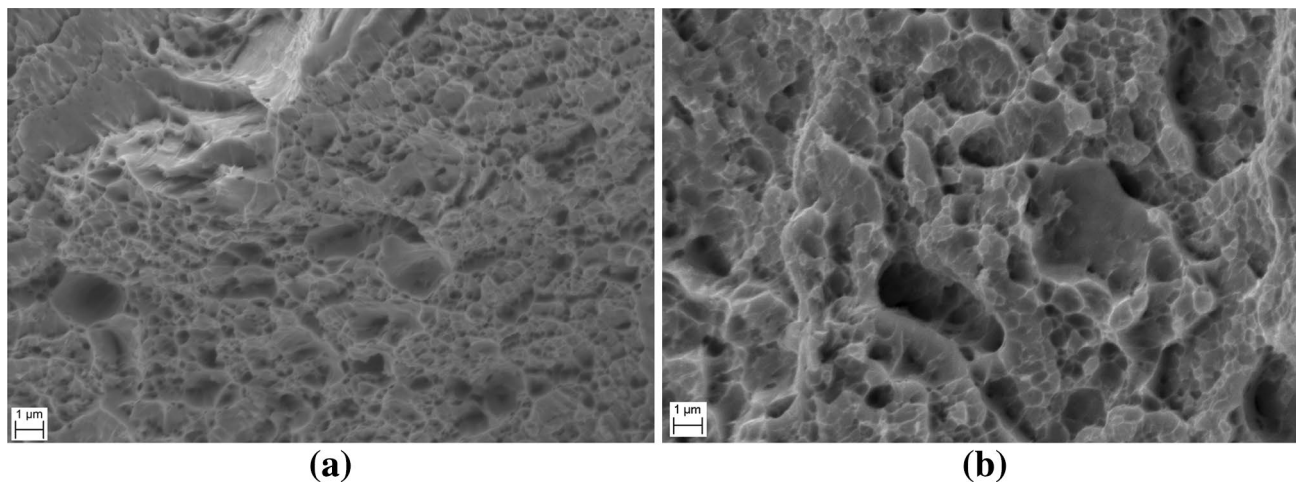
**Fig. 9** Tension specimens from  $0^{\circ}$  direction tested at room temperature. **a** Smooth. **b** Pre-notched with R0.8

A classic dimple structure was observed on the tension specimen surfaces at all temperatures, indicating ductile failure. More shallow dimples could be observed on the fracture surface of pre-notched tension specimens (see Fig. 9), indicating less ductile behaviour. This effect was experimentally confirmed and could be observed in Fig. 6b, where the strain to failure decreased while the stress triaxiality increased because of the introduction of the notch.

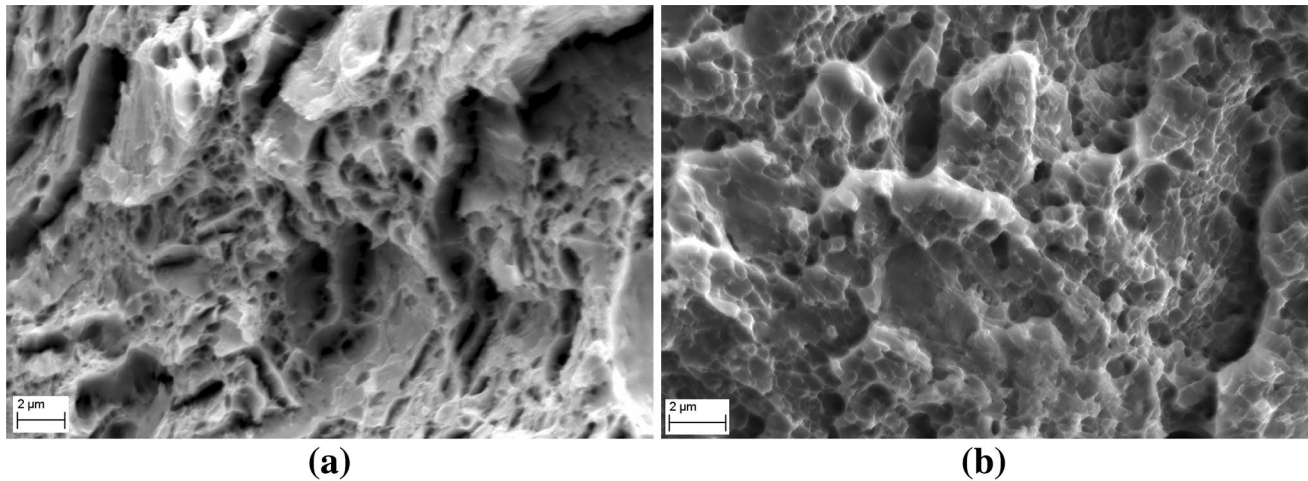
**Fig. 10** Tension specimens from 0° direction tested at  $-40\text{ }^{\circ}\text{C}$ . **a** Smooth. **b** Pre-notched with R0.8

As it can be seen in Fig. 10, dimples were shallower with decreasing temperature. One may assume that shallow dimples imply less ductile material behaviour. However, a reduction of strain to failure due to decreasing temperature could not be experimentally observed in Fig. 6b. The shallower dimples observed at  $-40\text{ }^{\circ}\text{C}$  could be a delayed void formation due to low temperatures.

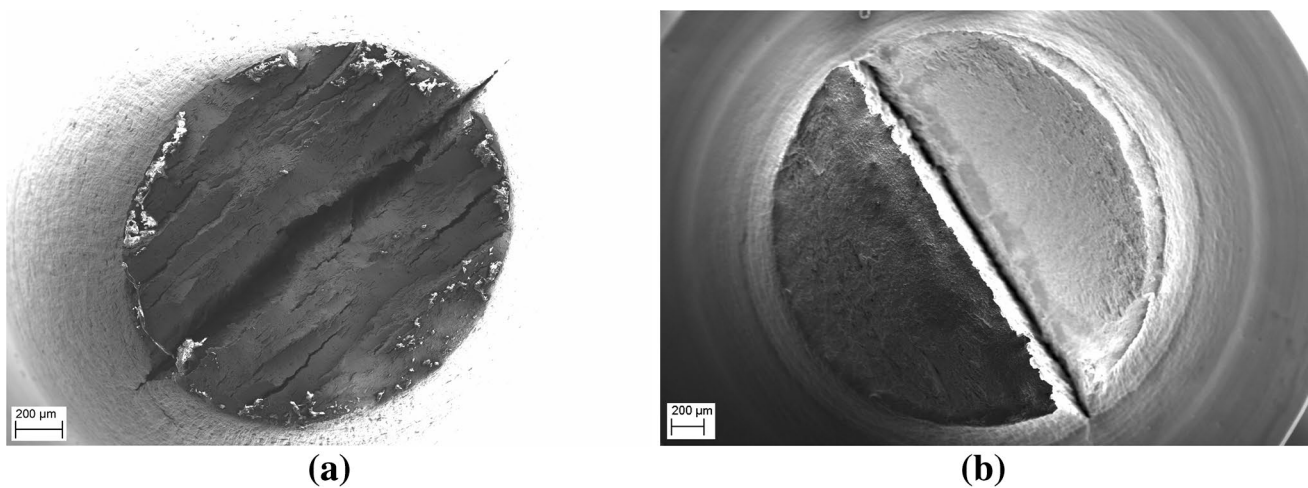
**Fig. 11** Tension specimens from 0° direction tested at room temperature. **a** Smooth. **b** Pre-notched with R0.8

Delamination was observed on all the specimens tested at both room temperature and  $-40\text{ }^{\circ}\text{C}$ . It can be seen as the cracks, which are perpendicular to the thickness direction of the smooth tension specimen in Fig. 11a. Also, a large crack perpendicular to the thickness direction was observed in the centre of the notched specimens (see Fig. 11b). Similar cracks were observed by Manes et al. [21] on a pipeline steel. A possible reason they found was the relatively large tensile stresses induced by the strong necking in the thickness direction that lead to secondary cracks along the rolling plane of the material.
