Surveying and diagnosing non-traditionally constructed houses in the United Kingdom

Journal of Building Appraisal (2009) 4, 239–245. doi:10.1057/jba.2009.5

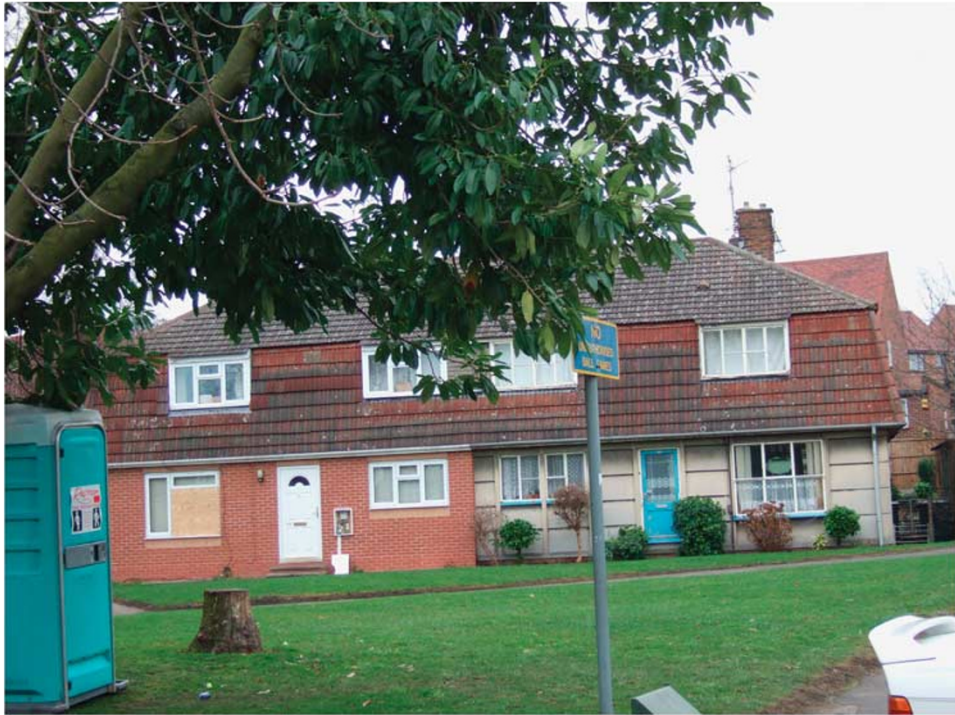
Figure 1: Original construction of small pre-cast concrete panels supported by pre-cast columns (right) and overladded with brick (left).

The following illustrations were taken recently from a substantial development of concrete panelled houses located in a prime residential position in the centre of a small urban town. Figure 1 shows the original construction form of small pre-cast concrete

panels supported by pre-cast columns, in the semi-detached house to the reader's right, whereas the left hand property has been overladded with brick. Many of these properties have become owner-occupied, and Figure 2 shows how once face-lifted with brick cladding and new UPVC fenestration they can be made aesthetically attractive. Figure 3 shows the different evolution of non-traditionally constructed semi-detached houses. The house left in its original form is now well past the original design life and consequentially the concrete panels, roof coverings and fenestration are all in extremely poor condition, and badly in need of exterior refurbishment.

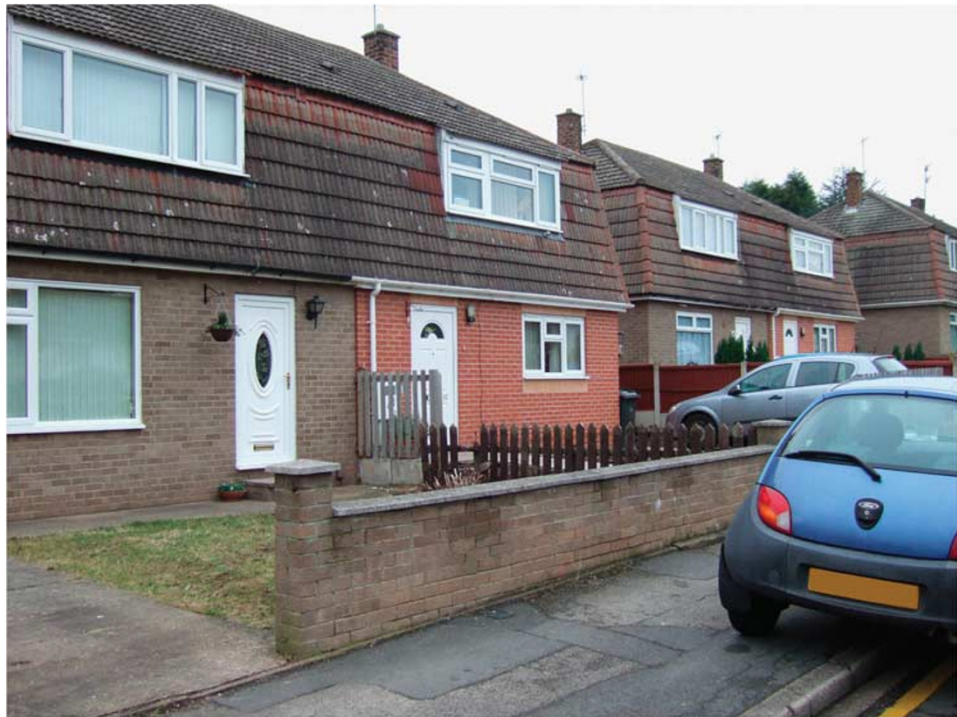
Figure 2: Once face-lifted with brick cladding and new UPVC fenestration, they can be made aesthetically attractive.

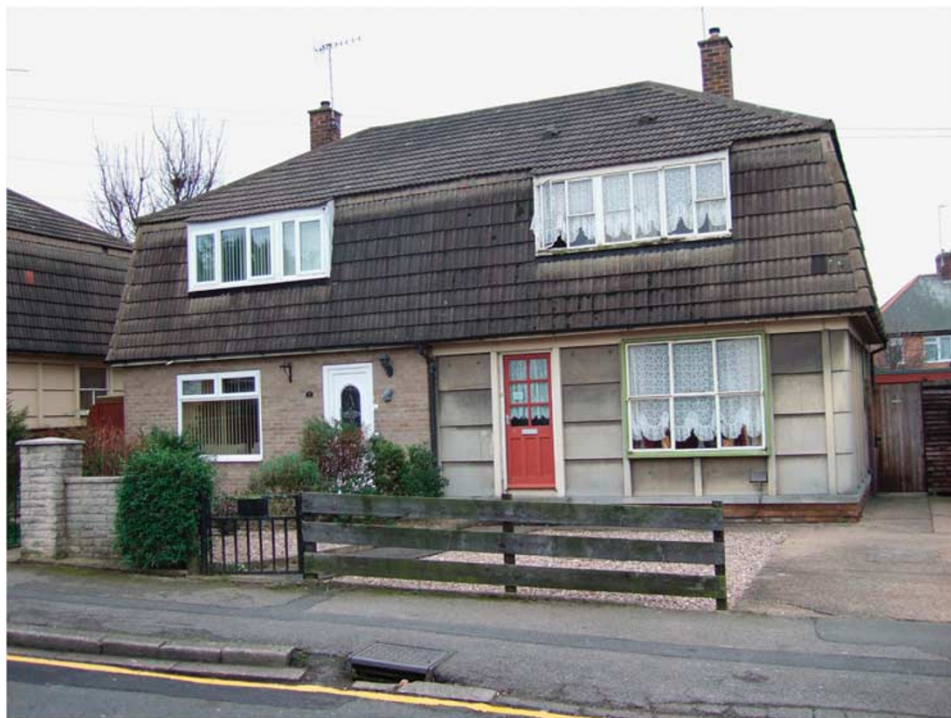
Figure 3: Different evolution of non-traditionally constructed semi-detached houses. The house still in its original form (right) requires significant refurbishment.

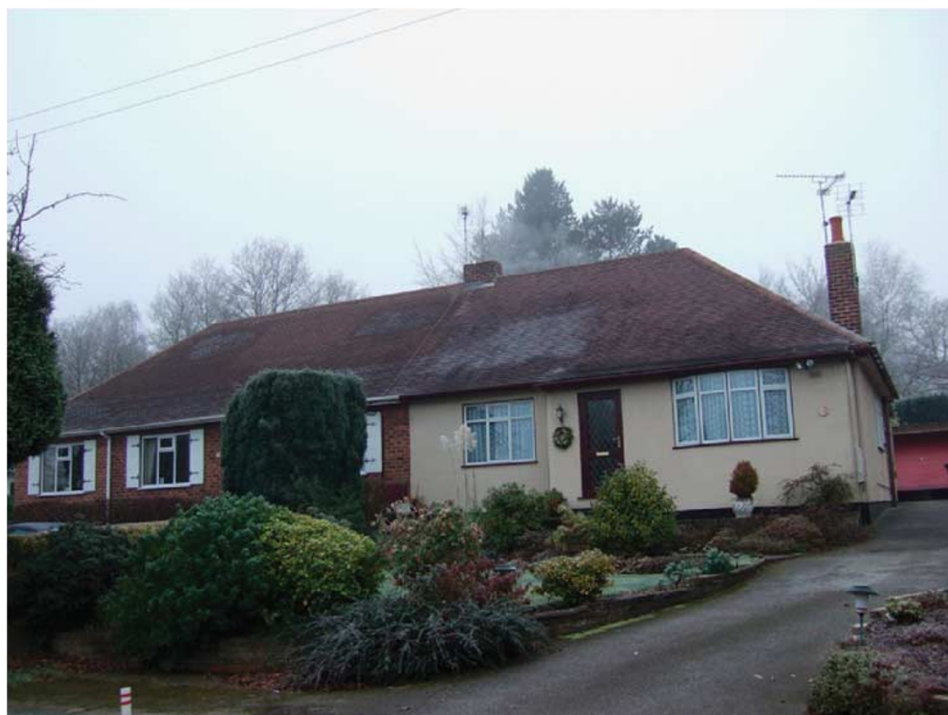
Figure 4: A pair of originally prefabricated semi-detached properties dating from the late 1950s which have evolved differently.

Figure 4 represents a pair of originally prefabricated semi-detached properties, which formed part of a small development reputedly dating from the late 1950s. It can be seen how the two semi-detached properties have evolved differently; however, the main issue with these would be that the area has evolved around them and they are now located in one of the most prestigious and expensive residential areas of the county.
