EDUCATIONAL REVIEW

Imaging of shoulder arthroplasties and their complications: a pictorial review

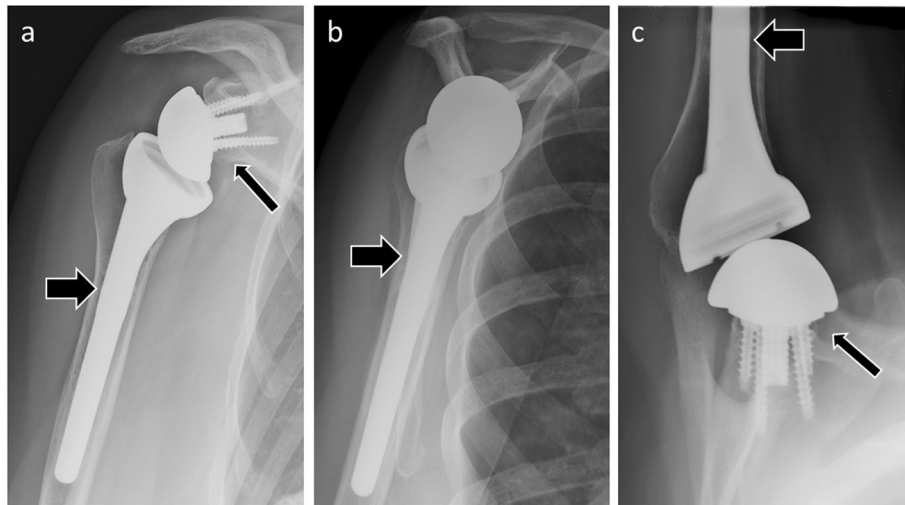
Fig. 2 Anteroposterior (a), scapular Y (b), and axillary (c) radiographs of normal findings in a patient with reverse shoulder arthroplasty. The humeral prosthetic stem (thick arrows) is centered within the humeral shaft. The glenosphere (thin arrows) is placed flush with the native glenoid (or slightly lowered) and the humeral component is centered on the glenosphere

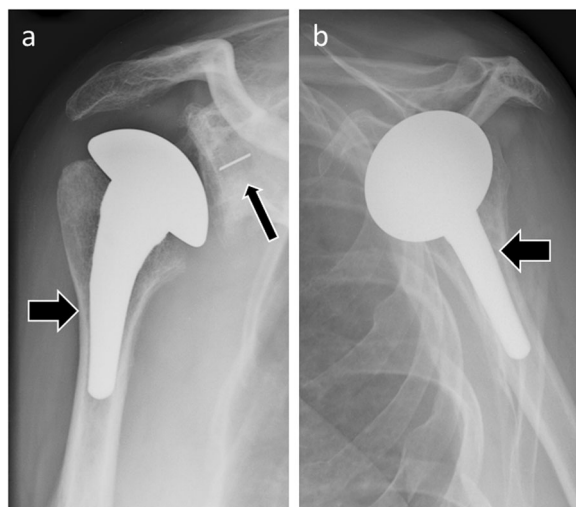
Fig. 3 Anteroposterior (a) and scapular Y (b) radiographs of normal findings in a patient with total shoulder arthroplasty. The humeral prosthetic stem (thick arrows) is centered within the humeral shaft. The humeral prosthetic head is centered within the glenoid implant (thin arrow), with a smooth arc between the cortex of the medial humeral calcar and that of the inferior glenoid and scapular neck

On normal postoperative radiographs, the glenoid component should have 0° version and inclination. The humeral head component is centered within the glenoid component, with a smooth arc between the cortex of the medial humeral calcar and that of the inferior glenoid and scapular neck. The humeral prosthetic stem should be centered within the humeral shaft [8] (Figs. 3 and 4).

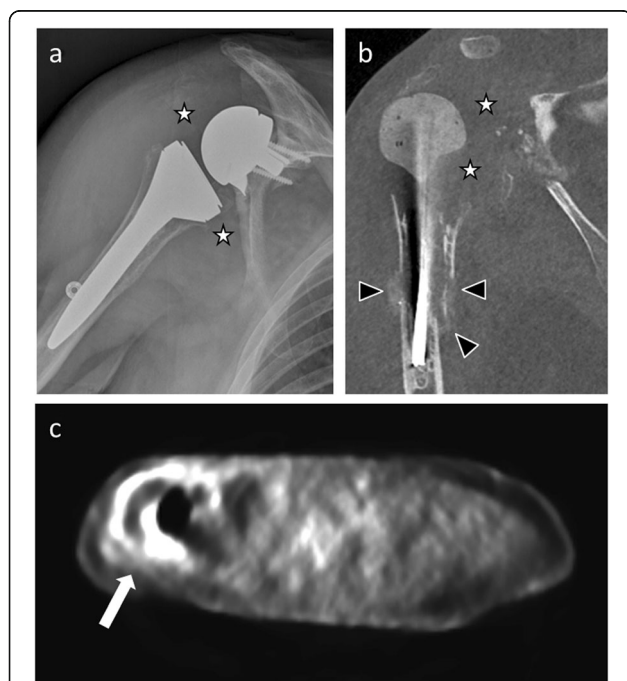
Fig. 6 **a** Anteroposterior radiograph of a 73 years-old man with periprosthetic joint infection shows a soft-tissue thickening (white stars) around the reverse shoulder arthroplasty. **b** Coronal CT image of the same patient as in **a**, immediately after surgical revision and placement of a spacer, shows the same soft-tissue thickening (white stars), focal cortical losses, and periosteal appositions (arrowheads). **c** Axial FDG-PET image of the same patient as in **a** before surgery shows abnormal uptake around the prosthesis

On radiographs, infection can result in progressive irregular lucency around the prosthesis and periosteal appositions. Unfortunately, these signs appear at an advanced stage of the disease. Cross-sectional imaging techniques, such as CT and MRI, add often limited value in the presence of metallic prosthetic implants owing to beam-hardening and dephasing artifacts. Nuclear medicine studies may be used to investigate these patients. The two oldest radionuclide imaging modalities used for this purpose are bone scintigraphy and gallium citrate scintigraphy. ^{111}In white blood cell (WBC) imaging in

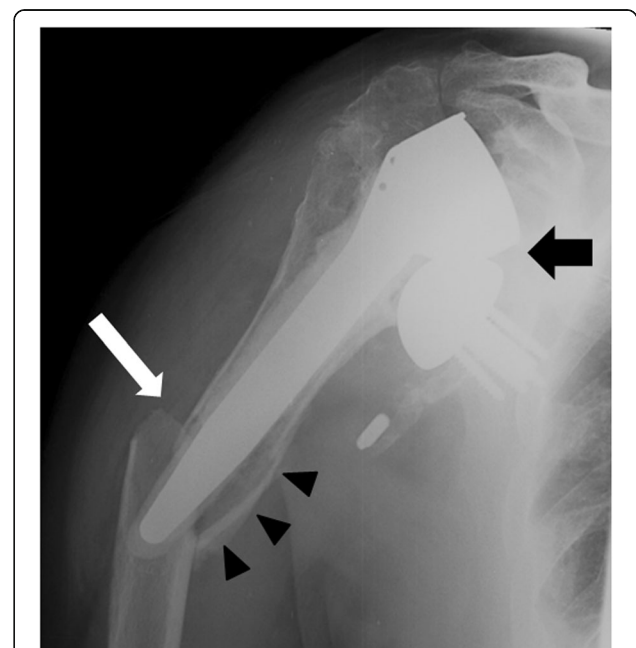
Fig. 7 Anteroposterior radiograph of a 73-year-old man shows a periprosthetic fracture (white arrow) and a complex glenohumeral dislocation (black arrow). Note that there was previously a stress shielding manifested by cortical thinning and radiolucency area around the distal humeral stem (arrowheads)

Osteoporosis could be a risk factor for stress shielding [28], as well as the relative stem size. Indeed, proximal stress shielding decreases with the use of short stems in total shoulder arthroplasty [29]. Radiographically, stress shielding is manifested by cortical thinning and increased central areas of radiolucency, reportedly more frequently in the proximal lateral humerus (Fig. 7).

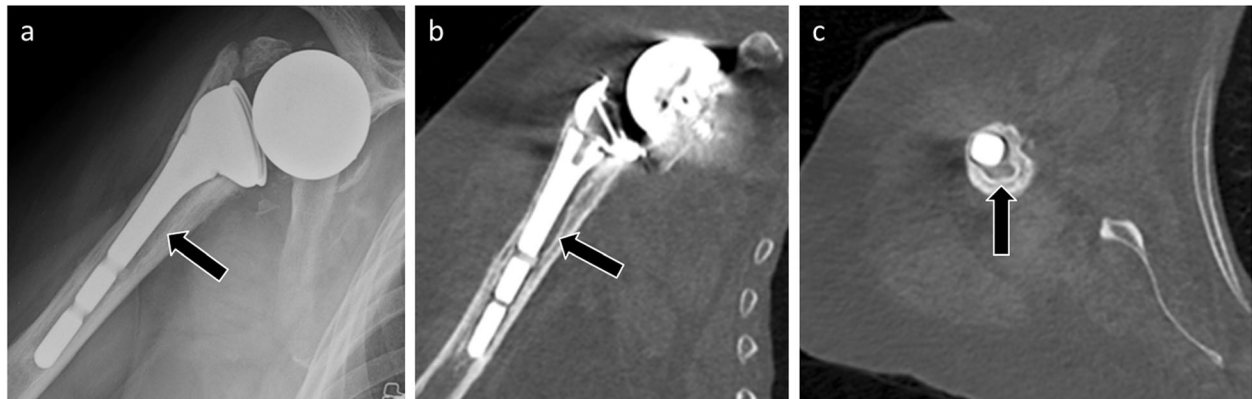
Fig. 8 Anteroposterior radiograph (a) and coronal (b) and axial CT (c) images of a 79-year-old woman with humeral component loosening manifested by an irregular radiolucent line > 2 mm around the prosthetic stem (arrows)

Radiological diagnosis of humeral component loosening is based on research and analysis of periprosthetic humeral radiolucent lines. By analogy with the hip arthroplasties, Sperling described eight zones bordering a humeral implant. A humeral component is considered "at risk" when a radiolucent 2-mm-wide line or greater is present in three or more of the eight zones [32] (Fig. 8). Humeral implant tilt or subsidence sign loosening as well.

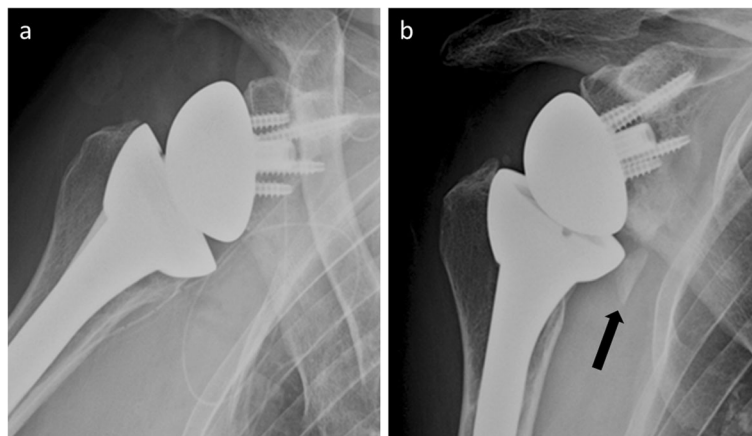
Fig. 9 Anteroposterior shoulder radiographs of an 84-year-old woman with reverse shoulder arthroplasty. a Normal postoperative radiograph. b One year later, radiograph shows heterotopic ossification (arrow), with the patient asymptomatic

is well analyzed in standard radiography (Fig. 9) and CT can provide more precise information on the anatomical location of bulky ossification that would be disabling.

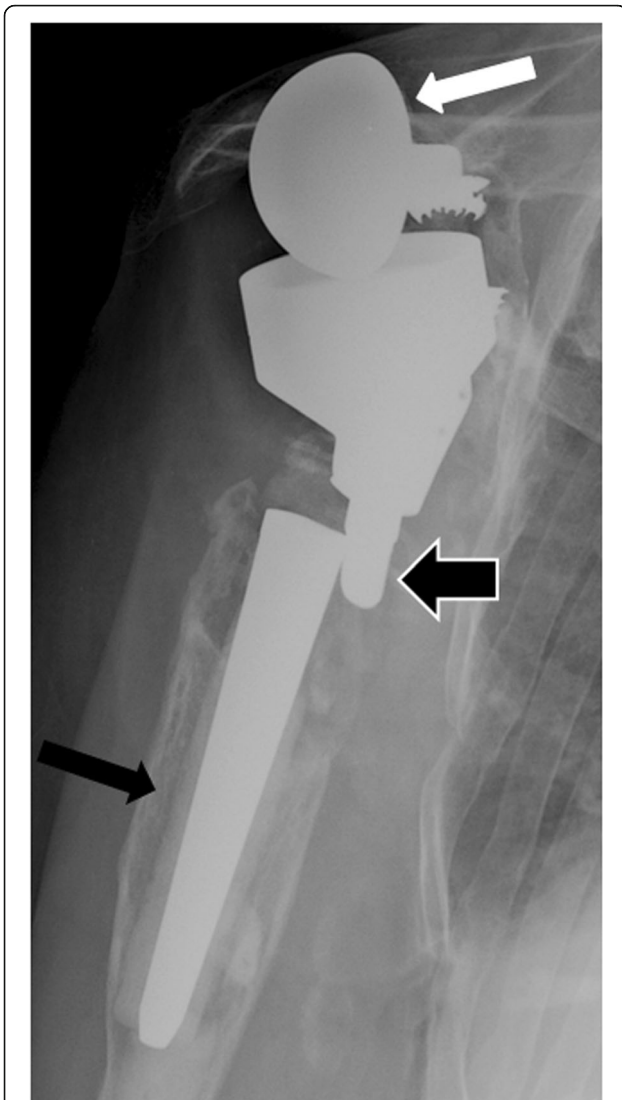
Fig. 10 Anteroposterior radiograph of a reverse shoulder arthroplasty in a 73-year-old patient shows humeral implant disjunction with unscrewing of the two components (thick arrow). This is secondary to both humeral loosening resulting in chronic abnormal mobility of the implant (black thin arrow), and glenoid loosening with the glenoid component “wedged” under the acromion (white thin arrow)

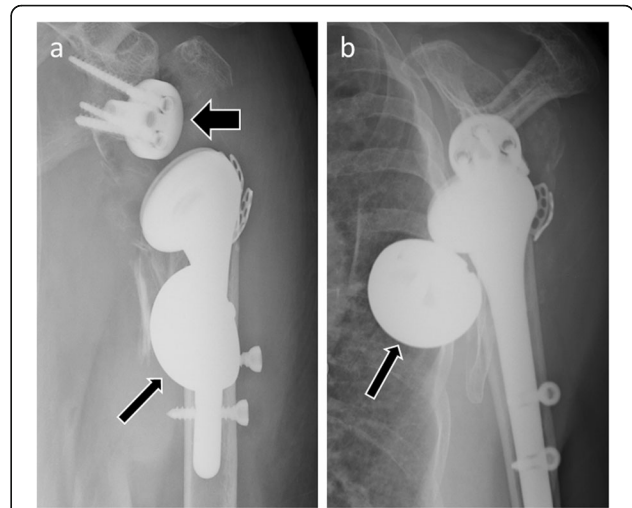
Fig. 11 Anteroposterior (a) and scapular Y (b) radiographs of a 87-year-old woman, with reverse shoulder arthroplasty placed 4 days earlier, show glenosphere anterior-inferior dislocation (thin arrows). Note the emptiness of the metaglene (thick arrow)

Implant failure is a rare complication, but usually imposes surgical revision. Subluxation or dislocation of polyethylene inlays, broken fixation screws, fracture of the keel or metal glenoid backing, dissociation of the polyethylene glenoid insert from its metal tray, dislocation of the humeral component (Fig. 10), and dissociation of the glenosphere from its metaglene (Fig. 11) can be observed. All these situations usually require surgical revision.

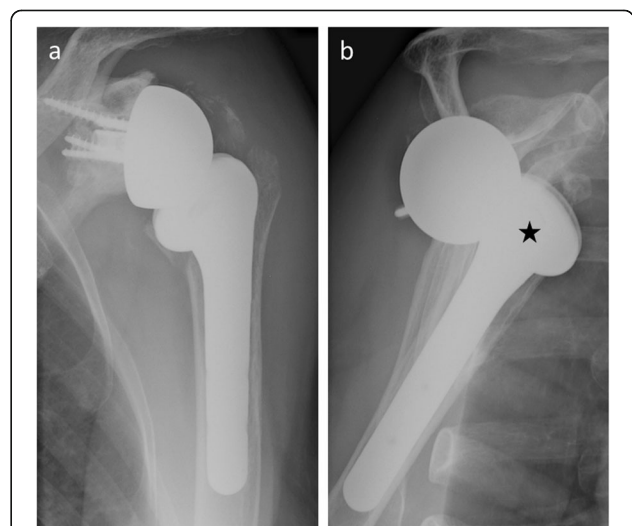
Fig. 12 Anteroposterior (a) and scapular Y (b) radiographs of a 76-year-old woman with reverse shoulder arthroplasty (2 months after surgery) show an evident anterior dislocation (star) in scapular Y view. Note that this dislocation is difficult to highlight on anteroposterior view

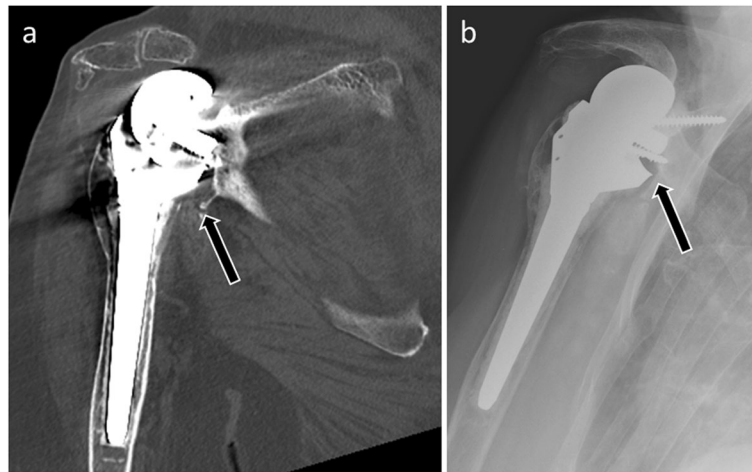
Fig. 13 Coronal CT image (a) and anteroposterior radiograph (b) of an 89-year-old patient with painful reverse shoulder arthroplasty show scapular notching manifested by bone resorption of the inferior scapular border (arrows)

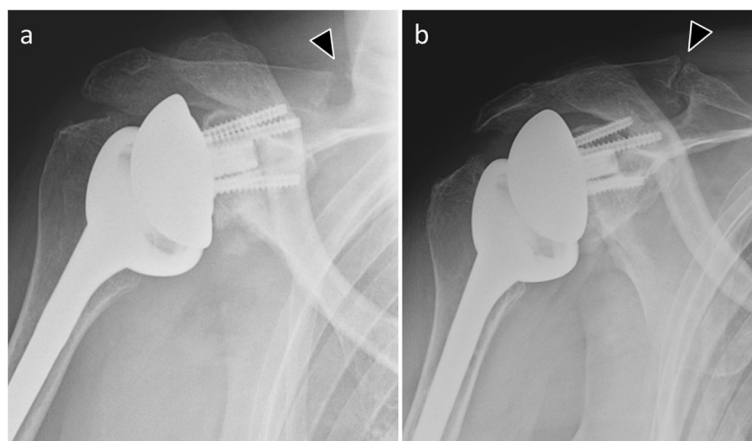
Fig. 14 Anteroposterior radiographs of a 67-year-old woman with reverse shoulder arthroplasty. a Radiograph shows a proximal scapular spine fracture (arrowhead). b This fracture is more visible after a few weeks due to pseudoarthrosis (arrowhead)

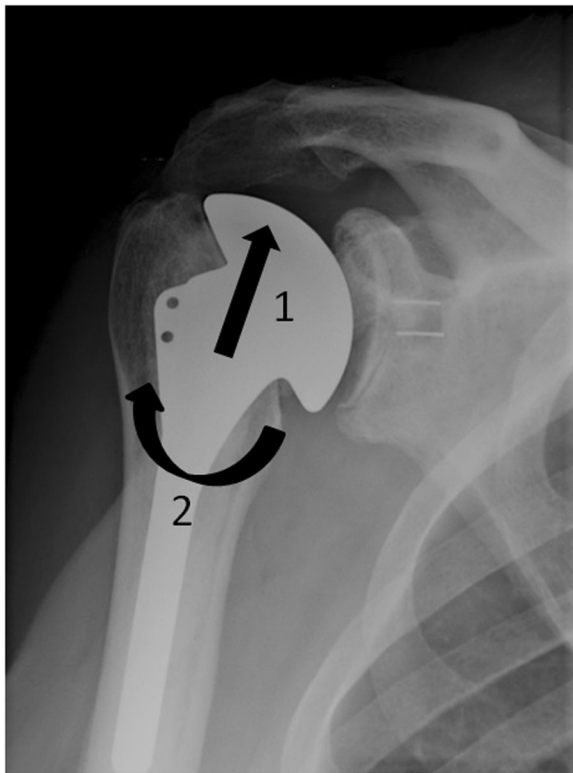
Fig. 15 Anteroposterior shoulder radiograph in a patient with total shoulder prosthesis shows the “rocking horse” effect: a superior humeral migration (arrow 1) associated with repetitive abduction movement (arrow 2) may generate superior tipping of the glenoid component favoring glenoid loosening

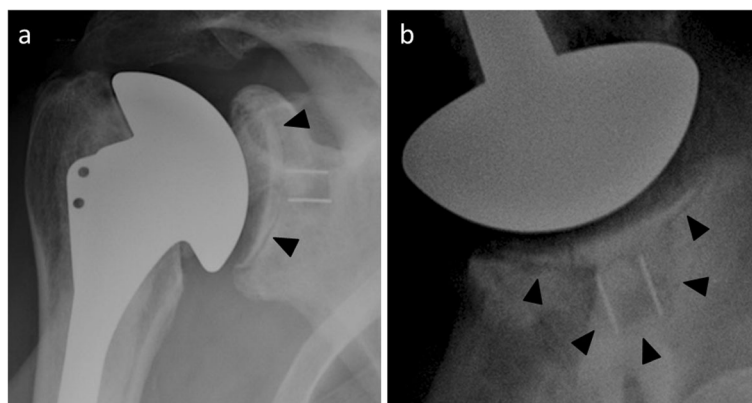
Fig. 16 Anteroposterior (a) and axillary (b) radiographs in a 66-year-old man with shoulder pain show a complete radiolucent line around the glenoid component revealing glenoid loosening

Radiographically, glenoid loosening is defined as glenoid component migration, tilt, or shift or as a complete radiolucent line more than 1.5 mm thick [17] (Fig. 16). Predictive radiological scores of loosening have been described; the most commonly used is the Molé score [47]. This score (maximum at 18) is applied to the analysis of 6 zones around the glenoid component, with allocation of 1 to 3 points depending on the

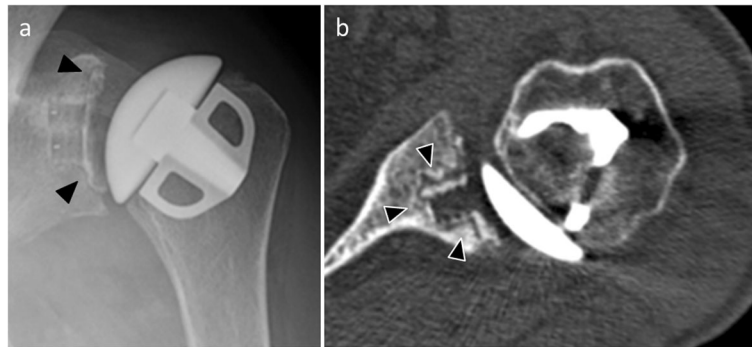
Fig. 17 **a** Anteroposterior shoulder radiograph of a 61-year-old man with total shoulder arthroplasty shows a radiolucent line around the glenoid component (black arrowheads). **b** Axial CT image in the same patient as **a** allows a more precise analysis of this radiolucent line (black and white arrowheads).

CT is more sensitive than conventional radiography to detect and analyze the radiolucencies around the glenoid component (Fig. 17). This imaging modality is also more reproducible [48]. Gregory described a specific patient position to reduce the hardening artifacts that may interfere with the glenoid loosening assessment: patient in lateral decubitus to three-quarter decubitus position, allowing the scapula to tilt and the shoulder to be in maximal forward flexion [49].

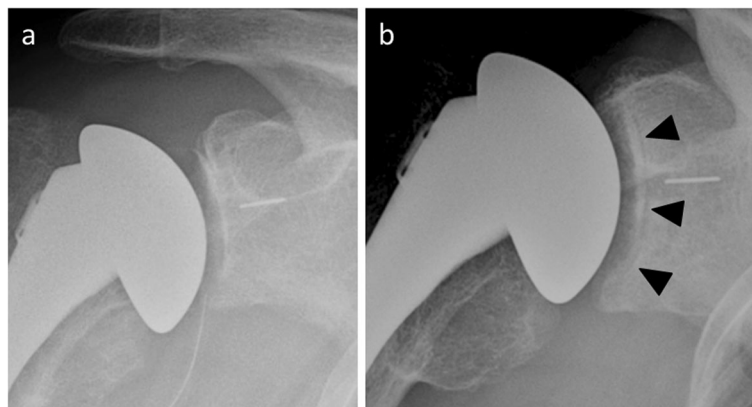
Fig. 18 **a** Normal postoperative anteroposterior shoulder radiograph of a 51-year-old man with total shoulder arthroplasty. **b** Anteroposterior radiograph in the same patient as **a** 4 years later shows a radiolucent line around the glenoid implant (arrowheads), while the patient is asymptomatic

The correlation between glenoid component loosening and radiolucencies is discussed. Indeed, incomplete periprosthetic radiolucent lines or radiolucent lines less than 1.5 mm thick are commonly seen (Fig. 18). Asymptomatic radiolucent lines occur at a rate of 7.3% per year after primary shoulder replacement [50]. In addition, while keeled glenoid components have greater rates of asymptomatic radiolucent lines compared with pegged glenoid components [50], pegged components are associated with a lower revision risk compared with keeled components [51]. This inverse relationship is similar between all-polyethylene components and metal-backed components [52]. Therefore, the interpretation of such radiological abnormalities must be confronted with clinical data and the

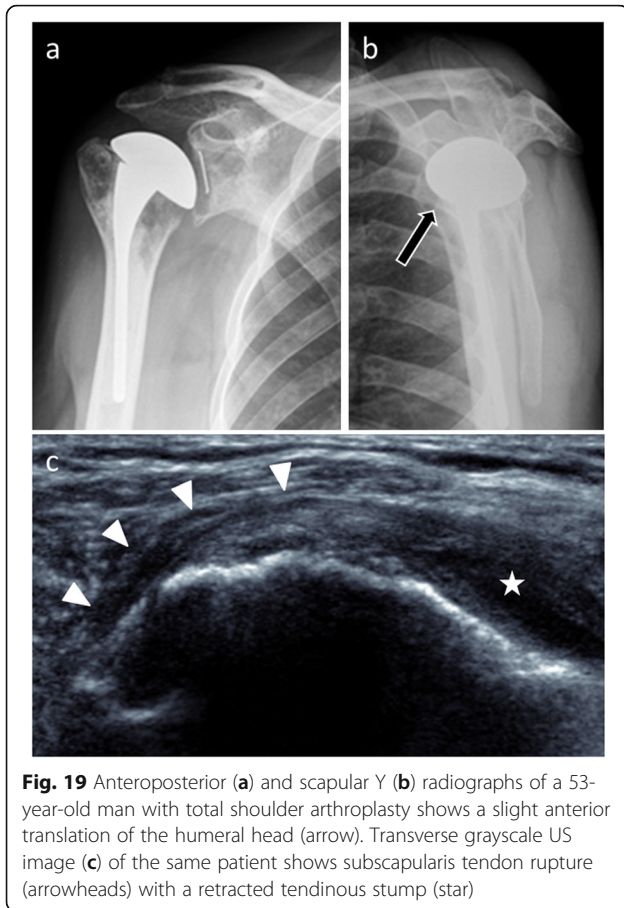
Fig. 19 Anteroposterior (a) and scapular Y (b) radiographs of a 53-year-old man with total shoulder arthroplasty shows a slight anterior translation of the humeral head (arrow). Transverse grayscale US image (c) of the same patient shows subscapularis tendon rupture (arrowheads) with a retracted tendinous stump (star)

In imaging, ultrasonography helps diagnosis when it directly visualizes the tear [11] (Fig. 19). MRI also contributes to this as long as susceptibility artifacts do not interfere with interpretation. In CT, rupture usually

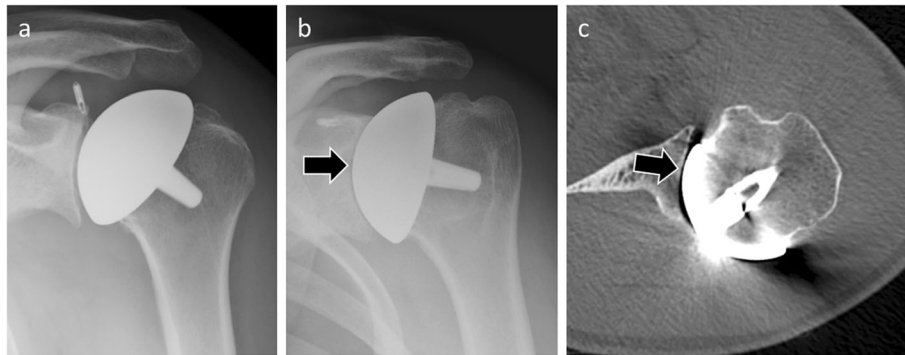
Fig. 21 **a** Anteroposterior radiograph of a 36-year-old man with humeral head resurfacing arthroplasty. Anteroposterior radiograph (**b**) and axial CT image (**c**) in the same patient as **a**, 7 years later, show native glenoid wear manifested by narrowing of the glenohumeral spacing (arrows)

The unique specific complication of the partial shoulder joint replacement is the progressive wear of the native glenoid. Indeed, replacement of the humeral head modifies biomechanical constraints on the glenoid, leading to the long-term development of osteoarthritic remodeling. In this case, prosthetic revision will then be proposed, with, generally, conversion to total shoulder arthroplasty. The radiological diagnosis will be made on the successive standard radiographs, showing a progressive narrowing of the glenohumeral spacing over a few months, associated with posterior glenoid wear [54] (Fig. 21).
