Evaluating watershed management activities of campaign work in Southern nations, nationalities and peoples' regional state of Ethiopia

Kebede Wolka Wolancho

Background: The Ethiopian government has been implementing watershed management mainly through public campaign work. However, its effects have not been evaluated in many micro-watersheds. This study evaluates watershed management activities and its socio-economic and biophysical role.

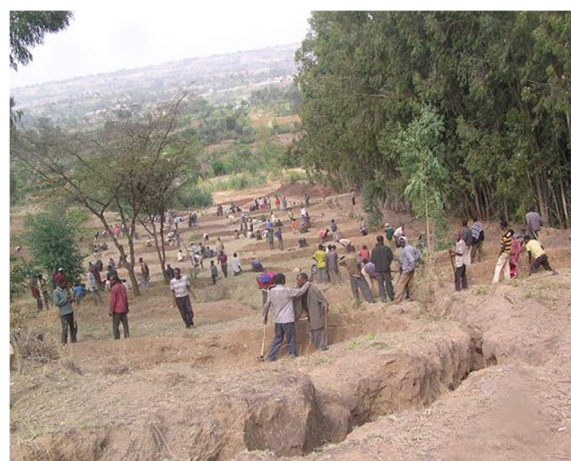
Figure 2 Public campaign workers building soil and water conservation measures in Hanja Chafa kebele, Chafa micro-watershed.

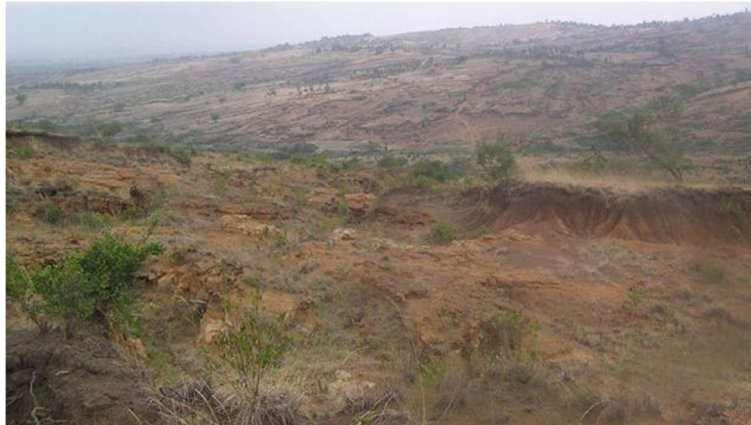
Figure 4 Partial view of abandoned degraded land in Kota Kombola kebele, waiting for watershed management.

In Kota Kombola kebele, there is significantly big degraded and abandoned area (Figure 4), which requires huge investment than the local labor. This challenges the community to achieve watershed management for entire kebele within few years. In all considered kebeles, the achievement data obtained from records/reports did not fit the amount of activity audited in many micro-watersheds. This also needs serious attention and discussion with the concerned institutions.

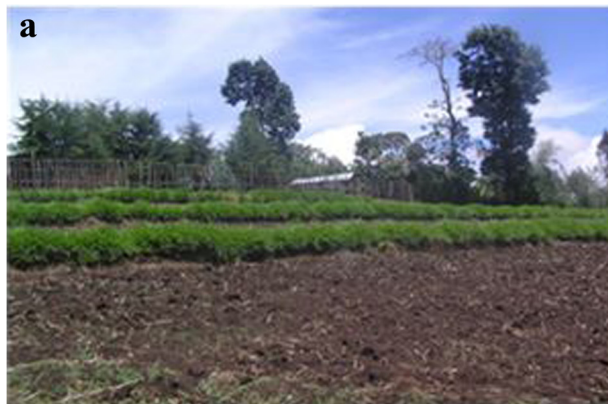
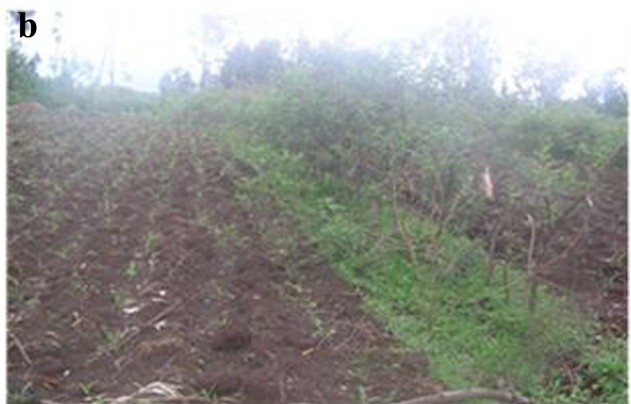
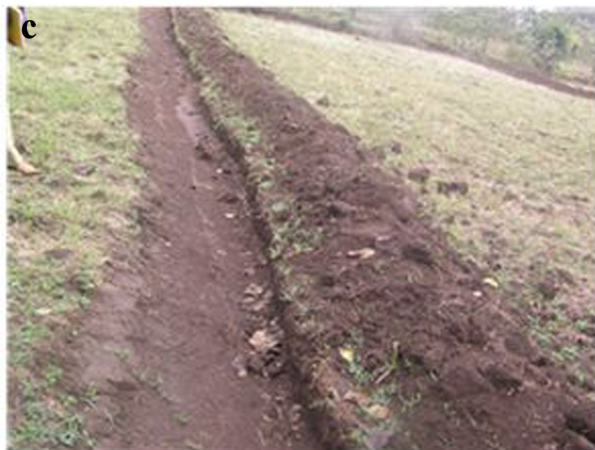
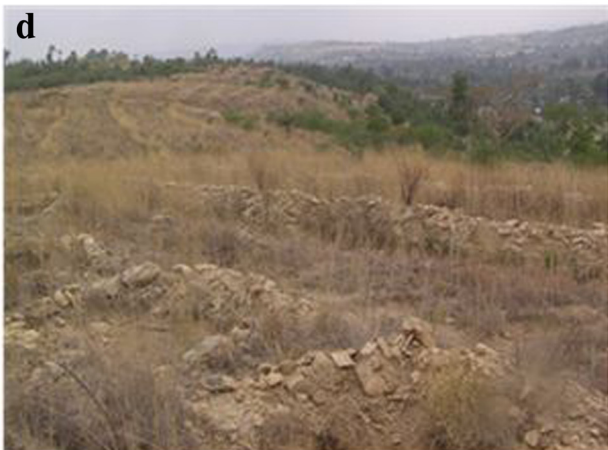
Figure 5 (a) Introduced fodder grass in zobcho kebele (b) *cajanus cajan* in Gendo Walcha kebele (c) typical soil bund modified to reduce the land occupied by it in Gede Genet kebele (d) exemplary rehabilitated land by watershed management in Hanja Chafa kebele.

has been achieved by planting seedlings in pits filled with forest soil and imported compost. The area serves as a model for tree seedling planting on poor land. In Gede Genet, Bucha and other kebeles the farmers modified the soil bunds to reduce the area of land occupied by the structure (Figure 5c). The effectiveness of this new design is still being tested. In most micro-watersheds, farmers attempt to make the embankment of structures productive by growing fodder grass (Figure 5a) and *cajanus cajan* (Figure 5b).
