Longevity of dams from landslides with sub-channel rupture surfaces, Peace River region, Canada

Background: We examined seven landslide dams and their changes over time in the Peace River region of Canada. These landslides had subchannel rupture surfaces in glacial and glaciolacustrine sediments. We assessed the stability of the dams using 6 separate, morphometric-based stability indices (with a total of 10 stability thresholds).

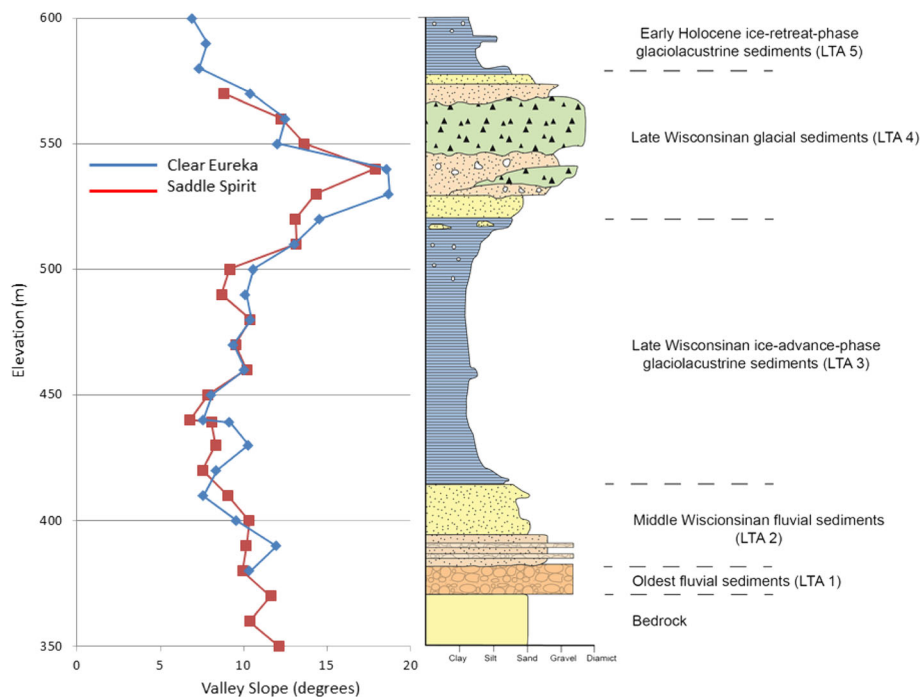
Fig. 2 Generalized stratigraphy found within buried preglacial valleys in the Peace River lowlands (right; modified after Morgan et al. 2012), and (left) average valley slopes of the lower Clear River (to the Eureka River) and the Eureka River (blue), and the lower Saddle River (to the Spirit River) and the Spirit River (red). Five of the landslides described appear to be associated with ice-advance -phase glaciolacustrine sediment (LTA3), and two with the lower portion of the glacial sediments (LTA4). The valley slopes appear to reflect the stratigraphy. The slopes are lowest where the rivers are incising through LTA3 or LTA5, and steepen where the river incises into LTA4. Note that thickness of LTA4 has been exaggerated in this diagram, as the diamict is not topography constrained and will impact the valley slope response to incision over a longer distance than the unit thickness would otherwise suggest

Figure 2 plots variable valley slopes (normal to valley axis) against the regional stratigraphy for segments of Clear and Eureka rivers, and the Saddle and Spirit rivers. The top of the plots represent the valley slope angles associated with stream incision into the uppermost

sedimentary unit, at the upper reaches of the streams; whereas, the bottom of the plots represent slope angles from stream incision through the entire sedimentary sequences. Postglacial stream incision through the stratigraphic sequence in Fig. 2 may have progressed as follows:

- Initial incision through the uppermost glaciolacustrine sediments (LTA5), resulting in slope angles from 5 to 10 degrees.
- Subsequent incision into the more stable glacial sediment (LTA4), resulting in slope angles of up to 18-degrees.
- Further incision into the advance-phase glaciolacustrine sediment (LTA3), where slopes decrease to as low as 6 degrees.
- Final incision into the lower fluvial units (LTA1 and 2) and into bedrock, where slopes increase to near 10 degrees.

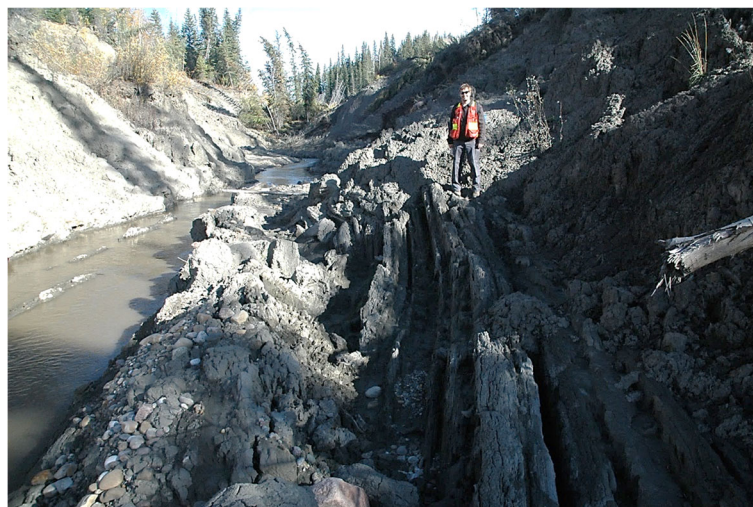
Fig. 3 Upthrust advance phase glacial lacustrine sediment (LTA3) at the toe of the Eureka River landslide. The reorientation of the lacustrine rhythmites to near vertical, was likely caused by the landslide. Note the scattering of boulders and cobbles at discrete locations. This material likely originated in the pre-landslide channel and was introduced into the post-landslide channel by bank erosion. Also note the small landslide into the channel in the distance. (Source: BGN Miller, September 28, 2007)

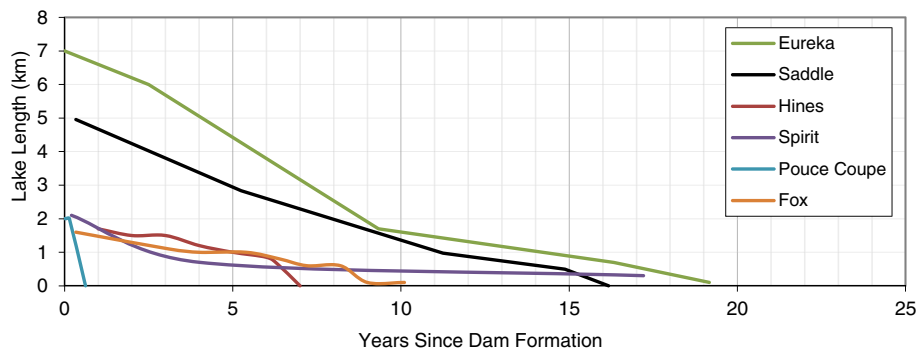
Fig. 4 Changes in the lengths of 6 landslide lakes over time, since the formation of the landslide dams. The data used to derive these curves forms Table 2. The lake lengths go to unity through a combination of incision into the landslide dams and sediment infilling of the basins

The following provides a description of seven landslide dams and their development over time (Tables 1 and 2, Fig. 4).

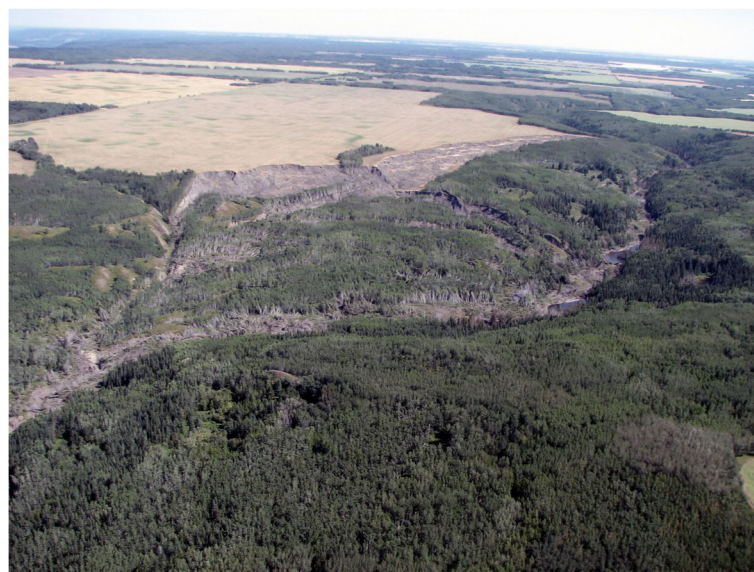
Fig. 7 Oblique air photo of the 2007 Fox Creek landslide, dam and lake, looking upstream. Note that much of the timber atop the landslide remained upright. (Source: Alberta Geological Survey, 2009; reproduced with permission)

The May 5, 2007 Fox Creek landslide was a rapid translational block slide involving about 47Mm³ of Quaternary sediments (Kim et al. 2010; Fig. 7). The basal rupture surface of the landslide, in advance-phase glaciolacustrine

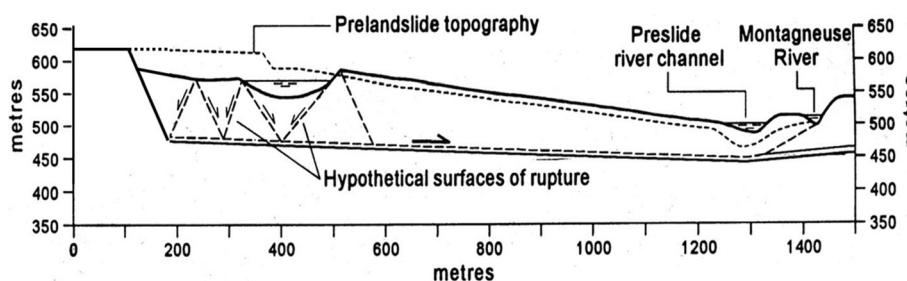
Fig. 9 Cross-section of the Montagneuse River landslide and dam. (Modified from Cruden et al. 1997)

landslide volume (V_D becomes V_{D10} in Table 3). Based on cross-sectional profiles through the described landslides and dams, we found that only approximately 10% of the landslide volume goes into forming the dams. Figure 9 provides an example of the typical landslide and dam configuration in the Peace River region. Figure 9 shows that only a very small portion of the landslide is involved in the stream obstruction, with most of the landslide remaining out of the valley bottom.

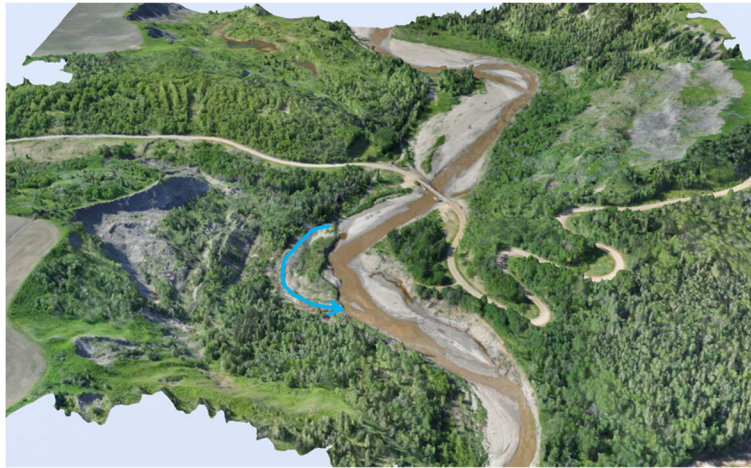
Fig. 10 Oblique aerial image mosaic of drone imagery, from June 2017, draped over a photogrammetrically generated digital elevation model depicting the Pouce Coupe River, and Landry Road and bridge (Source: Government of British Columbia; reproduced with permission). The 2013 landslide and dam are visible in the lower left. The approximate trace of the pre-landslide Pouce Coupe River channel is the blue line. The post-landslide stream channel cut through a point bar attached to the opposite stream bank, abandoning the pre-landslide channel

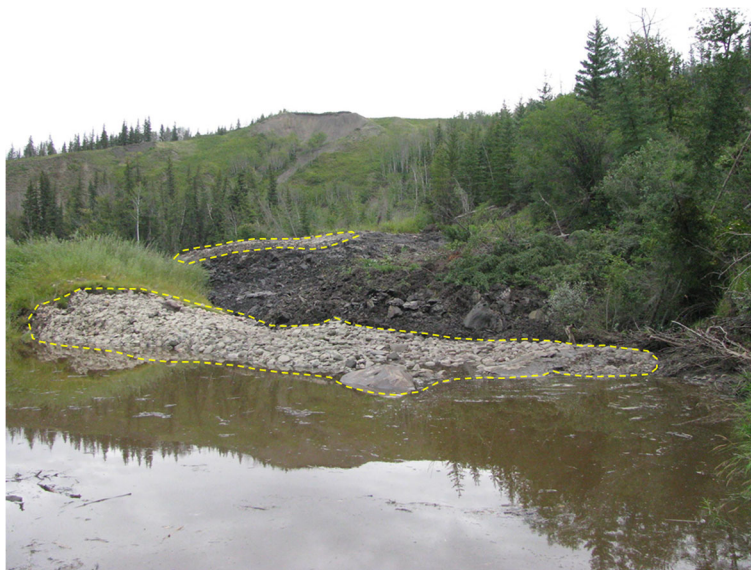
Fig. 11 The 2013 Pouce Coupe River landslide and dam, captured at the Landry Road bridge, looking downstream. The yellow polygons delineate uplifted channel alluvium. (Source: British Columbia Ministry of Transportation and Infrastructure, August 22, 2013; reproduced with permission)

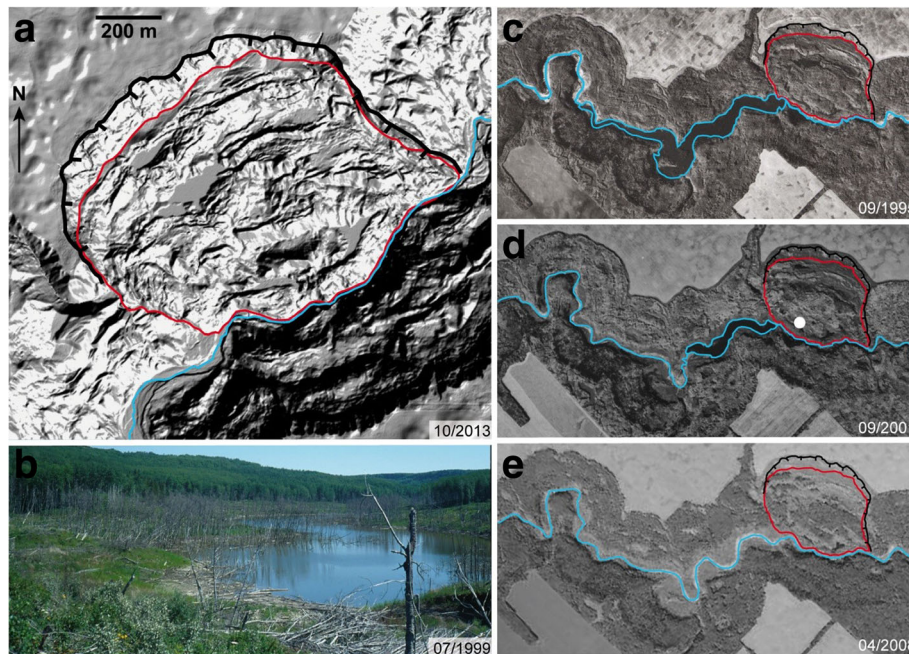
Fig. 12 The Saddle River landslide and dam. **a.** Digital Elevation Model derived using 2 m lidar data (dated October 22, 2013; source: Government of Alberta, reproduced with permission) showing the 1990 landslide colluvium (outlined in red) and main scarp (black). **b.** The landslide lake in July 1999. Note the drowned timber within the landslide dam basin. (source: BGN Miller, July 1999.) **c – e.** Time series of aerial photographs showing the landslide dam lake in September 1995 and 2001, and the drained basin in August 2006 (air photos AS4680–33, AS5194B–40, and TRSG0602–1536 respectively; source: Alberta Environment and Parks, Air Photo Distribution, Copyright Government of Alberta, reproduced with permission). The white dot in **d** indicates the photograph location of **b**

The June 1990 Saddle River landslide (Fig. 12) was a reactivated, retrogressive earth slide (Cruden et al. 1993). The landslide rupture surface, in advance phase glaciolacustrine sediment (LTA3), extended under the Saddle River, causing the streambed to be displaced southwards by 60 m and upwards by approximately 24.5 m, creating a Type VI landslide dam (Cruden et al. 1993; Alberta 1997). The volume of water retained behind the dam was estimated at approximately 4Mm³ (McClung and Weimer 1990).

encountered the pre-landslide channel alluvium (Cruden et al. 1993). The alluvium was later bypassed when the channel widened (Hansen 1994). Continued incision into the dam was accompanied by progressive shortening of the lake (Table 2, Figs. 12, 13). By August 13, 2006, the lake had fully drained.

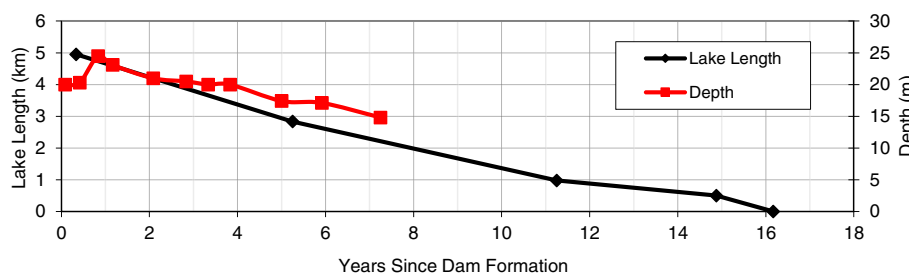
Fig. 13 Changes in the length and depth of Saddle River landslide lake since formation in June 1990. The depth data was derived from a bathymetry survey (Alberta 1997). The initial increase in the lake depth records basin flooding prior to the dam being overtopped

Overtopping of the dam began during the annual spring freshet of 1991 (Hanson 1994; Fig. 13), when a new channel formed at the toe of the landslide. Incision was slowed near the upstream edge of the dam, where the stream
