Chapter 15

Conservation Principles and Performance Based Strengthening of Heritage Buildings in Post-event Reconstruction

Dina D’Ayala

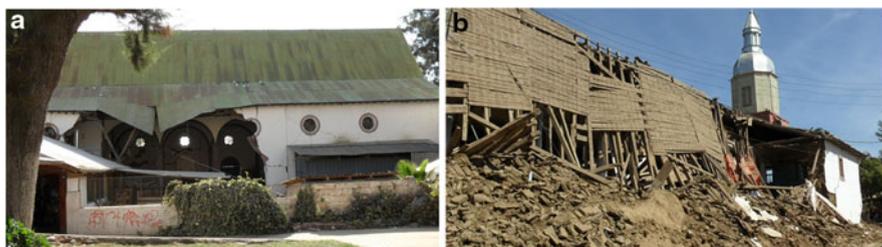
Fig. 15.1 (a) Church in Lalol, Colchagua, Chile. Collapse of the lateral adobe wall, strengthened by shotcrete. (b) Church in Curepto, Maule, Chile. Collapse of the lateral adobe wall, strengthened by shotcrete

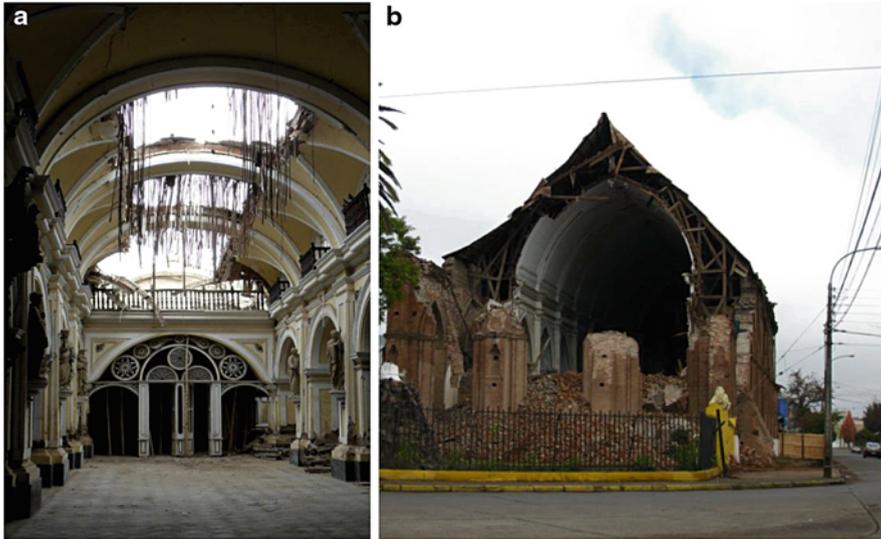
Fig. 15.2 (a) Ica cathedral, (Peru') collapse of the timber barrel vaults. (b) Collapse of the brickwork façade of the Church San Francisco of Curico', revealing the timber structure supporting the roof. Maule, Chile

The first two points highlight the out-of-plane rocking and in plane shear, respectively, of the lateral walls. All other observations describe failures of connections among macro-elements and resulting partial or total collapse. In churches with lateral aisles created by pillar-and-arch timber frames, the author observed failures due to excessive displacement of the internal pillars and collapse of the supported vaulted roof (Fig. 15.2a).

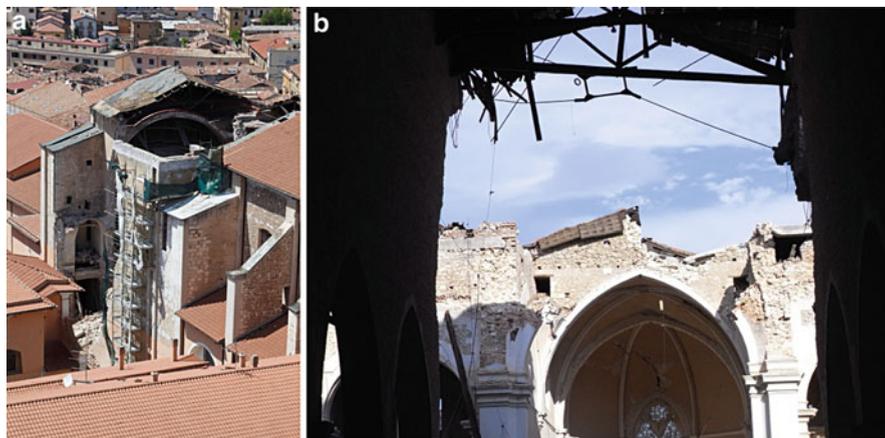
Fig. 15.3 (a) Cathedral of L'Aquila, Italy; (b) The basilica of Collemaggio in L'Aquila, Italy

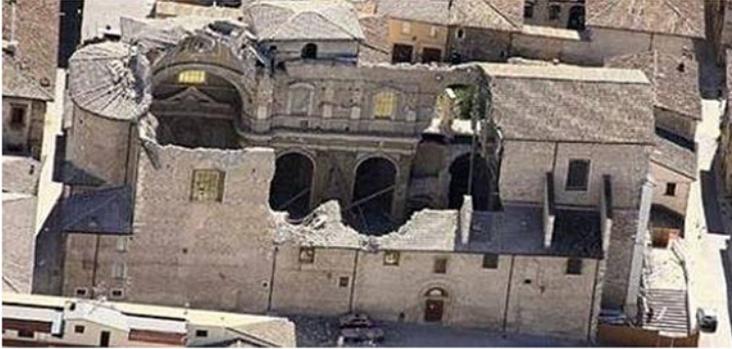
Fig. 15.4 Collapse of the roof and vaults of the church of Santa Maria Paganica, L'Aquila

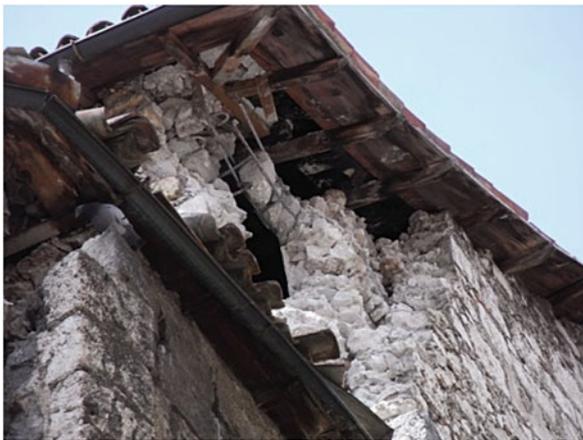
Fig. 15.5 Partial collapse and evidence of a reinforced masonry ring beam in the Church of Santa Giusta in L'Aquila

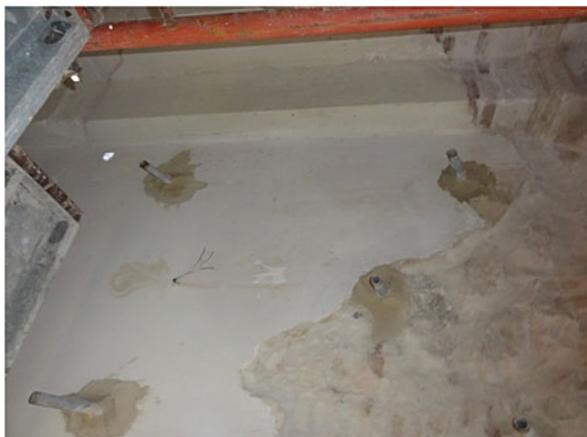
Fig. 15.6 Wall prepared for grout injection

such additives might improve the short term strength and cohesion of the masonry, they can create serious long term problems in terms of decay of the original materials due to different hygro-thermal behaviour and salt content release. One of the major issue is that such interventions are not directly monitorable. One way of verifying their effectiveness is to conduct flat jack tests of the masonry wall, before and after strengthening, although this is partially destructive.

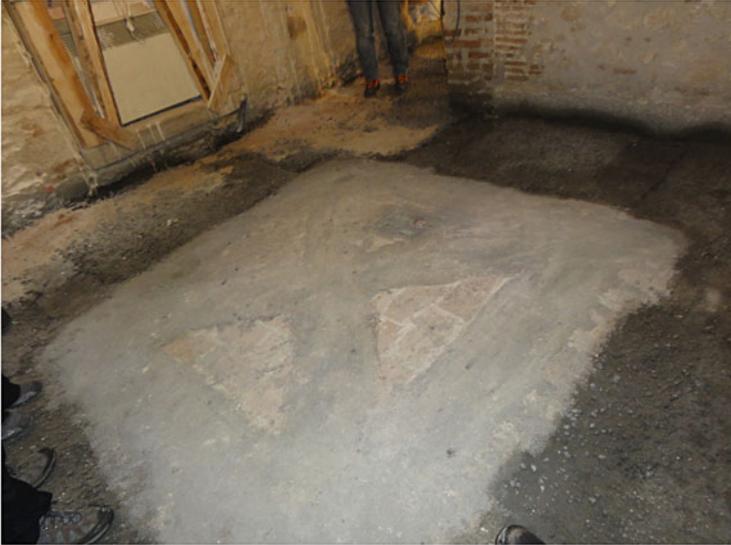
Fig. 15.7 Reinforcement of a cross vault with strips of FRP laid at the extrados

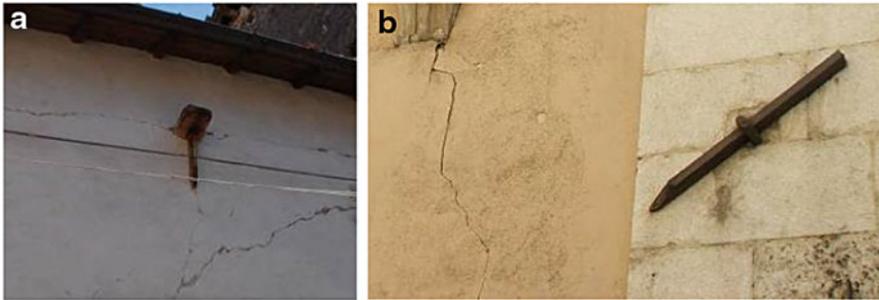
Fig. 15.8 Two examples of traditional reinforcement: (a) timber tie, (b) wrought iron cross tie inserted in a quoin

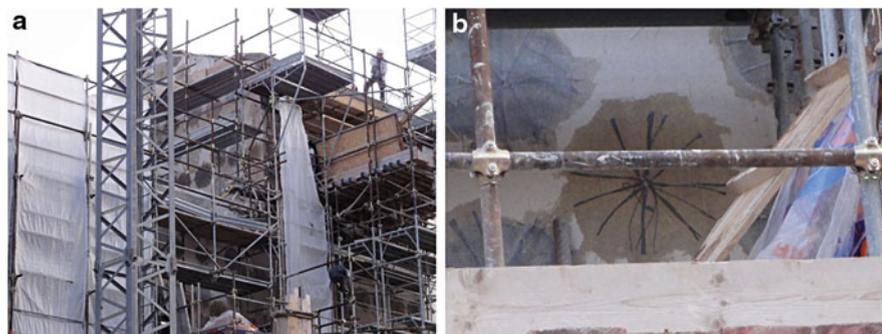
Fig. 15.9 Extensive use of reinforced coring with grouted injection with epoxy resins on the end wall of a 5 storey residential palace in the historic centre of L'Aquila

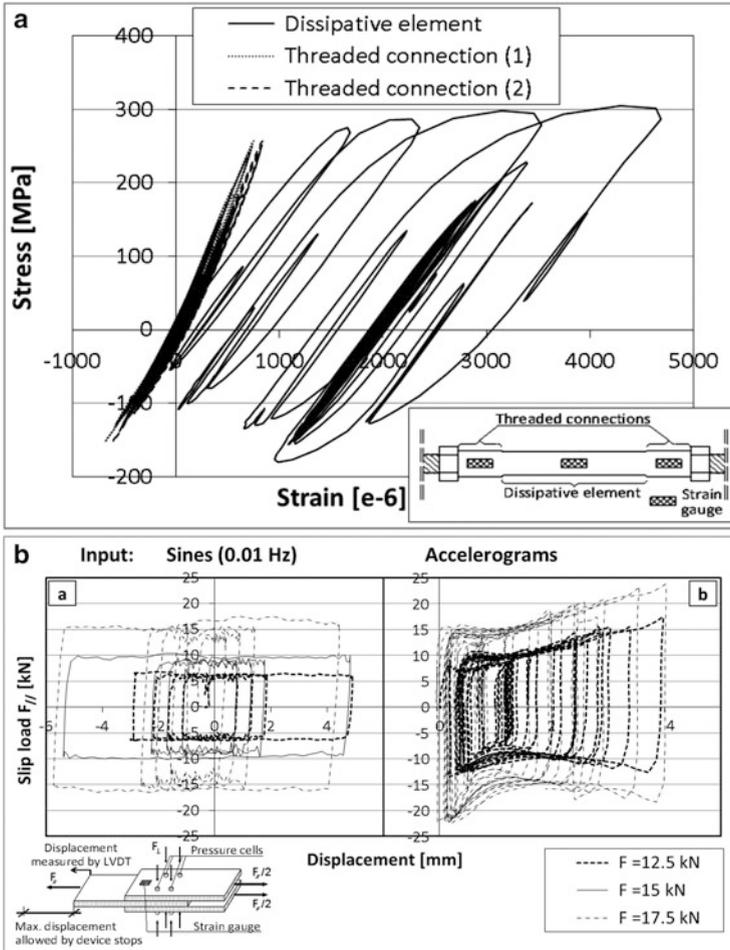
Fig. 15.11 Devices' response to accelerogramme excitation (a) hysteretic device and (b) friction device

The two dissipative devices, covered by patents, have been extensively validated by cyclic pseudo-static and dynamic tests on the isolated devices (Paganoni and D'Ayala 2010), and by cyclic pull-out tests on specimens modelling the T joint between two perpendicular walls connected by a passing anchor (D'Ayala and Paganoni 2014). The devices' performance has then been calibrated by using real time history obtained by obtaining from a finite element nonlinear analysis the relative motion at the crack of two orthogonal walls of a two storey house subjected to a real accelerogram from the L'Aquila earthquake. The response of the two devices is shown in Fig. 15.11.
