Research on Heavy-Rainfall-Induced and Hydraulic-Driven Geological Hazards in China (WCoE 2014–2017)

Yueping Yin, Yongqiang Xu, and Wenpei Wang

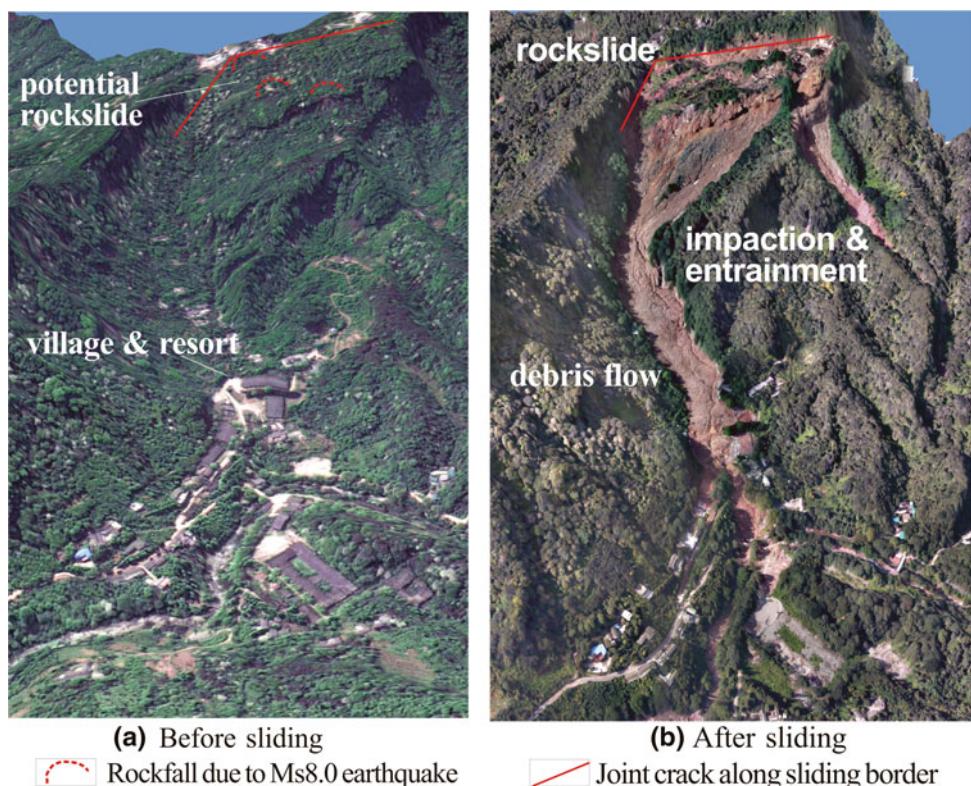
Fig. 1 3D images showing catastrophic rockslide-debris flows at Sanxicun, in the Wenchuan earthquake region (red dashed line indicates the small rockfall due to Ms 8.0 earthquake)

During July 7–12 of 2013, heavy rainfall occurred in the Wenchuan Ms 8.0 Earthquake area. The 5 days cumulative precipitation in the Dujiangyan area of Sichuan Province was up to 1129 mm, which was rare in previous years and exceeded the mean annual precipitation of 1110 mm over the twenty-five years from 1987 to 2012. The heavy rainfall triggered a rapid and long run-out rockslide in Sanxicun village. Its debris had a volume of 1.9 million m³, and it slid a distance of up to 1200 m, killing 166 people in the village. The Sanxicun landslide was located in Zhongxing Town, Dujiangyan City of Sichuan Province. The site is located at (E103°33'48", N30°54'55"), 68 km from Chengdu City to the east, and 16 km from the Dujiangyan urban district (Fig. 1) (Yin et al. 2016a).

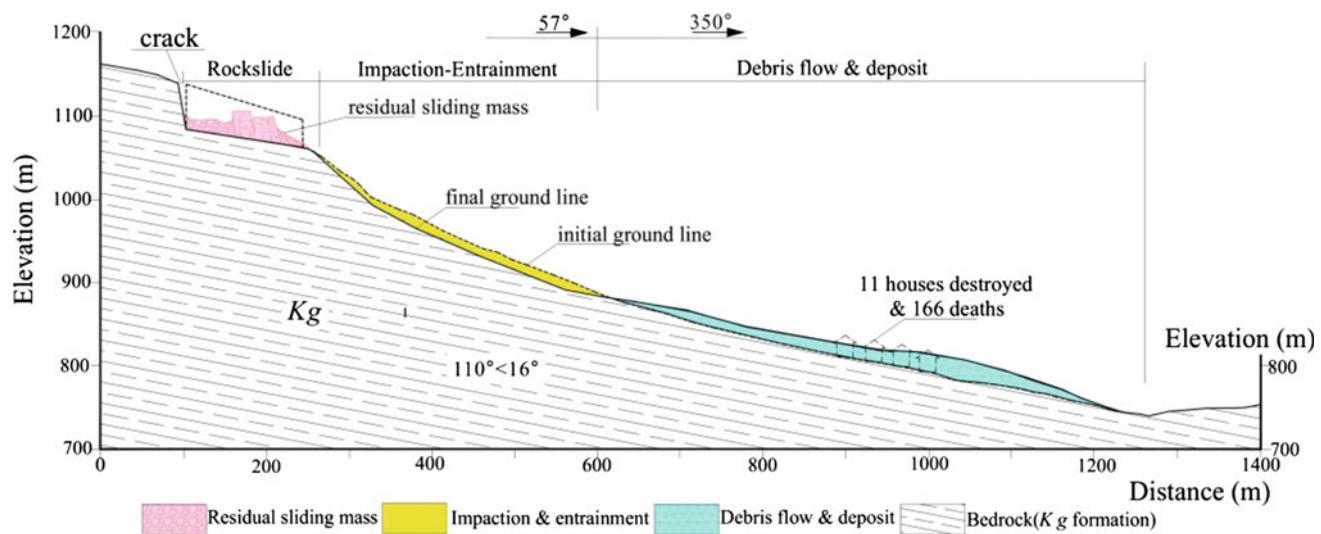
Fig. 2 Longitudinal profile of a rockslide-debris flow at Sanxicun, Wenchuan Ms 8.0 earthquake region

The parent rock of the Sanxicun rockslide is a slightly inclined, nearly horizontal strata sandstone formation with intact rock constituents (Fig. 2). This rockslide was located southwest of the Wenchuan Ms 8.0 Earthquake fault and was only 12 km away from the epicentral region. The seismic intensity in the Sanxicun area was up to degree IX.

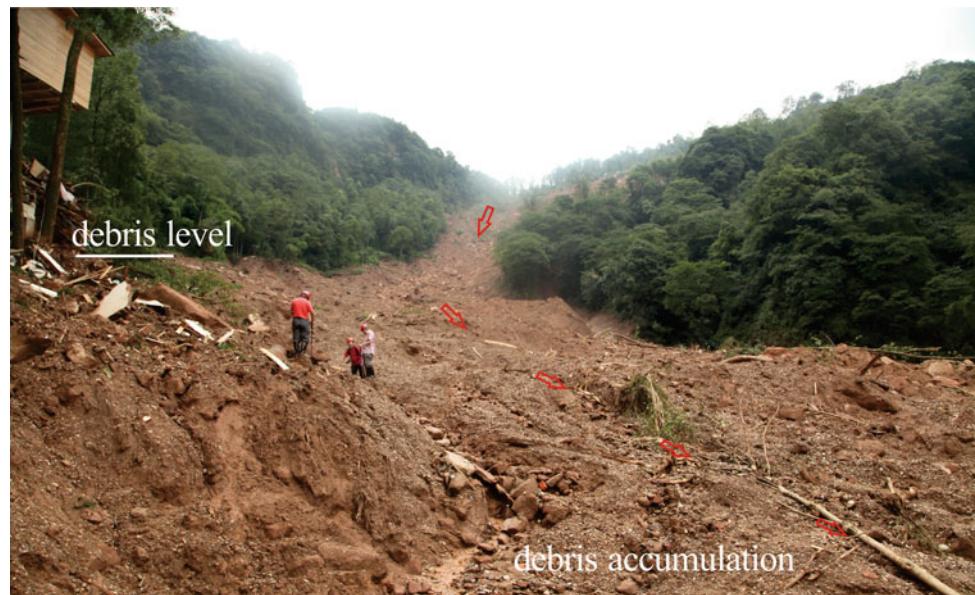
Fig. 3 The debris flow, showing the height difference of about 15 m between the maximum level and the accumulation

Based on the emergency investigation after the Wenchuan earthquake, three small-scale rockfalls were induced. Two rockfalls were at the margin of the slope of the rockslide source area and moved in the direction of NNE10°, and the other was at the southeastern corner and moved in the direction of NWW288°. The rockfalls disturbed or even damaged the slope. Research on this rockslide is significant for post-earthquake geological hazard prevention. Therefore, this project uses the Sanxicun landslide as an example to study the stability of fractured slopes after the Wenchuan Ms 8.0 Earthquake and the formation mechanism of rapid and long run-out rockslides triggered by heavy rainfall. The adverse conditions of the geological features prior to the rockslide are investigated, which provides a scientific basis for classifying hazard areas that should be subject to monitoring and prevention. The slope site was affected by the Wenchuan Ms 8.0 Earthquake in 2008. The sliding involved the thick fractured and layered rockmass with a gentle dip plane at Sanxicun. The formation processes included: (1) toppling due to shear failure at a high-level position,

(2) bulldozing of the accumulative layer below, (3) formation of a debris flow of the highly weathered bottom rockmass, and (4) flooding downward along the valley (Fig. 3).

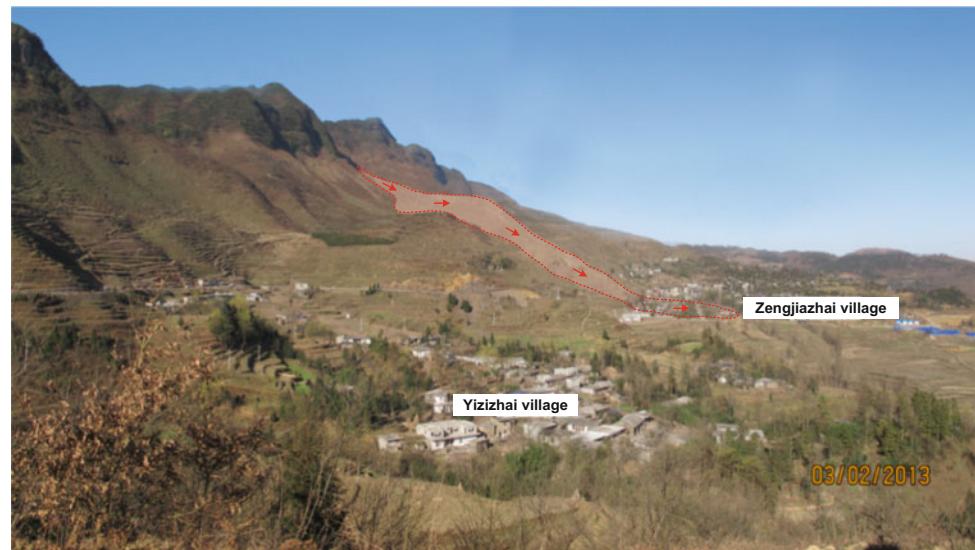
Fig. 4 Aerial view of the Zhenxiong landslide taken on 12 January 2013

On 11th January 2013 a catastrophic long-runout landslide (located at latitude 27°33'5" and longitude 104°59'15") triggered by a prolonged low-intensity rainfall occurred in Zhenxiong, Zhaotong, Yunnan, southwestern China. This landslide destroyed the village of Zhaojiagou, killing 46 people, and burying over 60 houses in the distal part of its path (Fig. 4).

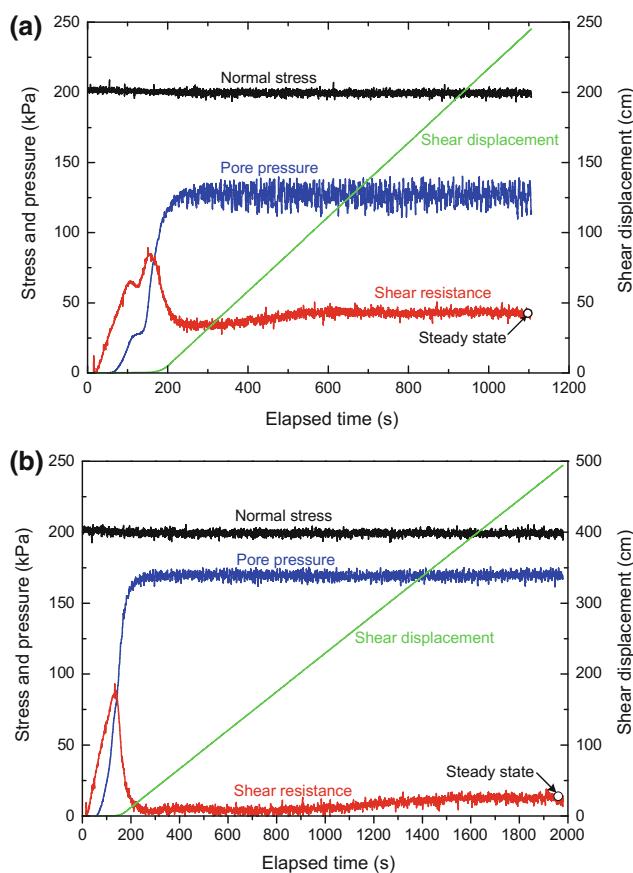
Fig. 5 Results of undrained ring-shear tests on the saturated samples taken from the source (a) and runout path (b)

In the project, we selected the Zhenxiong landslide to examine the possible mechanisms and behaviour of this type of landslide from initiation to final deposition. We conducted a series of ring shear tests on samples collected from the sliding surface and runout path to examine their shear behaviour under saturated conditions (Fig. 5). To determine

- The Zhenxiong landslide is a rapid and long-runout catastrophic landslide triggered by prolonged low-intensity rainfall. The undrained ring shear tests on the samples taken from the sliding surface and runout path reveal that the shear resistance of the samples can be decreased to a small value, and this enables the initiation and rapid movement of the landslide.

- The partially drained test suggests that the shear strength of samples from the sliding surface is less affected by shear rate, while the shear rate has a negative effect on the shear strength of runout path material.
- The DAN-W model was used to simulate the post-failure behaviour based on ring shear test results. The results show that the mobilized friction angle obtained from ring shear tests provided the best performance in simulating this landslide. The total duration of the landslide is 48 s for an average velocity of 16.7 m/s. There is good agreement between the observed and simulated results, suggesting that this model, using parameters obtained through ring shear tests and back analyses, could be a useful tool for predicting post-failure behaviour in the same area, and the information used to mitigate this type of landslide hazard.

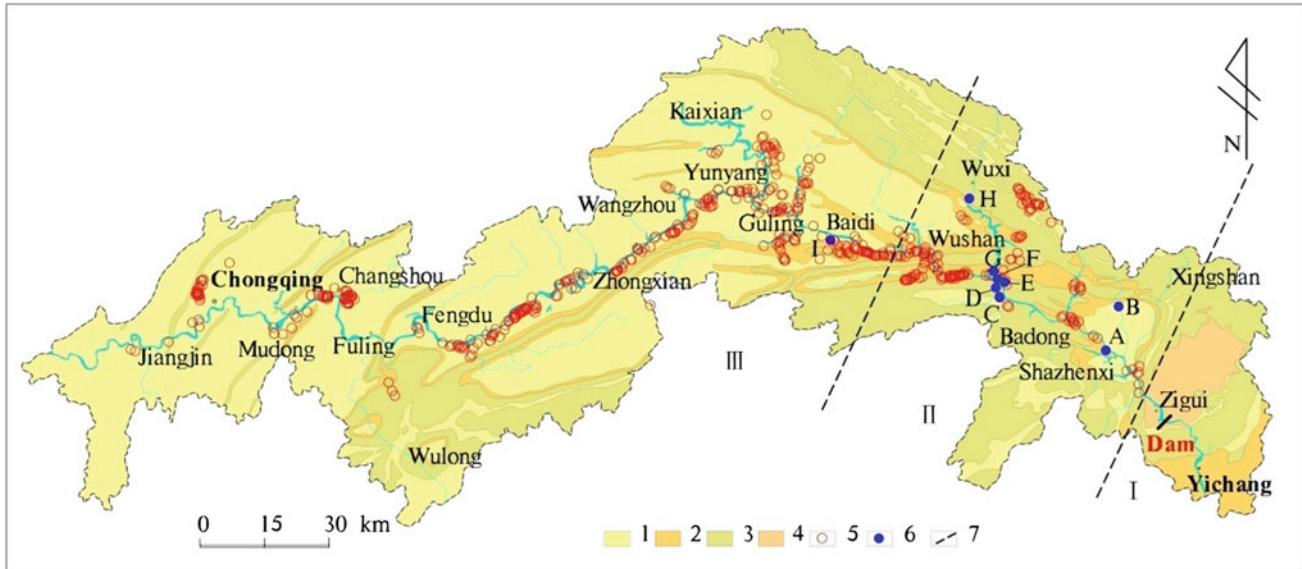
Fig. 6 Distribution map of landslides induced by six periods of 175 m asl trial impounding (Data from Sep. 1, 2008 to Aug. 31, 2014). Geology and locations: **1** sandstone, shale and coal strata, **2** mudstone mixed with sandstone and shale, **3** limestone, dolomite interbedded with shale, **4** granite, **5** six reservoir-induced landslides during 175 m asl trial impounding, **6** nine landslides described in the paper, **7** the section line of the reservoir region. Major landslides: **A** Shuping landslide, **B** Ni'erwang landslide, **C** Qingshi landslide, **D** Ganjingzi landslide, **E** Wangxia collapse, **F** Gongjiafang landslide, **G** Hongyanzi landslide, **H** Chuanzhu landslide, **I** Liangshuijing landslide

Figure 6 shows the locations of landslides induced by six periods of 175 m asl trial impoundments. From a geographical perspective, reservoir-induced landslides are mainly distributed along the main streams and some branches of the Yangtze River. Because of the marked differences in geological environment conditions of slopes along the Yangtze River, major differences in landslide occurrences in various sections were observed.

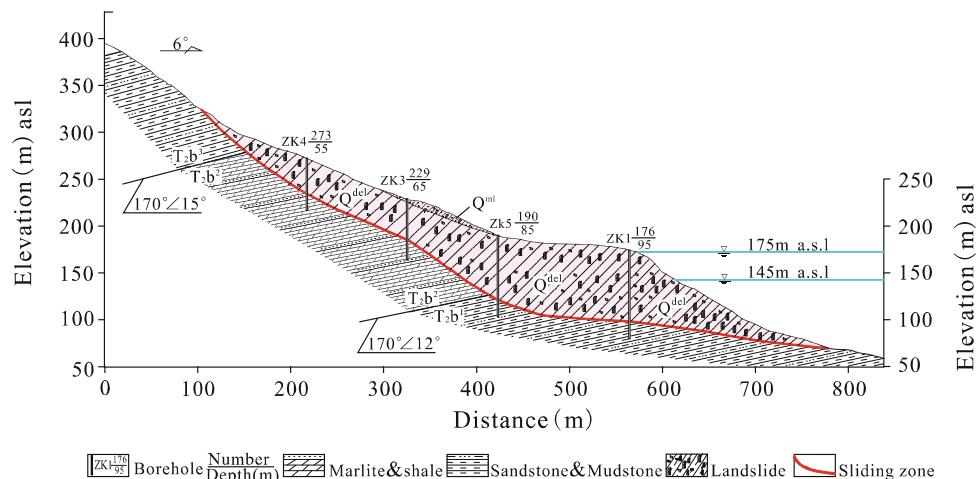
Fig. 7 Engineering geologic section for Shuping landslide in Zigui County, Hubei Province

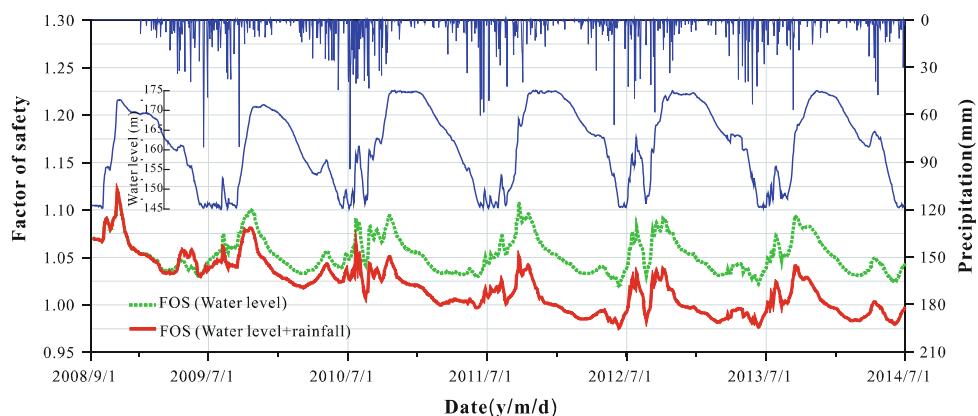
Fig. 8 Variations in the FOS of Shuping Landslide in Zigui County Hubei Province under the effects of water level and precipitation (data from Sep. 1, 2008 to Jul. 1, 2014)

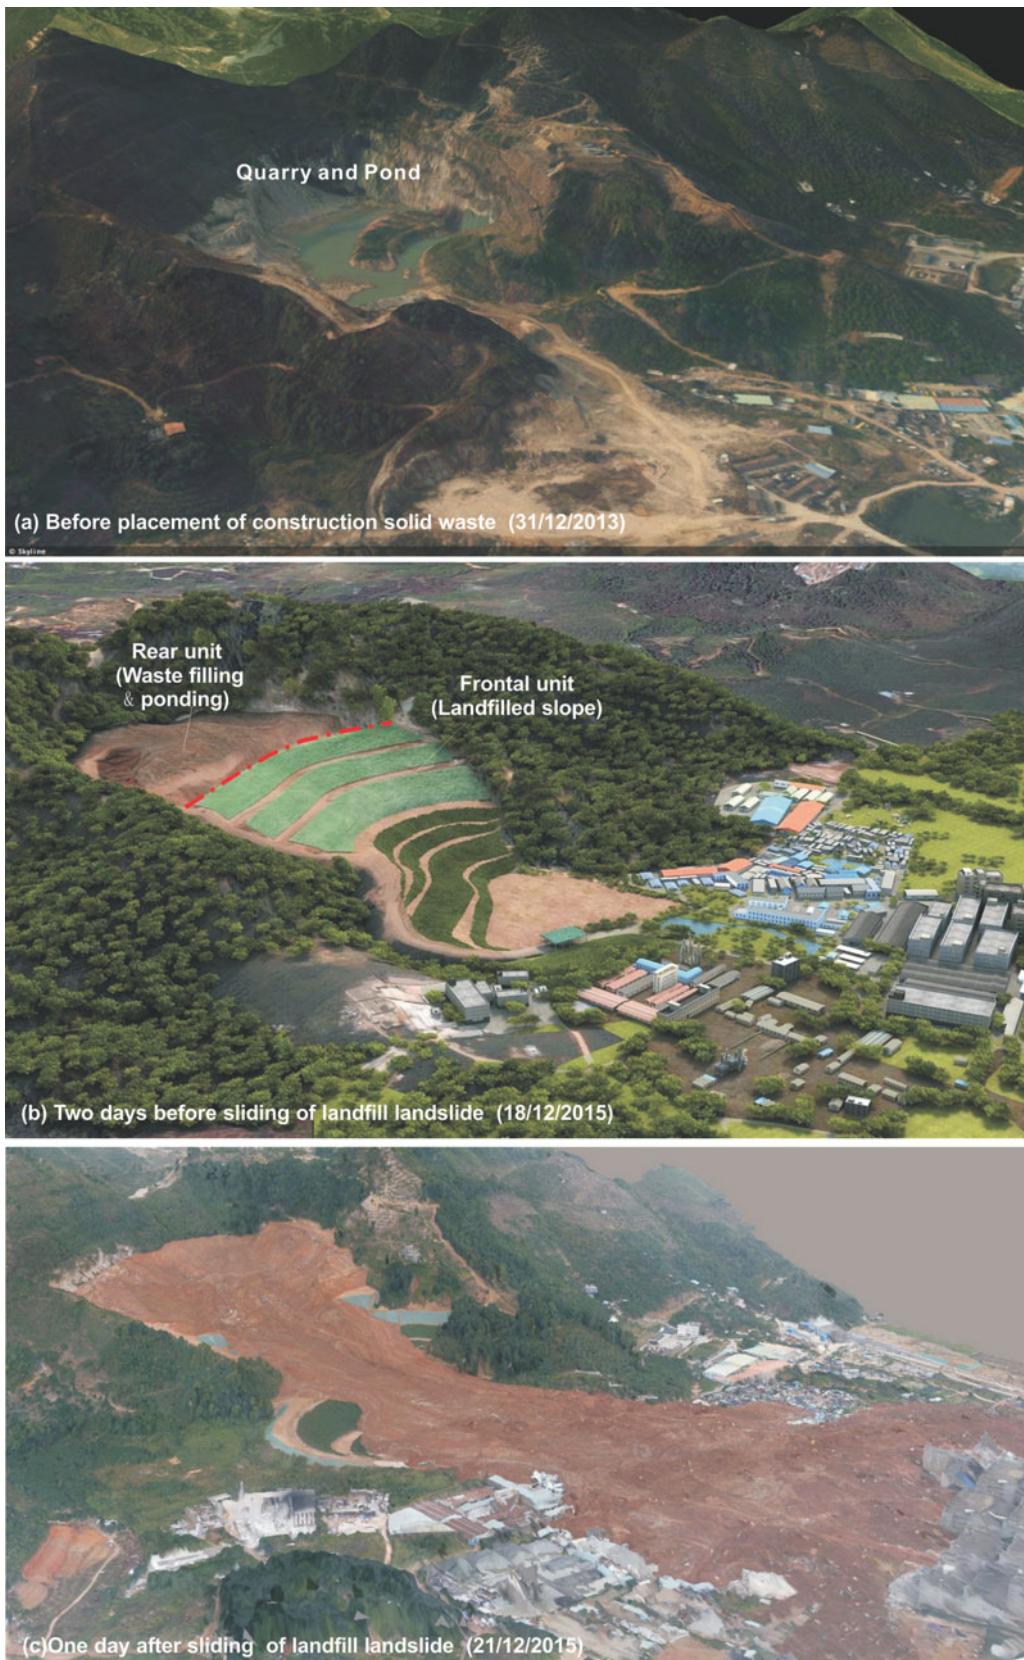
Fig. 9 Comparison of images showing the Hong'ao Village location, landfill, and landslide. **a** Remote-sensing image taken in December, 2013 (three months prior to CSW placement); **b** remote-sensing-based

image taken on December 18, 2015 (two days before the landslide); and **c** aerial view taken on December 21, 2015 (one day after the landslide) from a UAV

On December 20, 2015, a large landslide occurred at the Hong'ao Village construction solid waste (CSW) landfill in the Guangming New District of Shenzhen, Guangdong, China ($103^{\circ}33'48''E$, $30^{\circ}54'55''N$) (Fig. 9). The landslide involved 2.73 million m^3 of construction waste, and had a length of about 1100 m, making it the largest landfill slope failure in the world. Because the landslide killed 77 people and destroyed 33 houses within an industrial zone of Shenzhen, the State Council of China immediately organized an investigation team to look into the causes of the landslide. Prof. Yin Yueping (first author of this paper) was the head of the expert group within this investigation team. The CGS collectively produced the cause-analysis report for the State Council and conducted research on the failure mechanism of this landslide based on field investigations, unmanned aerial vehicle (UAV) drone 3D photogrammetry, the dynamic analysis of multiphase remote-sensing images, in situ and laboratory physical-mechanics tests, computer simulation, relevant archives, and witness interviews. With increasing volumes of waste and constant changes in a landfill's slope structures, the physical and mechanical properties and the hydrologic performance of a given landfill changes over time. Therefore, in contrast to analysis of natural landslides, the study of landfill slope failures must employ a dynamic analysis that probes into boundary conditions and stability. For this landslide investigation, we adopted a multistage modeling technique to study the influence of soil mass structure and hydrologic performance changes on the stability of the landfill landslide during different phases of

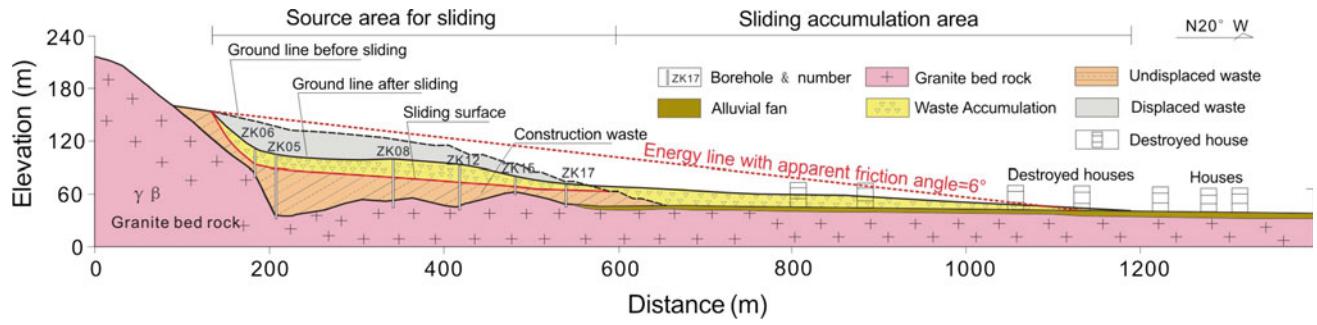
Fig. 10 Longitudinal profile of the landslide at the Shenzhen landfill. The energy line is indicated from scar of landslide to the front of accumulation with an angle of 6° and the drilling holes after sliding

reveal that the slip zone is translational with a angle of 4° . The landslide exits at the terrace T1

We applied a multistage modeling technique to study the various characteristics of CSW landfill's slope structure during the five stages of CSW placement, and used non-steady fluid flow theory to analyze the groundwater seepage affecting the landfill. The results show that the landfill could be divided into two units: the frontal unit (the landfill slope), with low water content, and the rear unit (fresh waste), with ponded water and high moisture levels. This structure created two effects to trigger the landslide at the landfill—surface water infiltration and consolidation seepage. We also used soil dynamic parameters of the landslide from cone penetration, triaxial, and ring-shear tests to simulate the characteristics of a flowing slide with a long run-out due to the liquefaction effect. The result suggested that the landslide had a maximum speed of about 30 m/s with a maximum width of about 23 m, and traveled about 610 m in 130 s, at an apparent friction angle of 6° (Fig. 10).

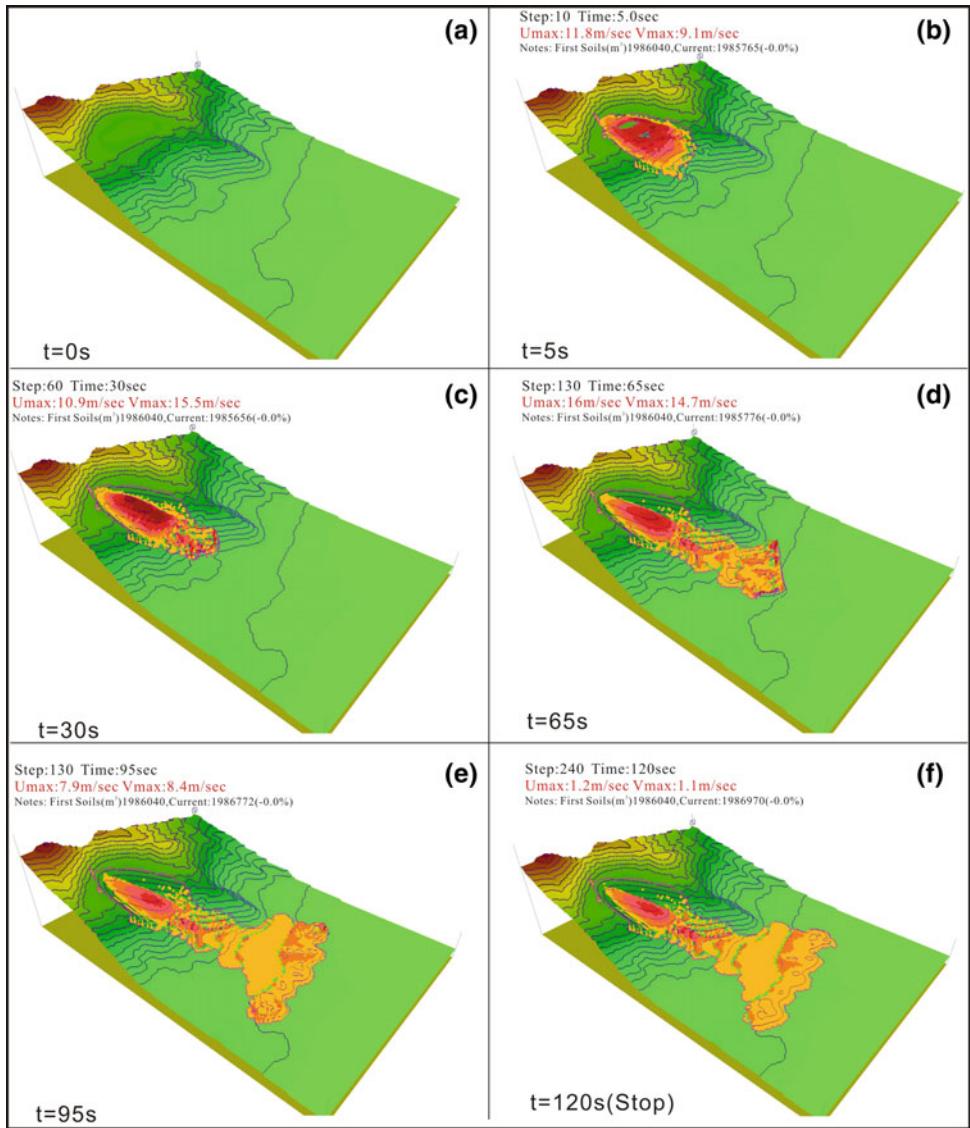
Fig. 11 Simulation result of the long run-out of the landslide at the Shenzhen landfill with LS-RAPID

Figure 11 shows the simulation result from LS-RAPID of the landslide at the Shenzhen landfill, showing the movement and accumulation at different times. The red grids represent the moving landslide and the green grids represent the stable mountain and plain. Figure 11a at 0 s represents the initial state of the landslide, showing the morphological characteristics before the landslide failure. Figure 11b at 5 s represents the launch of the landslide. The whole slope failure starts to move downward, with a speed of 14 m/s and a movement distance of 480 m. Figure 11c at 30 s represents the moving downward stage. The slide mass exits and the rear and its periphery collapse to the middle, with a maximum speed of 18 m/s and a movement distance of 560 m. Figure 11d at 65 s represents the stage of continuous

speed forward. The slide mass gradually disperses, with a maximum speed of 21.7 m/s and a movement distance of 720 m. Figure 21e at 95 s represents the decelerated motion stage. The accumulation is changing constantly, with a maximum speed of 11.5 m/s and a movement distance of 920 m. Figure 11f at 120 s represents the front accumulation stage. After dispersing over flat ground, the accumulation is still changing, with a maximum speed of 1.4 m/s and a movement distance of 1060 m.
