Chapter 5

Extended Non-destructive Testing Technique Demonstration in a Realistic Environment with Technology Assessment

Abstract This chapter highlights two advances towards a higher maturity of versatile extended non-destructive testing (ENDT) procedures. Full-scale demonstration tests are presented in realistic user application cases that involve typical production or repair scenarios. Subsequently, the investigations used to assess the probability

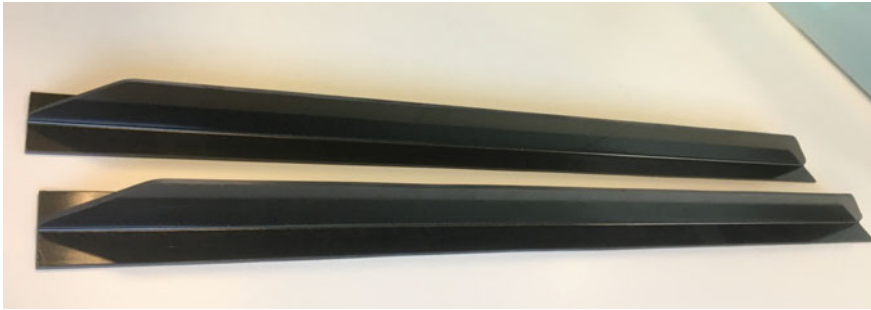
Fig. 5.1 Image of manufactured T-stringers

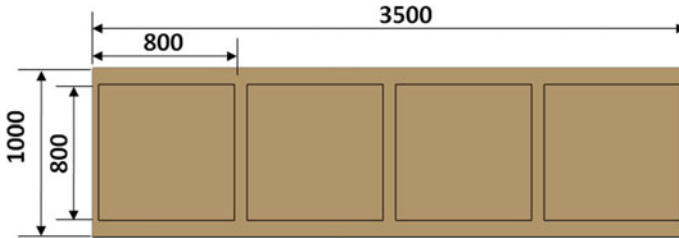
Fig. 5.2 Flat panel manufactured for four square skin samples; dimensions are given in mm

The production began with the manufacture of a 3500 mm by 1000 mm flat panel laminated using ATL. The distribution of the skin samples within this panel is depicted in Fig. 5.2.

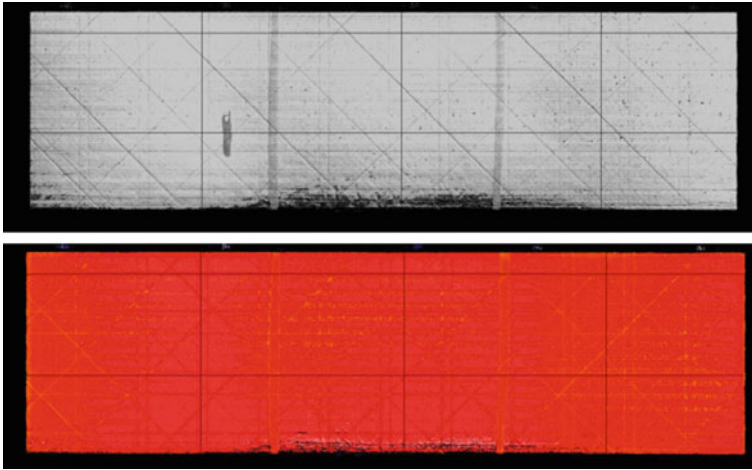
Fig. 5.3 Color-coded representation of the findings from the ultrasonic inspection of the flat panel

After the curing cycle, the flat panel was automatically inspected using pulse-echo equipment with water as the coupling medium to ensure the quality of the part manufactured. No defects were revealed (see Fig. 5.3). After the inspection, a trimming operation was performed to obtain the number of skin samples required for the mechanical testing (see Chap. 2) and full-scale demonstration.

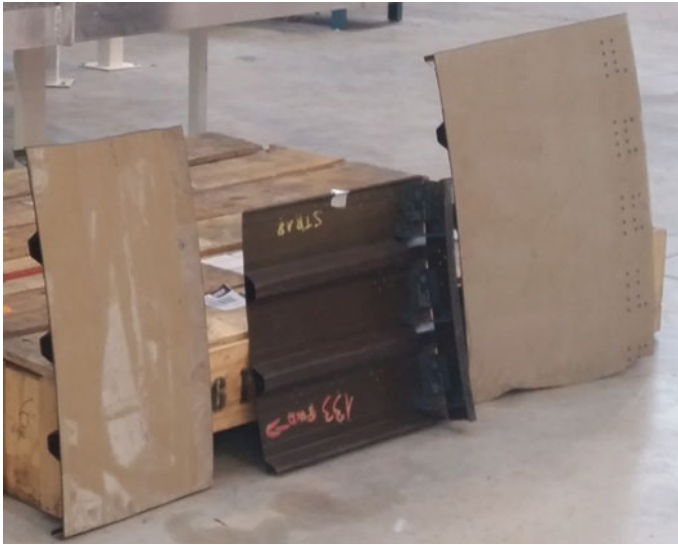
Fig. 5.4 A350 aircraft fuselage panels provided by Airbus for the demonstration of a full-scale bonded repair

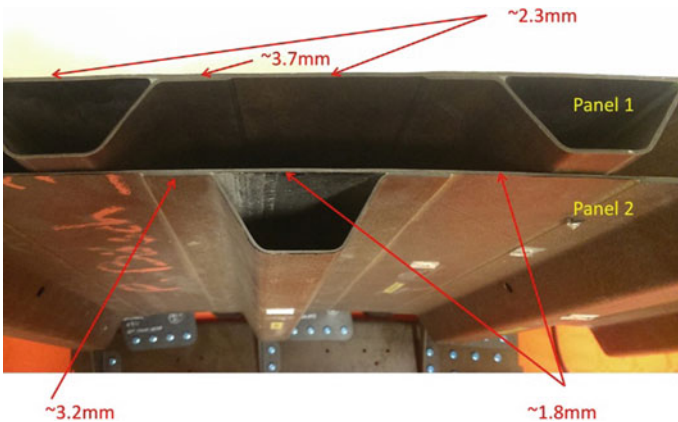
Fig. 5.5 Detailed view of the A350 fuselage panels used for the demonstration of quality assessment during bonded repair; the skin thickness is indicated at specific positions

range of 1.5–2.5 mm, which corresponds to the coupon and pilot sample geometries because—once repaired—the assembly thickness increased to about 2.5 mm. In addition, either two or three omega stringers reinforced the skin. The stringer foot was about 1.5 mm, which means that the total thickness was a maximum of 4 mm in this region. The panel material was the composite IMA/M21E (Hexcel), similar to the material used for the coupon and pilot samples.

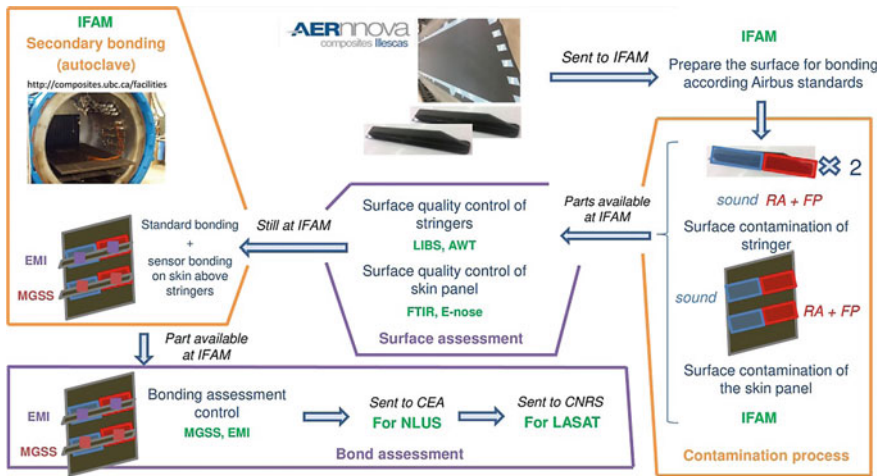
Fig. 5.6 The full-scale demonstration workflow for the panel used in the production user case

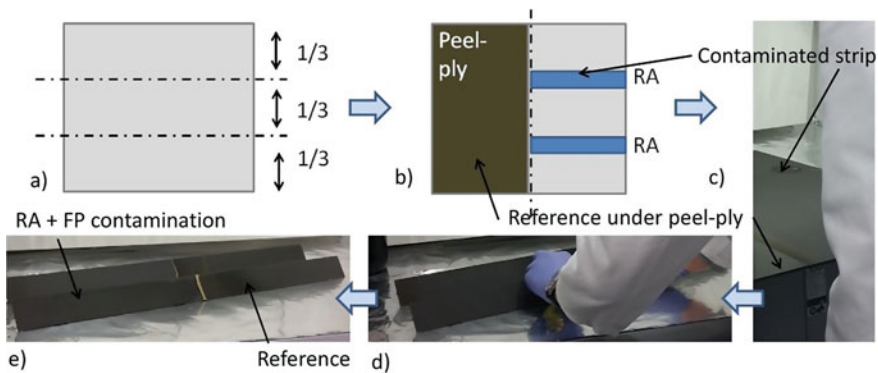
Fig. 5.7 The two-step contamination process “RA+FP” for the production user case; **a** position of the stringers, **b** regions to be contaminated with RA, **c** view of both areas contaminated with RA as well as the region where the FP contamination was randomly applied on the skin, **d** contamination of the stringer feet with RA, and **e** final contamination state of the stringer surfaces after the concluding deposition of salt-based FP

using flat specimens. Following the RA contamination, the skin was placed in an oven for 1 h at 80 °C. Subsequently, the FP contamination operation of the production user case was conducted in the same way as in the FP scenario for the coupon pilot specimens. We did not specify the distance between the applied prints in the contaminated region because we intended a random distribution, and their number should have been sufficient to be representative and unforeseeably positioned within the scanning areas of all the investigated techniques. It should be noted that during the whole contamination process, we retained the peel ply in the reference area to avoid any contamination of this region, as shown in Fig. 5.7. The stringers were then contaminated using the same process. RA was first spread on half of the finger foot surface using the same solution and a sponge (see Fig. 5.7d). They were then placed in the same oven, after which a worker marked the modified surface with FP deposits. The final state of the stringer surfaces was an “RA+FP” coated contamination area near a reference area below the peel ply, as presented in Fig. 5.7e.

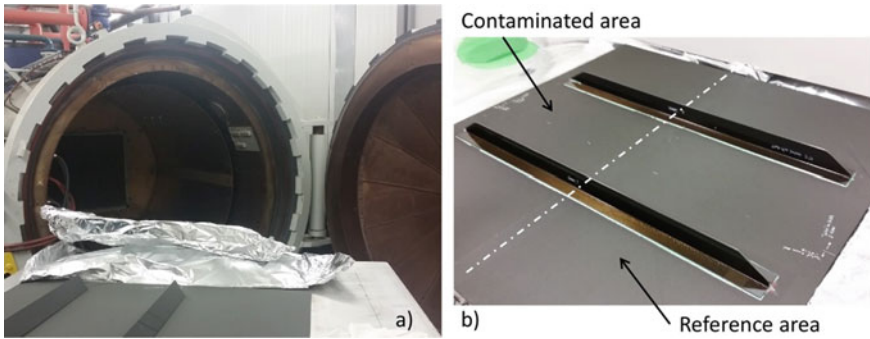
Fig. 5.8 Aspects of the bonding operation performed during the full-scale demonstration event in the ComBoNDT project: **a** panel and stringers in front of the autoclave before bonding and **b** fully cured stiffened panel

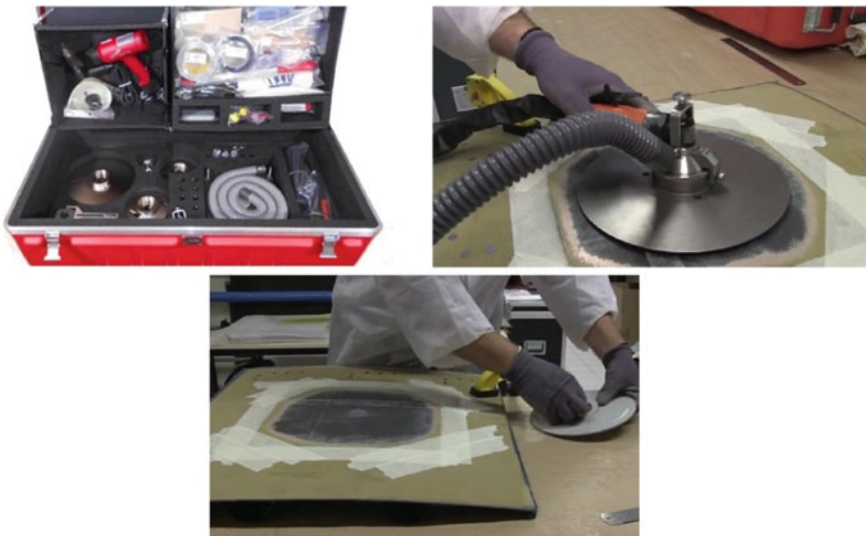
Fig. 5.10 Illustration of the stepping process prior to the application of a repair patch in the bonded repair user case

- A circular repair geometry was used with a maximum diameter of approximately 200 mm
- The average thickness of one ply was 0.15 mm
- The overlap ratio was 1:60, i.e., a step width of approximately 10 mm
- Seven steps were performed to achieve a depth of 1 mm

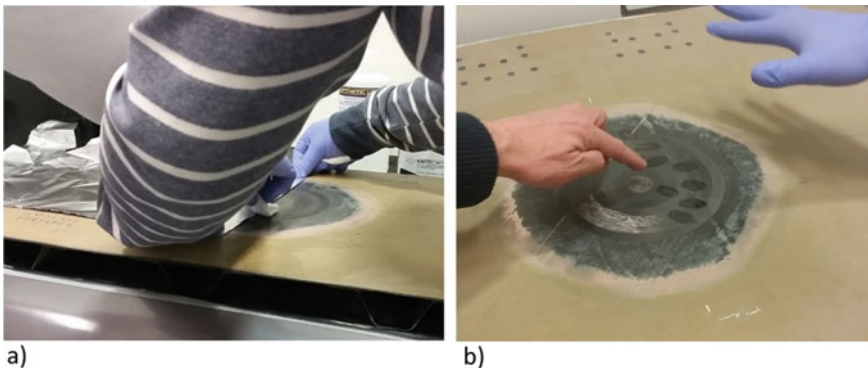
Fig. 5.11 Contamination operation applied for the panels of the repair user case, with regionally applying contamination by **a** a liquid de-icing solution while maintaining a contaminant-free reference area, and **b** a hydraulic oil solution deposited within the fingerprinted areas

This section provides more details about the contamination process. The images taken during the operations are presented in Fig. 5.11. Similar to the production user case, the repair user case comprised the intentional application of a combined contamination, although the respectively deposited solutions were different. Following the contamination scenario for the repair user case, the solution containing de-icing (DI) fluid was first applied. Similar to the RA contamination, a small sponge was used to spread the DI solution onto the stepped surface. Aluminum foil was then placed on the panel in such a way that it would keep half of the repair surface clean, as shown in Fig. 5.11a. As this was a manual operation and in view of the shape of the scarfing, some liquid might have moved towards the reference area. Thus, the boundary region between the reference and contaminated areas might have been

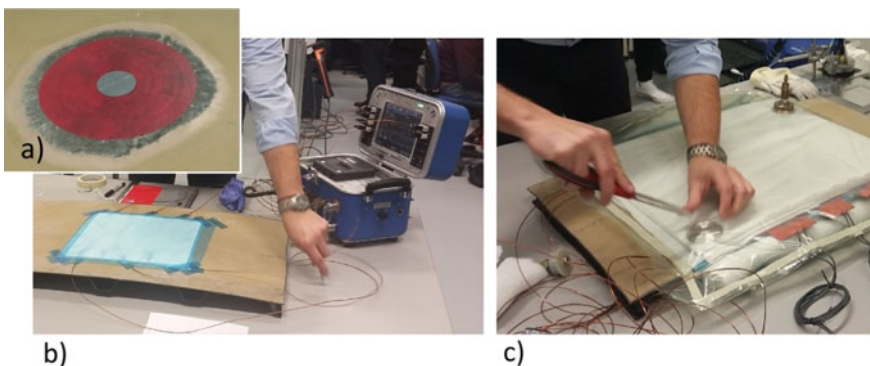
Fig. 5.12 The distinct operations conducted during the bonded repair of CFRP panels showing **a** the raw F300-2 M bonding material, **b** the placement of the heating device, and **c** the preparation of the capping vacuum bag

The repair process involved the replacement of each carbon fiber layer that had been removed during the scarfing operation by a new fiber layer exhibiting an orientation that matched that of the original layer. Additionally, a film adhesive was placed between the structure and the carbon fiber layers, as shown in Fig. 5.12a.

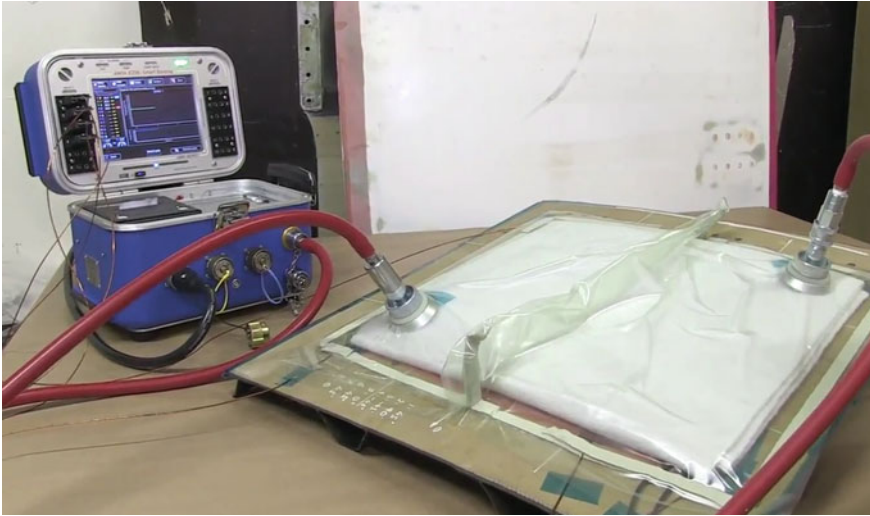
Fig. 5.13 Image taken during the full-scale demonstration of the repair process using the ANITA EZ0901 hot bonder in the ComBoNDT project

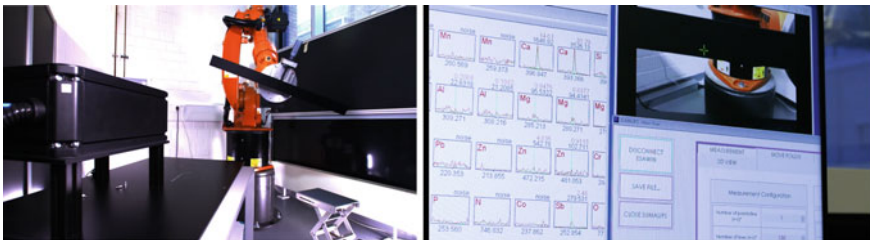
Fig. 5.14 The handling of a stringer by a fine-tuned industrial robot (left) and the well-arranged control unit for the operator (right)

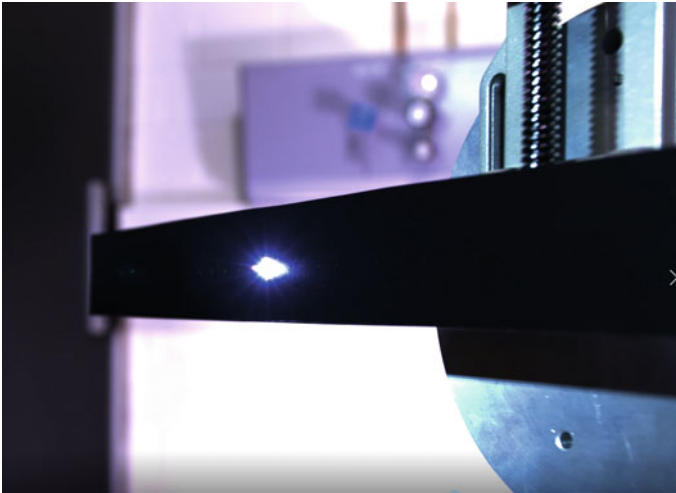
Fig. 5.15 The plasma generation during the LIBS measurement on the realistic stringer specimen

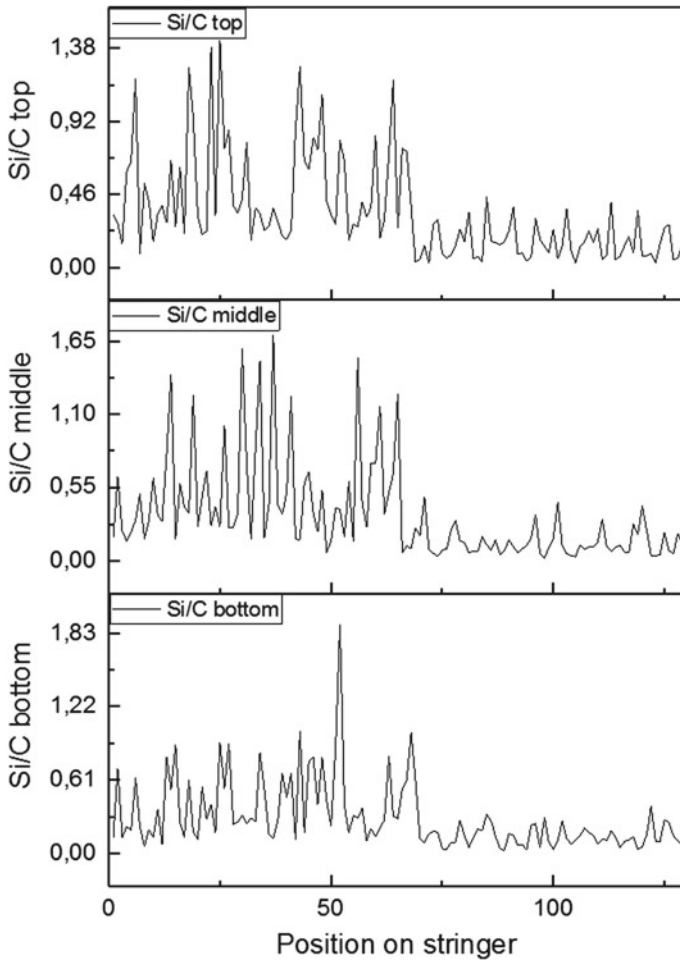
Fig. 5.17 LIBS findings from three horizontal lines composed of 130 positions on a partially contaminated CFRP, highlighting Si/C signal ratios measured on the composite surface in the contaminated area (left) and the clean reference area (right)

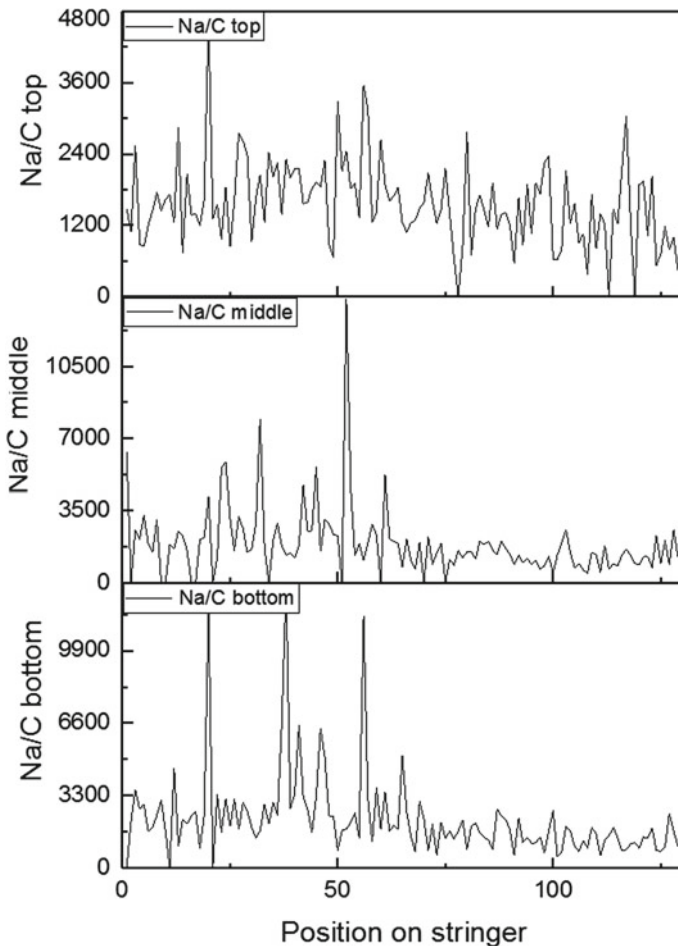
Fig. 5.18 Sodium signals for the three lines measured on the stringer surface give an idea about the contaminated areas (left) and the clean reference area (right)

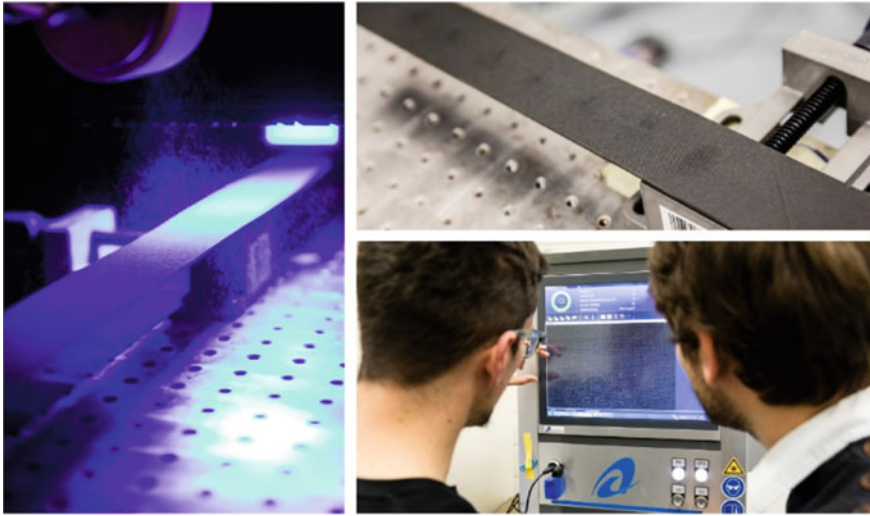
Fig. 5.19 An overview of the AWT-based investigations of a stringer surface during a full-scale demonstration

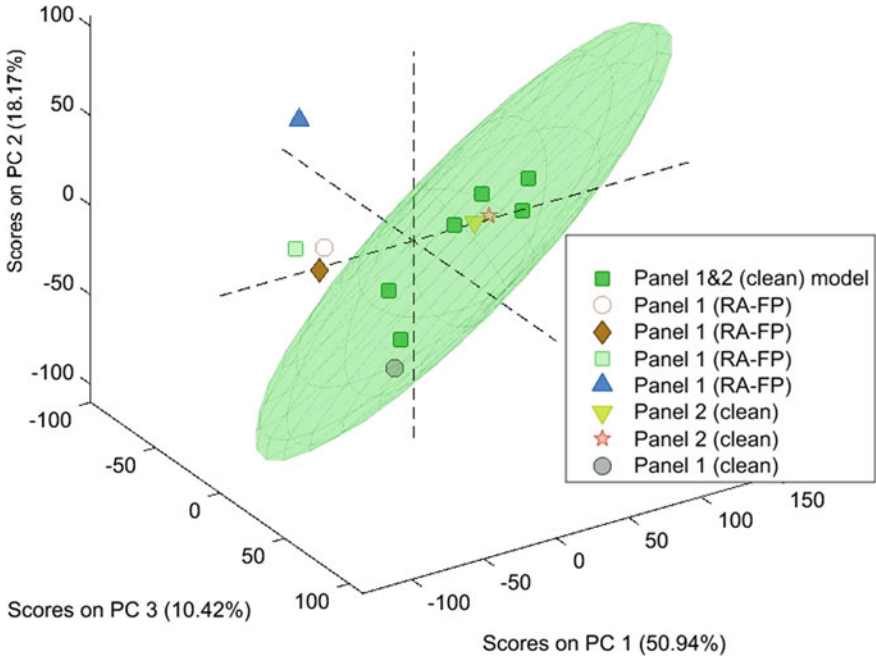
Fig. 5.22 Single-class identification of e-nose results following PCA-based data evaluation from measurements on technologically realistic parts. The green domain indicates the region of measurements on clean samples with a confidence level of 95%

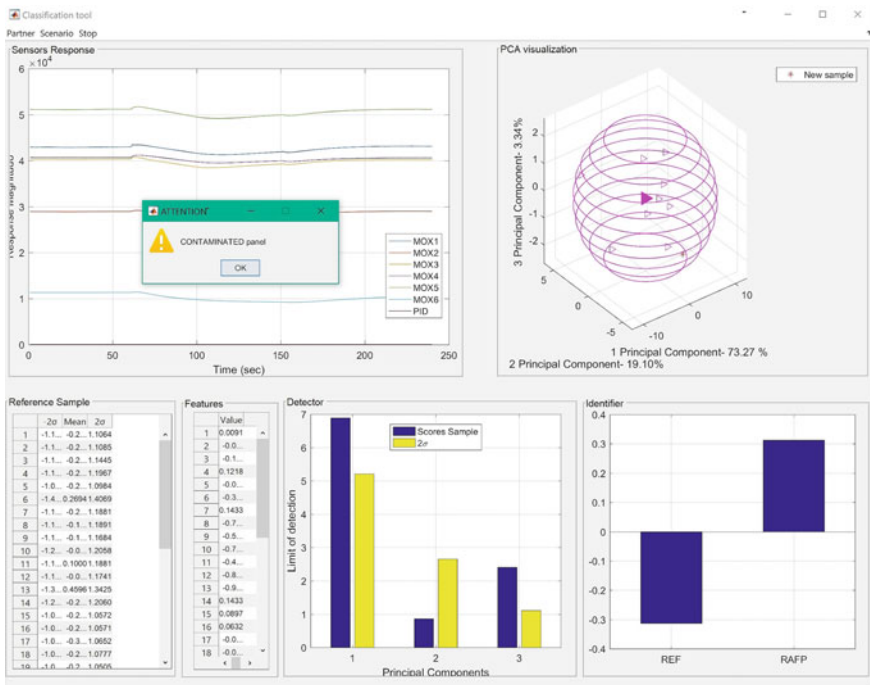
Fig. 5.24 Screenshot of the ENEA GUI employed for the detection and identification tasks based on the e-nose investigations of contaminated realistic CFRP parts within the production user scenario during the full-scale demonstration event

from areas that had been contaminated previously following the “RA-FP” scenario. In summary, we measured 18 samples, of which nine were set apart to build the training set of the PCA-based detector, while the other nine were used for testing purposes. The joint GUI was able to show the results in real-time immediately after the measurement was taken. A screenshot of the active GUI is displayed in Fig. 5.24.

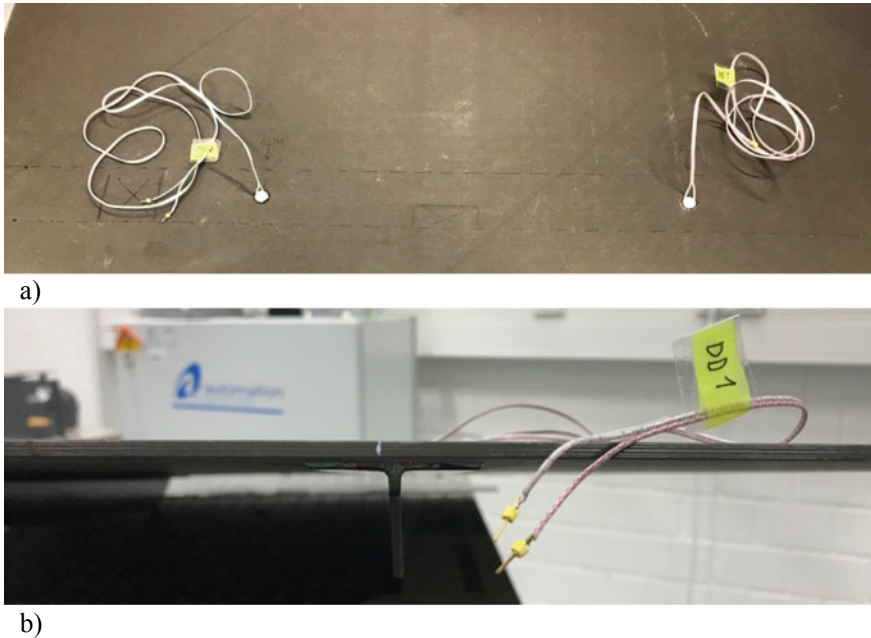
Fig. 5.25 The realistic CFRP panel used as one partially contaminated adherend within the production user case, with **a** the piezoelectric sensors for EMI measurements and **b** the stiffener bonded to the front side. In (a), the sensor on the left-hand side (DD2) is bonded to a contaminated surface area and the sensor on the right-hand side (DD1) is bonded to a clean adherend area

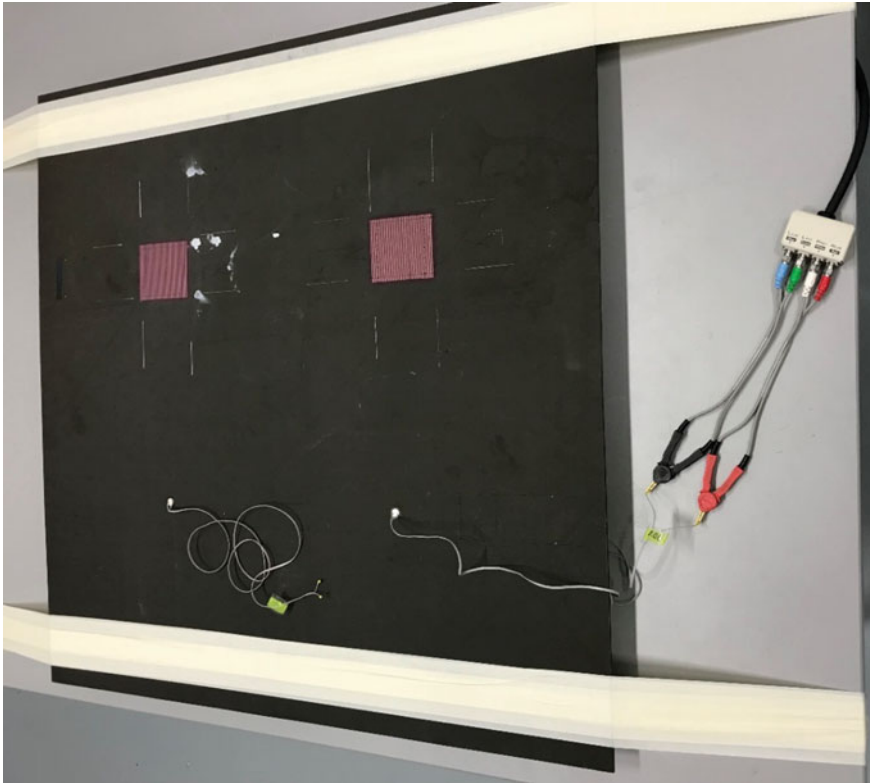
Fig. 5.26 The curved realistic part for the production user case with a loading situation introduced by fixing the CFRP panel in a flattened adjustment using adhesive tape. The square patches with pink color are strain sensors introduced by GMI AERO

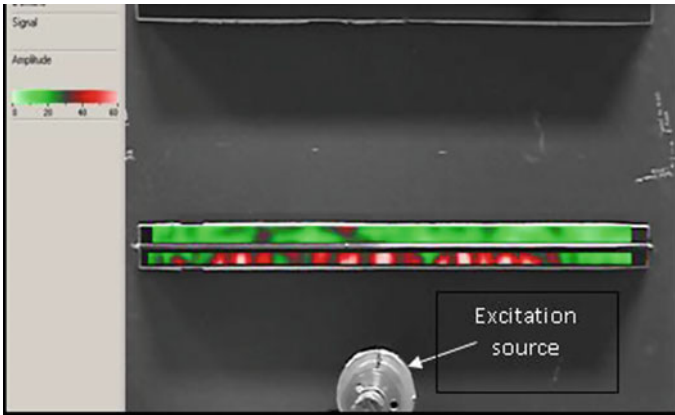
Fig. 5.29 Distribution of the fundamental ultrasonic frequency (20 kHz) amplitude along the stringer in the realistic bonded CFRP specimen from the production user case, as observed during the NLUS inspection

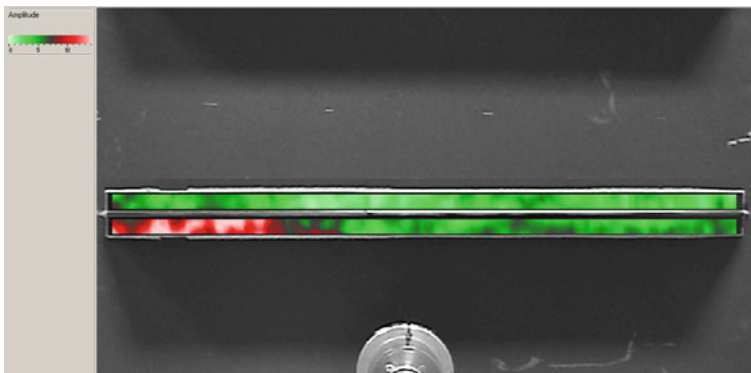
Fig. 5.30 Distribution of the second-highest harmonic (40 kHz) along the stringer length in the bonded production CFRP component, as observed during the NLUS inspection

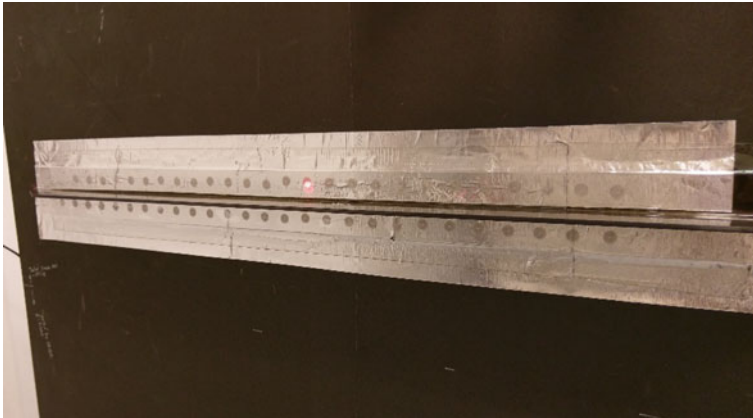
Fig. 5.34 A prepared production CFRP panel after S-LASAT investigation

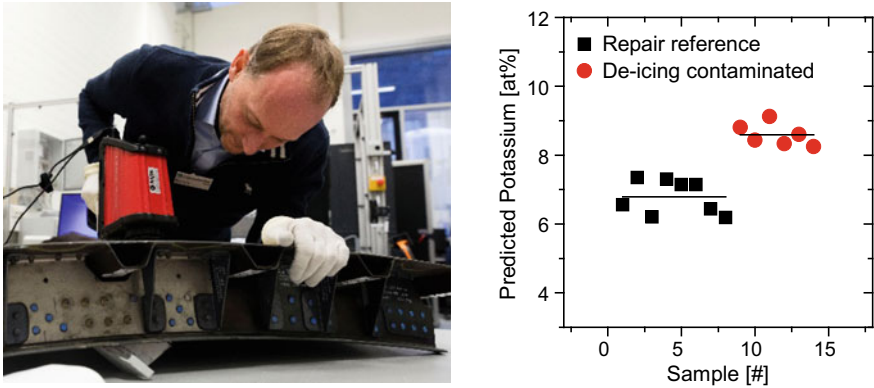
Fig. 5.36 (Left) image showing the performance of the FTIR investigations and (right) plot indicating the amount of potassium on 14 sampling regions as obtained with a PLS algorithm from FTIR spectra recorded on a technologically realistic part

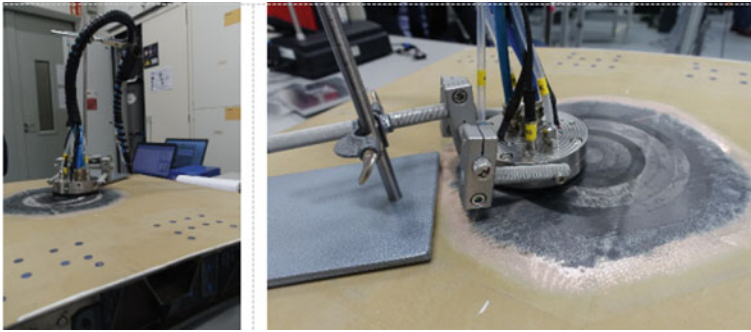
Fig. 5.37 (Left) the e-nose desorber device in use while conducting measurements on a CFRP fuselage part and (right) a close-up view of a scarfed area of a fuselage part

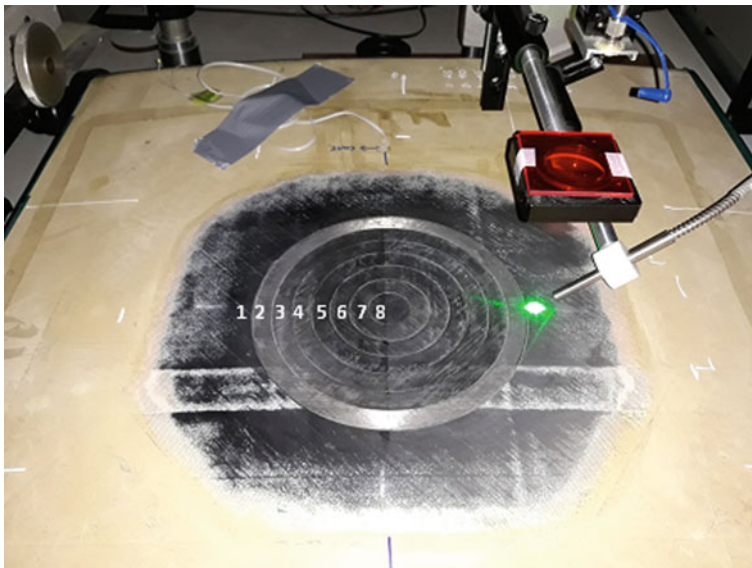
Fig. 5.39 Inspection of a real aircraft part using the LIF technique. The left semi-circular scarfed subarea appears darker and is contaminated, while the brighter right subarea is clean; the circular rings of the stepped surface prepared for bonded repair are numbered, with number 1 indicating the topmost material layer

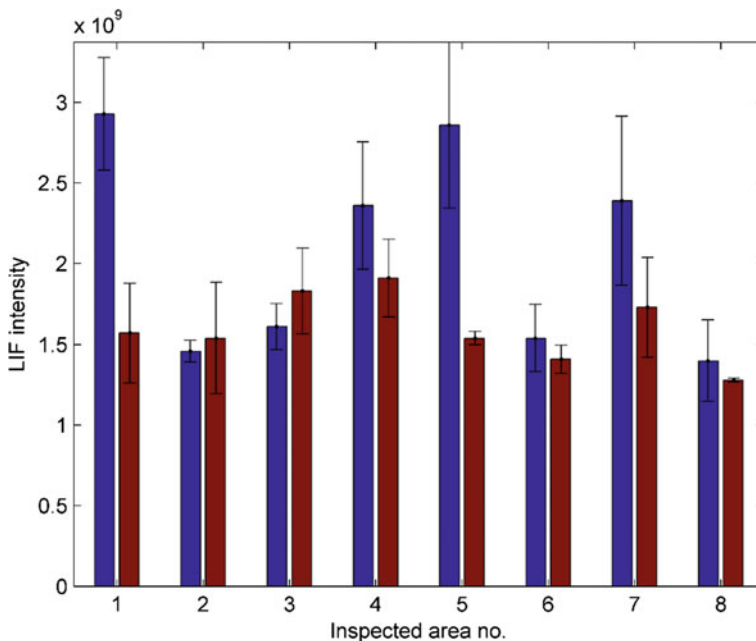
Fig. 5.40 LIF results from the inspection of a real CFRP aircraft part; the blue bars correspond to clean areas; the red bars correspond to contaminated areas; the numbers of inspected areas denote the ring zones defined in Fig. 5.39

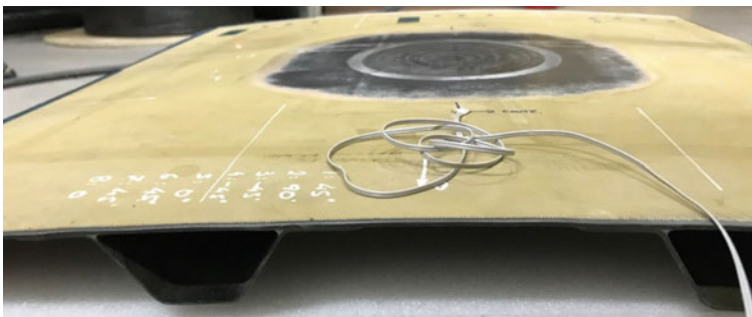
Fig. 5.41 The setup for the laser vibrometry inspection of a real CFRP panel with the scarfed and stepped areas for bonded repair

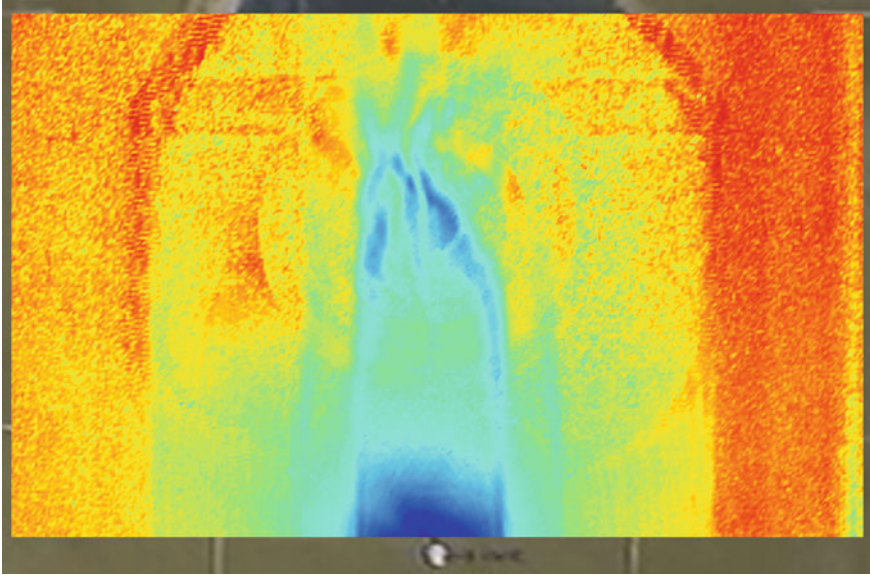
Fig. 5.42 Space-resolved RMS plot obtained from the vibrometer software. The image section is roughly half of that shown in this figure. As illustrated by the lateral view, the roundish delimitation of the area prepared for bonding is located between two omega stringers. Excitation of an elastic wave in this area results in concentrations of the wave energy between the stringers, as indicated by greenish and blueish colors

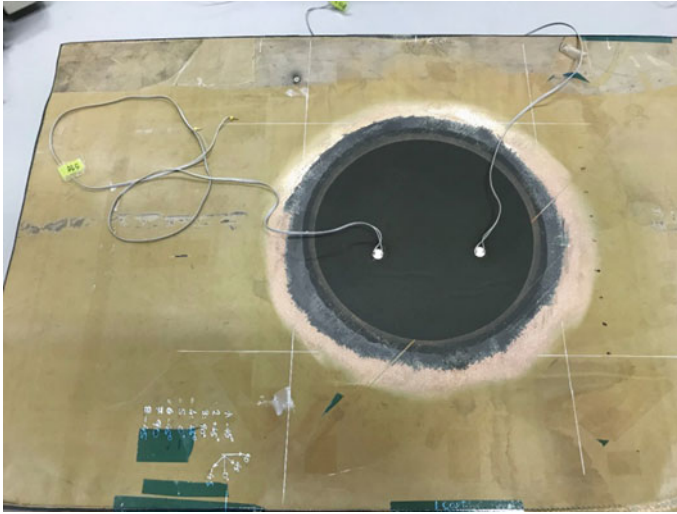
Fig. 5.43 Photograph showing a real aircraft CFRP panel with an adhesively bonded circular repair patch

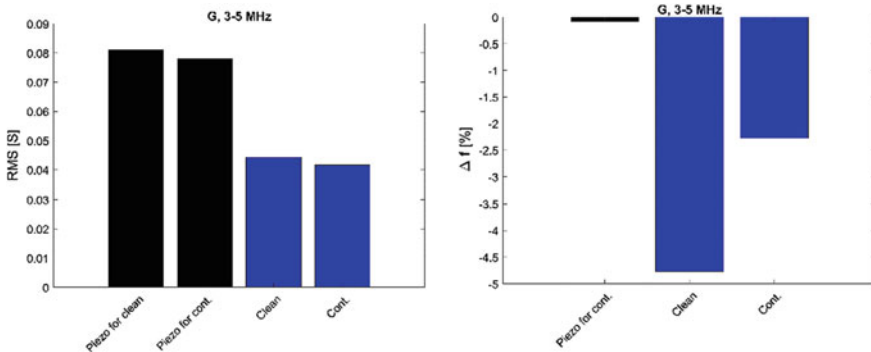
Fig. 5.44 EMI results in the 3–5 MHz frequency region for the six joint states of a realistic CFRP aircraft part that was repaired and investigated within the repair user case; **a** RMS values of conductance and **b** frequency shift of the conductance peak

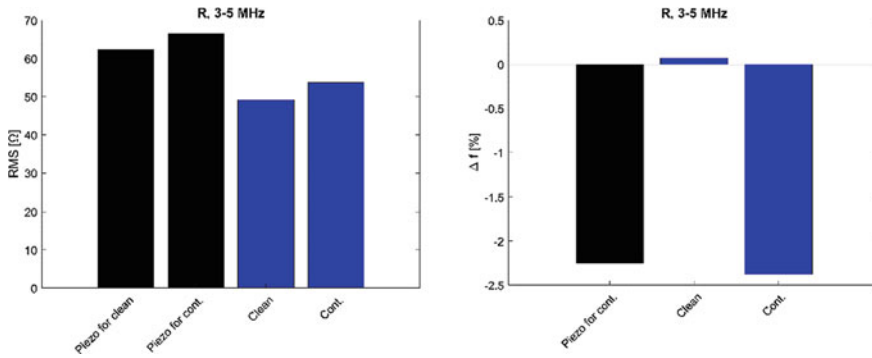
Fig. 5.45 EMI results for 3–5 MHz frequency region for six investigated states of a realistic part from the repair user case; **a** RMS values of resistance presented and **b** frequency shift of the resistance peak

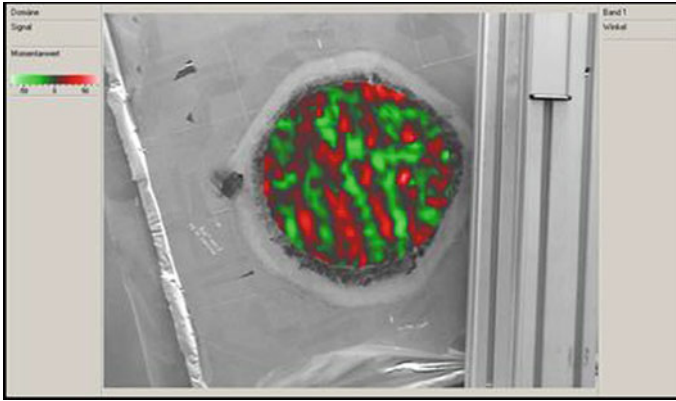
Fig. 5.46 NLUS fundamental frequency field excited in the bonded repair patch region of the CFRP specimen from the repair user case

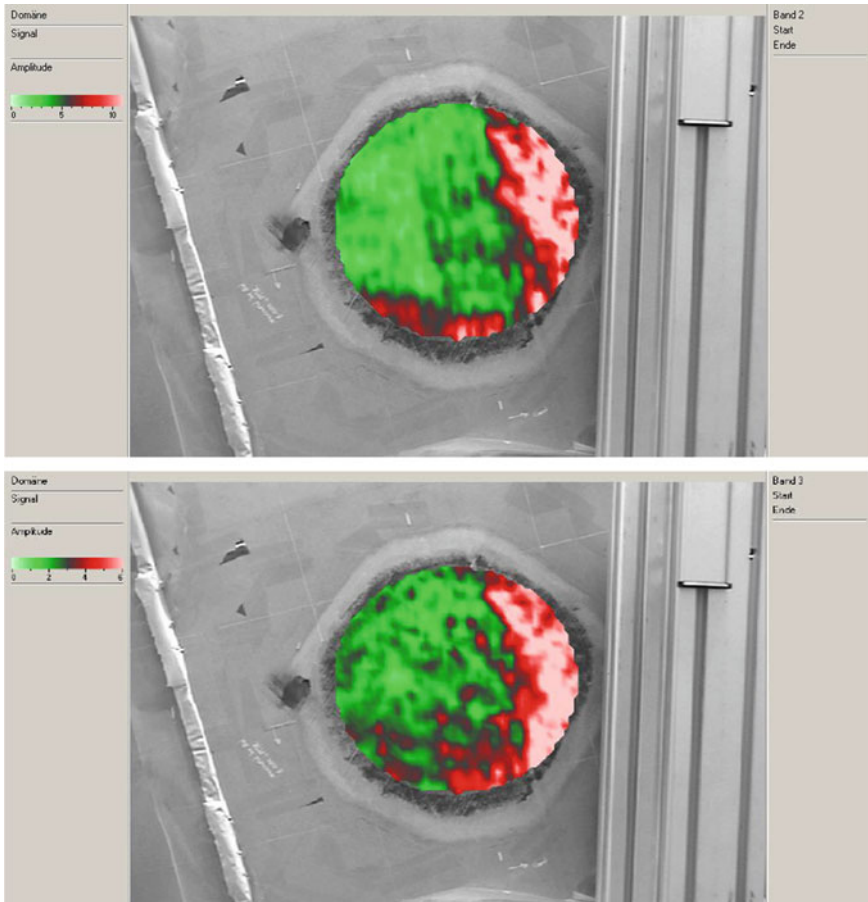
Fig. 5.47 The second harmonic (40 kHz, top) and the third harmonic (60 kHz, bottom) NLUS fields in the repair patch of the fuselage panel from the repair user case

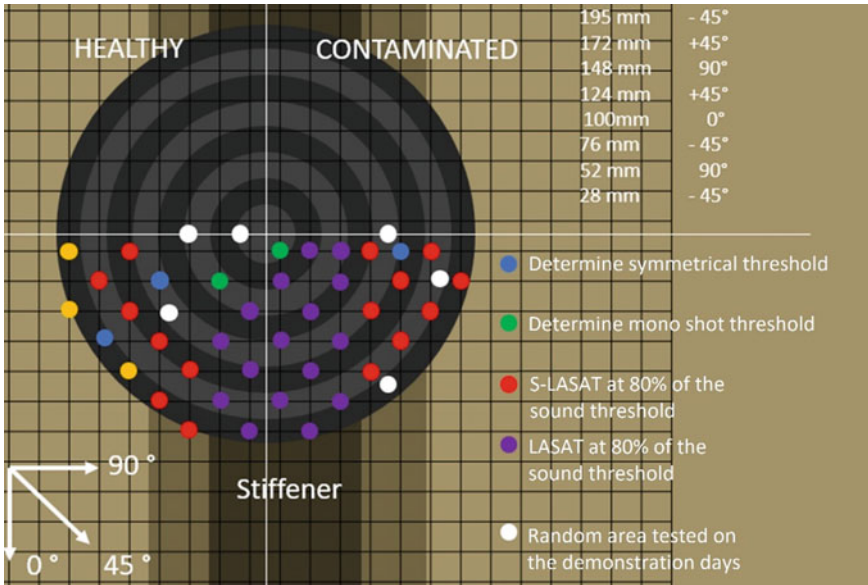
Fig. 5.48 Diagram of the LASAT shot partitioning on the adhesively bonded repair patch within the CFRP panel of the repair user case. Contaminated joint regions (in contrast to clean ones) are based on intentionally contaminated adherend surface regions

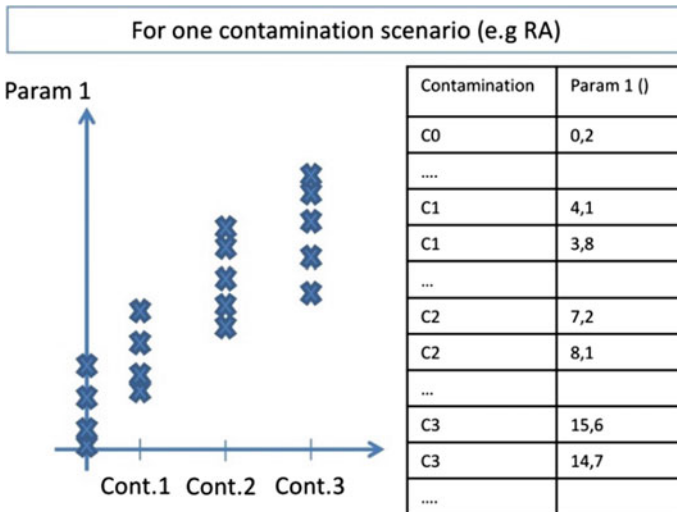
Fig. 5.50 Schematic description of the input data required for the exemplified POD approach. The contamination degrees Cont. 1, Cont. 2, and Cont. 3 were adjusted according to an accurate intentional contamination procedure and were characterized by laboratory-based analysis, while the ordinate values for Param 1 were obtained from the ENDT inspection

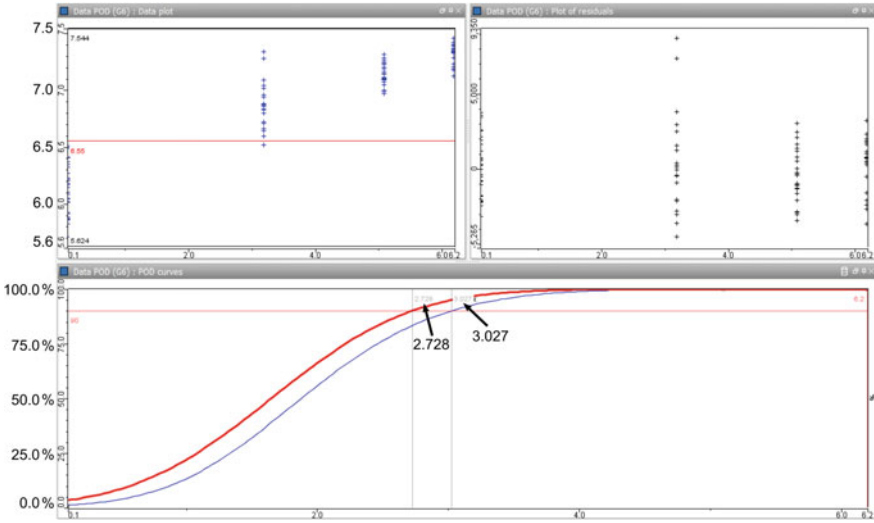
Fig. 5.51 POD curve for the AWT data obtained for the RA contamination scenario within the production user case when using the droplet diameter on the CFRP surface as the feature for evaluation

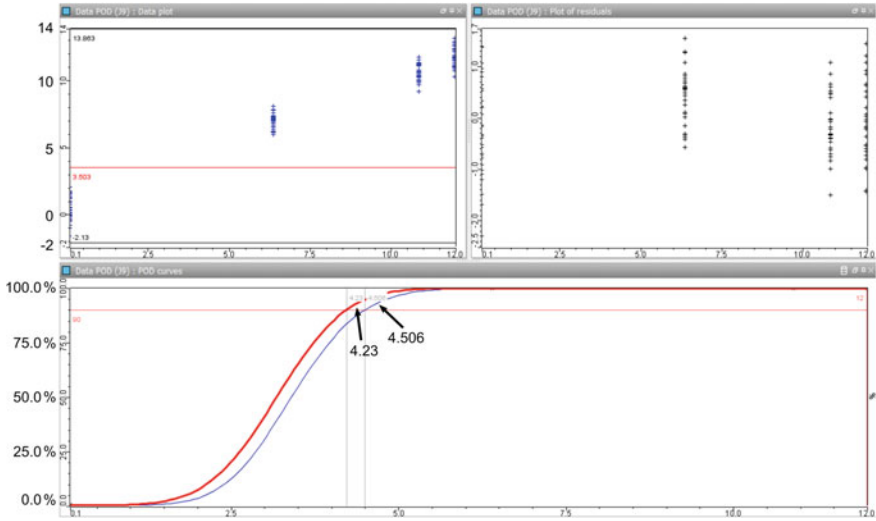
Fig. 5.54 POD curve for the FTIR datasets in the case of the DI fluid contamination scenario within the repair user case

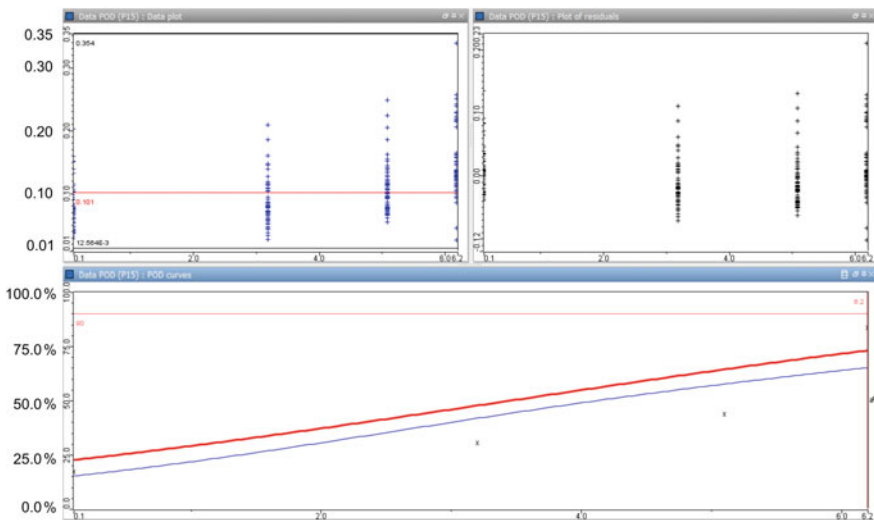
Fig. 5.56 POD curve for the LIBS datasets in the case of the RA contamination scenario within the production user case; the POD findings shown here were obtained by considering an evaluation procedure without averaging

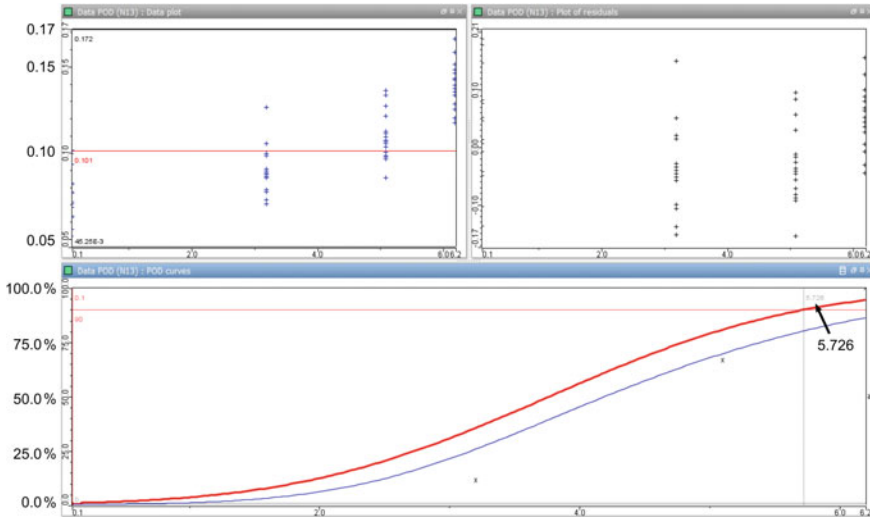
Fig. 5.57 POD curve for the LIBS datasets in the case of the RA contamination scenario within the production user case. The POD findings shown here were obtained considering an evaluation procedure involving an average measurement per group of ten data points

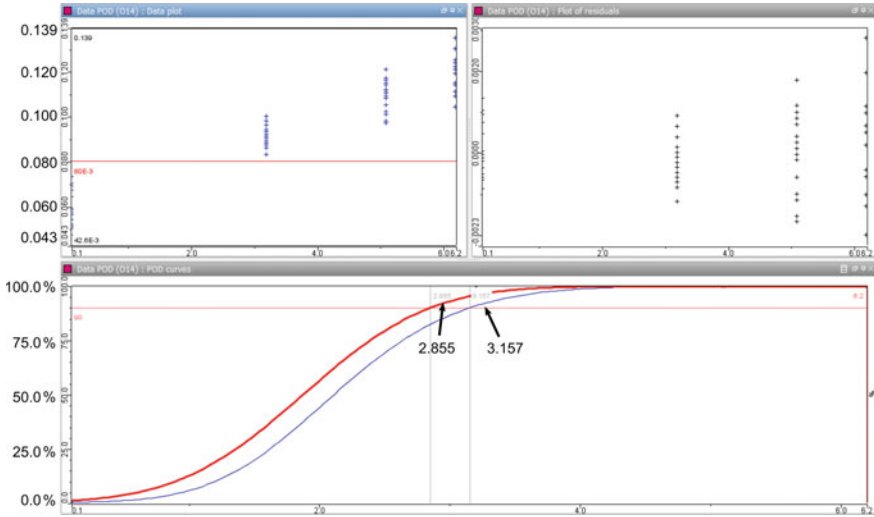
Fig. 5.58 POD curve for the LIBS datasets in the case of the RA contamination scenario within the production user case. The POD findings shown here were obtained considering an evaluation procedure involving an average measurement per group of 36 data points

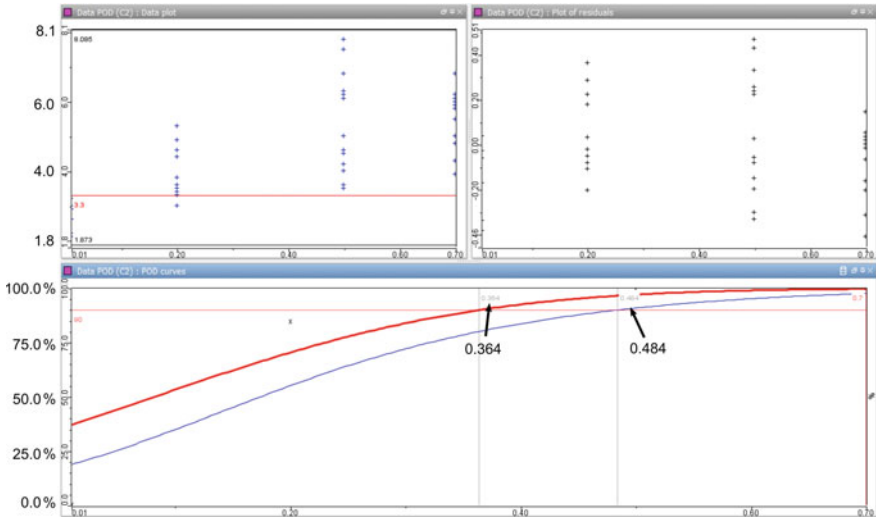
Fig. 5.59 POD curve for the NLUS datasets from the FP contamination scenario, applying a hit/miss model approach

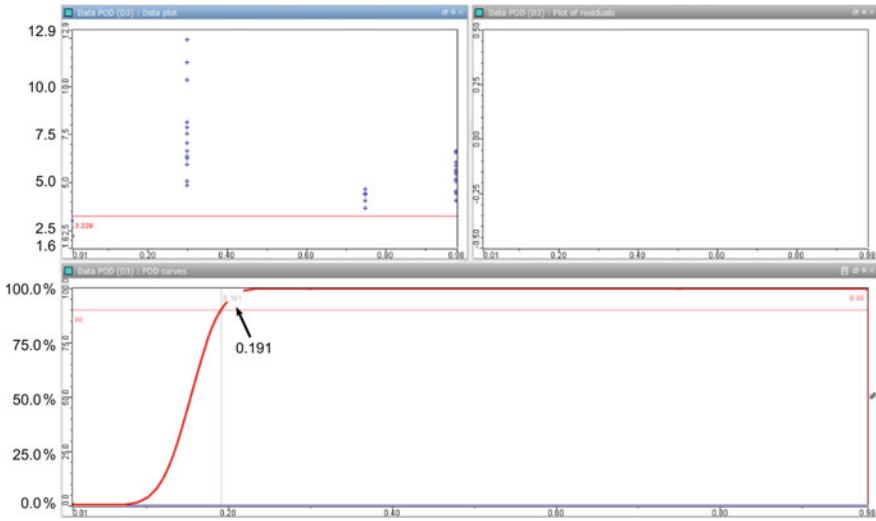
Fig. 5.60 POD curve for the NLUS datasets from the MO contamination scenario, applying a hit/miss model approach
