# Experimental Study on Ultrasonic Monitoring of Splitting Failure in Reinforced Concrete

Magdalena Rucka · Krzysztof Wilde

**Abstract** This paper investigates inspection of reinforced concrete elements sensitive to the splitting failure. The behaviour of a reinforced concrete specimen subjected to a tensile stress is considered. The damage detection procedure is based on the ultrasonic wave propagation technique. The piezoelectric transducers are located on both ends of the specimen and the measurements are taken periodically during the incrementally increased loading. The features of measured signals in time and frequency domains as well as wavelet transforms before and after the splitting failure are studied. The experimental results show that proposed method can be used for monitoring of damage evolution in concrete elements. The method makes possible detection of the moment just before the splitting failure occurs.

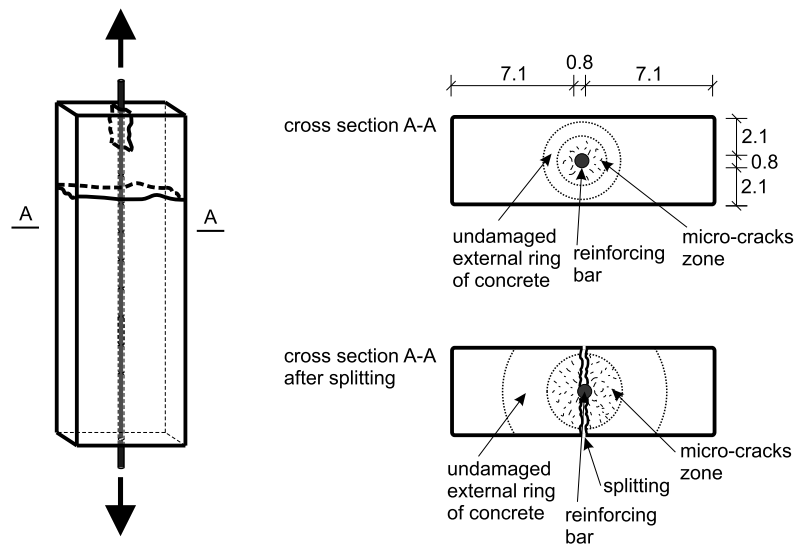
**Fig. 1** Considered concrete specimen in tension and sketch of formation of micro-cracks before and after splitting (dimensions shown in cm)

The splitting failure is a complex phenomenon that can lead to a collapse of a whole concrete element. Sensitive to the splitting failure are elements with reinforcement bars in tension with high bound stresses like anchorages with limited transverse pressure, heads of pre-stressed, pre-tensioned thin webbed beams [18]. The splitting failure of concrete elements is caused by a local collapse of the bond between steel bars and surrounding concrete. During loading, at first stage, radial micro-cracks develop in a limited zone around the reinforcement bar. The external ring of undamaged concrete provides sufficient confinement that prevents splitting. At large external loads the undamaged external ring becomes too thin and cracks spread through the element. When the splitting failure occurs the bond between the reinforcement and concrete is lost and cracks are wide open resulting in significant reduction of loading capacity. Problems of the bond and the splitting failure have been investigated by many researchers, e.g. [18–20]. Gambarova et al. [18] carried out tests on the concrete splitting along an anchored bar subjected to a pull-out force. Numerical analyses of the bond splitting failure were conducted by Ogura et al. [19]. Gálvez et al. [20] presented an experimental study on the bond-splitting in precast prestressed concrete during the release of a prestressing force. They examined the longitudinal splitting of the concrete specimens of dimensions  $40 \times 6 \times 6$  cm with one wire of diameter 4 mm embedded longitudinally in the specimen. The release of the load in the wire caused the longitudinal splitting of the concrete prism.

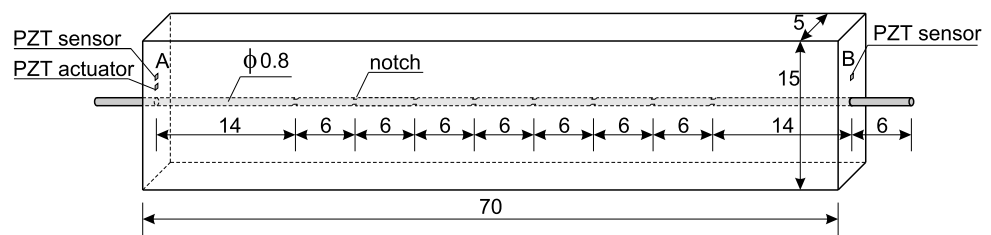
**Fig. 2** Geometry and dimensions of the tested reinforced specimen (dimensions shown in cm)

The concrete specimen with cross-section of  $5 \text{ cm} \times 15 \text{ cm}$  and length of 70 cm was considered as the testing element. Figure 2 presents the geometry and dimensions of the tested specimen. The ingredients of concrete were: Portland cement type CEM I 42.5R, sand (0–2 mm), fine aggregate (2–8 mm), coarse aggregate (8–16 mm), ash and superplasticizers. The proportion of concrete mix is outlined in Ta-

ble 1. The specimen was reinforced in longitudinal direction with one deformed steel bar of diameter 8 mm. Eight notches were cut on the bar at the distance of 6 cm (Fig. 2). The notches were applied to ensure that the splitting failure occurred within the concrete part of the specimen and to avoid damage of the bar outside of the concrete prism. The large number of notches was cut to cause relatively homogeneous damage zone that can be easily detected by ultrasonic methods.

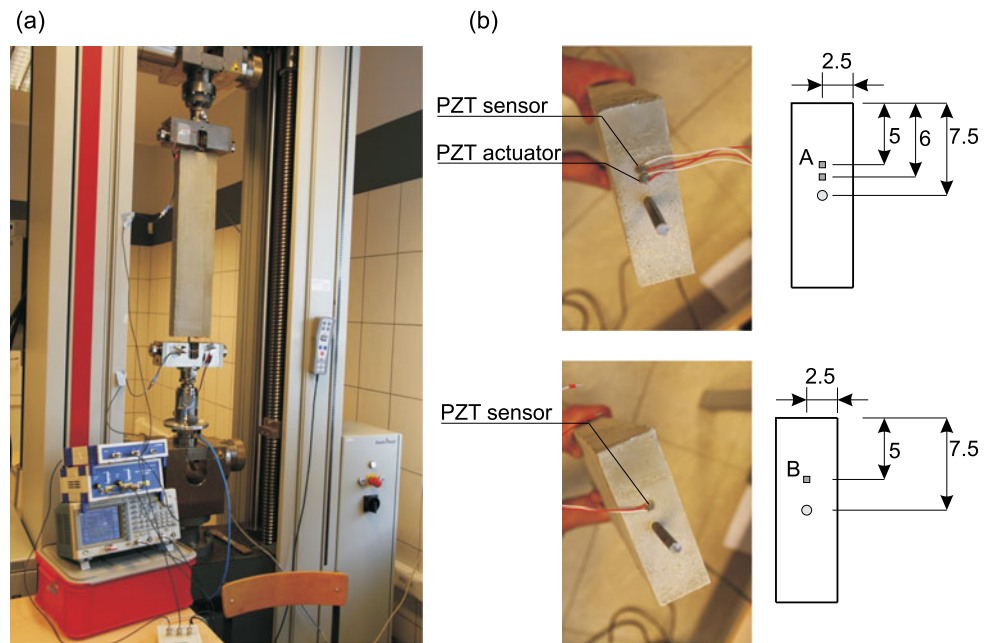
**Fig. 3** Experimental set-up for measurements of ultrasonic waves in the reinforced specimen under tensile loading: (a) photograph of instrumentation; (b) details showing location of PZT actuator and PZT sensors on the specimen (dimensions shown in cm)

The concrete specimen was subjected to axial tensile loading applied at both exposed ends of the embedded bar. The tensile tests were carried out in a testing machine Zwick/Roell Z400 using displacement control with the speed of the cross-head of 0.5 mm/min. The photo of the experimental set-up is shown in Fig. 3a.

During the tensile test, ultrasonic elastic waves were generated and propagated through the specimen. The ultrasonic waves were excited in the longitudinal direction by means of a plate PZT actuator Noliac CMAP11 of dimensions 5 mm × 5 mm × 2 mm bonded at the end of the concrete specimen by wax. Two PZT sensors bonded on both ends of the concrete specimen (sensors A and B, as depicted in Fig. 2 and Fig. 3b) were utilized for wave sensing. An arbitrary waveform generator (Tektronix AFG 3022) with a high voltage amplifier (EC Electronics PPA 2000) created an excitation voltage signal applied next to the PZT actuator, which converted it into a mechanical force. As a result of application the voltage amplifier the measured signal was amplified ten times. A digital oscilloscope (ScopeDAQ) was used to collect the A-scan signals with a sampling frequency of 1 MHz. During the tensile test, the ultrasonic wave signals were excited and acquired every 15 s, until the speci-

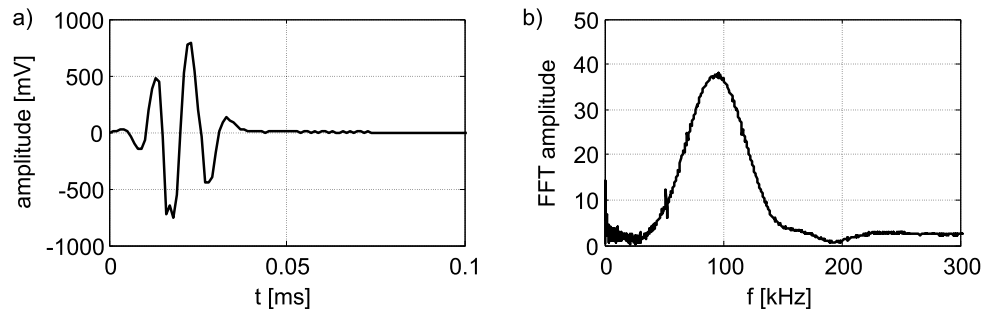
**Fig. 4** Excitation signal: (a) in time domain; (b) in frequency domain

The excitation signal considered in this study was chosen as a single-frequency smoothed tone burst (also known as a wave packet) obtained from the multiplication of a sinusoidal function of established frequency by a Hanning function. The Hanning window provides smoothed tone burst in order to reduce the excitation of side frequencies [17]. This aspect of excitation of coherent single-frequency waves is important in the context of ultrasonic diagnostics. The number of cycles in the tone burst has a strong influence on the bandwidth of the input signal. For the established frequency of the sine wave, a large number of cycles is advantageous to obtain a narrow band in the frequency domain. On the other side, too many cycles causes increasing of wave packet length in the time domain. In this study, a four-peak sinusoidal signal with a central frequency of 96 kHz modulated by the Hanning window (Fig. 4) was chosen as a compromise between acceptable level of resolution in the time and frequency domains.

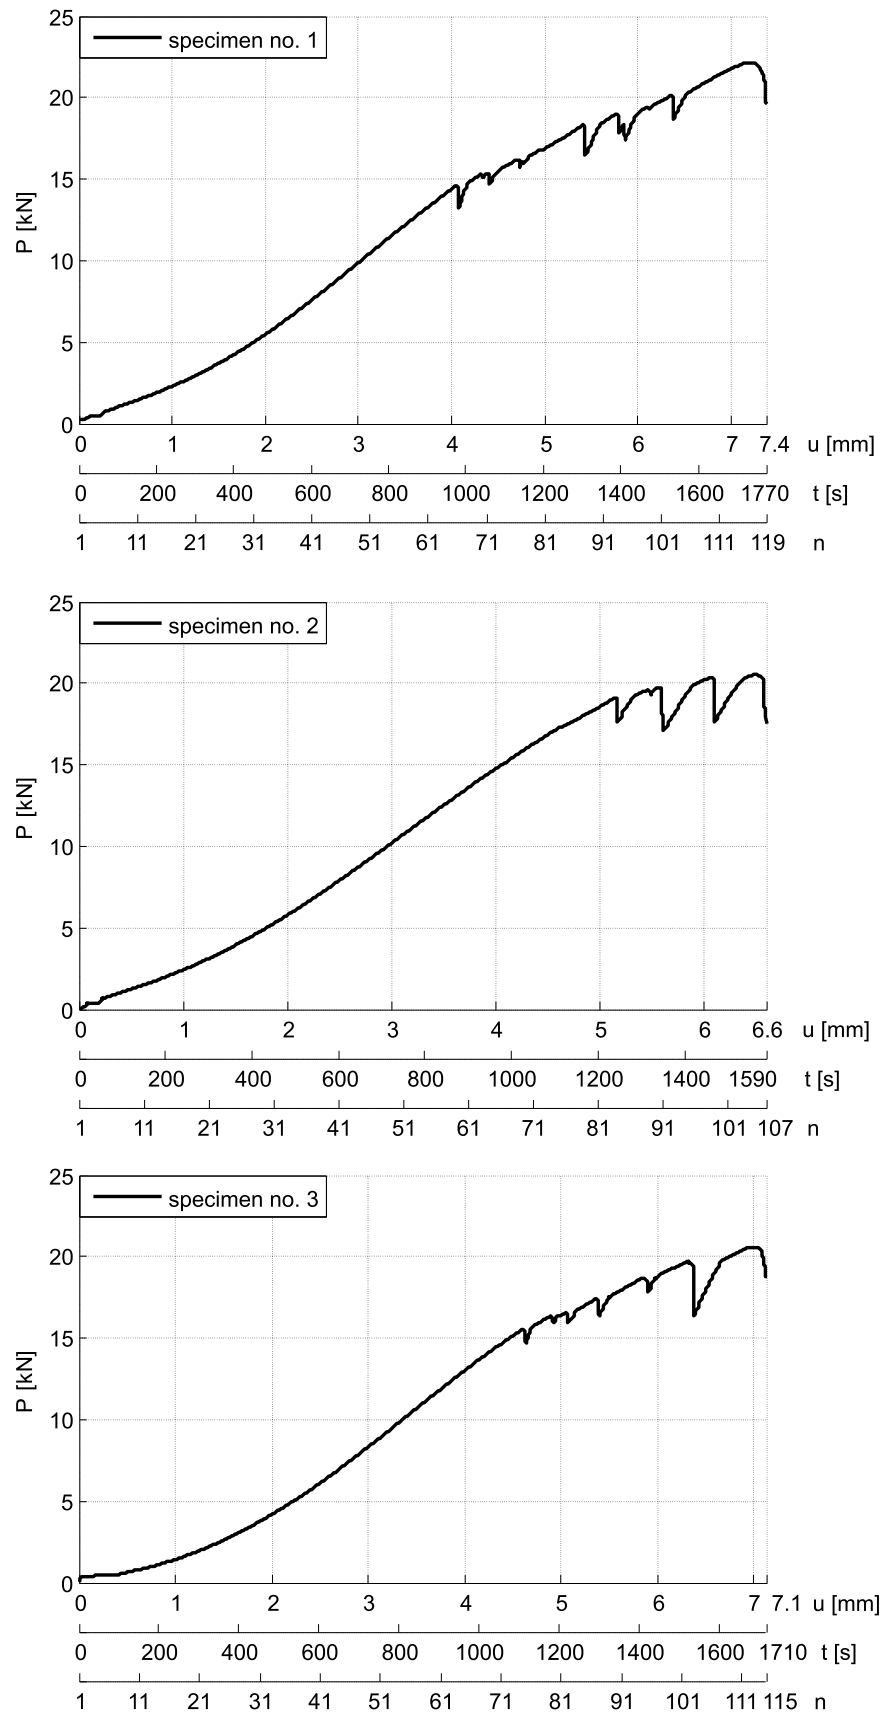
**Fig. 5** Experimental load-deflection ( $P-u$ ) and load-time ( $P-t$ ) curves of three reinforced concrete specimens

During the tensile tests, the displacement of the cross-head and the force level were recorded. Figure 5 shows the force-displacement ( $P-u$ ) and the force-time ( $P-t$ ) curves for the tested specimens. There are sudden drops of the force at the moments when the major splitting cracks appear and the load distribution within the specimen alters in time. It was noted that the sizes of the notches were not identical within the given element since they were cut by hand. The time of duration of the tensile test was 1770 s, 1590 s and 1710 s for specimen no. 1, no. 2 and no. 3, respectively. The maximum displacement  $u_{max}$  of the cross-head in the longitudinal direction was 7.38 mm, 6.6 mm and 7.12 mm for specimen no. 1, no. 2 and no. 3, respectively. During the tensile test, wave propagation measurements were conducted. Time signals were taken each 15 seconds and each signal was assigned ordinal number  $n$ . Parameter  $n$  started from  $n = 1$

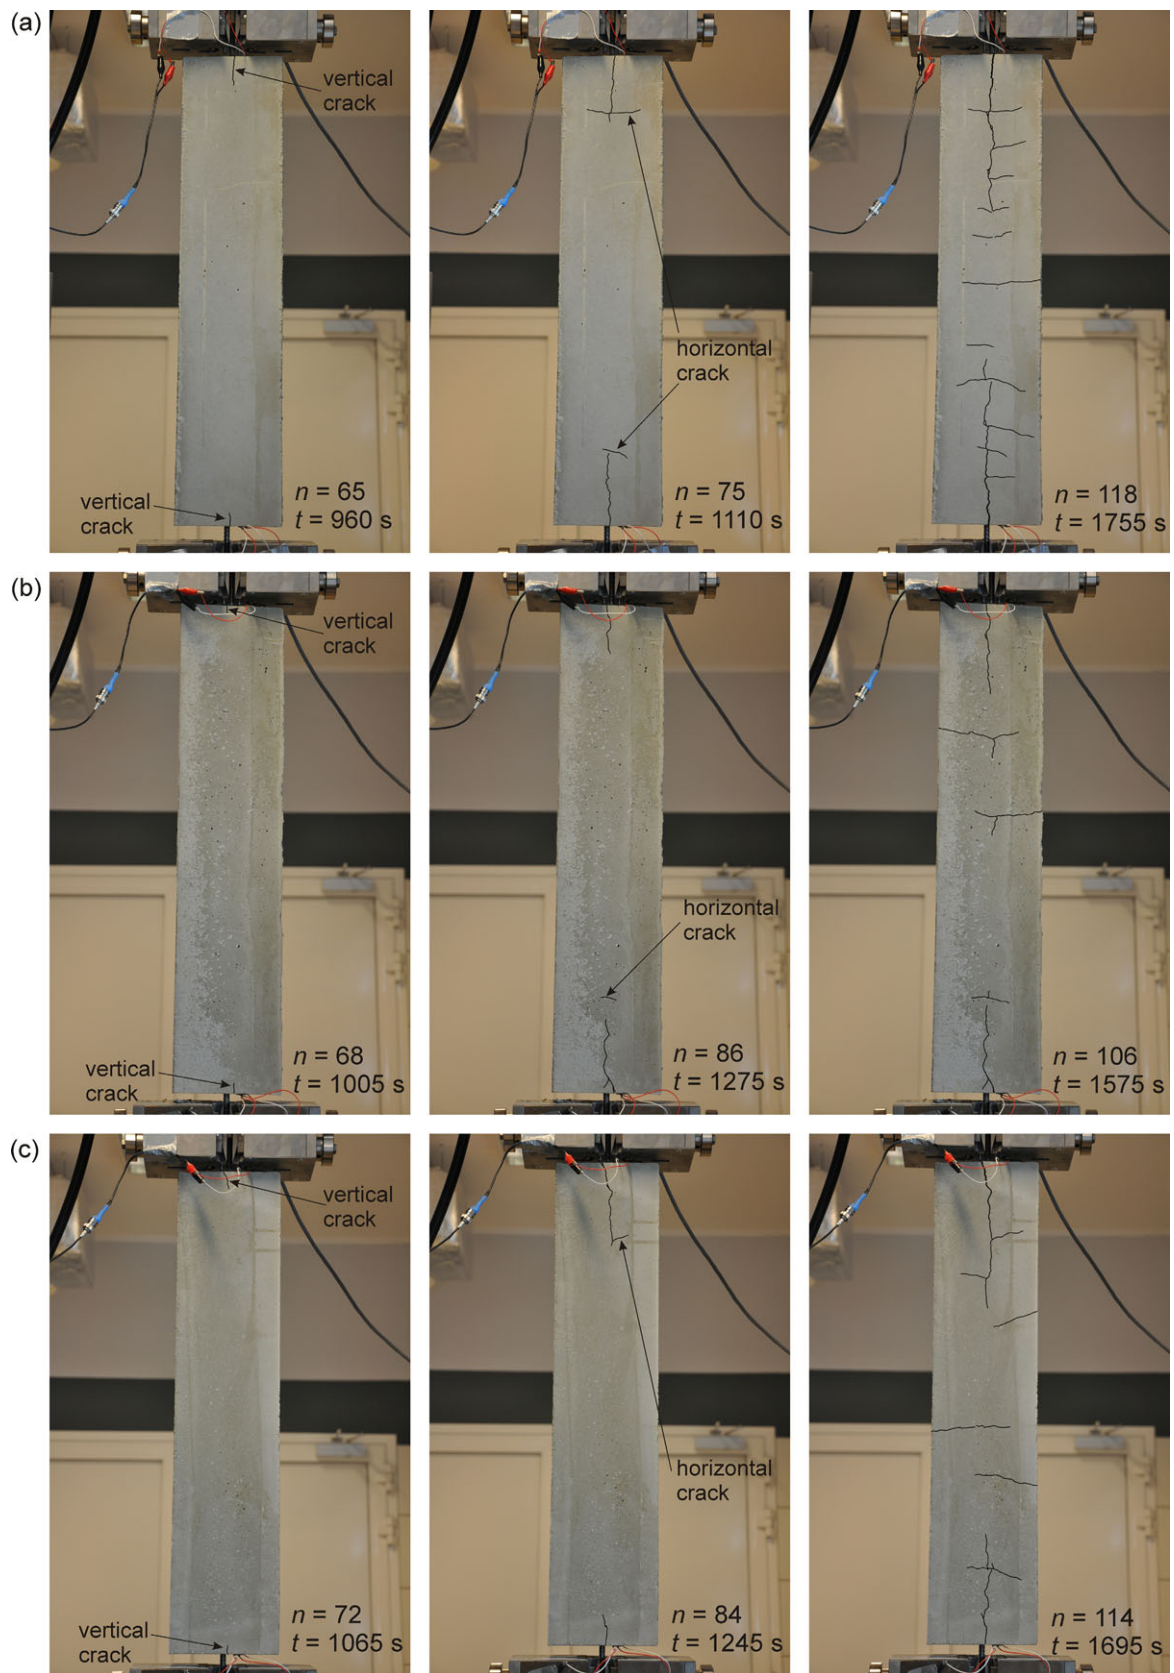
**Fig. 6** Experimental damage evolution and crack patterns of three tested specimens (state of initiation of vertical cracks, state of initiation of horizontal cracks, penultimate stage of damage): (a) specimen no. 1; (b) specimen no. 2; (c) specimen no. 3

Figure 6 presents the crack formation and damage evolution in the tested specimens at the increasing load levels. At the first stage of the fracture process, two vertical cracks started to develop at the top and the bottom of the specimen. These cracks were initiated at  $t = 960$  s ( $n = 65$ ,  $u = 0.54u_{max}$ ) for specimen no. 1, at  $t = 1005$  s ( $n = 68$ ,  $u = 0.63u_{max}$ ) for specimen no. 2 and at  $t = 1065$  s ( $n = 72$ ,  $u = 0.62u_{max}$ ) for specimen no. 3 (the first column of photographs in Fig. 6). Next the horizontal splitting of the concrete prism appeared at  $t = 1110$  s ( $n = 75$ ,  $u = 0.62u_{max}$ ) for specimen no. 1, at  $t = 1275$  s ( $n = 86$ ,  $u = 0.80u_{max}$ ) for specimen no. 2 and at  $t = 1245$  s ( $n = 84$ ,  $u = 0.73u_{max}$ ) for specimen no. 3. This stage of damage is illustrated by the second column of photographs in Fig. 6. The penultimate stage of damage is given in the third column in Fig. 6. It occurred at  $t = 1755$  s ( $n = 118$ ,  $u = 0.99u_{max}$ ) for specimen no. 1, at  $t = 1575$  s ( $n = 106$ ,  $u = 0.99u_{max}$ ) for specimen no. 2 and at  $t = 1695$  s ( $n = 114$ ,  $u = 0.99u_{max}$ ) for specimen no. 3. The tensile tests were stopped as a result of the tension failure of the steel bar. Figure 7 shows the details of the concrete specimen after the splitting failure. The prints of the lugs of the reinforcing bar are clearly seen on the piece of damaged concrete. Therefore, the slipping of the steel bar and damage of the bar surrounding concrete by the tips of the rebar lugs did not take place.

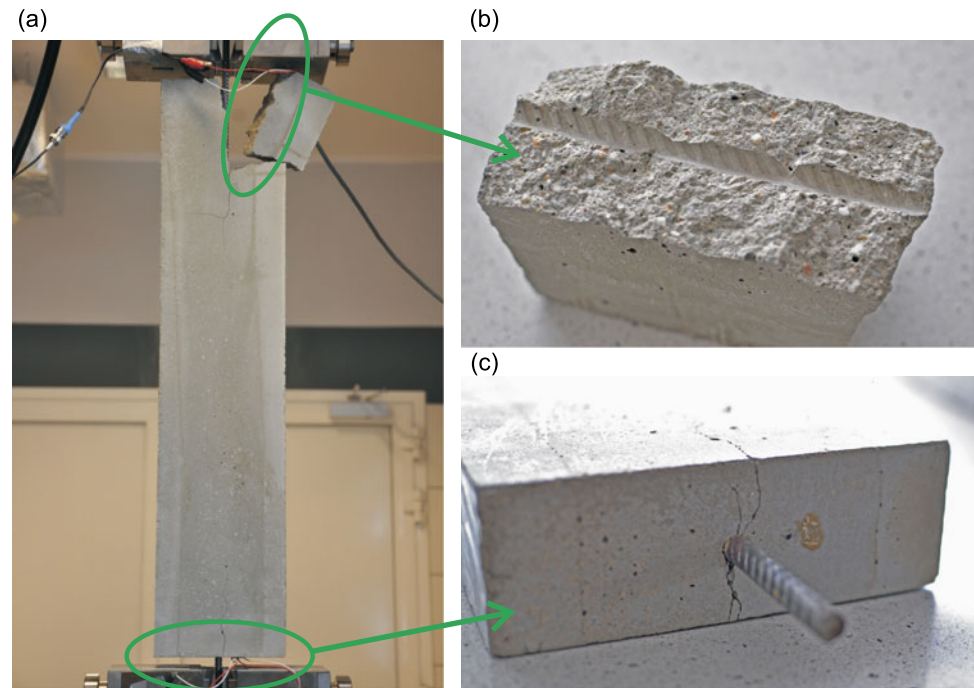
**Fig. 7** Specimen no. 3 after damage: (a) the view of the specimen; (b) interface between steel and concrete; (c) splitting cracks on the bottom part of the specimen

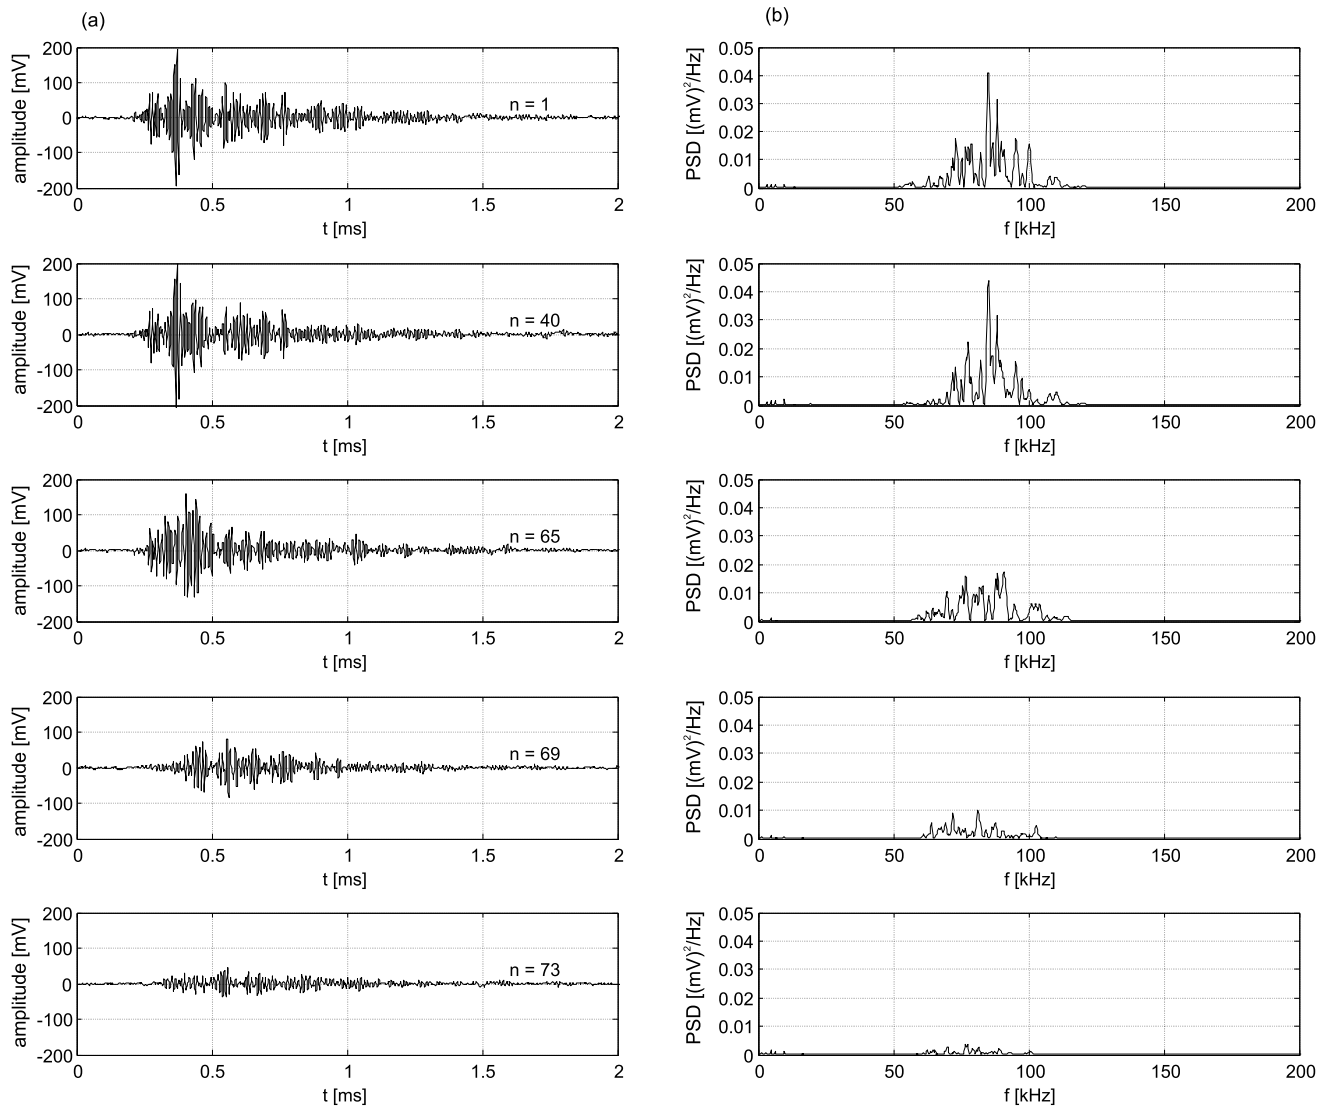
**Fig. 8** Ultrasonic signals registered at point B in specimen no. 1 for different load levels: (a) A-scan signals in time domain; (b) power spectral densities of time waveforms

The interpretation of measured signals in the frequency domain was performed by the power spectral density (PSD). The PSD function was used since it shows the signal power that better displays the changes in the wave propagation signals due to material degradation than Fourier transform. The PSD was computed using MATLAB®. The examples of the ultrasonic signals acquired at point B for specimen no. 1 and their power spectral densities are shown in Fig. 8. It can be seen that at the initial stage, no significant differences were visible in the measured time signals (e.g.  $n = 1$  and  $n = 40$ ).

The maximum amplitudes of the signals acquired at point B (on the opposite side then the PZT actuator) were practically the same for the signals from  $n = 1$  to  $n = 65$  and, then they decreased with the increase of the external tensile loading.

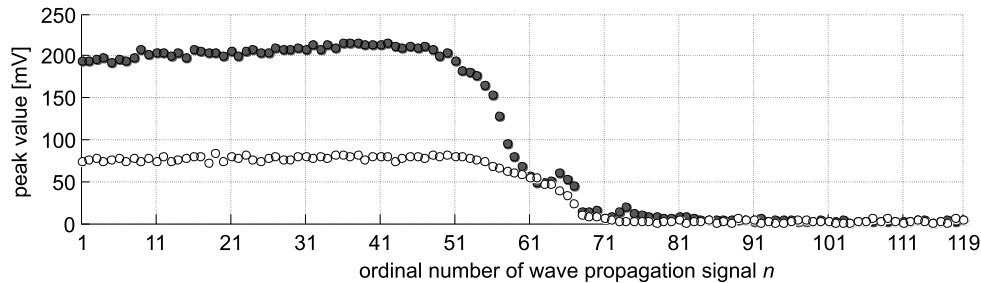
**Fig. 9** Peak values of wave propagation signals registered at point B in the specimen no. 1: the first wave packet corresponding to the first pressure wave traveling in the specimen (white dots) and the second wave

packet associated with interference of shearing and pressure waves reflected from the specimen cross-section boundaries (grey dots)

Figure 9 shows the peak values of the signals registered at point B for the specimen no. 1. Data in Fig. 9 are taken from the time signals (so called A-scans) for consecutive measurements of propagating ultrasonic waves. Peak values of the first incoming wave packet for the signals from  $n = 1$  to  $n = 119$  were plotted with white dots (Fig. 9). The first wave packet corresponds to the first pressure wave traveling in the specimen. The initial value of the peak was of about 80 mV. The first wave packet can be clearly seen for signal numbers from  $n = 1$  to  $n = 40$  (Fig. 9a). For the time records corresponding to higher signal numbers, the peak values of the first wave packet were determined for the time range  $t = 0.27$ – $0.28$  ms. The peak values of the second wave packet that can be seen at  $t = 0.37$ – $0.38$  ms were plotted in Fig. 9 with grey dots. The initial peak value of the second waveform was of about 200 mV. The second wave packet was associated with interference of shearing and pressure waves reflected from the specimen cross-section boundaries. The recognition which wave packet in the registered signal corresponds to pressure and shear waves was done based on wave velocities.

The amplitudes of the first wave packet were similar for the signal numbers from  $n = 1$  to  $n = 55$  (Fig. 9). From  $n = 56$  to  $n = 67$  the amplitudes started to decrease and from  $n = 68$  they became close to zero. Small micro-cracked

zones did not significantly affect the first pressure wave, and therefore, the significant drop of the maximum amplitudes was noticed when the first vertical crack appeared (at  $n = 65$ ). The amplitudes of the second wave packet were constant for signal numbers from  $n = 1$  to  $n = 51$  and the relatively rapid decrease of the amplitudes took place till  $n = 61$ . At signal number  $n = 75$  the maximum amplitudes of the second wave packet became very small. It seems that the change of the peak values of the second wave packet indicated the development of the micro-crack zone before splitting takes place. The vertical splitting cracks were observed for  $n = 65$  while the reduction of the amplitudes starts at  $n = 51$ . Formations of micro-crack zones had relatively large influence on the reflected shear and pressure waves resulting in large attenuation of the second wave packet.

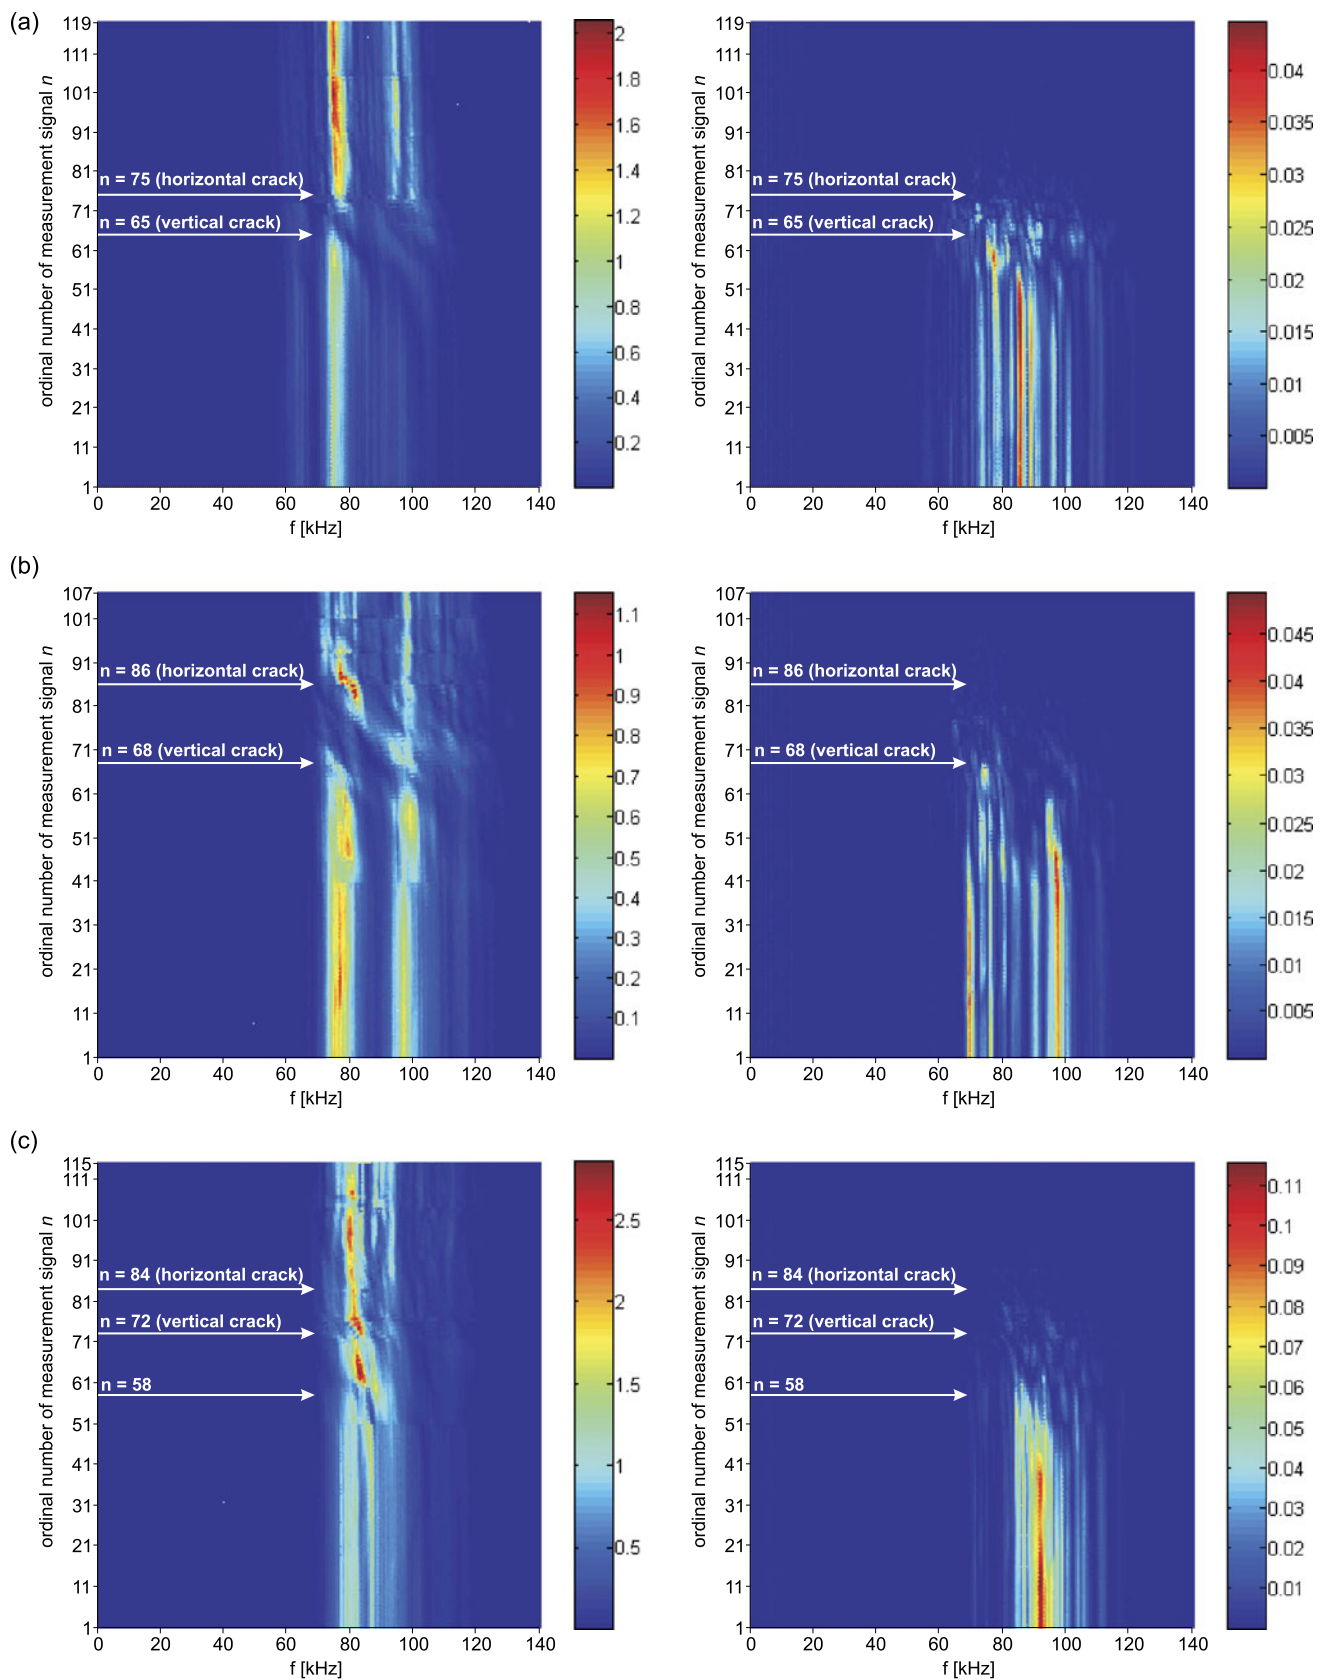
**Fig. 10** Power spectral density maps of registered signals at point A (left column) and at point B (right column): (a) specimen no. 1; (b) specimen no. 2; (c) specimen no. 3 (power spectral densities are in units of  $(\text{mV})^2/\text{Hz}$ )

The evolution of the frequency spectrums in time for specimen no. 1, 2 and 3 are shown in Fig. 10. The power spectral densities of all ultrasonic signals acquired during the tensile test were plotted in the form of maps. White arrows indicate two characteristic measurements for each specimen: the measurement associated with the appearance of the first vertical crack and the measurement associated with the appearance of the first horizontal crack. The right column of Fig. 10 illustrates the power spectral densities of the A-scan signals measured at point B. It can be observed, that the amplitudes decreased with the increase of the damage stage. At the moment of the first vertical crack development, the amplitudes of the PSD revealed sudden change. The decrease in amplitudes occurred in a quasi-

The left column of Fig. 10 presents the power spectral densities of the signals measured at point A. These signals had similar amplitudes during all measurements because of

their close location to the PZT actuator. Clear oblique lines are visible in the PSD maps for all specimens. At the moment of initiation of vertical crack, local decrease in the PSD amplitudes can be observed. It started at  $n = 65$  for the specimen no. 1 and  $n = 68$  for the specimen no. 2. This local decrease had an oblique line shape, i.e. first higher frequencies are damped, while the lower frequencies are damped at the next time instances. In the specimen no. 3 the first vertical crack was observed for measurement  $n = 72$ . However, it can be seen at the PSD map, that additional local decrease of amplitudes occurred ( $n = 58$ ), probably as a result of other vertical crack on the opposite side (not monitored by camera).

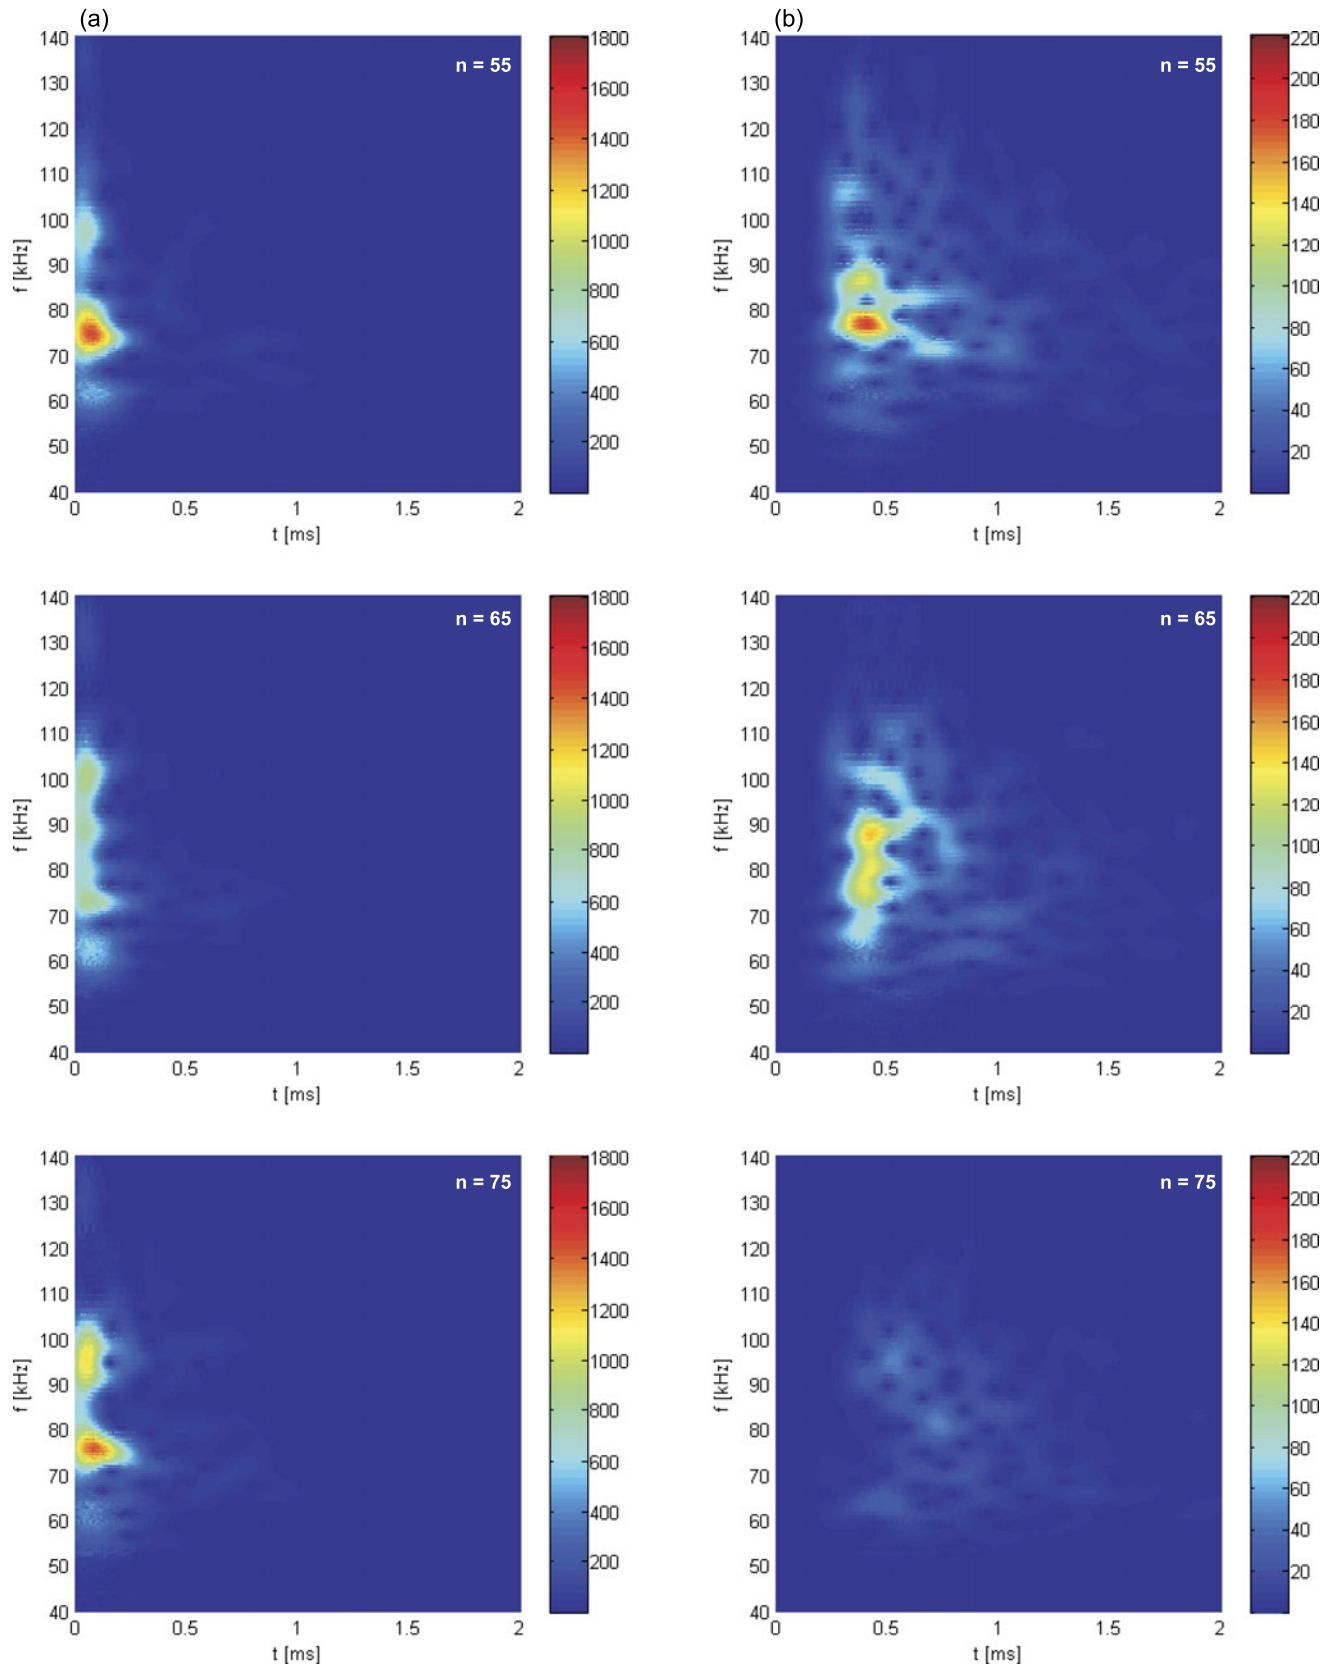
**Fig. 11** Wavelet transforms for specimen no. 1 for different load levels: (a) signals registered at point A; (b) signals registered at point B (wavelet transforms are in units of mV)

The wavelet transform results for the selected A-scan signals for specimen no. 1 are presented in Fig. 11. The left column of Fig. 11 shows the wavelet coefficients of the signals registered at point A and the right column depicts the wavelet coefficients of signals registered at point B for time steps corresponding to  $n = 55$  (stage before splitting),  $n = 65$  (appearance of the first vertical splitting crack) and  $n = 75$  (after the splitting failure). For  $n = 55$ , the elastic waves of frequency 76 kHz travelled through the concrete specimen and they can be observed in both signals measured at points A and B. At the beginning of development of the first splitting crack ( $n = 65$ ), the micro-crack zones were the biggest, causing a significant reduction of the amplitudes of ultrasonic waves at points A and B. Wave packets had frequency range from 70 kHz to 100 kHz. Further increase of

the external loading (e.g.  $n = 75$ ) resulted in the appearance of several large splitting crack and yielding of the steel bar. Plastic deformation of the bar near the notch changed the longitudinal load distribution. Largest deformations were in the areas near the notches. The internal forces in the specimen in the region from its top (the location of point A) to the first horizontal splitting crack were reduced. Therefore, the micro-crack zone became smaller and the waves generated in the neighbourhood of the measurement point A could travel with relatively small damping. Figure 11a (left column) shows large wavelet coefficients at frequency 76 kHz and 96 kHz for the specimen after splitting failure ( $n = 75$ ). The right column of Fig. 11b shows the wavelet coefficients of the signals at point B ( $n = 75$ ). There are no large values of the wavelet coefficients since the specimen have been destroyed by the horizontal splitting cracks that prevented propagation of ultrasonic waves from point A to point B through the concrete.
