Experimental study of casing wear under impact-sliding conditions

Chu Shengli, Zhang Laibin*, Fan Jianchun, Zheng Wenpei and Yu Huiyuan

School of Mechanical and Electronic Engineering, China University of Petroleum, Beijing 102249, China

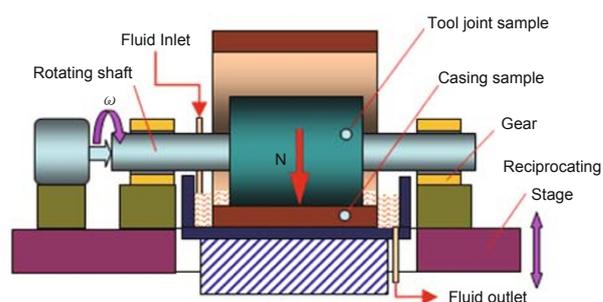
A DCWT-1000 casing-wear test facility used is a new type of full-scale impact-sliding test machine (Chu et al, 2007), and its schematic diagram is shown in Fig. 1. The tool-joint sample was mounted on a rotating shaft, which was linked to the reciprocating stage by two gears. The rotating shaft drove the tool-joint sample to rotate and the reciprocating stage drove the rotating shaft to move up and down. Thus, the machine built could be used to carry out impact-sliding wear tests. The casing was fixed on a floating landing stage

Fig. 1 Schematic diagram of casing-wear tester

with a force sensor that could measure real-time contact force between the casing and the tool joint. Wall thickness loss and driving torque were measured on-line as well (Chu, 2006).

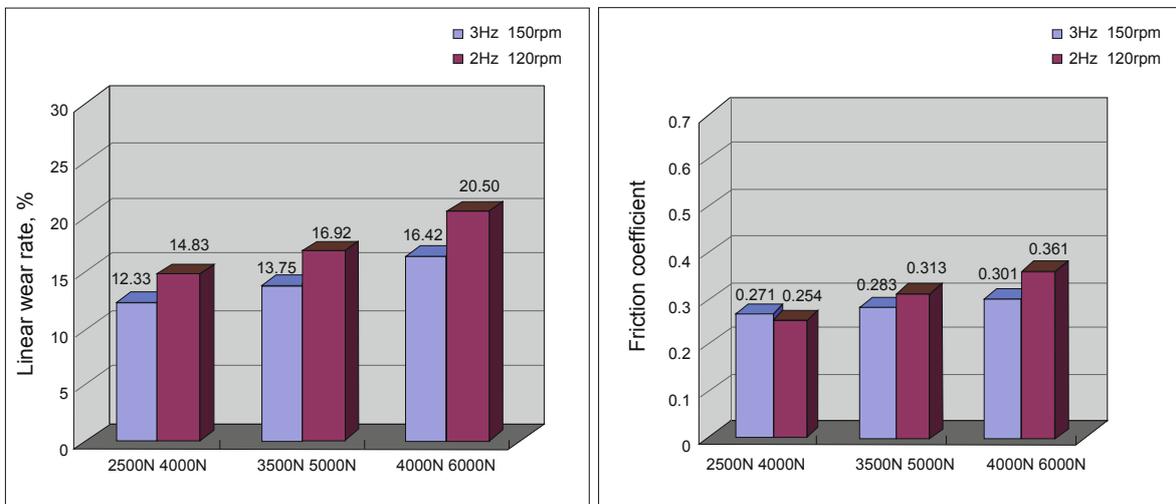
In this paper, the thickness loss of the casing wall (wear depth), linear wear rate, and friction coefficient were introduced to evaluate casing wear. The linear wear rate was defined as the wear depth divided by the initial thickness of the casing wall. Fig. 2 shows test results of linear wear rate and average friction coefficient under two different impact conditions. Fig. 3 shows the variation in thickness loss of the casing wall with wear time under different impact loads and frequency conditions. Eight hour wear test results showed that the linear wear rate, friction coefficient, and wall thickness loss of casings increased significantly as the impact load increased. The three-dimensional topography of worn surface of casings after wear test were measured with casing surface topography test equipment (Chen et al, 2007) and shown in Fig. 4. For comparison, the surface of the casing before wear test was also shown in Fig. 4. It is clearly shown that as the impact load increased, the worn surface of the casing became more uneven, more noticeably convex peaks and concave cavities were visible on the worn surface of casings, and more rough peaks were detected. The larger the impact load, the rougher the worn surface of casing.

Fig. 2 Linear wear rate of casings and friction coefficient under different impact load conditions

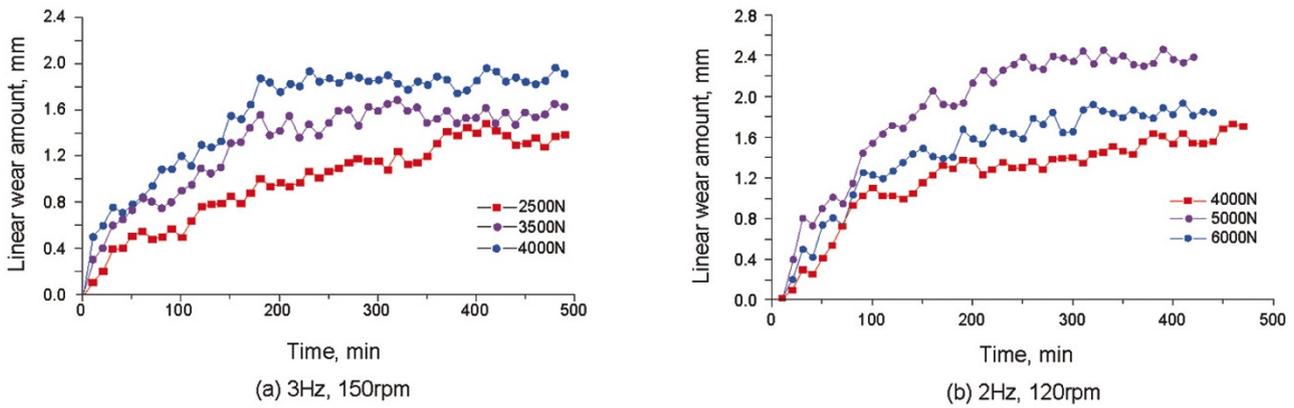
Fig. 3 Variation in dynamic thickness loss of casing wall under different impact load conditions

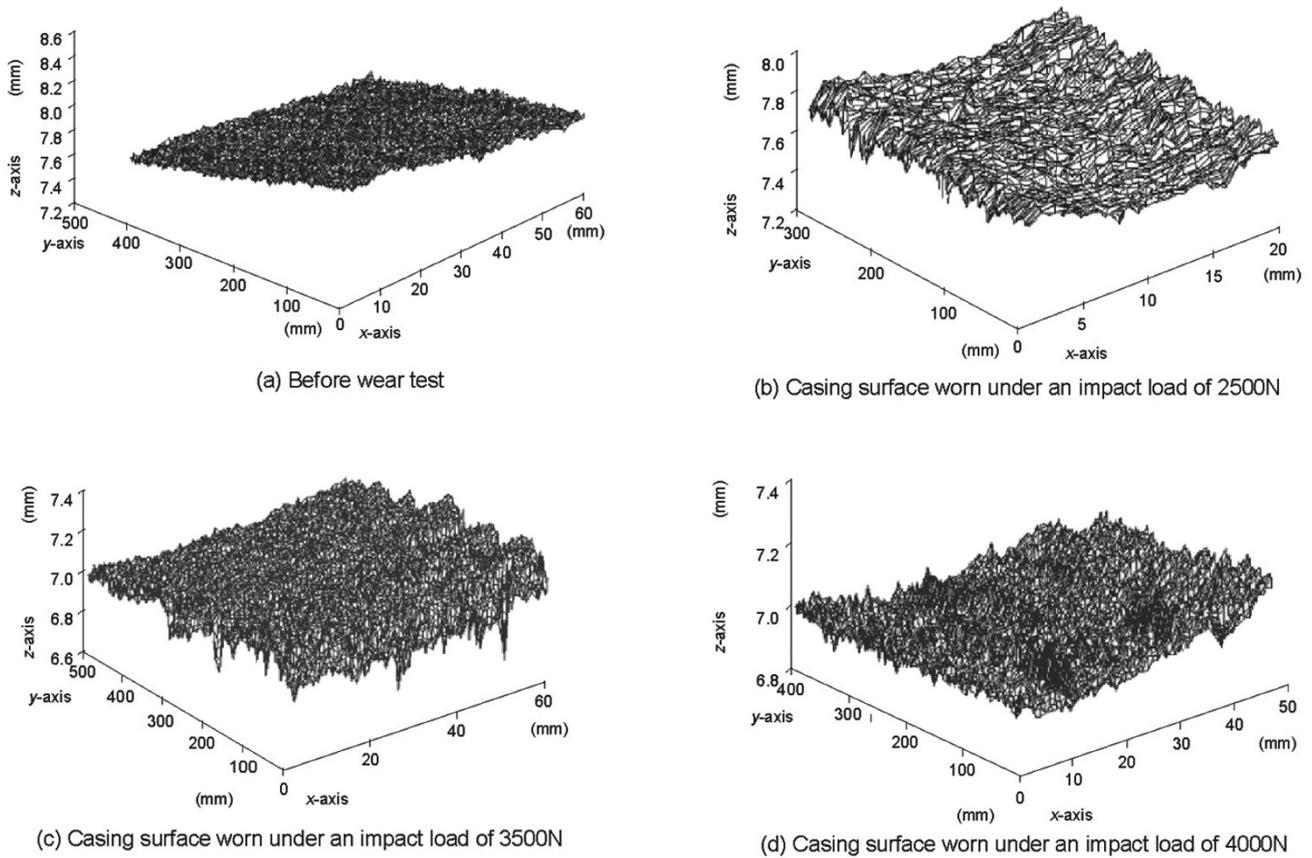
Fig. 4 3-D surface topography of casings before and after wear tests

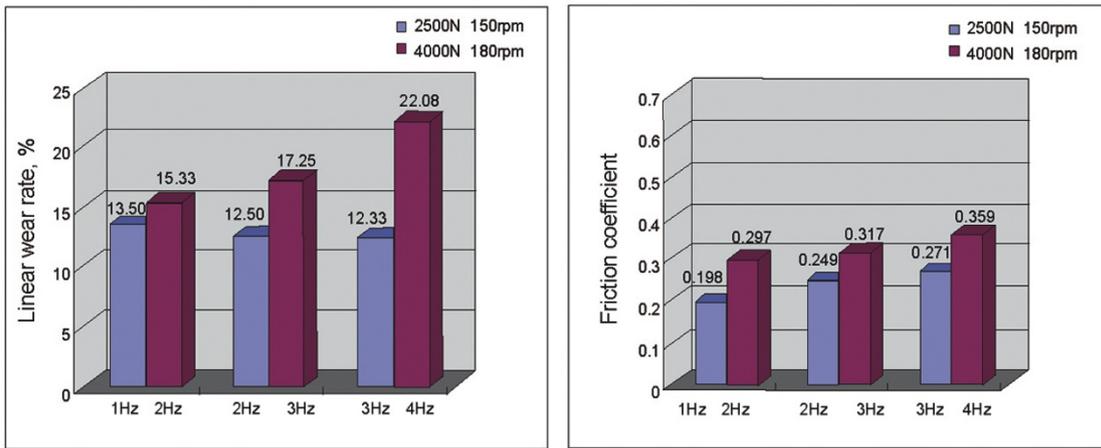
Eight hour wear test results (Fig. 5) showed that the linear wear rate decreased slightly but the average friction coefficient increased slightly with an increase in impact frequency under relative low impact load (2,500 N). However, both the linear wear rate of the casing and average friction coefficient increased substantially with an increase in impact frequency under relative high impact load (4,000 N).

Fig 5 Linear wear rate of casings and friction coefficient under different impact frequency conditions

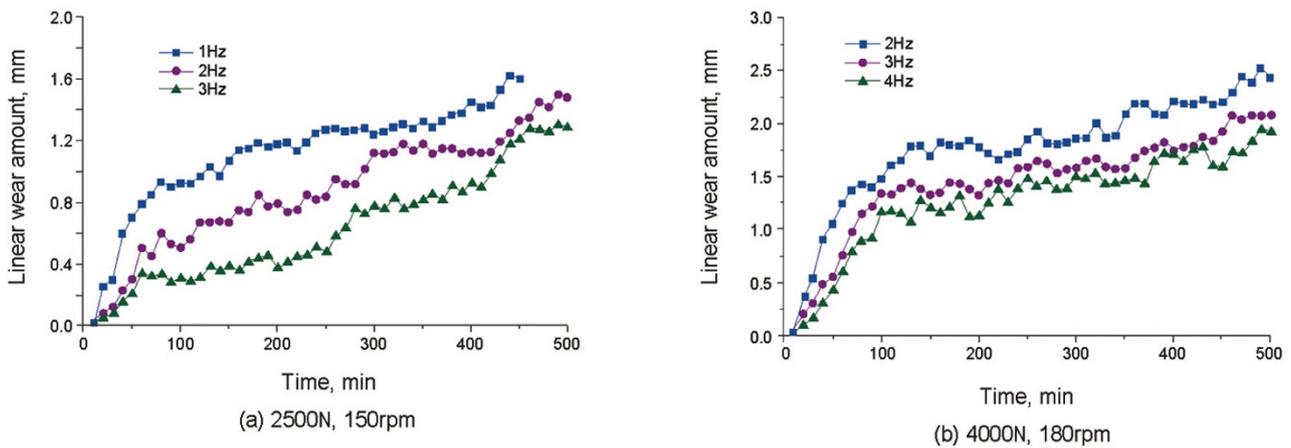
The dynamic casing wear under different impact frequency and impact load values was presented in Fig. 6. The eight hour test results showed that when impact frequency was relative low (2 Hz) the casing wear increased more rapidly at the early stage of wear tests, but when the impact frequency was relative high (3 Hz) the casing wear increased slowly at the early stage of wear tests and quickly at the later stage. A reason for this result is that during an impact cycle, relative longer contact time between two samples can cause more casing wear under relative low load (2,500 N) and impact frequency. However, under high impact load (4,000 N) and frequency (more than 2 Hz) fatigue micro-cracks form

Fig. 6 Variation in dynamic linear wear rate under different impact load conditions

more easily on the surfaces of samples, and the fatigue wear results in more casing wear (shown in the Fig. 6(b)). Fig. 7 showed that the casing surface worn under higher impact frequency was rougher than that worn under lower impact frequency.

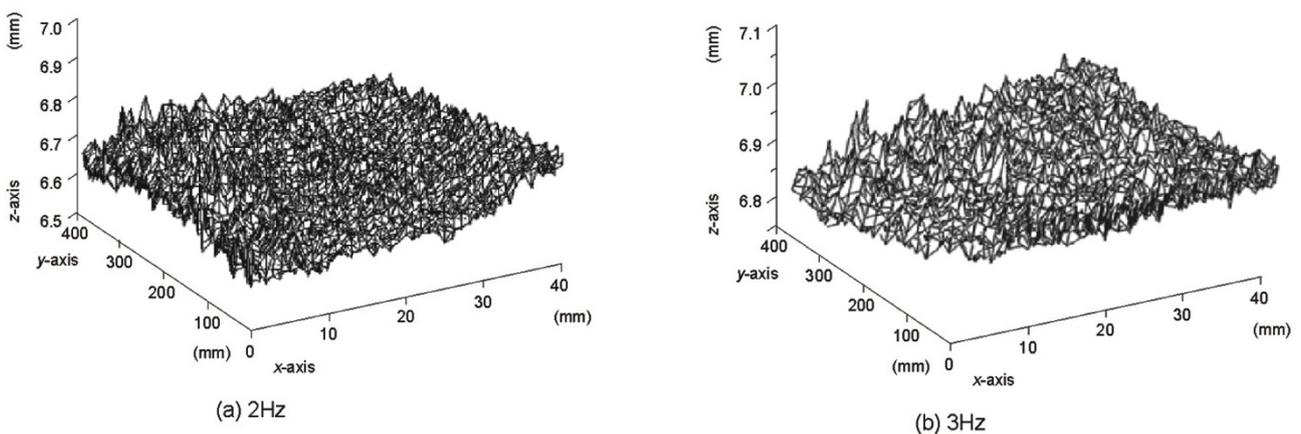
Fig. 7 3-D wear surface topography of casings under an impact load of 4000N

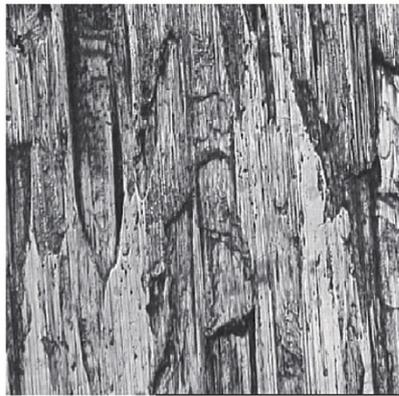
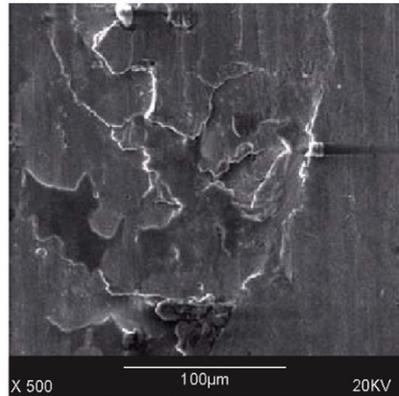
Typical optical and SEM images of casing surfaces worn under different test conditions are shown in Fig. 8. Noticeable plastic flow and plastic accumulation were observed on the optical image of the casing wear surface when the wear test was performed at an impact frequency of 2 Hz and an impact load of 2,500 N (shown in the left-hand side of Fig. 8(a)). Many fatigue flakes were observed clearly in its SEM image.

(a) 2500N, 2Hz (OM×100; SEM×500)

Fig. 8 Optical and SEM images of casing surfaces worn under different conditions

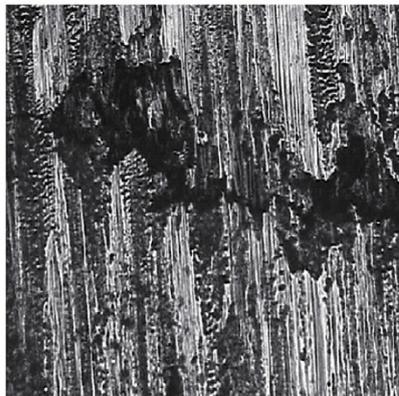
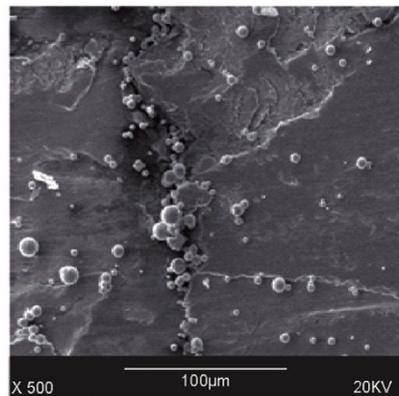
Fig. 8(b) showed that serious ploughed furrows and fatigue pits, which connected with fatigue cracks, were formed on the worn surface of casings (shown on the optical image of Fig. 8(b)), and large fatigue cavities linked with fatigue cracks occurred on the surface of casings worn against the tool joint at an impact frequency of 3 Hz. Adhesive wear and

large fatigue peelings, and a number of spherical fatigue-wear particles were visible on the SEM image of Fig. 8(b).

(b) 2500N, 3Hz (OM×100; SEM×500)

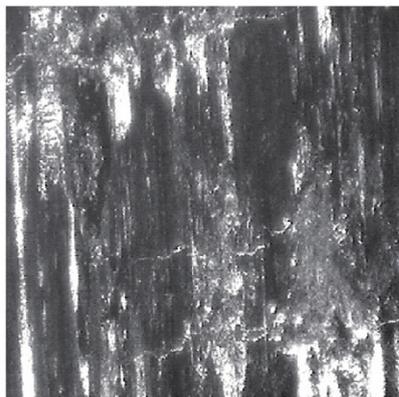
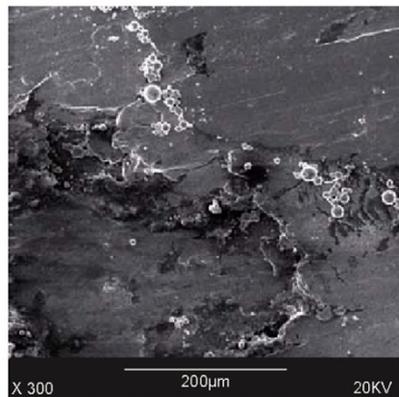
Obvious fatigue wear and adhesion appeared on the casing surface under an impact load of 4,000 N. It can be seen from Fig. 8(c), the generated fatigue cracks propagated continuously and were accompanied by adhesion wear. Deep

(c) 4000N, 2Hz (OM×100; SEM×300)

cavities were observed on the SEM image of Fig. 8(c), this is typical of fatigue wear. Connection between fatigue cavities, adhesion wear, and abrasion marks appeared on the SEM image of Fig. 8(d) (Yu et al, 2004).

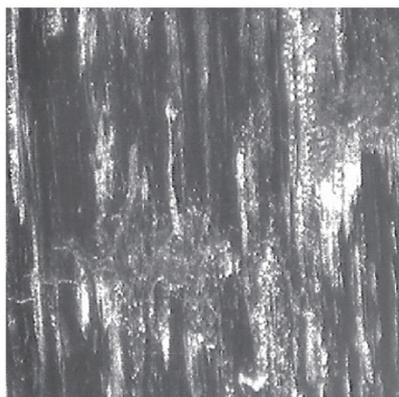
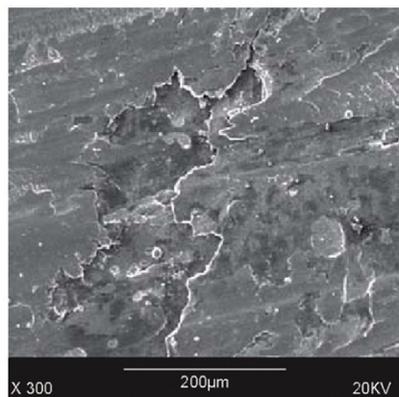
(d) 4000N, 3Hz (OM×100; SEM×300)
