An integrated framework for non-destructive evaluation of bridges using UAS: a case study

Abstract

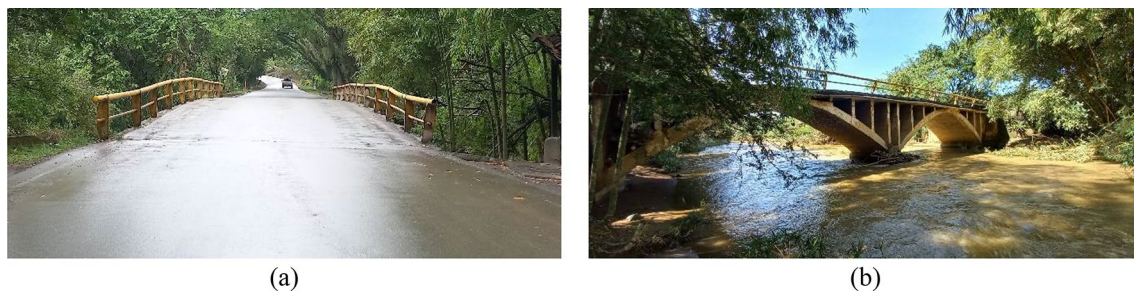
Fig. 5 The Río Claro Bridge: **a** Road view **b** Isometric view

The Río Claro Bridge, presented in Fig. 5, complied with the abovementioned criteria and was selected as the case study. The bridge is located on the road connecting the municipality of Jamundí in the Valle del Cauca Department to the municipality of Suárez in the Cauca Department. The bridge has a length of 28.5 m (93.5 feet) and a deck width of 6.58 m (22.47 feet). The bridge comprises a reinforced concrete arch-type system with metal railings, asphalt-type road, deck, and arch-deck with walls, arches, cutwater, abutments, debris fins, and foundations.

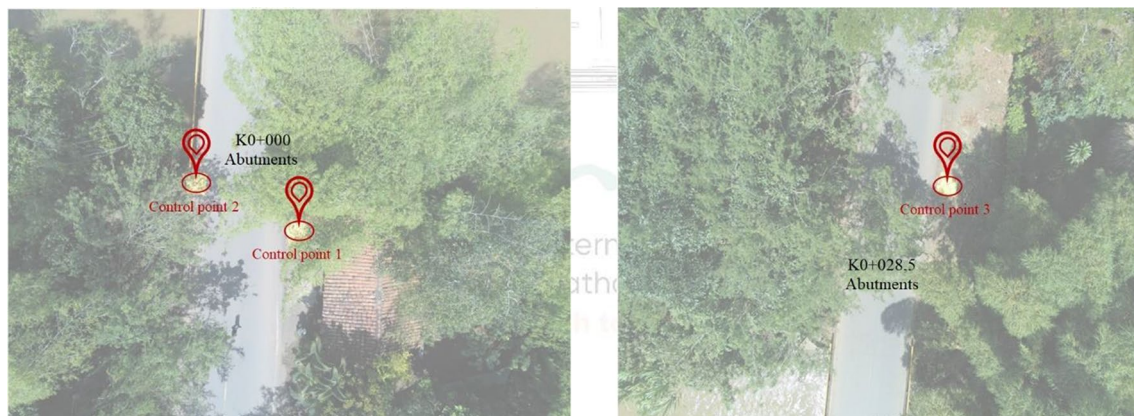
Fig. 6 Plan views of control points near the case study bridge

this information, a first “simple grid” flight mission was completed to identify bridge sections and surrounding areas. The mission was conducted 20 m above the bridge deck with the UAV camera oriented at a 90° angle. The total mission time was 2 min at a speed of 2 m/s (4.47 mph). The purpose of this flight was to locate control points using Global Positioning System (GPS) to enable georeferencing pictures.

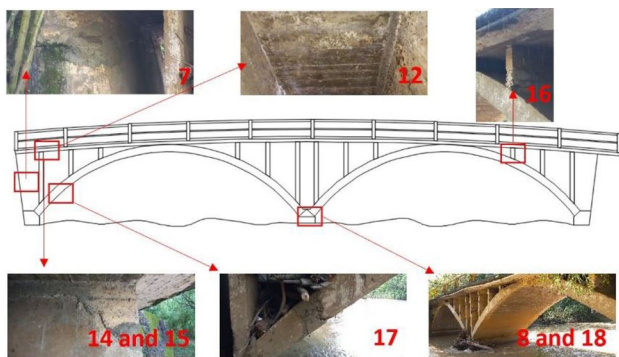
Fig. 8 Elevation view of the bridge with defects obtained by traditional inspection

A visual representation of Table 1 is presented in Figs. 8 and 9. Each image contains a number corresponding to the element number in Table 1.

No	Elements	Defects	Measure	Numerical rating
1	Asphalt wearing surface	Transverse crack	2.45 m	3
2	Asphalt wearing surface	Expansion joint crack	13.16 m	3
3	Steel railing	Painted steel railing	140 m	2
4	Steel railing	Deformations by vehicular impact	19.8 m	4
5	Wing wall and abutments	Vegetation growing	63.73 m ²	2
6	Wing wall and abutments	Inadequate construction joint	7 m	4
7	Wing wall and abutments	Crack due to movement of the abutments wall	9.58 m	4
8	Cutwater	Accumulation of debris	–	–
9	Reinforced concrete deck slab	Exposed reinforcing bars	0.82 m ²	4
10	Reinforced concrete deck slab	Efflorescence	2.98 m ²	3
11	Reinforced concrete deck slab	Inadequate coating thickness	–	–
12	Reinforced concrete deck slab	Honeycombing	0.60 m ²	2
13	Reinforced concrete deck slab	Vegetation growing	8.54 m ²	2
14	Open-spandrel wall	Shear cracks	1.20 m	4
15	Open-spandrel wall	Inadequate construction joint	9.04 m	4
16	Open-spandrel wall	Honeycombing	–	–

17	Reinforced concrete arch	Honeycombing	0.34 m ²	3
18	Reinforced concrete arch	Efflorescence	–	–

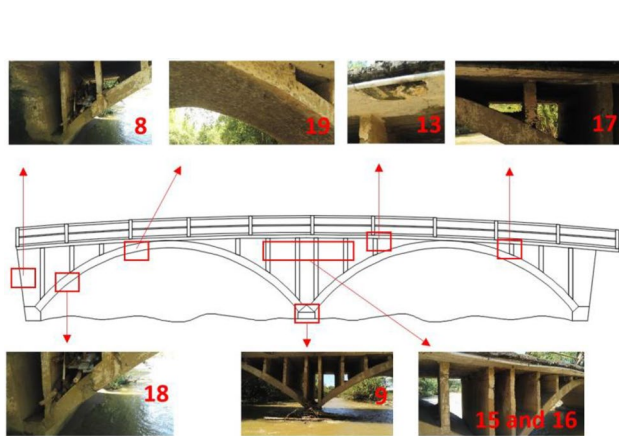
Fig. 10 Bridge elevation view with defects captured by UAS

Table 2 summarizes the inspection report prepared with information obtained by the UAS. In addition, Figs. 10 and 11 provide a visual representation of the defects on the case study bridge obtained by UAS inspection. Each image contains a number corresponding to the element number in Table 2.

No	Elements	Defects	Measure	Numerical rating
1	Asphalt wearing surface	Transverse crack	2.27 m	3
2	Asphalt wearing surface	Longitudinal crack	0.88 m	3
3	Asphalt wearing surface	Expansion joint crack	12.56 m	3
4	Steel railing	Painted steel railing	118 m	2
5	Steel railing	Deformations by vehicular impact	6.84 m	4
6	Wing wall and abutments	Vegetation growing	68 m ²	2
7	Wing wall and abutments	Inadequate construction joint	13.48 m	4
8	Wing wall and abutments	Crack due to movement of the abutments wall	6.68 m	4
9	Cutwater	Accumulation of debris	3 m ²	3
10	Reinforced concrete deck slab	Exposed reinforcing bars	1.45 m ²	4
11	Reinforced concrete deck slab	Efflorescence	7.98 m ²	3
12	Reinforced concrete deck slab	Inadequate coating thickness	1.20 m ²	3
13	Reinforced concrete deck slab	Honeycombing	0.60 m ²	2
14	Reinforced concrete deck slab	Vegetation growing	8.53 m ²	2
15	Open-spandrel wall	Shear cracks	2.66 m	4

16	Open-spandrel wall	Inadequate construction joint	57.85 m	4
17	Open-spandrel wall	Honeycombing	2.22 m ²	4
18	Reinforced concrete arch	Honeycombing	0.24 m ²	3
19	Reinforced concrete arch	Efflorescence	50 m ²	3

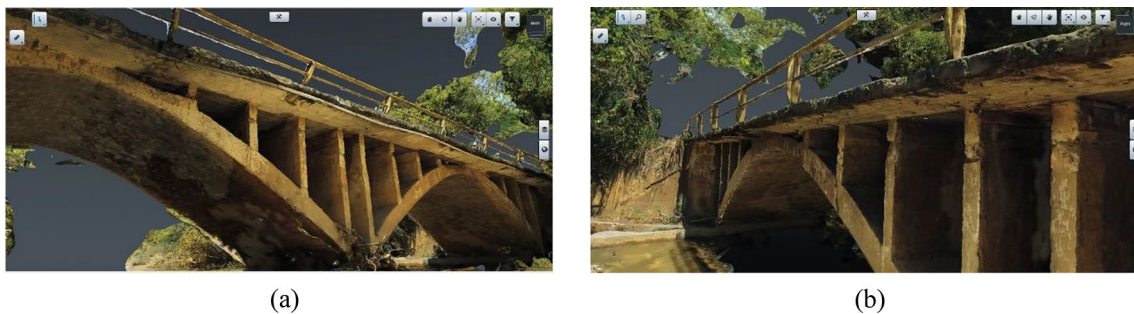
Fig. 13 3D model of the case study bridge: **a** upstream view and **b** downstream view

The final product of this innovative analysis is the 3D model presented in Fig. 13. The model allowed the quantification of previously undetected structural defects using

traditional inspection. Defects determined from the 3D model include cracks, joint damage, fissures, efflorescence, segregation, and defects in the arches, slab, and railings.

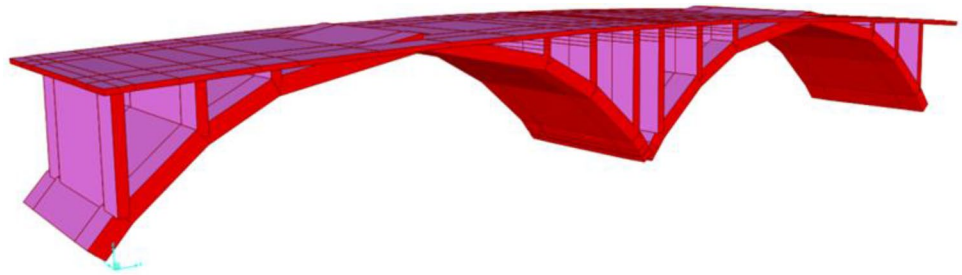
Fig. 14 3D structural model

from the 3D modeling obtained using the images captured by the UAS. The components were assigned a shell-type configuration in the software and support as either pinned or fixed, as presented in Fig. 14.

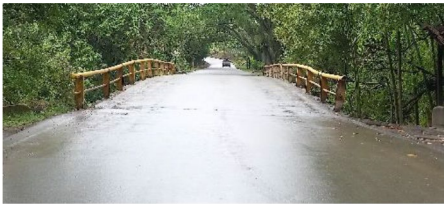
High: e.g., a measure of honeycombing in the reinforced concrete arch (0.244 m ²) presented in the figure  
Accuracy in the damage quantification of elements with limited access	Not possible	High: e.g., honeycombing in an open spandrel wall (1.0 m ²)
