# Safeguarding and Preservation Activities at the Giant Buddhas and Other Monuments in the Bamiyan Valley 2004–2017

Bert Praxenthaler and Matthias Beckh

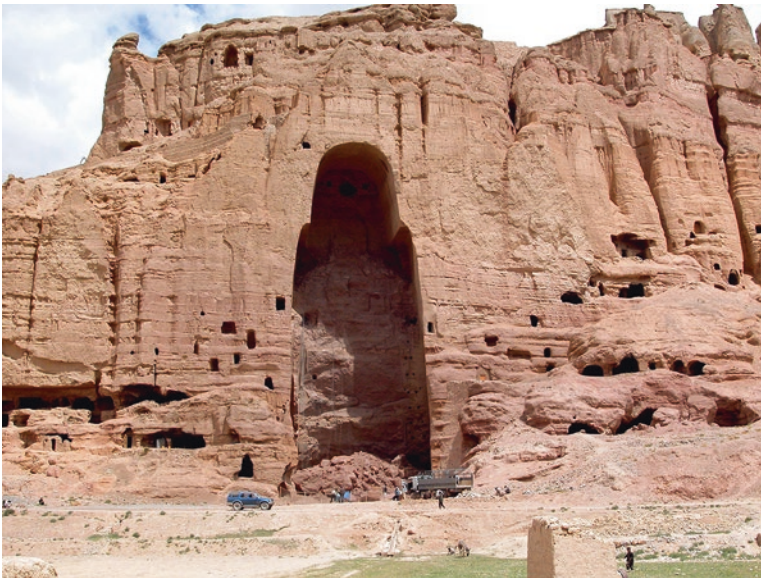
**Photo 1** Western Buddha, June 2004, at the start of the mission. (© Matthias Beckh)

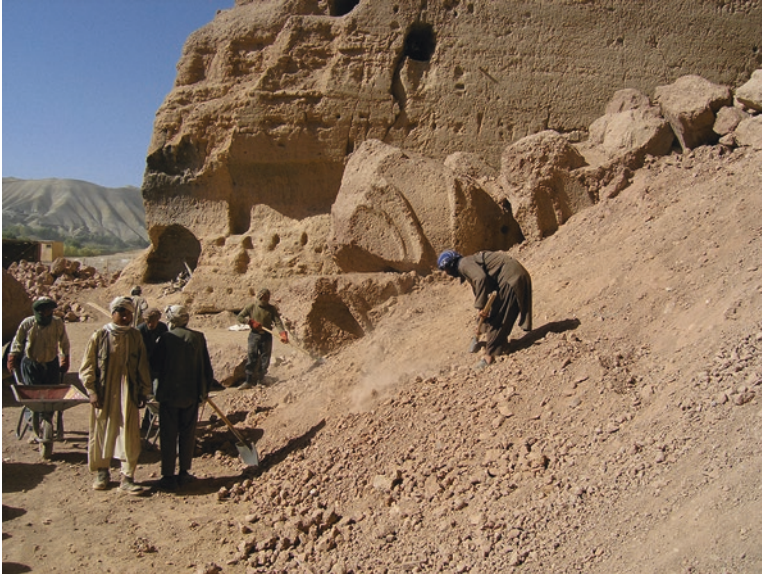
**Photo 2** Western Buddha, June 2004: salvaging fragments by the Afghan team. (© Bert Praxenthaler)

The salvage work was primarily carried out by laborers from Bamiyan using shovels and wheelbarrows (Photo 2). Wheel loaders and heavy-duty cranes were used as well, in particular to move the heavier fragments of up to 30 tons to the storage deposit. (Photo 3) An essential part of the salvage operation was the work done by the demining experts. The work sites needed to be checked on a daily basis as the rubble contained large amounts of shell splinters, other debris from explosions, and especially unexploded parts of anti-tank mines, aircraft bombs, etc. Initially, the Taliban used self-propelled guns to fire at the Buddha, yet only with limited success. Later, they piled up and detonated large amounts of explosives underneath the Buddha in order to execute their plan to destroy the statues. As a consequence, the rubble contained many exploded and unexploded parts (Praxenthaler 2009a, pp. 66).

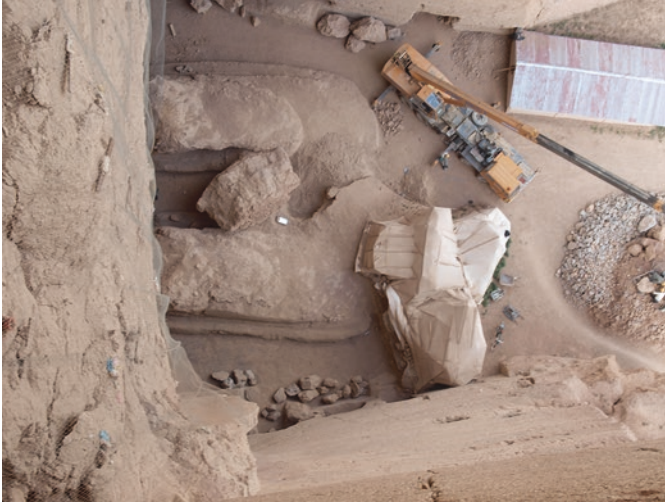
**Photo 3** Western Buddha, July 2009: from top of the niche: the giant feet of the Buddha are excavated. (© Bert Praxenthaler)

80 tons, which so far could not be lifted with the cranes available in Bamiyan. Those large fragments are still lying in front of the excavated feet of the Western Buddha and have been supplied with on-site weather protection.

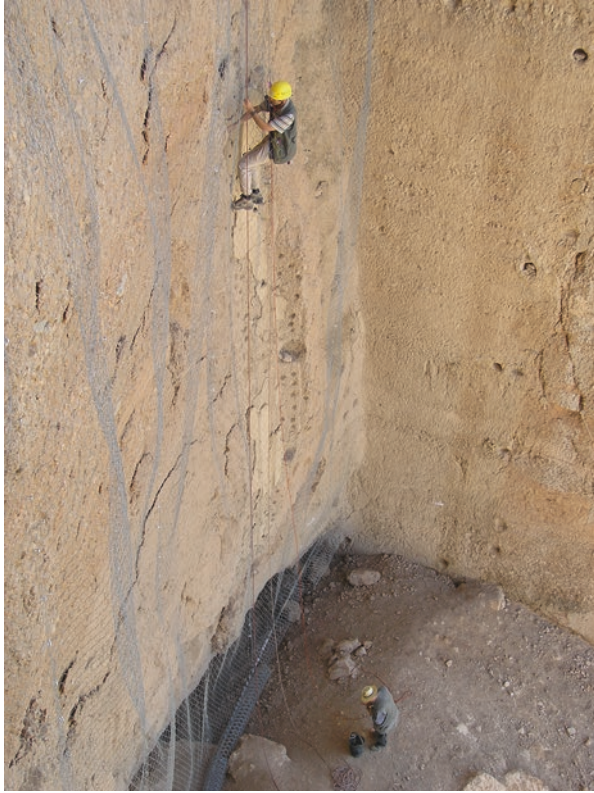
**Photo 4** Eastern Buddha, July 2004: Emergency safeguarding of original fragments of clay plaster at the rear face of the Eastern Buddha. (© Bert Praxenthaler)

Parts of the Eastern Buddha remained intact after the detonation: parts of the right shoulder, some remains of the garment folds, and some mud plaster were still in situ, although dangerously prone to detach. The main goal was to preserve as many fragments as possible in their original location. As a scaffold could not be mounted at the time, the initial emergency safeguarding work on the clay plaster was conducted in 2004 in alpine style (Photo 4). The original mud plaster fragments that were still hanging from the wall were reached by rappelling. Rubble that had accumulated behind the somewhat detached mud plaster pieces was removed. The pieces were temporarily and reversibly secured with a punctually applied adhesion consisting of a mixture of mud, lime, and gypsum. The scaffolding could only be erected after the niche was mostly cleared, in 2008. Several of our staff members from Bamiyan, who since 2004 had gained considerable skills in the course of the clearing work of the niches, were able to expand their skill set in the field of restoration as builders, securing the still in situ mud plaster pieces.

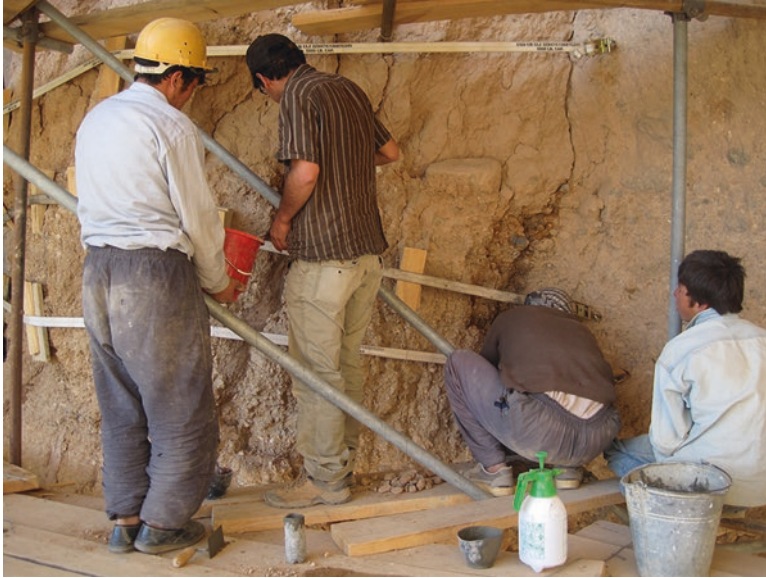
**Photo 5** Eastern Buddha, October 2009: stabilising the rear face of the Eastern Buddha by Afghan team Wahab, Mujtabah Mirzai, Baba Qurban and Isa. (© Bert Praxenthaler)

The stabilization of the back wall began in 2009, after a detailed damage assessment carried out by Fecker and Margottini. Although in a very fragile state, parts of the right shoulder, folds of the garment, and fragments of the head were still in situ. The outline of part of the left garment was also preserved. The right shoulder, in particular, is still almost completely preserved; however, the original pieces tear off easily, and at the head section, the stone fragments have separated from the back wall and shifted a couple centimeters downward. In order to preserve the silhouette of the figure (at least partly), the goal was to secure as many pieces in situ as possible. To be able to even begin with the consolidation measures, the unstable pieces needed to be secured with preliminary measures like installing steel cables and heavy-duty nylon tension belts (Photo 5).

After that, the gradual infilling of the cracks with adhesive mortar could be pursued. Using this method, the stability of the loose stone fragments could be increased day by day. After the completion of this infilling process, the needling and armature boring was done. The borings were also used to fill with mortar the gaps that could not be reached from the front. After this injection process, the long anchors could be inserted (Praxenthaler 2014, pp. 265; Photo 6). A total of 44 stainless steel anchors were needed and spread over a total area of 200 m<sup>2</sup>. The principle to preserve the remaining, albeit limited, original substance of the monument could be realized at this point.

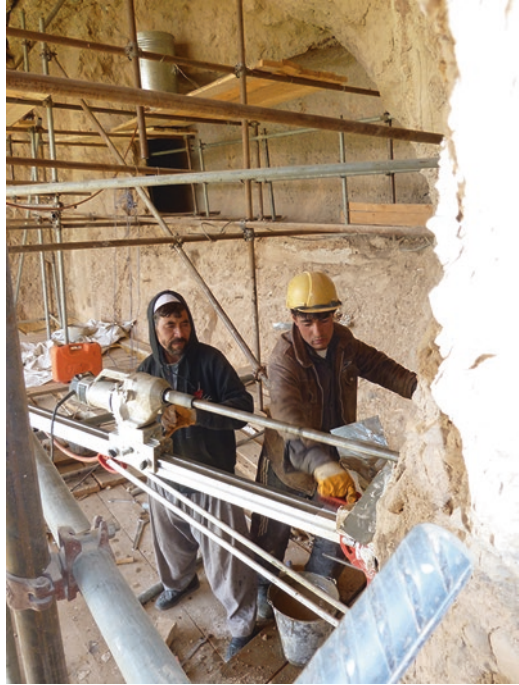
**Photo 6** Eastern Buddha, July 2010: drilling the bore holes for grouting and setting anchors by Afghan team Khan Ali and Eshaq. (© Bert Praxenthaler)

developed and tested. The consolidation of the original mud plaster was accomplished not only by means of dorsal bonding with the edging but also with needling, consisting of thin bolts of stainless steel and glass fiber.

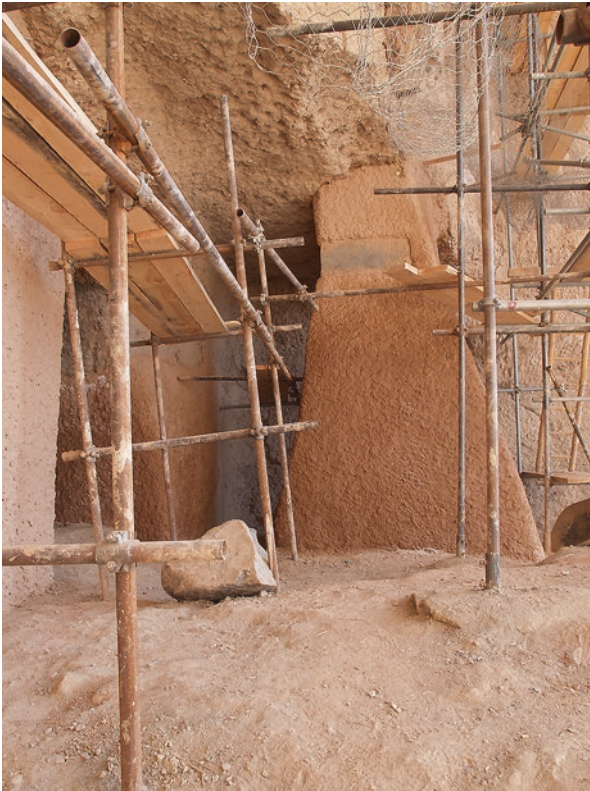
**Photo 7** Eastern Buddha, September 2009: reconstruction of cave walls and a pillar at the lower gallery by Erwin Emmerlin, Edwin Fecker and Sekandar Seradj. (© Bert Praxenthaler)

In 2008, by means of consolidating the first section of the back wall, the formerly destroyed walls of the sanctuaries behind the feet of the Eastern Buddha and a pillar in the right part of the niche could be rebuilt. Due to the destruction of the side and front walls of the temple rooms caused by the detonation, the entire block of the back wall was lacking support from below (Fecker 2009, pp. 145). The walls were rebuilt with quarry stones, in a similar fashion to the restoration conducted in the 1970s.

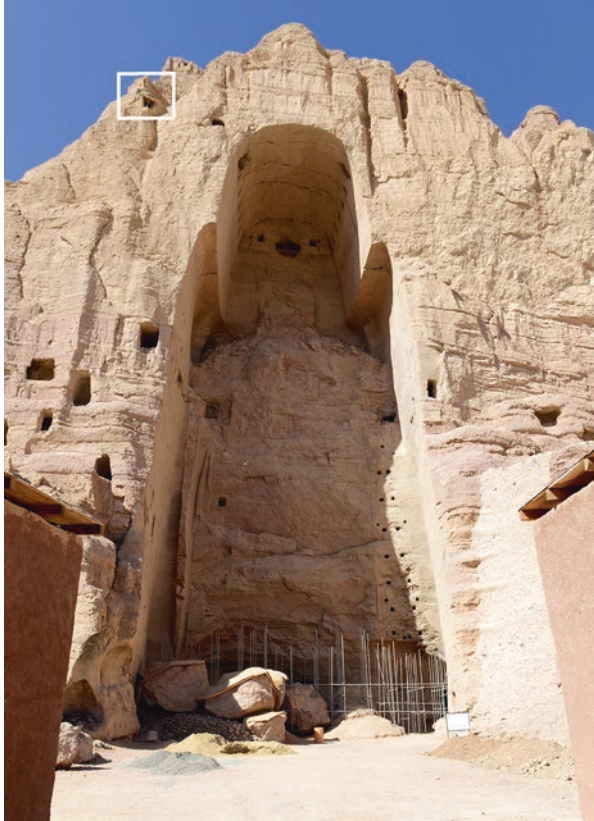
The original access to the top area of the Western Buddha by a system of stairways similar to the situation at the Eastern Buddha is no longer possible. Such ancient access remained only partially, as most of the stairways had been eroded in the course of the last centuries. Today, the only access to the top area of the niche is made through a pathway that comes from the western slope, alongside a system of water channels,<sup>1</sup> entering the niche by a tunnel. The damage caused by the water channels resulted in the degradation of the top entrance of the tunnel. A large boulder – the “dangerous rock” – has been washed out and was in danger of falling off the cliff from a height of about 65 m. On top of that rock, there is a water collecting platform for the channels (Photo 8).<sup>2</sup>

**Photo 8** Western Buddha, October 2013: Safeguarding the upper access to the top of the Buddha (marked in white, top left). (© Bert Praxenthaler)

In order to pre-stabilize that critical dangerous rock, steel ropes and heavy load belts were set. After cracks and fissures were grouted, boreholes for long anchors could be drilled with diamond core heads.<sup>3</sup> This rather exposed location, with a height of 65 m above the ground, required a hanging scaffold construction outside the cliff with security nets. The anchors provide a cross-stabilization of the rock boulder. After the stabilization of the rock, the cause of the damage – the leaking water channels – had to be repaired. The one adjacent to the tunnel has been reconstructed by a combination of an anchored reinforced concrete foundations and stone masonry work. On top of the cliff, the damaged water collector could be repaired. In the course of that work, all adjacent water channels were also cleaned and repaired (Photo 9). The work was accompanied by a demining action<sup>4</sup> (Praxenthaler 2016, pp. 271). In addition to this project at the Western Buddha niche, the collected stone fragments have been regrouped in the newly built third storage building. The debris, which had been removed, was deposited at the left hand side of the niche.

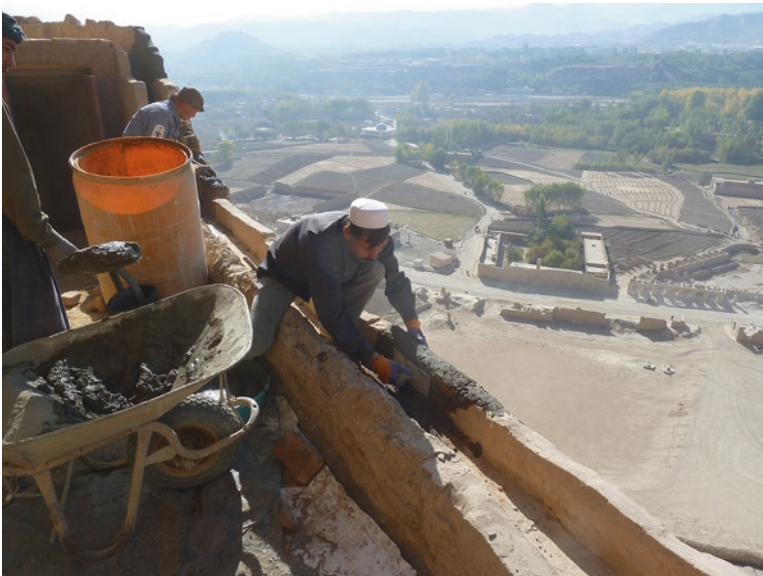
**Photo 9** Western Buddha, October 2013: Repair of the water channels. (© Bert Praxenthaler)

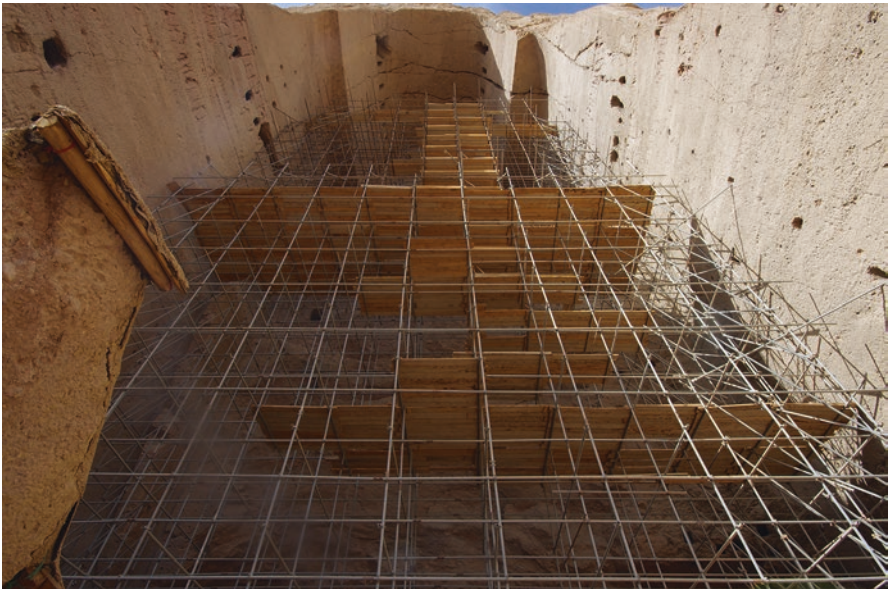
Western Buddha niche with scaffold structure. Situation in October 2015. (© Matthias Beckh)

demanded a large-scale scaffold structure. The planning of the scaffold structure, which started in 2013, posed the next challenge to the project. Due to the significantly larger height and volume of the niche, the design of the scaffold structure proved to be quite demanding. The basis of the scaffold members was the high-quality steel pipes that the Messerschmitt Foundation had bequeathed to the project. However, due to the sheer height and immense volume of the niche, more than twice the amount of scaffold material of the Eastern niche was required. During a site inspection in June/July, an inventory of the existing scaffold materials was compiled, and a scaffold mock-up was erected in order to obtain a better understanding of the adaptivity to uneven terrain and craggy bearing conditions.

Based on the structural assessment of the niche and the scaffold materials at hand, different scaffold options were investigated. Alternative options comprised a base structure over the full width of the niche with one-sided towers as well as a hanging platform. During a meeting in August 2013, in Munich, several options were discussed. Finally, it was decided to adopt a scheme that would in general follow the Eastern Buddha scaffold system, yet with a denser grid of vertical members to account for the greater height of the niche. The selected scaffold system was designed in August and September 2013, based on a 3D scan of the niche that was kindly provided by Sekandar Seradj. For the sake of simplicity, a column grid of  $2\text{ m} \times 2\text{ m}$  was selected. In order to facilitate the arrangement of diagonal members for bracing, the floor levels were set at intervals of  $2\text{ m}$  as well. The resulting spatial module of  $2\text{ m}$  had already proven advantageous during the design of the Eastern Buddha scaffold. Due to the increased height, three additional rows of columns were inserted perpendicular to the rear wall to lower the axial loads in the verticals, thereby altering the grid in this area to  $2\text{ m} \times 1\text{ m}$ . The scaffold was attached to the adjacent rock surface of the side walls of the niche at various levels, in order to gain more horizontal stability.<sup>5</sup>

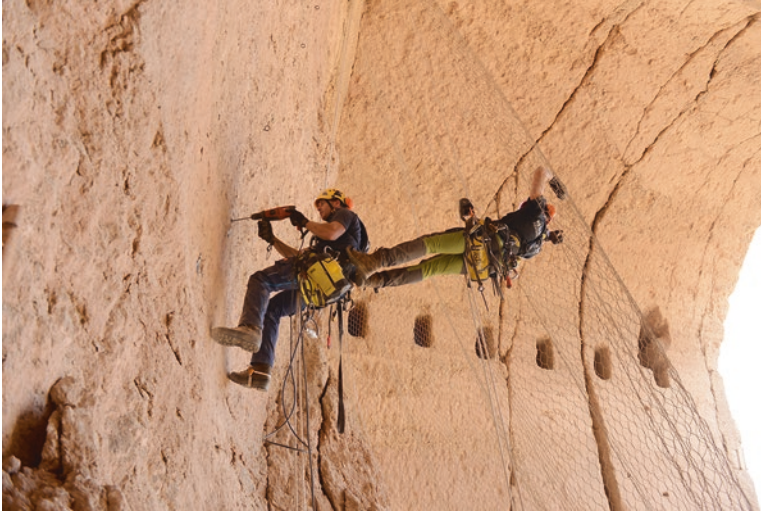
**Photo 10** Western Buddha niche, September 2017: Prestabilisation measures on Western Buddha rear face, former head area (BRR-team Klaus Vogt und Stephan Hardt). (© Bert Praxenthaler)

Buddha. Cleaning up these areas is absolutely essential before installing the required foundations, to extend the scaffold to the shoulder area. The left shoulder and main parts of the right shoulder could be cleaned completely thanks to the dedication of the hardworking and diligent local team. The fragile detached rocks could be temporarily stabilized by steel ropes attached to newly installed anchors on either side of the former head of the Buddha (Photos 10, 11).

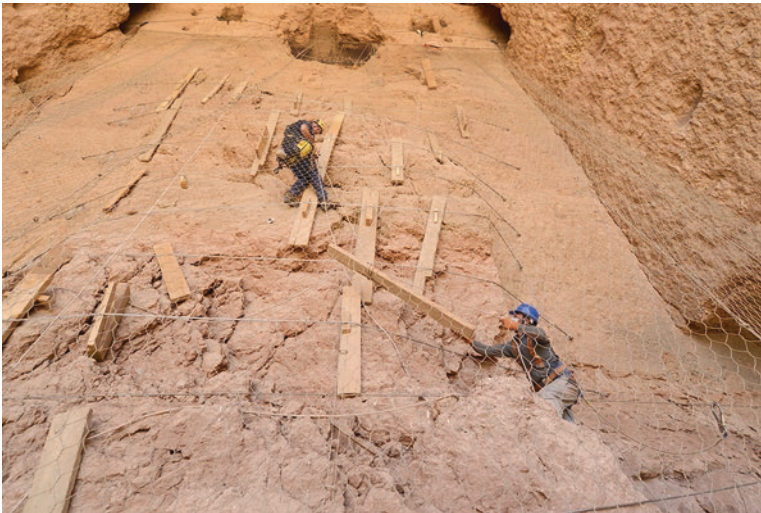
**Photo 11** Western Buddha niche, September 2017: Prestabilisation measures on Western Buddha rear face, former head area (BRR-team Klaus Vogt und Haji Hossein). (© Bert Praxenthaler)
