Chapter 5

The Modified Post-earthquake Damage Assessment Methodology for TCIP (TCIP-DAM-2020)

A. Ilki, O. F. Halici, M. Comert, and C. Demir

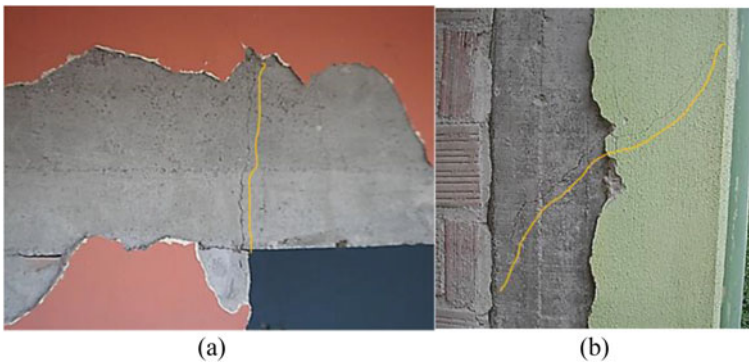
Fig. 5.1 Examples of Type A Damage Category; **a** flexural damage; **b** shear damage

Vertical and horizontal RC structural members which contain at least one crack with a maximum residual width of 0.5 mm that was formed due to earthquake actions are defined as Type A damaged element. The categorization is carried out regardless of whether the cracks are formed due to bending or shear effects. Typical examples of Type A damages are presented in Fig. 5.1 for bending and shear cracks.

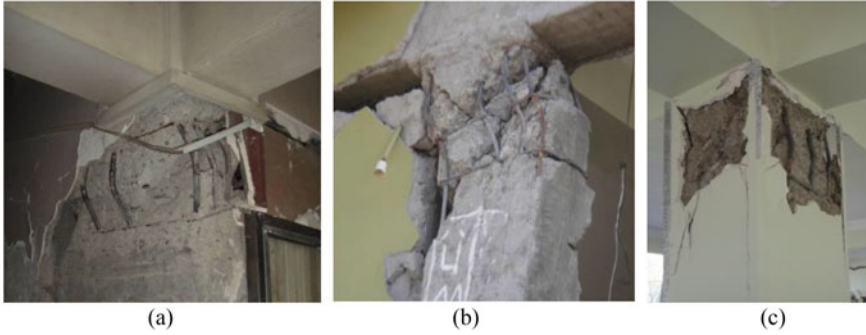
Fig. 5.4 Examples of Type D Damage Category; **a** flexural damage; **b** shear damage; **c** buckling of reinforcement and core crushing

Vertical and horizontal structural members exhibiting core concrete crushing, reinforcement buckling, stirrup rupture or distinctive residual deformations that are formed due to earthquake actions are categorized as Type D damaged elements. Descriptive structural elements having Type D damage are presented in Fig. 5.4.

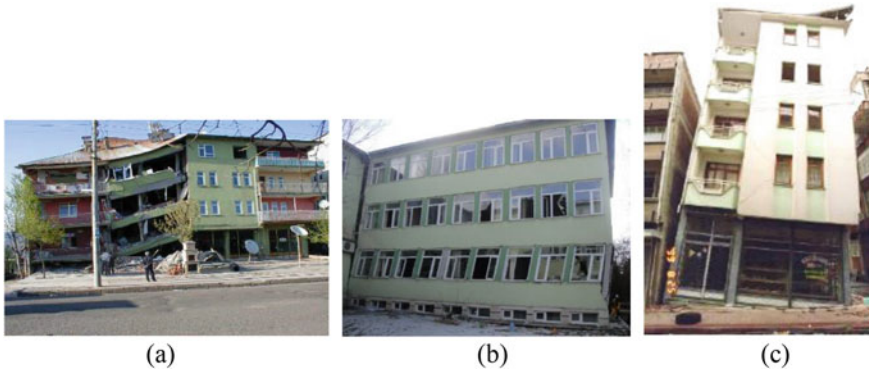
Fig. 5.5 Damaged structures; **a** partial collapse; **b** excessive residual drift; **c** tilting

- If the building is entirely collapsed, the damage categorization of the building is determined as Collapsed Building. If a partial collapse is observed (Fig. 5.5a), the damage assessment is concluded by classifying the structure as Building to be Urgently Demolished.

is greater than 4° , the damage assessment is concluded by categorizing the structure as Building to be Urgently Demolished. Figure 5.5c shows a structure that significantly tilted due to rigid rotation at the base. A schematic illustration of the tilting angle is presented in Fig. 5.6c.

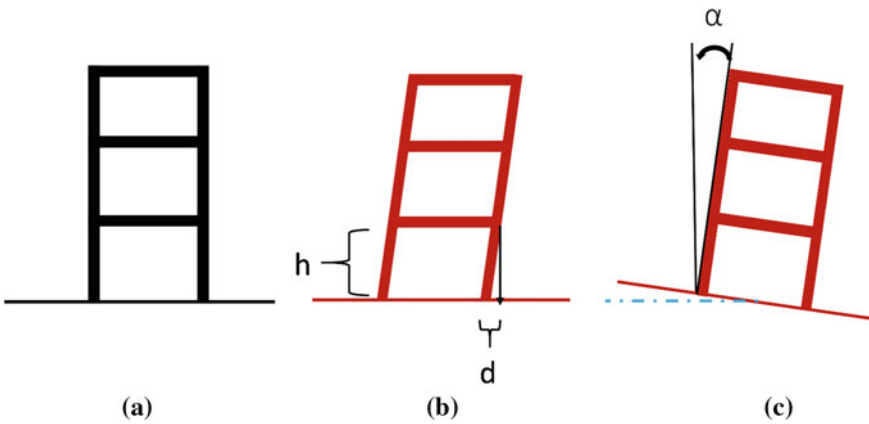
Fig. 5.6 **a** undamaged building; **b** building with residual drift; **c** tilted building

- If the permanent horizontal residual displacement measured at any story in the building is greater than 1% of the corresponding story height, the building is categorized as Heavily Damaged Building and the assessment is finished. If the horizontal residual displacement at any story is greater than 3% of the corresponding story height, the building is classified as Building to be Urgently Demolished. Figure 5.5b shows a building that suffered from excessive residual displacements that occurred due to seismic actions. The story height (h) and the horizontal residual displacement (d) are schematically illustrated in Fig. 5.6b.

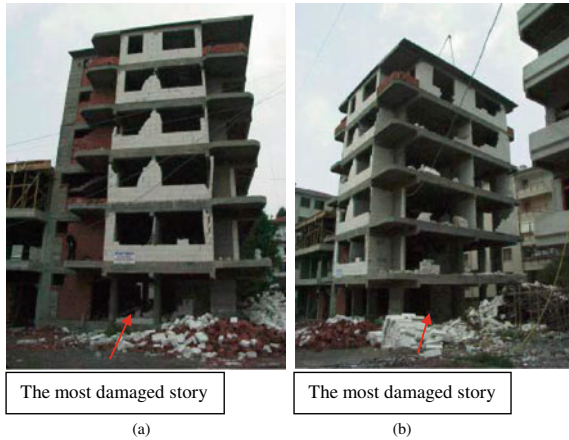
Fig. 5.9 Views of the building; **a** Western side; **b** Southwestern side (Modified from AIJ/JSCE/JGS 2001)

The structural system of the building did not exhibit partial or total collapse after the earthquake. However, many of the infill walls in the structure were heavily damaged. The walls on the cantilever beams were constructed with AAC blocks and the rest of the infills were built with hollow clay bricks. General views of the structure after the earthquake are shown in Fig. 5.9. The outer dimensions of the structure are

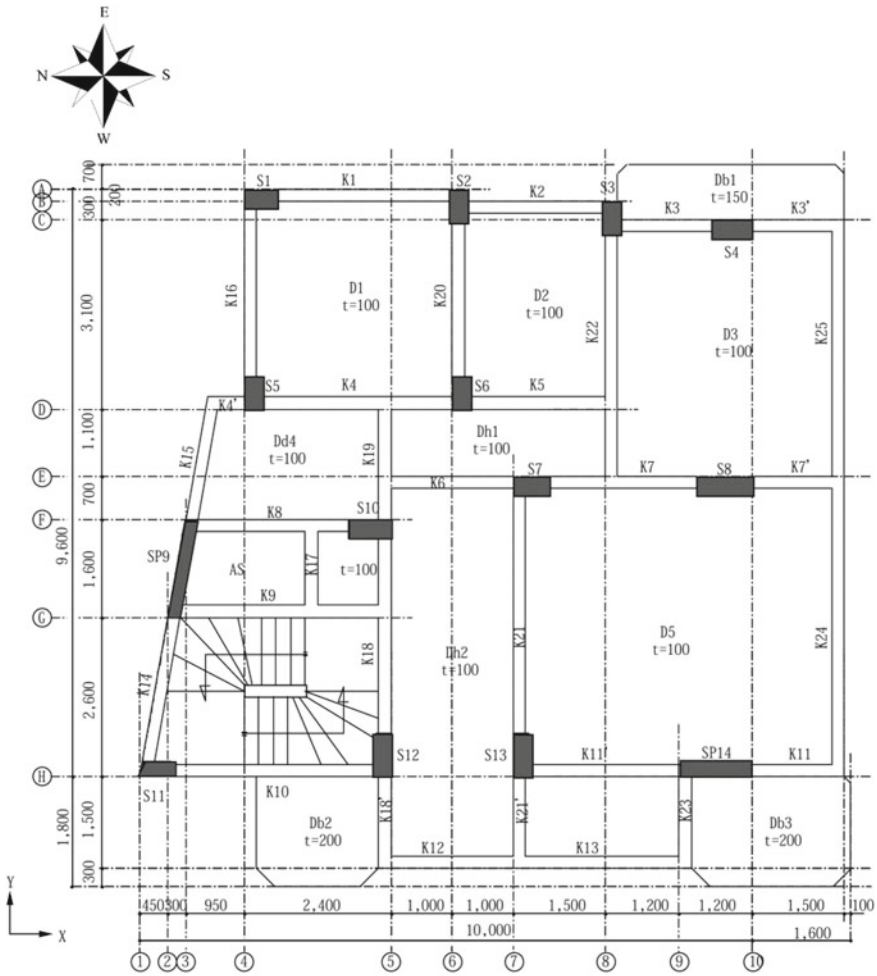
Fig. 5.10 Plan view of the evaluated building (AIJ/JSCE/JGS 2001) (mm)

11.6 and 11.4 m in X and Y directions, respectively. The PA of the structure is approximately 125 m². The plan view of the first story of the structure is shown in Fig. 5.10. The report (AIJ/JSCE/JGS 2001) stated that typical columns have 250 × 500 mm cross-section dimensions and have 8 longitudinal reinforcing bars with a diameter of 16 mm, which corresponds to 1.29% of a longitudinal reinforcement ratio. No information was given regarding stirrup diameter, spacing and hook details. Typical beams in the building have 200 × 500 mm cross-section dimensions. It was stated that bars with diameters of 12 and 14 mm were used as longitudinal reinforcements in the beams together with 6 mm stirrups with a spacing of 250 mm.
