Chapter 1

Microbial Growth and its Effects on Inorganic Heritage Materials

Daniela Pinna

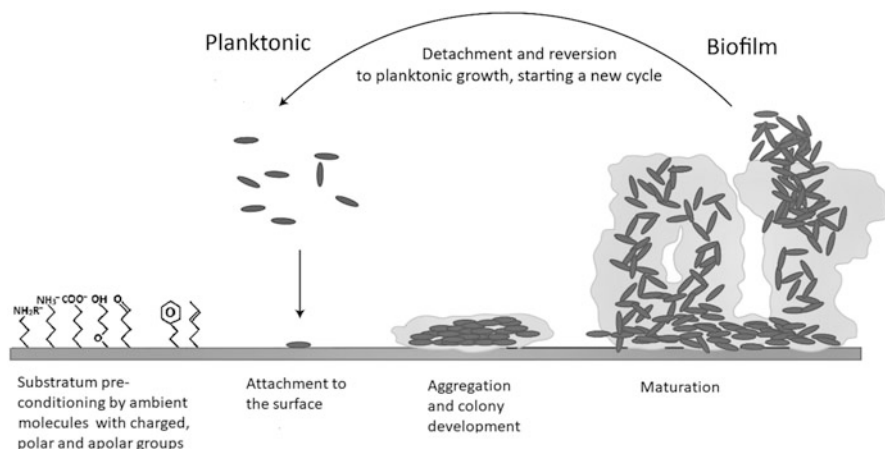
Fig. 1.1 Stages leading to microbial formation on a surface. Once cells attach to surfaces irreversibly, they replicate and grow forming microcolonies. The microbial cells secrete extracellular polymeric substances (EPS) and become encapsulated in a hydrogel layer, which forms a physical barrier between the community and the extracellular environment. The community forms a three-dimensional structure and matures into a biofilm. Cells in an established biofilm are “glued” together by the EPS, which resist mechanical stresses and detachment of the community from the surface of the substratum. Some cells detach from regions of the biofilm and disperse to form biofilms in new environmental niches

The first step in the development of biofilms is the formation of a conditioning layer on noncolonized surfaces (Fig. 1.1). The layer is formed by organic substances like polysaccharides and proteins which improve the attachment of initial colonizers. In the second step, microbial cells attach to these substances due to their size and net negative charge by nonspecific interactions, such as electrostatic, hydrophobic, and van der Waals forces (Mittelmann 2018). Hydrophobicity and electric charge of the conditioning substances are of importance in bacterial adhesion (Diao et al. 2014). The electrostatic forces are weak and reversible at this stage. At a later stage, cells firmly adhere to the surface and to each other, producing EPS that entrap cells and debris within a glue-like matrix (Fig. 1.1). EPS can increase the rate of coaggregation of cells (Mittelmann 2018). Polysaccharides are characteristic components of the EPS, but proteins, nucleic acids, lipids, and humic substances have also been identified, sometimes in substantial amount. As mentioned above, the matrix—a three-dimensional, gel-like, highly hydrated and locally charged (often anionic) material—is composed of EPS the proportion of which, in general, can vary between roughly 50% and 90% of the total organic matter. EPS play significant roles in the attachment of microorganisms to the mineral surfaces and in the protection of the microbial community from toxic compounds (Diao et al. 2014). At this stage, the

biofilm environment is a rich layer of nutrients that can support rapid growth of the microorganisms within it. Biofilms are thus accumulations of microorganisms, EPS, multivalent cations, inorganic particles, biogenic materials, colloidal, and dissolved compounds. As the microcolonies grow, additional species, the so-called secondary colonizers, are recruited through coaggregation and nonspecific aggregation interactions, increasing the biofilm biomass and species complexity (Katharios-Lanwermyer et al. 2014). This process allows species that cannot adhere to the noncolonized surfaces to become part of the biofilm (Gorbushina 2007). In the mature biofilm, complex diffusion channels transport nutrients, oxygen, and other necessary elements for cells, and carry away metabolic waste products. The last stage of biofilm lifestyle is the dispersal of cells from the biofilm colony, which enables it to spread and colonize new surfaces (Fig. 1.1).

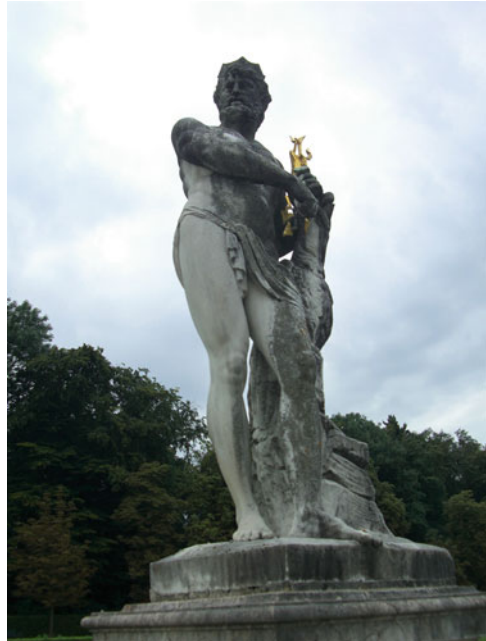
Fig. 1.2 Statue in the park of Nympeburg, Munich, Germany. The statue's surface is almost completely covered by biofilms and lichens that strongly compromise its legibility

As for natural and artificial stones, the aesthetic aspects assume an important role because biofilms' and lichens' development is an impediment to the site's presentation to the audience when it compromises the legibility of a monument (Ashbee 2010) (Fig. 1.2).

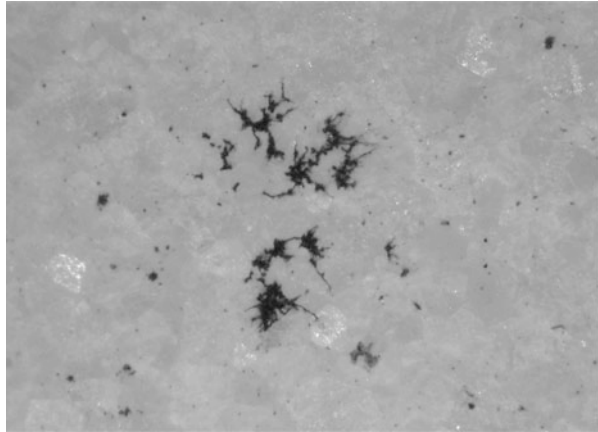
Fig. 1.3 Early development of black meristematic fungi on the wealthy surface of a marble model sample exposed outdoor. Stereomicroscope, 50×

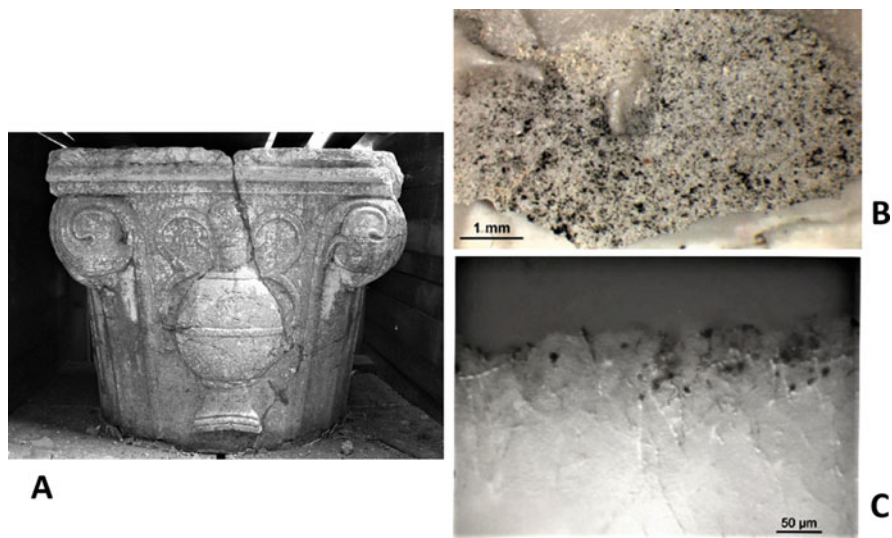
Fig. 1.4 Marble well-curb (Montefiore Conca, Italy) colonized by biofilms (a). Peculiar pattern of stone weathering on a sample. Biofilms form little black spot on the surface. Stereomicroscope (b). Polished cross section of the sample showing black fungi on the surface and hyaline hyphae in the bulk of the stone (c)

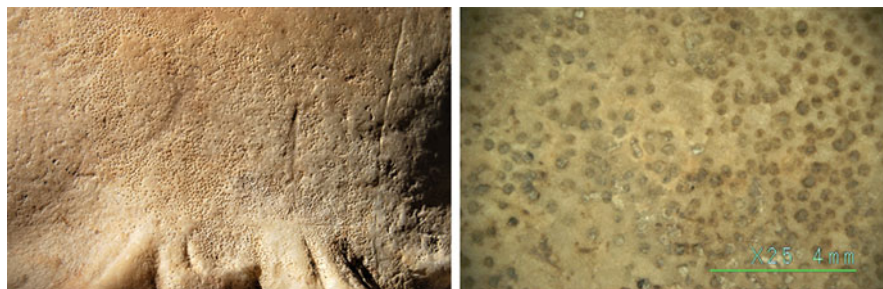
Fig. 1.5 Biopitting on a stone statue, Uffizi Gallery (Firenze, Italy). Close-up of a detail of the surface (right). The circular micro-holes were likely produced by endolithic lichens that grew when the statue was located outdoors. The fruiting bodies were present inside the holes. After the lichens died, they left just the empty holes

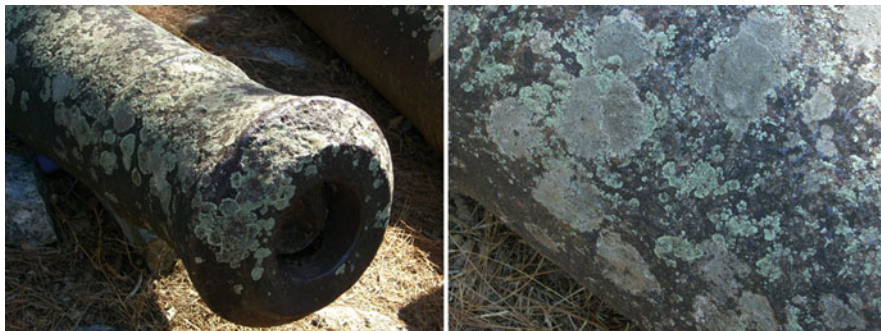
Fig. 1.6 Widespread lichen colonization on metals. Ancient cannon, Ioannina, Greece (left). A close-up of the colonized metal surface (right)
