Chapter 8

Testing Historic Masonry Elements and/or Building Models

Elizabeth Vintzileou

Abstract This paper provides an overview of the Literature on the behaviour of historic masonry elements and building models. The purpose of this paper is to identify the main parameters affecting the seismic behaviour of historic masonry buildings, as illustrated through the experimental campaigns carried out by numerous researchers. Furthermore, aspects of the seismic behaviour that are not sufficiently studied to-date are identified. Thus, selected publications are evaluated related to the behaviour of historic masonry elements in compression, in diagonal compression, in in-plane shear and simultaneous compression, out-of-plane bending, as well as publications related to the behaviour of subassemblies and building models subjected to monotonic, pseudo-dynamic or dynamic tests on earthquake simulator. The available experimental results illustrate the main weaknesses of historic masonry elements and bearing systems, namely the vulnerability to in-plane shear and to out-of-plane bending, the limited ductility, the negative effect of the flexibility of timber floors and roofs, etc. On the othe

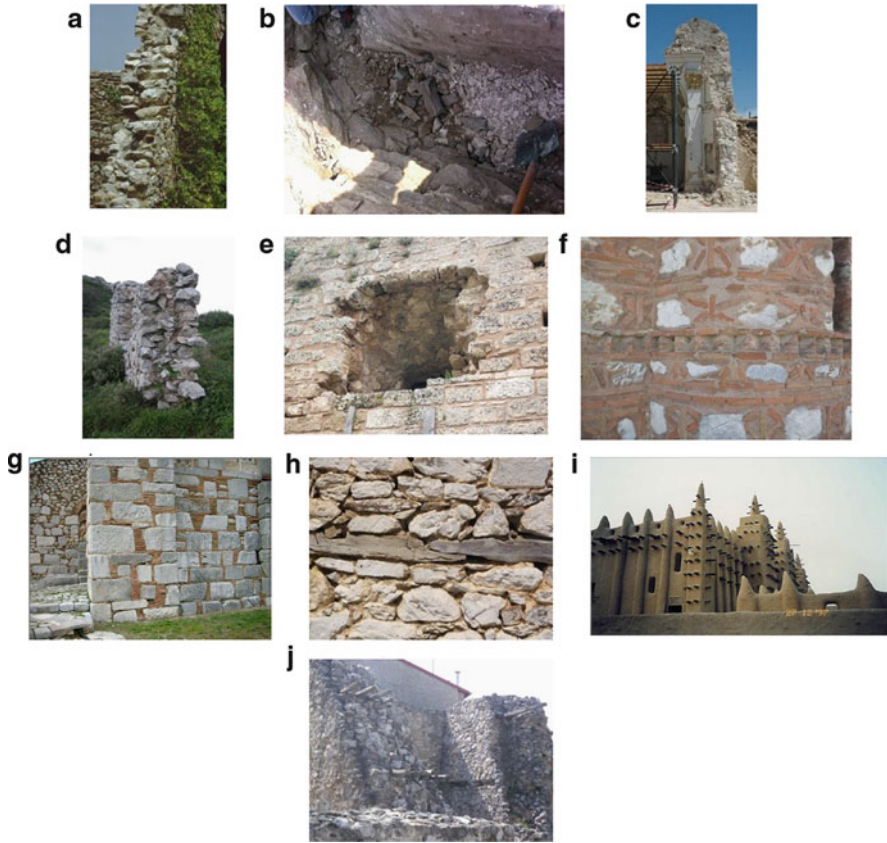
Fig. 8.1 Examples of types of historic masonries. (a) Double-leaf stone masonry with sporadic header stones. (b) Three-leaf stone masonry - thick interior leaf with very large voids. (c) Poor quality three-leaf rubble stone masonry. (d) Three-leaf rubble stone masonry. (e) Multi-leaf masonry with high mortar volume. (f) Mixed stone-brick masonry with large mortar volume. (g) Mixed brick-stone masonry of good quality. (h) Timber reinforced rubble stone masonry. (i) Timber reinforced adobe. (j) Timber reinforced multiple leaf masonry

The systematic documentation of historic masonry buildings in various Italian regions (Binda and Saisi 2001) shows that single leaf rubble stone masonry is a quite general term in the sense that the total volume of mortar may vary between 11 and 37 % of the volume of masonry. Furthermore, in case of three-leaf masonry,

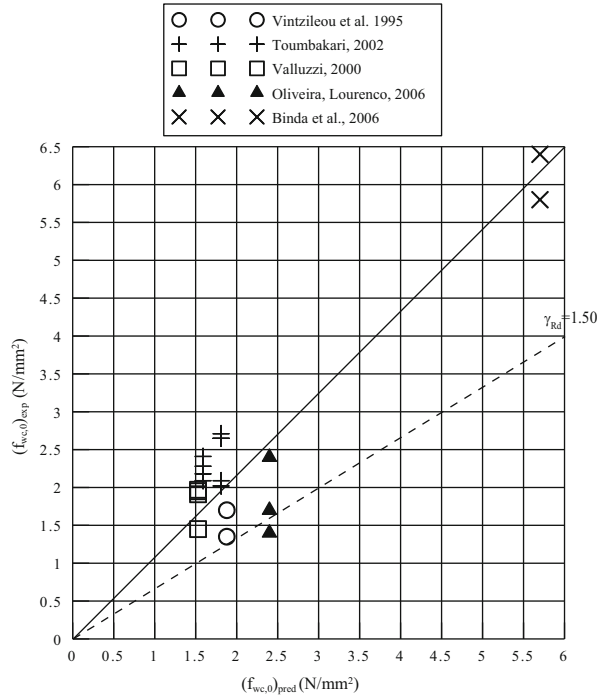
Fig. 8.2 Comparison between experimental and predicted (Tassios 2004) values of the compressive strength of three-leaf masonry (Vintzileou 2011b)

usually, the ratio between the thickness of each exterior leaf and that of the infill is approximately equal to 1:0.50 (Binda et al. 1999). The survey carried out by the Politecnico of Milan, together with the evaluation of the data reported in (da Porto et al. 2003), led to the following geometrical data for three-leaf masonries: Percentage of stones/mortar/voids: 55–85 %/12–36 %/0.4–15 %. It is obvious (see also Fig. 8.1) that even if those masonries were made of exactly the same materials, their compressive strengths would result significantly different. Actually, according to the evaluation of experimental data and in-situ measurements, da Porto et al. (2003), the compressive strength of three-leaf stone masonry varies between 0.60 and 2.40 MPa.

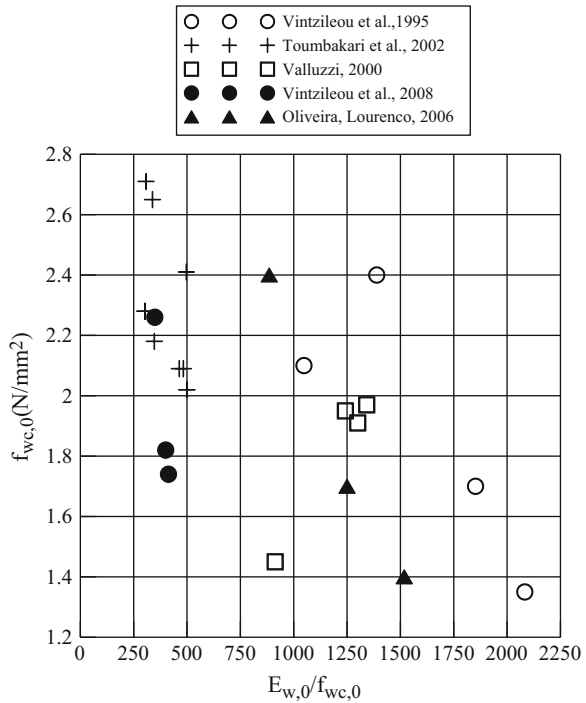
Fig. 8.3 The initial elastic modulus of elasticity reported to the compressive strength of three-leaf stone masonry as a function of the compressive strength of masonry (Vintzileou 2011b)

The deformation properties of historic masonries are quite scattered as well. As reported by Marcari et al. (2010), as well as by Tassios (2013), the strain corresponding to the compressive strength of single- or three-leaf masonry may vary between 0.20 and 0.80 %. Similar large scatter is observed in case of the elastic modulus of elasticity (Fig. 8.3).

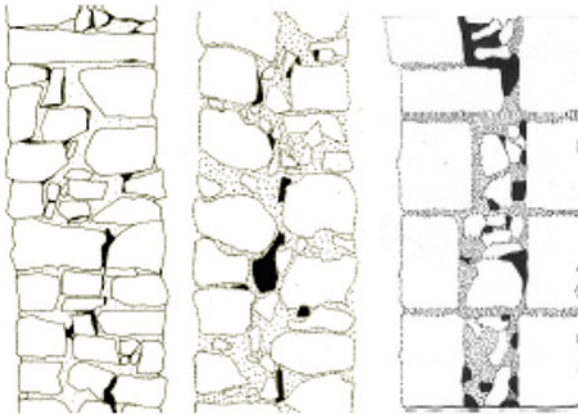
Fig. 8.5 Surveyed types of historic masonries (Binda and Saisi 2001)

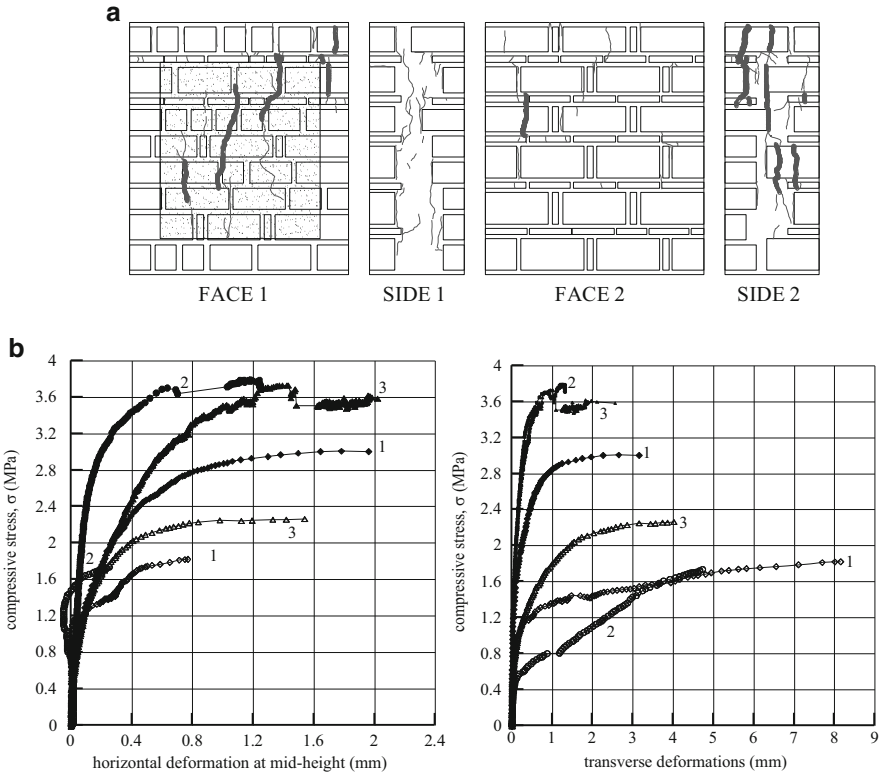
Fig. 8.6 (a) Typical crack pattern for three-leaf masonry in compression, (b) opening of vertical cracks on the faces of masonry, as well as within its thickness as a function of compressive stresses (Vintzileou and Miltiadou 2008)

Actually, although the two families of cracks open at almost the same vertical load, the transverse ones grow faster. Thus, the failure of masonry is due to simultaneous compression and out-of-plane flexure of the leaves.

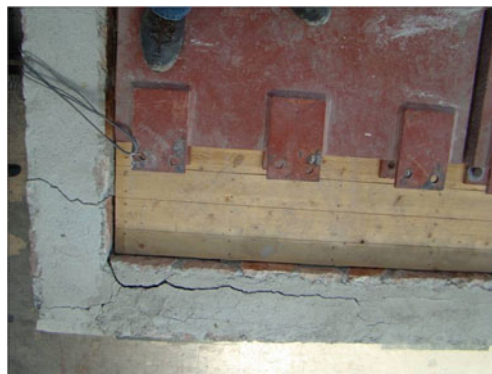
Fig. 8.7 Separation of the leaves of masonry walls during tests on the shaking table (Mouzakis et al. 2012a)

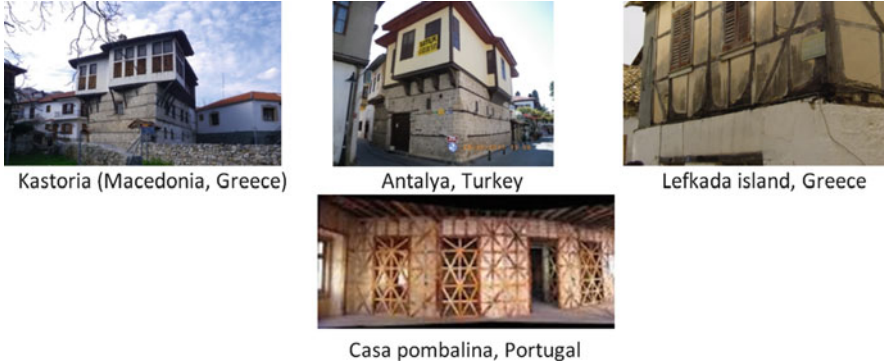
Fig. 8.8 Various types of timber reinforced structures in Europe (Source: <https://www.google.gr/search?q=casa+pombalina+lisboa>)

In earthquake prone areas around the globe (around the Mediterranean, in Asia, as well as in Latin America), systematic reinforcement of masonry is observed (Fig. 8.8). Although there is a vast variety of structural systems involving timber within masonry, there are clear signs testifying that those structural systems were developed with the purpose of resisting seismic actions (see e.g. Vintzileou 2011a).

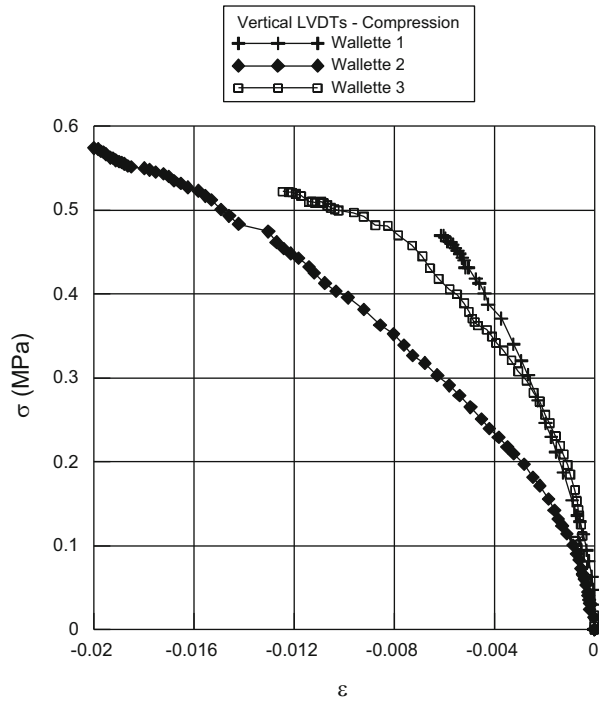
Fig. 8.9 Compressive stress-vertical strain for masonry wallettes: Waillette 1-plain masonry, Waillettes 2 and 3-timber laced masonry (Vintzileou 2008)

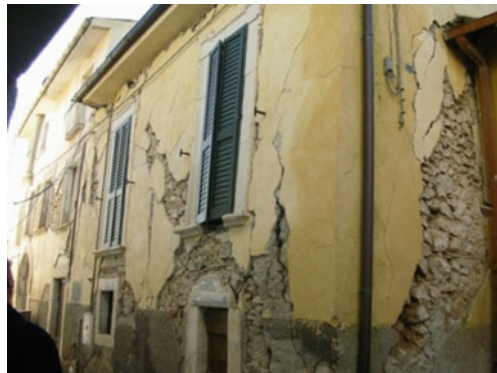
Fig. 8.10 Severe damages to shear walls and spandrels (Onna, after the 2009 earthquake of L’Aquila, Italy)

The behaviour of masonry elements under in-plane shear is of major significance for the seismic response of buildings, as documented by typical damage, i.e. diagonal or bi-diagonal cracks in walls and spandrels (Fig. 8.10). Thus, numerous research works were devoted to the behaviour of masonry under shear.

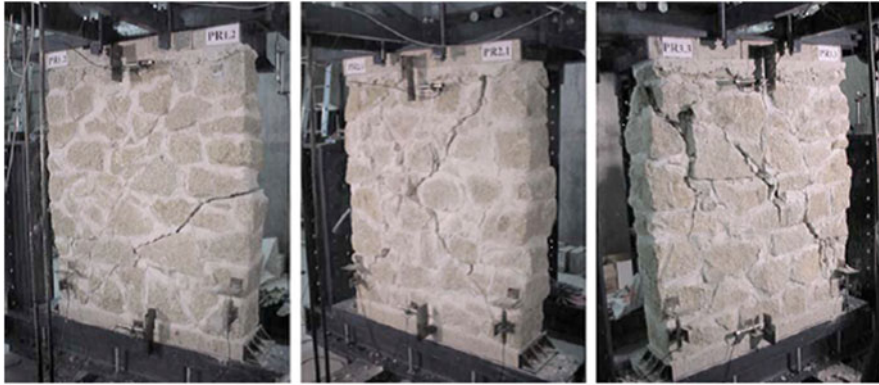
Fig. 8.11 Typical shear failure of stone masonry walls under simultaneous vertical load (Vasconcelos and Lourenco 2009)

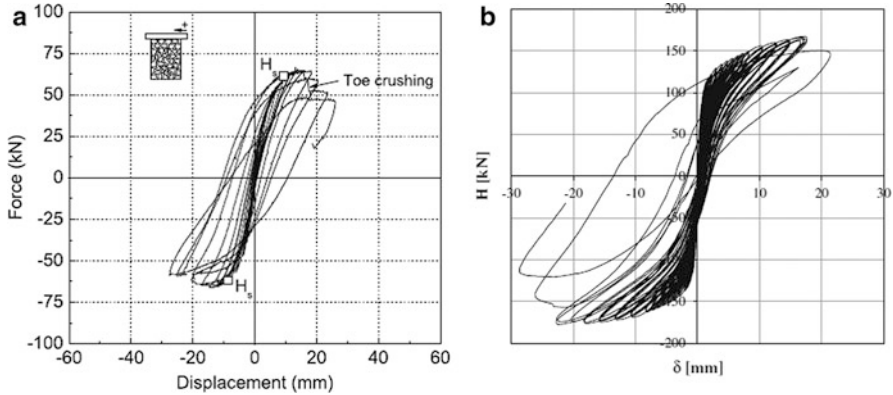
Fig. 8.12 (a) Typical hysteresis loops for stone masonry walls failed in shear (Vasconcelos and Lourenco 2009), (b) Typical hysteresis loops for rocking stone masonry wall (Silva et al. 2014)

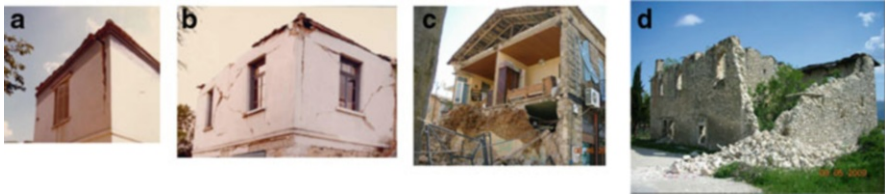
Fig. 8.13 Typical damages due to out-of-plane seismic actions. (a) Typical vertical crack due to out-of-plane bending of the solid wall. (b) Typical vertical crack at mid-length of the wall and separation of walls at the corner of the building. (c) Out-of-plane collapse of wall. (d) Collapse of the corner of a building (due to combined in-and out-of-plane action)

The vulnerability to out-of-plane actions is due to typical characteristics of historic masonry buildings, namely, the flexible floor and roof diaphragms (Fig. 8.13b), as well as the defective connection between floors/roof and walls (allowing for significant out-of-plane deformations of walls), the defective connection of walls at building corners (Fig. 8.13a, c), the presence of openings close to the corners of the building and, last but not least, the frequent construction type of

historic masonry (double- or three-leaf). Actually, the separation between leaves (due either to decay or to previous actions) leads to significant reduction of the out-of-plane stiffness of walls, whereas the masonry cross section is also significantly reduced (Fig. 8.13d) and Giuffrè et al. (1993).

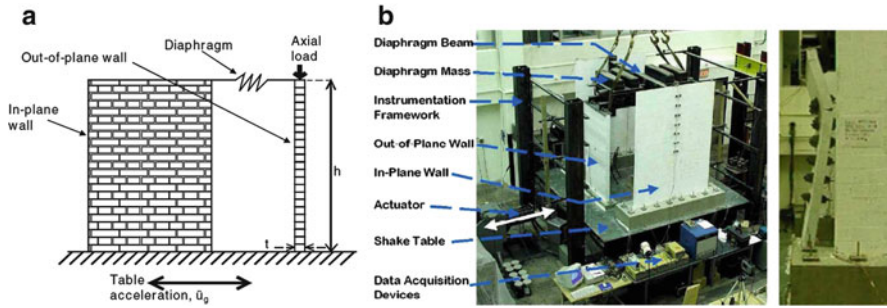
Fig. 8.14 (a) Test set-up and (b) specimen at the shaking table (Simsir et al. 2004)

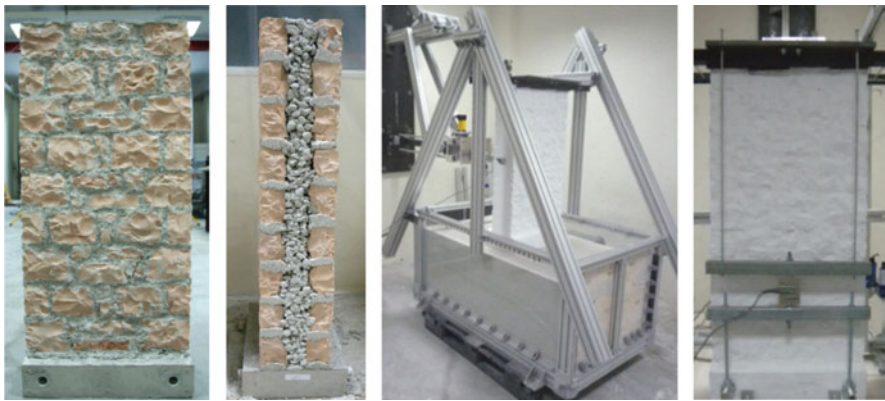
Fig. 8.15 Three-leaf stone masonry piers and experimental setup (Manoledaki et al. 2012)

Manoledaki et al. (2012) have tested piers made of three-leaf stone masonry. The piers were sitting on either a loose ($D_r = 33\%$) or a dense ($D_r = 92\%$) sand, through a rectangular RC footing (Fig. 8.15). The walls, either constrained or free at their top, were subjected to horizontal displacements at their mid-height.

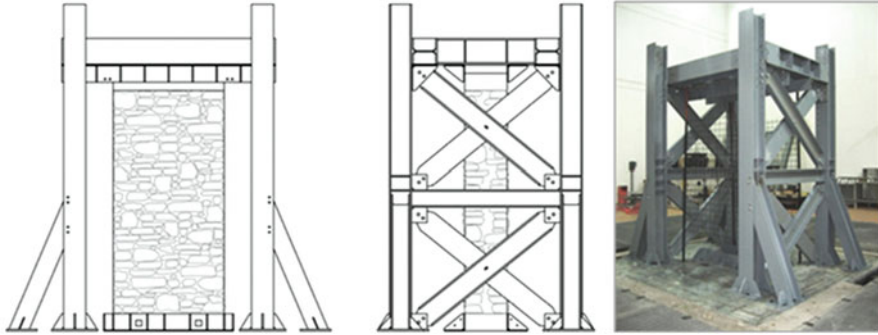
Fig. 8.17 Test specimens and experimental setup (Valluzzi et al. 2013)

Recently, within the EU funded project NIKER, tests were carried out (Valluzzi et al. 2013) on three-leaf rubble stone masonry full scale panels (Fig. 8.17) subjected to out-of-plane excitations on a shaking table. The panels (1.30 m long, 2.60 m high and 0.50 m thick) were subjected to adequately scaled real accelerograms.

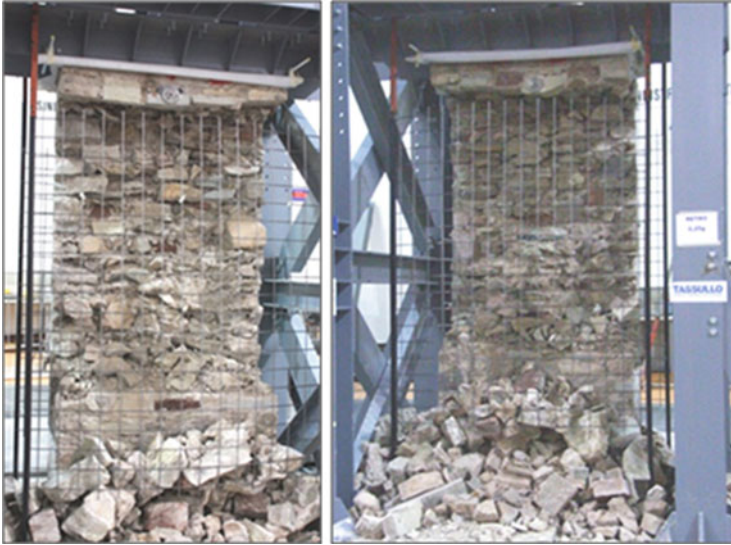
Fig. 8.19 Failure of walls 1 and 2 (Valluzzi et al. 2013)

The panels failed under acceleration approximately equal to 0.30 g. As shown in Fig. 8.18, cracks typical for out-of-plane bending have occurred. Failure was due to the separation of the leaves of masonry and to the collapse of one of the two exterior leaves (Fig. 8.19).

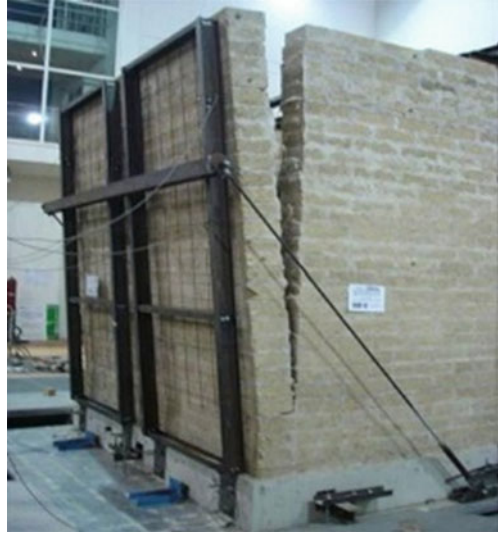
Fig. 8.20 Photo of a specimen after the test: case of out-of-plane loaded wall connected to the transversal walls through a mortar joint (Al Shawa et al. 2009)

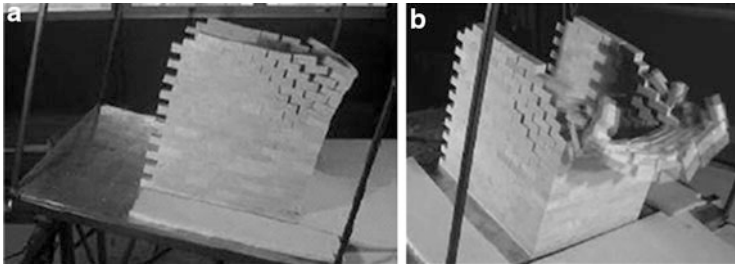
Fig. 8.21 Failure mode of out-of-plane loaded walls connected to portions of transverse walls Restrepo-Vélez (2004) and Restrepo-Vélez and Magenes (2004)

The mechanisms of out-of-plane failure of a wall connected with transverse ones was studied by Restrepo-Vélez (2004) and Restrepo-Vélez and Magenes (2004) through testing of subassemblies made of dry stack masonry (Fig. 8.21). The models (scale 1:5) allowed for identification of the two possible failure modes, i.e. detachment of the out-of-plane loaded wall from the transverse ones and out-of-plane collapse of the wall.

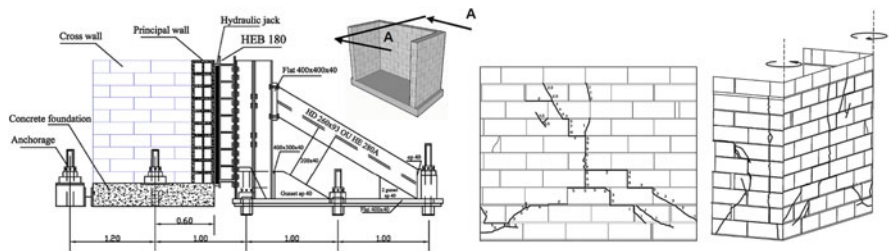
Fig. 8.22 Test setup and failure mode of walls with flanges (Bui et al. 2010)

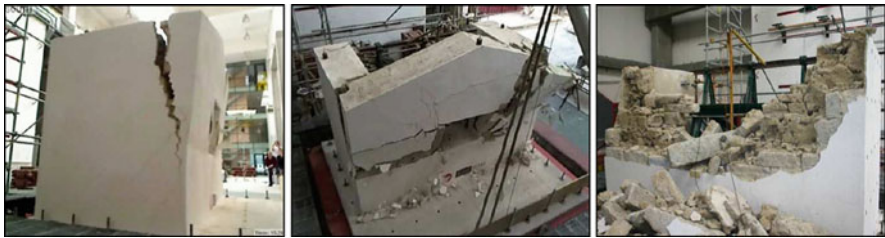
Fig. 8.23 Failure mode of subassembly (Costa et al. 2012a)

A full scale shaking table test on a 3-D specimen made of three-leaf masonry was performed by Costa et al. (2012a). The subassembly-simulating a typical façade of historic buildings in the Azores-exhibited the same failure mechanisms, together with detachment of the leaves of masonry (Fig. 8.23).

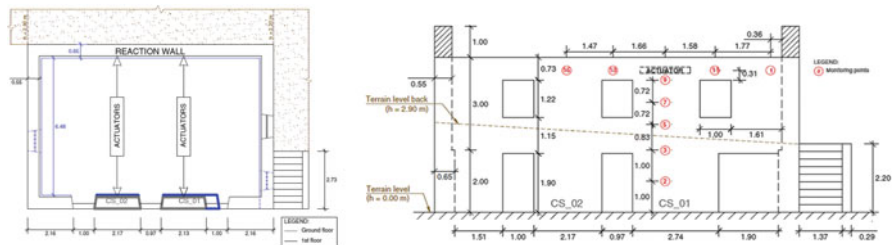
Fig. 8.24 Testing arrangement and instrumentation of a building tested on situ (Costa et al. 2012b)

Costa et al. (2012b) carried out an in situ test on a building severely damaged during the Azores earthquake in 1998 (Fig. 8.24). The building was made of double leaf stone masonry.

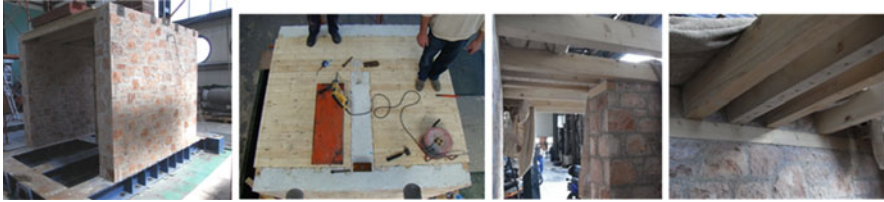
Fig. 8.25 The specimen and its construction details (Vintzileou et al. 2012)

A 3D subassembly was tested within the EU funded project NIKER (Vintzileou et al. 2012a, b). The subassembly (made of three-leaf stone masonry) consists in one wall with a portion of a transverse wall at its mid-length and a parallel wall of rectangular section (Fig. 8.25). A timber floor (typical for historic buildings) is

provided. For dynamic similitude purposes, additional masses are fixed on the floor before testing on the earthquake simulator. The subassembly was subjected to a series of adequately scaled accelerograms of the Irpinia, Italy 1980 earthquake out-of-the plane of the parallel walls. Figure 8.26 shows the crack pattern (at $PGA \sim 0.50$ g). The effect of the portion of the transverse wall (failed in shear) on the longitudinal wall to which it is connected is shown. Furthermore, the flexible wall of rectangular section was not severely damaged. It exhibited, however, extensive detachment of the masonry leaves. It should be noted that the same subassembly after strengthening (grouting of masonry, enhancement of the diaphragm action of the floor and connection thereof with the walls) exhibited a clear rocking behaviour.

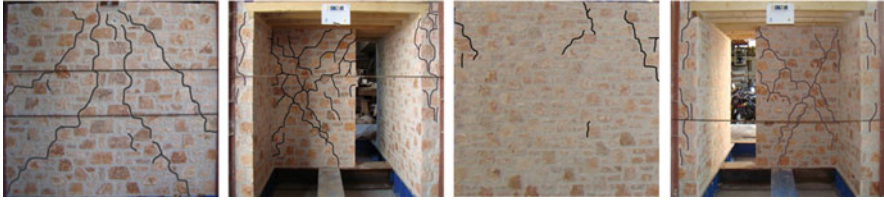
Fig. 8.26 Crack pattern of the subassembly (Vintzileou et al. 2012)

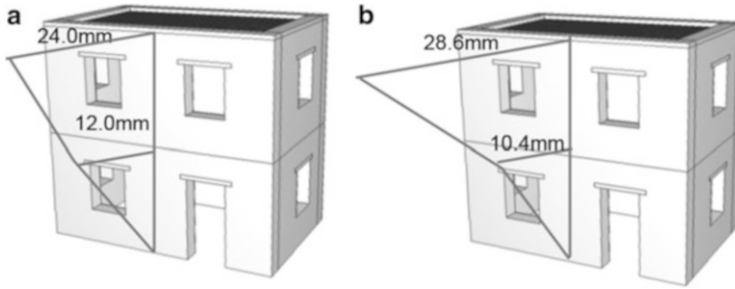
Fig. 8.29 (a) Plain masonry model: Out-of-plane displacements of the long wall for an input motion equal to 90 % Kalamata earthquake, (b) timber laced model: Out-of-plane displacements of the long wall for an input motion equal to 120 % Kalamata earthquake (Mouzakis et al. 2012a, b; Adami et al. 2012)

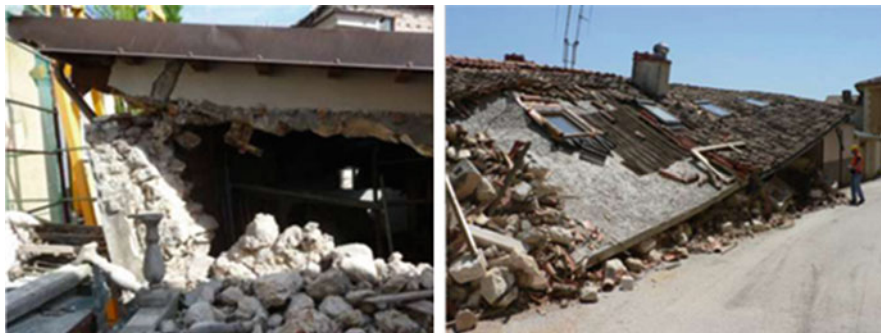
Fig. 8.30 Catastrophic effect of RC slabs on poor quality (unstrengthened) masonry (courtesy of Prof. C.Modena)

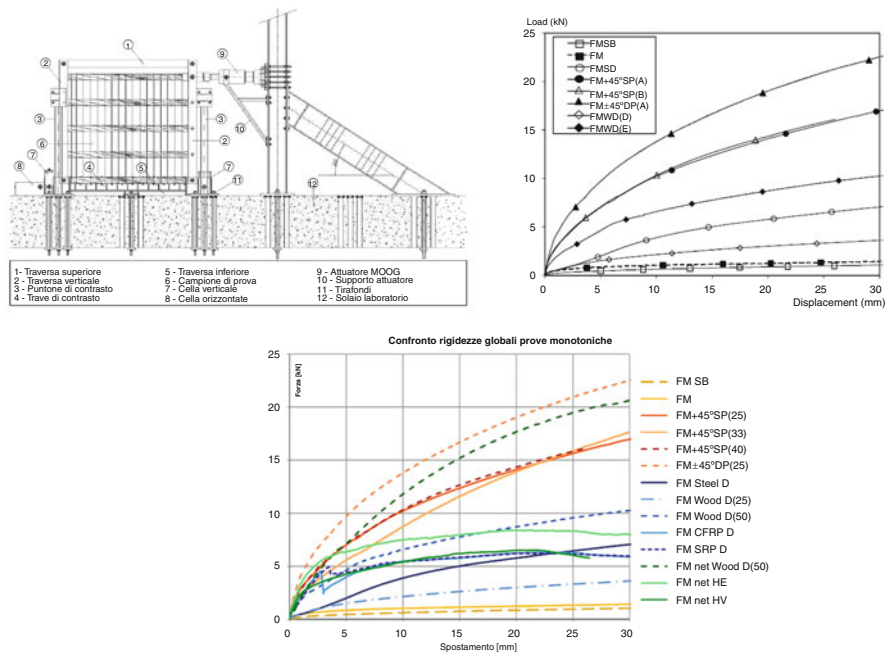
Fig. 8.32 Test setup and main results (Valluzzi et al. 2010; Zaopo 2011)

Piazza et al. (2008), Valluzzi et al. (2010), Wilson et al. (2011), Zaopo (2011) have tested timber diaphragms either as-built or stiffened using various techniques (e.g. double board, FRP strips, diagonal steel ties, plywood panels, RC slab, etc.). They have tested single span diaphragms in their plane (monotonically or cyclically) and they have recorded both the deflection of the diaphragm and the

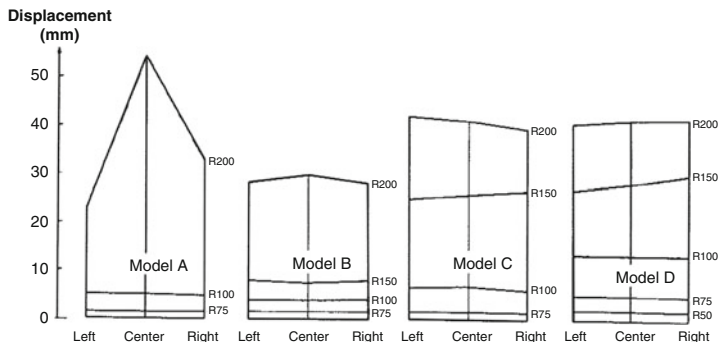
Fig. 8.33 Out-of-plane displacements of walls for various alternative floor types (Tomažević et al. 1991, 1993)

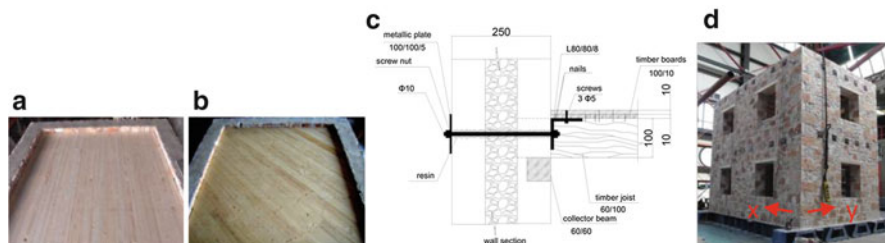
Fig. 8.34 Enhancement of the diaphragm action of floors (Mouzakis et al. 2012a): (a) the original pavement, (b) the pavement with the second layer of boards, (c) detail of the connection between diaphragm and walls, (d) the model after strengthening

Mouzakis et al. (2012a) in their shaking table tests have provided to the building models a second layer of boards (at an angle of 45° with respect to the original pavement, Fig. 8.34). Natural frequency measurements along x and y axes have shown a significant difference along the two axes (6.05 and 4.21 Hz respectively), due to the significantly smaller stiffness perpendicular to the long side of the model.

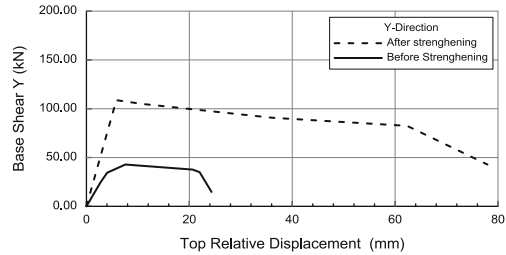
Fig. 8.35 Envelop of hysteresis loops for a plain masonry building model tested on the shaking table before and after strengthening (Mouzakis et al. 2012a)

After strengthening, the two values were substantially larger (10.36 and 9.95 Hz respectively) indicating a significant overall increase of the stiffness of the model. More importantly, the two frequency values are almost equal along the two axes, indicating that the stiffness of the strengthened diaphragms was able to ensure the box action of the model.
