# Chapter 13

## Mitigating Coastal Erosion in Fort Dauphin, Madagascar

**Abstract** The city of Fort Dauphin is one of the most attractive tourist spots in Madagascar. In recent years, it has become one of the development centers of the island. However, the city is facing coastal erosion related to human activity as well as natural factors. Mitigation of coastal erosion at the catchment and regional scale is extremely important for the sustainable economic and social development of this region. Spatial analysis using satellite imagery over a long period has been considered as an important tool for determining the extent of the most affected areas and for analyzing how the erosion has developed in the past and at present. Measurement and field work need to be integrated to develop appropriate strategies to mitigate the problems. Satellite imagery analysis in combination with field work and measurement consists of generating long-term information required to determine threats and pressures in time and space. It takes into consideration assessment of land use, the geology of the area, urban planning, local and regional climate, and coastal management. Madagascar faces multiple chall

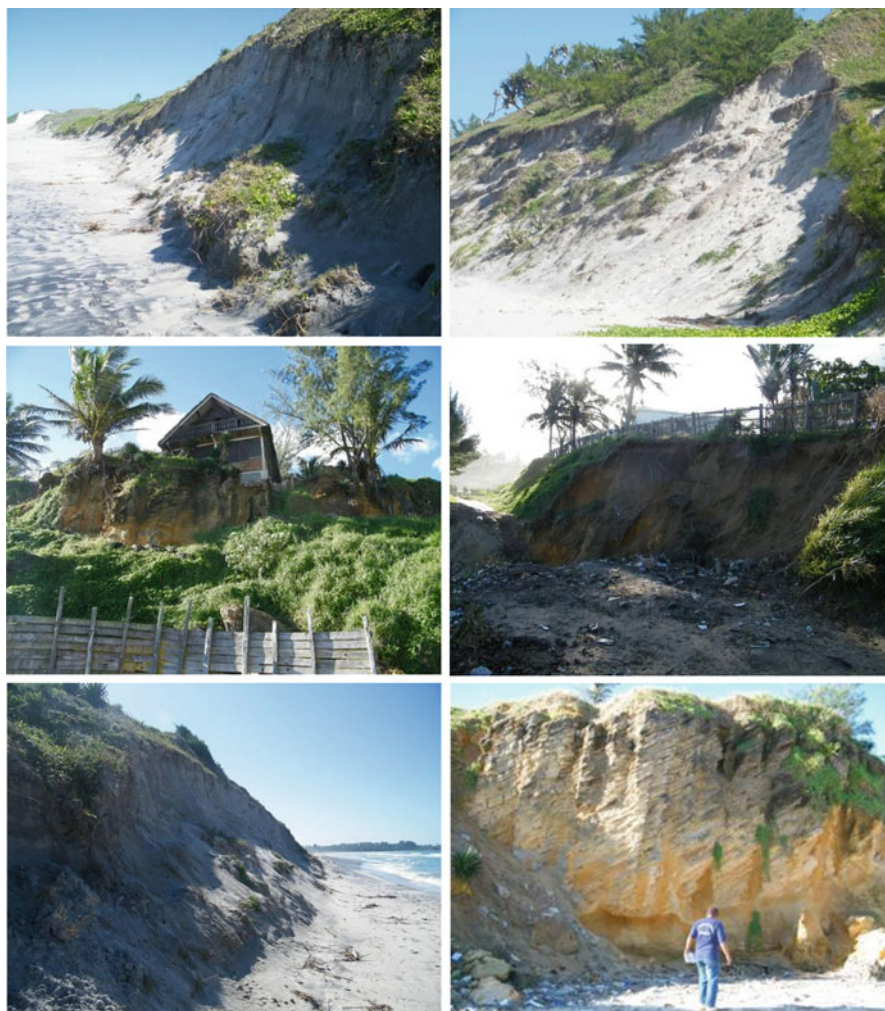
The impacts of coastal erosion most frequently encountered in Fort Dauphin can be grouped into three categories: coastal flooding as a result of dune erosion, undermining of sea defenses associated with foreshore and subaerial erosion, and retreating cliffs, beaches, and dunes causing loss of land (Fig. 13.4).

Fig. 13.4 Impacts of coastal erosion in Fort Dauphin

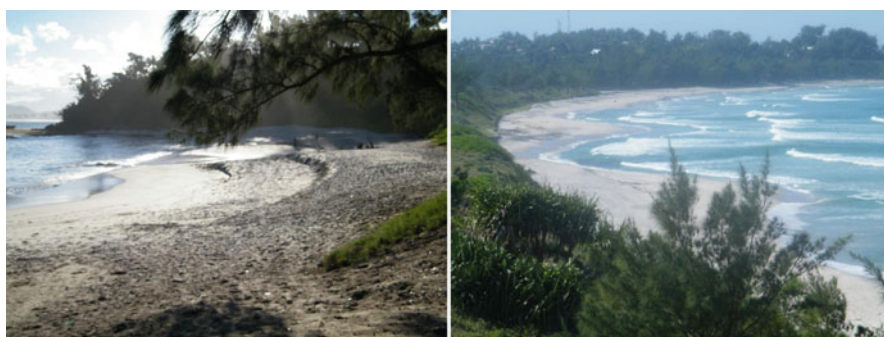
The manifestation and activity of these two parameters on beach and dunes could be explained by combinations of various natural forces such as the wave direction approach, as well as the dredging (digging) phenomenon in the coastal area. Before explaining the coastal erosion process in Fort Dauphin, it is interesting to remember that the surf zone is the area where waves break. It is a turbulent zone, as waves smash and dissipate their energy in this area while producing intense local currents that eventually reach the coastal shores (Hyndman 2006). During this turbulent time, water removes sediment in its path and then local currents carry it to the sea when leaving the coast. The same process occurs in the wave zone; in this zone, the depth of breaking varies depending on wave size (Hyndman 2006). This phenomenon is observed on all the beaches in Fort Dauphin, and beach and dune dredging appears in the same manner as shown in Fig. 13.9.

Fig. 13.9 Image showing the actual state of Libanona in Galions Bay, 2012

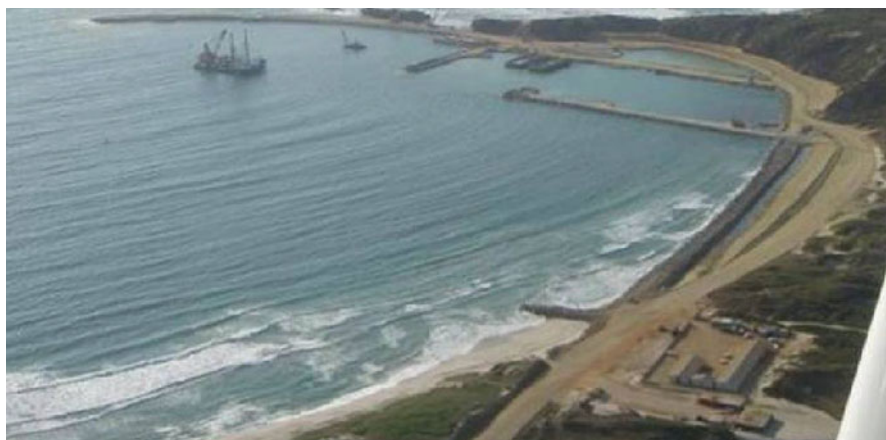
This technique is based on the construction of stone or concrete walls perpendicular to the shore and extending into the water. They are primarily intended to promote the accumulation of sand on the beach by trapping the sand, or slowing its movement along the shore. They can also be constructed of either wood or steel. The groins can be built separately or in groups along the beach (Fig. 13.11).

**Fig. 13.11** Groins installed close to the Ehoala port

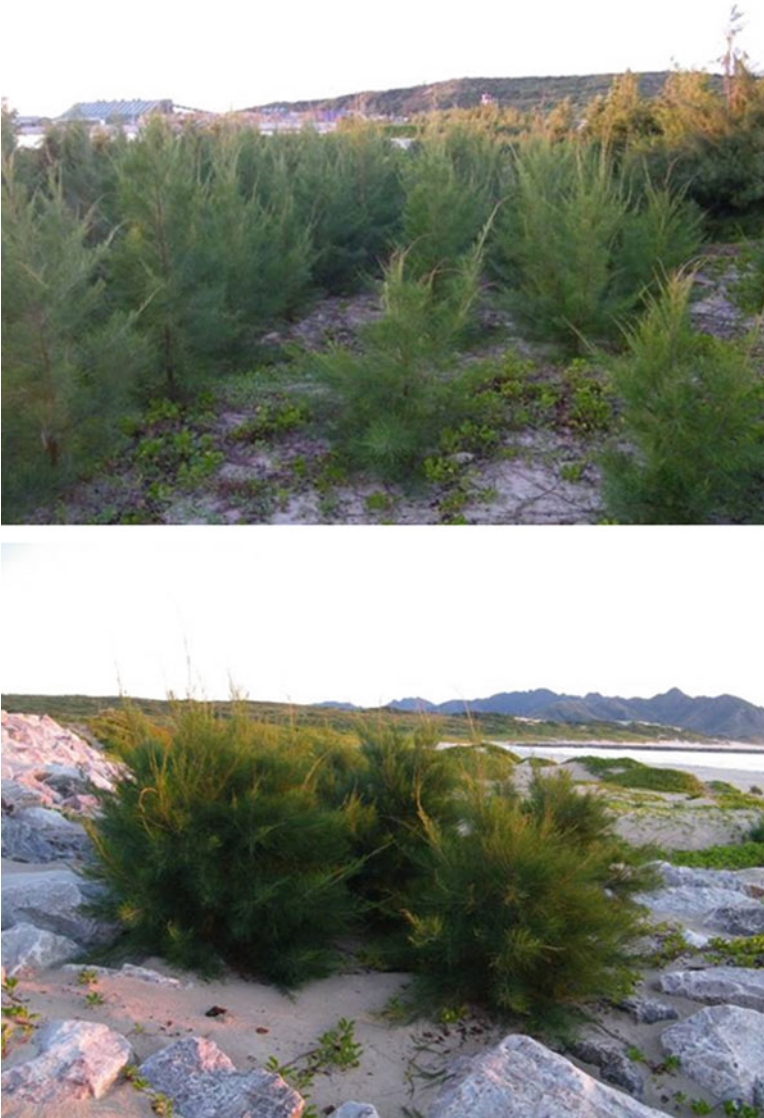
**Fig. 13.13** Casuarinas trees planted near the Ehoala port

Once the dunes are stable, planted trees can withstand the actions of the wind over time. Use of *Vetiver* has already shown great success in watershed protection in Madagascar. This species is capable of sinking its roots up to three meters deep and grows almost everywhere. The same is true for *casuarinas*, which have already been planted in Fort Dauphin along the road leading to the Ehoala port as a kind of windbreak (Fig. 13.13). To date this species has grown well and met expectations.
