Rock slope stability evaluation in static and seismic conditions for left bank of Jinsha River Bridge along Lijiang-Xamgyi'nyilha railway, China

Abstract: Jinsha River Bridge is located along the Lijiang-Xamgyi'nyilha railway on the southeastern Tibet plateau; it is an area with a high prevalence of earthquakes. The bridge abutments were designed to be constructed in river bank slopes, where rocks are controlled by two sets of joint planes that significantly influence the stability of the left bank slope. According to the engineering-geological conditions and the characteristics of discontinuities, strength properties of the rock mass were obtained based on Barton model and direct shear test. Numerical analyses were performed using FLAC^{3D} software to examine the slope's response to seismic loading. Then in order to evaluate the damage trends of the rock mass under the different loading conditions, a calculation model based on the geological parameters and slope stability was simulated and analyzed using the discrete element numerical simulation program UDEC (Universal Distinct Element Code), and the effect of degradation of discontinuities on the slope stability was investigate

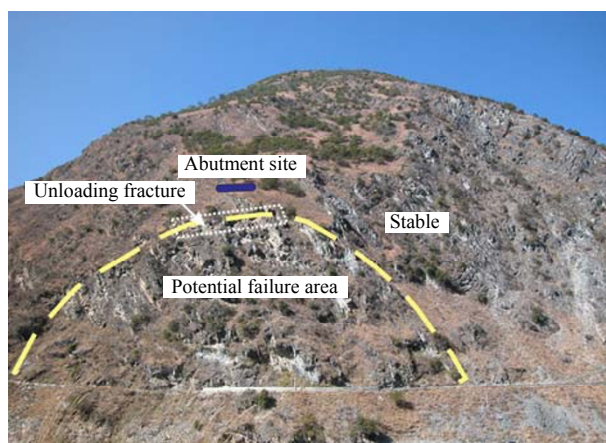
Fig. 2 Panorama view of the rock slope

At the bridge site, the Jinsha River flows in an NNE direction with a 100–200 m width. Morphologically, the slope of the river banks is very steep, especially where the vegetation is not developed. As a result, collapse and rock slides toward the valley occur frequently. There is an unloading fracture with a length of about 60 m parallel to the river direction (Fig. 2).

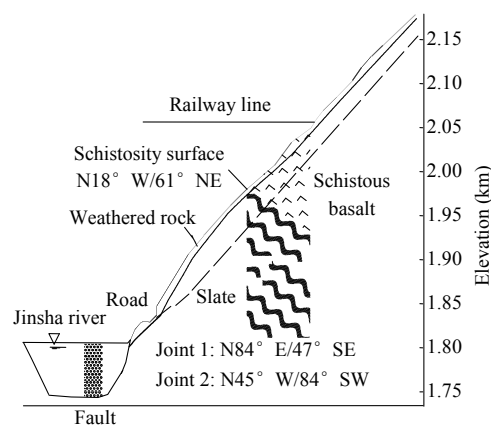
Fig. 3 Stratigraphical cross section of the rock slope

From the lithological point of view, the exposed Triassic metamorphic rocks mainly consist of moderately thick layers of slate overlain by schistose basalt. A representative geological cross section of the rock slope was obtained as illustrated in Fig. 3. The rocks are intensively schistose, striking $N18^{\circ}W$ with a dip angle 61° to the NE. The foliation planes are slightly weathered with no rust dye and mineral alteration (carbontization,

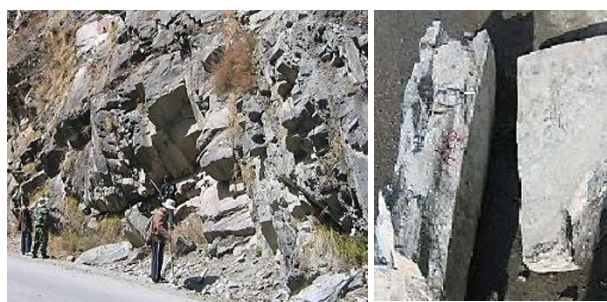
Fig. 4 Side and close-up view of rock slope showing fracturing and dimension of the rock mass

The rocks are characterized by two distinct major joint sets: a) trending $N84^{\circ}E$ dipping 47° to the SE, and b) trending $N45^{\circ}E$ with dip angle 84° to the SE. Due to the joints intersecting, the rock mass separated into small blocks ranging from 30 cm to 80 cm thick (Fig. 4).

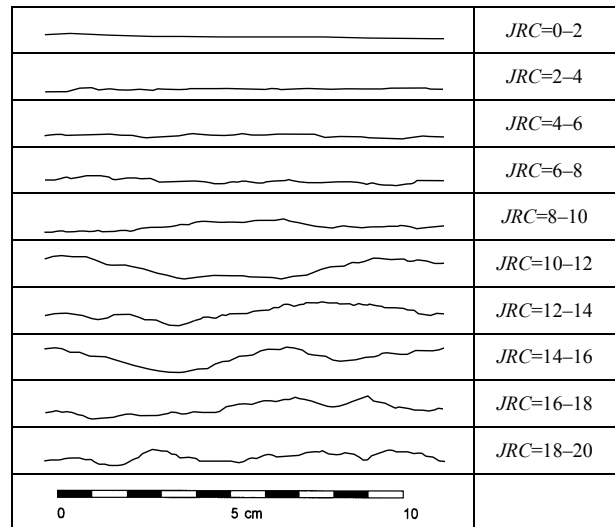
Fig. 5 Marked range of JRC value of discontinuity surface [17]

The amplitude of *JRC* was estimated by visually comparing the appearance of the joint surface with Barton and Choubey standard profile [17] (Fig. 5), where the value of *JCS* was calculated by the following equation [18]:

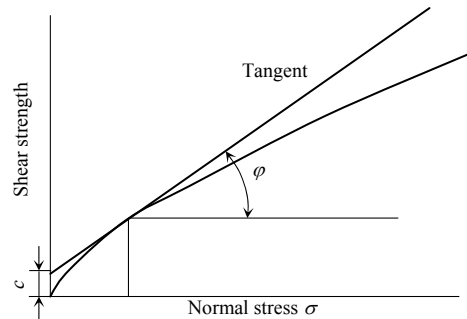
Fig. 6 The calculation model of shear strength parameters (*c* and ϕ) of the discontinuity

The value of friction angle ϕ and cohesion *c* can be calculated according to the model as shown in Fig. 6:

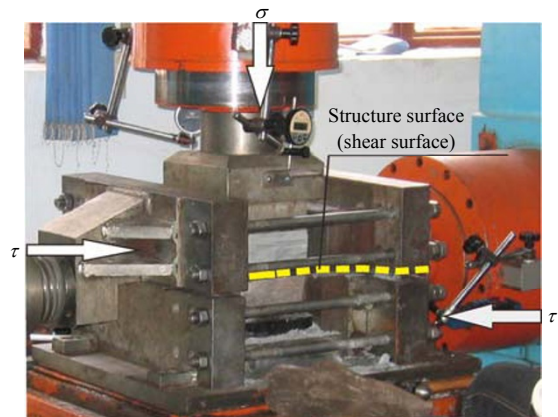
Fig. 7 Direct shear test apparatus for discontinuities

fully for laboratory test. The test was done by direct shear test apparatus (Fig. 7). The test specimens are cubic in shape with length not less than 150 mm (Figs. 7 and 8). In the test, the shear displacement was 1.0 cm, the maximum normal stress was scheduled to be 10 MPa

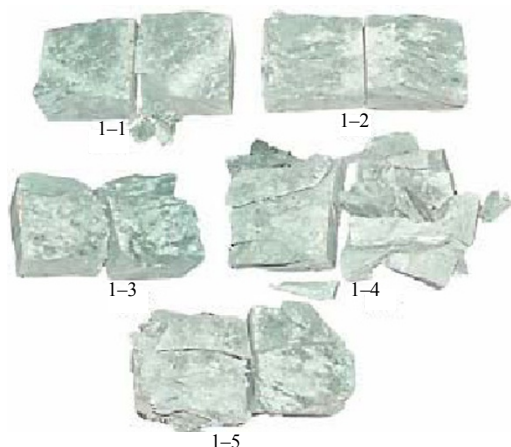
Fig. 8 Morphologies of specimens after laboratory experiment

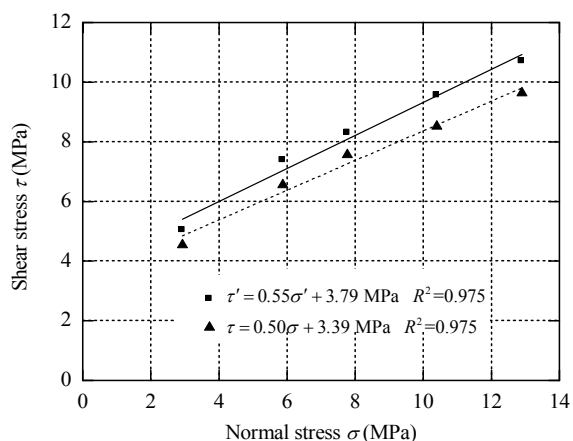
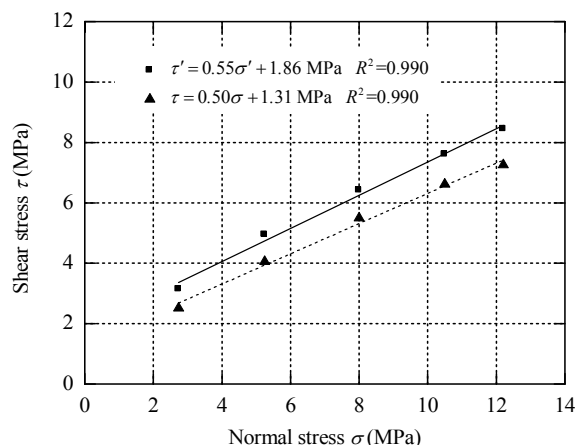
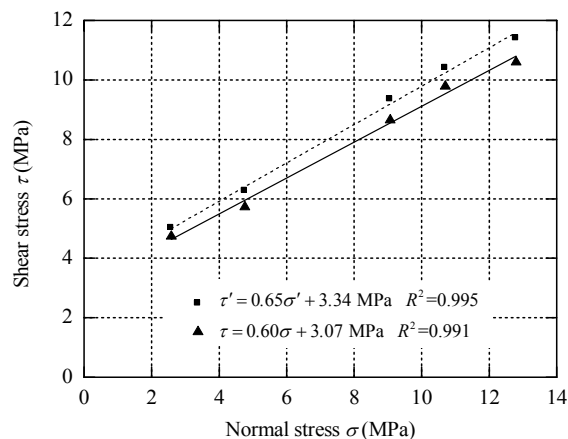
(a) Schistose plane

(b) Joint No. 1

(c) Joint No. 2

Fig. 9 Shear strength-normal stress diagrams

and adjusted appropriately according to the specimens and deformation conditions). Based on the peak value, the critical shear strength parameters (φ' , c') are calculated with least square method [20] (see Fig. 9, where τ' is the critical shear strength). The results are shown in Table 2.

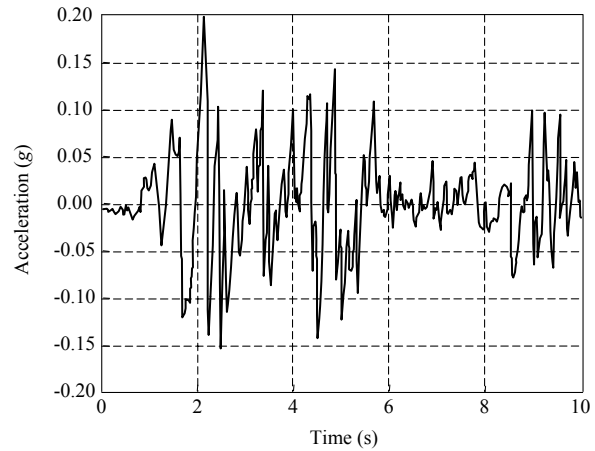
Fig. 10 Time-history curve of the ground surface acceleration used in the model

To analyze the stability of the left bank slope of the bridge site, a 3D numerical simulation analysis using FLAC^{3D} software [23] has been used. The earthquakes spectrum reported by Ref. [3] is used here for dynamic analysis. Basic parameters of slope analysis are as follows: damping ratio is 0.05, the peak ground acceleration (PGA) is 0.20g, and the time history of the ground surface acceleration is adopted as the input ground motion, as shown in Fig. 10. According to the seismic data and mechanical parameters of the rock mass (Table 3), the base of the slope model is set with a static boundary and the flanks are set with a free boundary (Fig. 11).

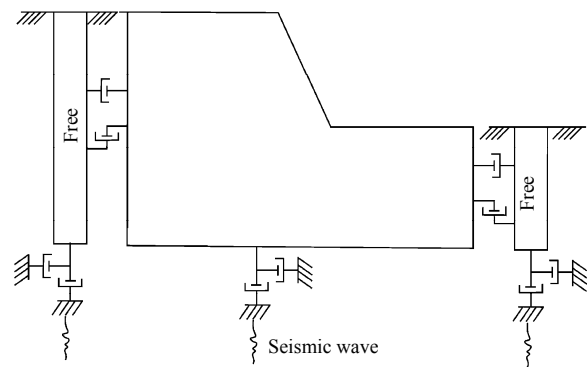
Fig. 11 Boundary conditions for the dynamic analyses

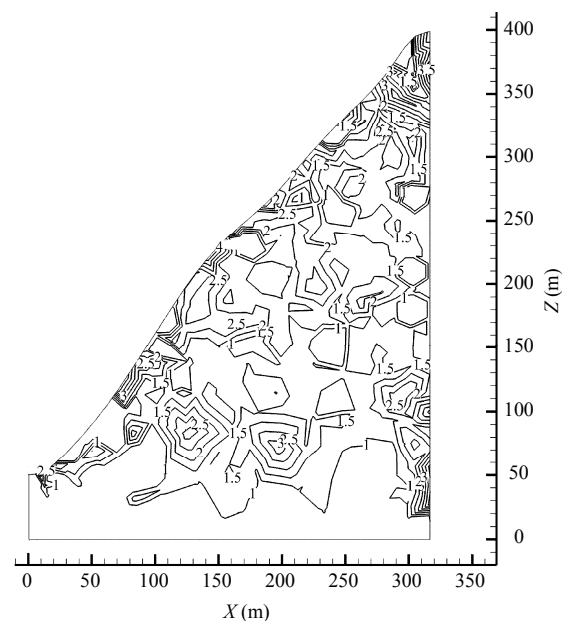
Fig. 12 The acceleration amplification coefficient in the x direction

In order to detect the amplification and attenuation states in the numerical model under seismic loading, the acceleration response is monitored at the top and bottom of the slope model (Figs. 12 and 13).

(2) From the results of the dynamic analysis of rock the slope, the isolines of acceleration are parallel to the slope surface as shown in Fig. 12. The amplification coefficient increases from inside to outside, and reaches a maximum at the slope surface. From the toe of the slope, the acceleration at the surface increases in a fluctuating manner with slope height. It reaches a maximum at the height of about 120–200 m of the slope (4 times more than that at the toe). Similar distribution characteristics are found in the amplification coefficient of x -velocity (Fig. 13) that reaches a maximum at the height of approximately 200 m (4 times more than that at the toe). Thus, from the numerical analyses, it is clear that the rock mass of the bank slope separated by joint discontinuities is unstable at the height of about 200 m and will undergo failure under seismic load (Fig. 14).

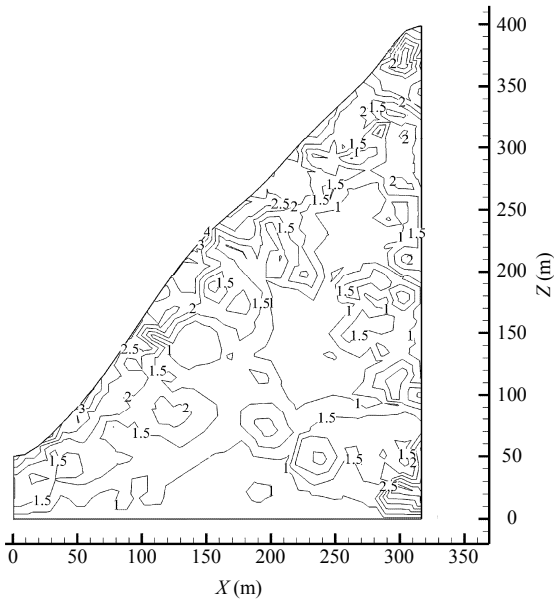
Fig. 13 The velocity amplification coefficient in the x direction

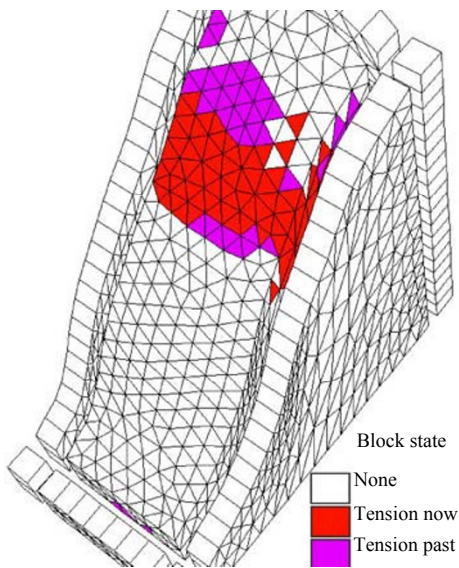
Fig. 14 The status of rock block

To illustrate the status and structural behaviour of the rock slope, a 3D model was constructed, which shows the distribution characteristics of maximum shear stress of each block under the seismic load, and the areas of tensile stress concentration (Fig. 14).

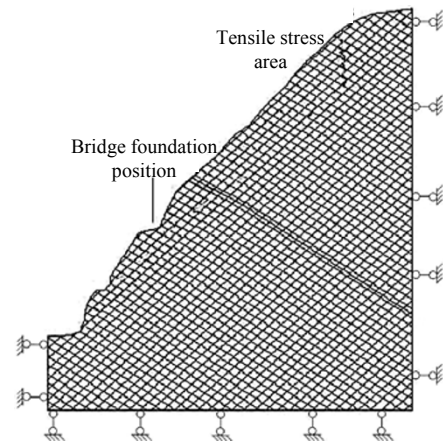
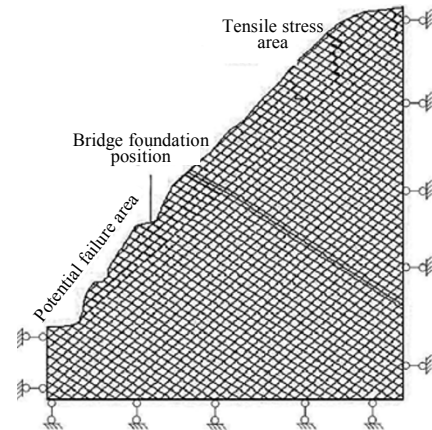
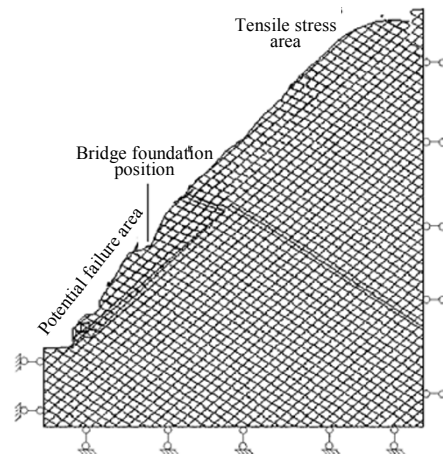
(a) Under gravity

(b) Under bridge loading

(c) Under both static and seismic loading

Fig. 15 Characteristic failure of slope under different loading

placement. The mechanical parameters of the intact rock and discontinuities are shown in Tables 2 and 3, respectively. The boundary conditions are assumed along the lateral sides of the model such that no displacement is allowed in the x direction. At the base of the numerical model, the boundary is fixed such that no displacement is allowed in the y direction (Fig. 15).

(3) According to the DEM analysis, the failure of the rock mass under gravity, bridge foundation, and seismic load are mainly concentrated at 30 m depth. The natural slope and the slope under loading (bridge foundation and seismic load) may slip along joint planes, where the whole slope is stable.
