# ERRATA

## Recuperator Alloys for High-Temperature Waste Heat Recovery

G.Y. Lai, M.F. Rothman, S. Baranow, and R.B. Herchenroeder

The following figures are the correct Figures 1, 5, and 6 for this article published in the July issue.

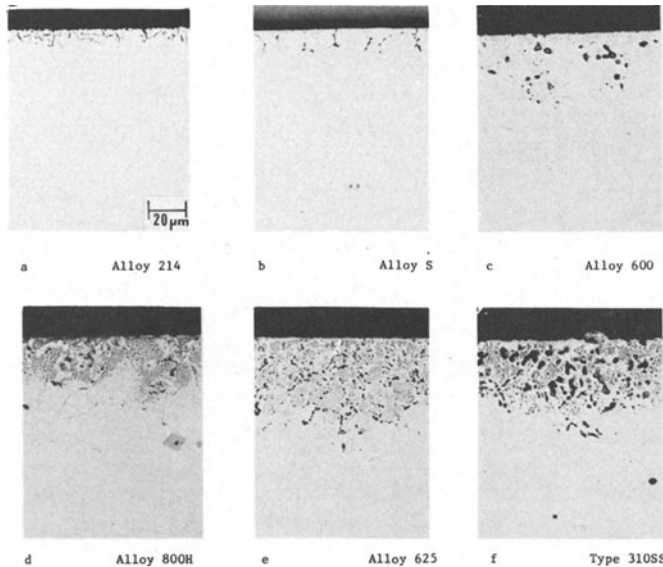
Figure 6. Optical photomicrographs showing corrosion attack upon various alloys in Ar-4% H<sub>2</sub>-4% HCl at 1650°F (900°C)/8 h.
