## A Decade After the 2004 Indian Ocean Tsunami: The Progress in Disaster Preparedness and Future Challenges in Indonesia, Sri Lanka, Thailand and the Maldives

**Abstract**—The 2004 Indian Ocean tsunami was one of the most devastating tsunamis in world history. The tsunami caused damage to most of the Asian and other countries bordering the Indian Ocean. After a decade, reconstruction has been completed with different levels of tsunami countermeasures in most areas; however, some land use planning using probabilistic tsunami hazard maps and vulnerabilities should be addressed to prepare for future tsunamis. Examples of early-stage reconstruction are herein provided alongside a summary of some of the major tsunamis that have occurred since 2004, revealing the tsunami countermeasures established during the reconstruction period. Our primary objective is to report on and discuss the vulnerabilities found during our field visits to the tsunami-affected countries—namely, Indonesia, Sri Lanka, Thailand and the Maldives. For each country, future challenges based on current tsunami countermeasures, such as land use planning, warning systems, evacuation facilities, disaster education and d

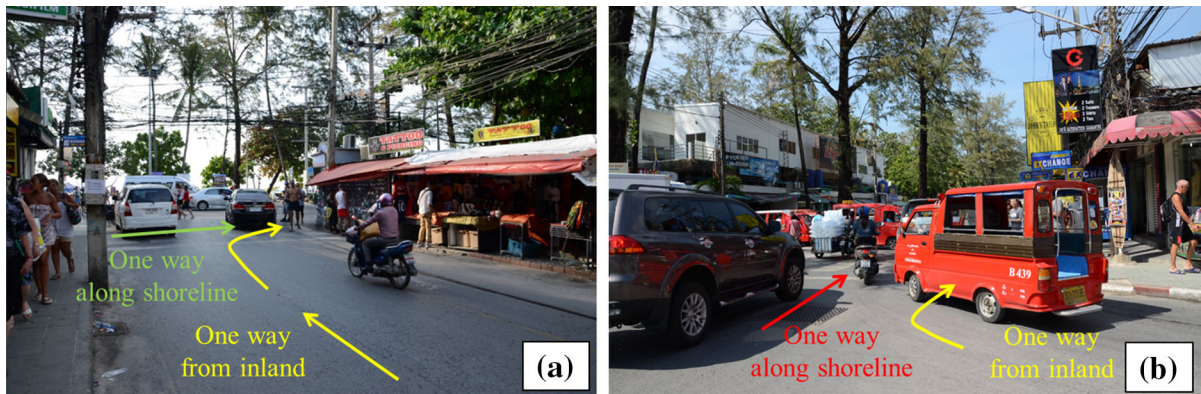
Figure 14  
Traffic direction in Patong beach (a) in the south and (b) in the north

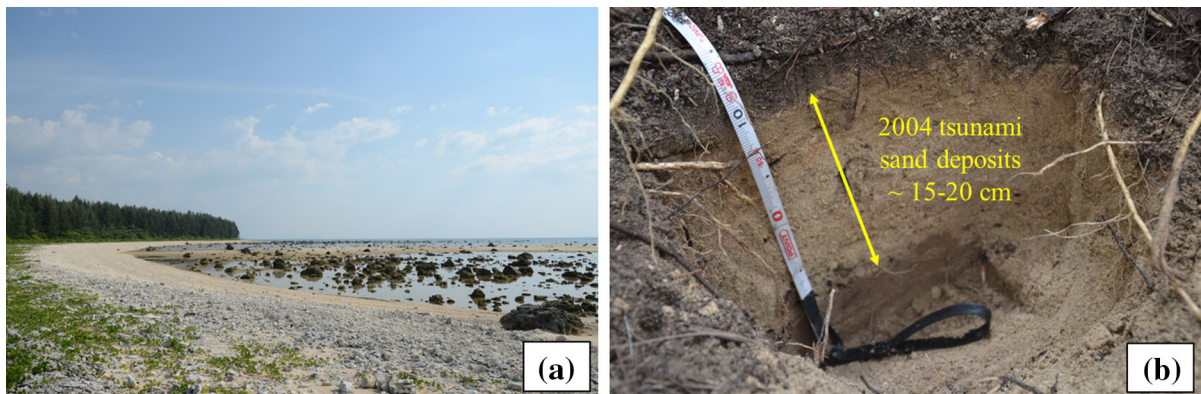
Figure 15  
Remaining geological evidence at Pakarang Cape, a tsunami boulders and b tsunami sand deposits

The tsunami in 2004 transported thousands of meters-long boulders shoreward at Pakarang Cape, Thailand. Goro *et al.* (2007) investigated the size, position and long-axis orientation of 467 boulders on the cape. Most of the boulders found on the cape were well rounded, ellipsoid and without sharp, broken edges. They were fragments of reef rocks, and their sizes were estimated to be an average of  $14 \text{ m}^3$  (22.7 t). Goto *et al.* (2007) calculated the tsunami inundation at Pakarang Cape. They suggested that the tsunami waves, which were directed eastward, struck both reef rocks and coral colonies that were originally located on the shallow sea bottom near the reef edge; these detached, and the boulders were transported shoreward. During our visit in February 2013 (Fig. 15a), the boulders were still there. Conversely, sand accumulation was remarkable on the tidal bench, and the beach berm had quickly recovered.

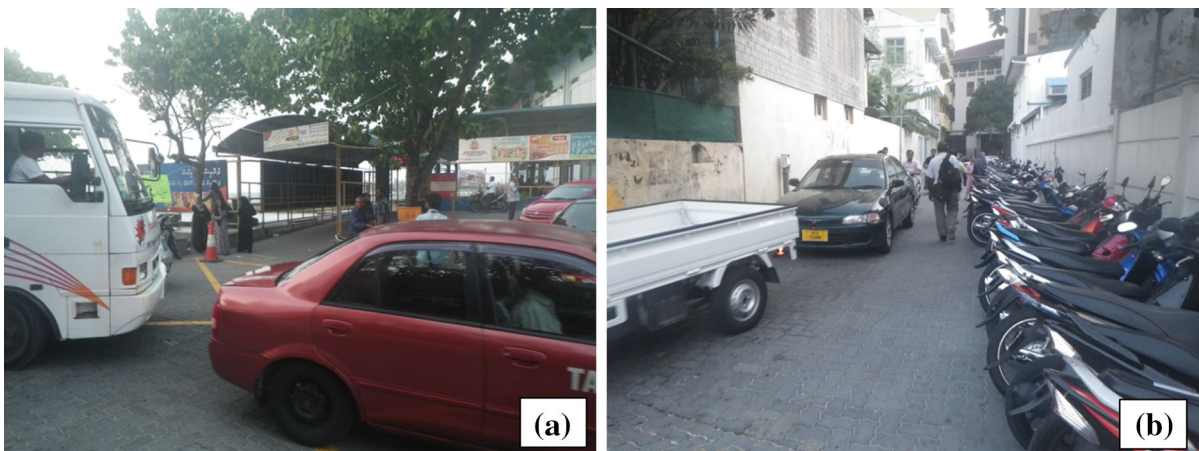
Figure 18  
**a** Crowded traffic during rush hour in the road along the coast and **b** an evacuation route that is blocked by parked motorcycles
