Preliminary Observations and Impact in Japan of the Tsunami Caused by the Tonga Volcanic Eruption on January 15, 2022

Abstract—The tsunami caused by the Tonga submarine volcanic eruption that occurred at 13:15 Japan Time (JST) on January 15, 2022, exposed a blind spot in Japan’s tsunami monitoring and warning system, which was established in 1952 for local tsunamis and expanded to distant tsunamis after the 1960 Chile tsunami. This paper summarizes how the warning system responded to the unprecedented tsunami, the actual evacuation process, and the damage it caused in Japan. Initially, the tsunami from the volcanic eruption was expected to arrive at approximately midnight with amplitudes of less than 20 cm. However, a series of short waves arrived at approximately 21:00, a few hours earlier than expected. The early arrival of these sea waves coincided with a rapid increase in atmospheric pressure; then, the short-period component was predominant, and the wave height was amplified while forming wave groups. After a 1.2 m tsunami was observed in Amami City in southern Japan at 23:55 JST, the Japan Meteorological Agency issued a tsunami warning/advisory. The tsunami continued, and al

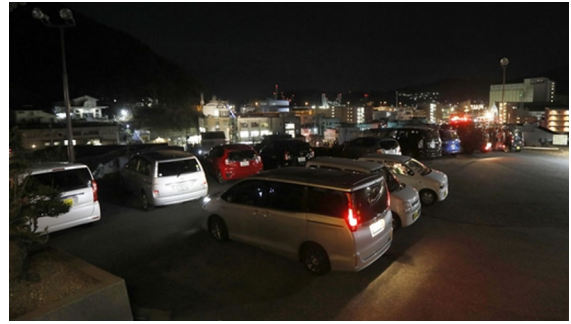
Photo 1

Cars gathered on a hill (Kamaishi City, Iwate Prefecture). A tsunami warning was issued, and the cars of evacuees gathered at a temple on a hill = 3:52 am on January 16 [Provided by Kyodo News]

Regarding the use of cars in a tsunami evacuation, many people reportedly evacuated by car not only in Amami Oshima Island but also in Ofunato and Kamaishi City, Iwate Prefecture (Photo 1, Kyodo, 2022); thus, it is possible that car evacuation has become usual. Travel by car occurs daily in an aging society, and cars are often indispensable as a means of transportation. Therefore, it is necessary to consider realistic measures according to the state of society. Evacuation at night hinders evacuation behavior. It is also possible that evacuation by car may be necessary after drinking alcohol with a meal, even though drunk driving laws are very strict in Japan. In addition, it was difficult to evacuate uphill at night due to the cold winter weather (Photo 2). In response to hoax information such as that posted on social network sites (SNS) (for example, a video of another tsunami shown as a video of the current tsunami), it is important that information be provided by reliable resources. It is currently difficult to deal with this problem, but it is important to build a mechanism that allows users to instantly judge the reliability of information.

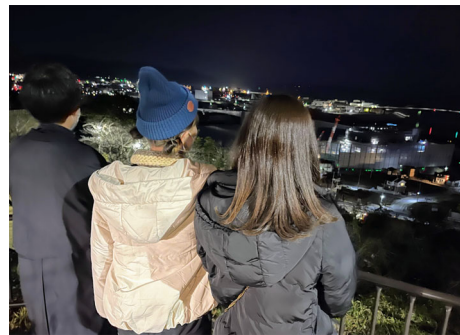
Photo 2

Evacuees gathered on a hill (Hiyoriyama, Ishinomaki City affected by the 2011 Great East Japan Earthquake tsunami) [Provided by Sanriku Kahoku Shimpo]

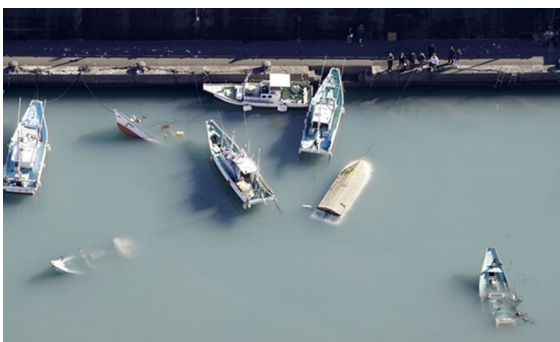
Photo 3

Capsized fishing boat 3 (Muroto City, Kochi Prefecture). Port of Muroto City, Kochi Prefecture, where multiple ships capsized or sank = 10:24 JST on January 16 (from Kyodo News helicopter)
[Provided by Kyodo News]

This tsunami had no runoff or overflow of riverbanks and was not on a scale that would cause enormous damage (Kyodo, 2022), but damage and effects in the sea area were reported (Photo 3). The tsunami occurred at the time to harvest oysters, scallops, and early-picked wakame seaweed, and there is concern that the damage will continue to spread. In Japan, fisheries have been damaged in distant tsunamis, including the 1960 Chile tsunami, the 2010 Chile tsunami (Kato et al., 2010), and the

According to satellite images, approximately 50 fishing boats are normally moored at Sakihama Port, Muroto City, Kochi Prefecture, which suffered the most damage. Since 10 ships were damaged, the damage ratio can be estimated to be approximately 20%. Few fishing boats were damaged when the 2010 Chile tsunami struck, which indicates that short-period tsunamis are more likely to damage fishing boats; thus, it is necessary to consider measures such as mooring methods in the future. In a long-period tsunami, a rope several tens of meters long will be in a tense state, and the mooring rope and anchor will not be able to resist the fluid force acting on the boat or aquaculture facility and will moved or break. This means that the drift of the boat or aquaculture facility
