Causes of acromion and scapular spine fractures following reverse shoulder arthroplasty: a retrospective analysis and literature review

Richard W. Nyffeler¹ · Bartu Altioklar¹ · Philipp Bissig¹

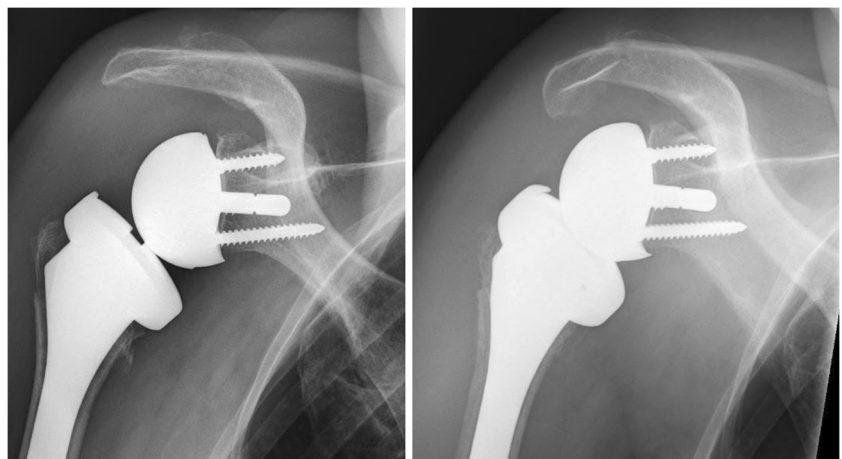
Fig. 1 Anteroposterior radiographs of patient 4 treated with a reverse shoulder prosthesis for an acute humeral head fracture after a fall. The patient reported another accidental fall 3 month after surgery. X-ray pictures showed a type I acromion fracture

Since April 2009, the Duocentric prosthesis (Aston Medical, Saint-Etienne, France) was used in all cases treated in our clinic. It was designed with the intention to reduce the incidence of scapular notching and improving the range of motion. Its glenoid baseplate is characterized by an inferior extension, a 20-mm-long or 40-mm-long and 6-mm-thin central peg, and 3 screw holes for the fixation to the scapula. There are two sizes, for a 36-mm or 40-mm glenosphere. Its centre of rotation is lateral to the implant-bone interface. The humeral component includes an onlay design with a standard stem, an adjustable epiphyseal plate with a neck-shaft angle of 145°, and a symmetric liner of different thicknesses (4 mm, 9 mm and 12 mm). The prosthesis was designed for degenerative conditions and proximal humeral fractures (Fig. 1).

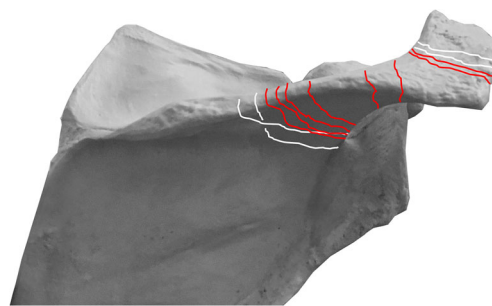
**Fig. 2** Graphic representation showing the fracture lines detected in our patient cohort. Type I fractures passed through the lateral border of the acromion, type II fractures through the posterior border of the acromion and type III fractures through the scapular spine. Traumatic fractures are represented with red lines, non-traumatic fractures with white lines

The fractures were classified into types I to III according to Levy et al. [33]. In this classification, type I fractures pass through the lateral border of the acromion, type II fractures through the posterior aspect of the acromion and type III fractures through the scapular spine, medial to the plane of the glenoid. Lengthening of the arm was determined on anteroposterior radiographs of the shoulder with the arm in adduction.

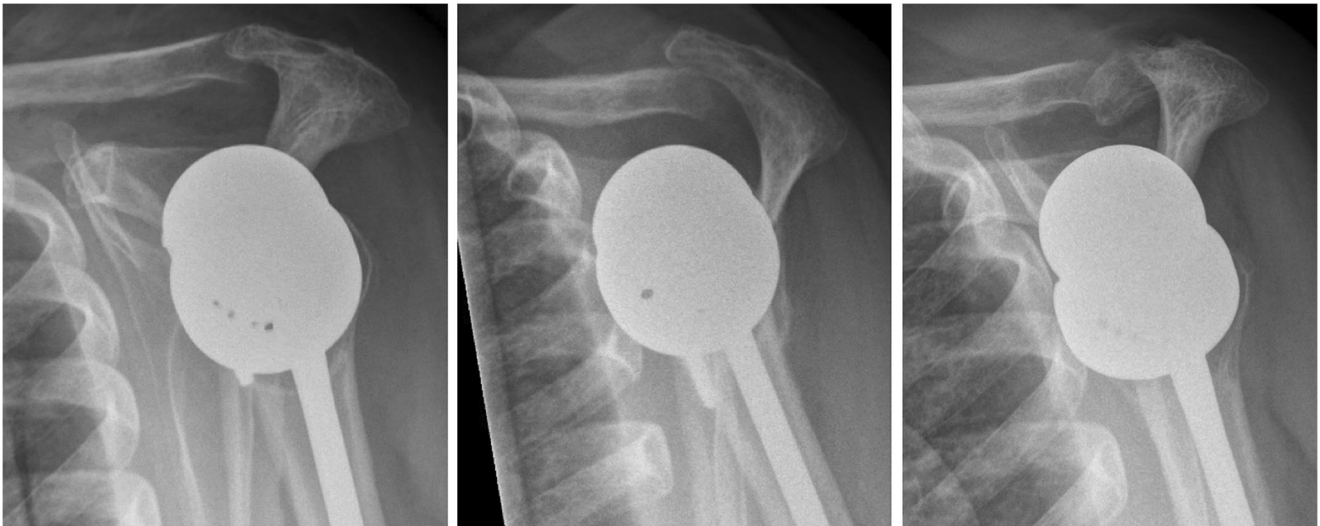
Fig. 3 Lateral views of patient 2 showing a normal alignment of the lateral clavicle with the acromion 6 weeks after reverse shoulder arthroplasty, a dislocation of the clavicle under the acromion after

3 months and an acromion type I fracture after 4 months. The AC joint was resected during the procedure

Numerous other factors have been taken into consideration. Crosby et al. [18] described 3 scapular spine fractures that appeared to propagate from the tip of the superior screw for the fixation of the glenoid baseplate. The authors suggested that these screws acted as stress risers and they tried to confirm their hypothesis with a biomechanical experiment [25]. However, the experimental setup was designed to test the resistance of a glenoid component under a force directed from the humerus to the scapula. The deltoid muscle itself was not simulated in their experiments. Other authors [23] postulated that a stiff AC joint may cause a stress concentration in the acromion, resulting in a fracture after the patient has regained shoulder mobility. We could not confirm this hypothesis. In our series, resection of the AC joint was probably a cofactor

for an acromion fracture (patient 2). Taylor and coworkers [32] introduced the scapular ring concept, which assumes that the coracoacromial ligament (CAL) can distribute strain patterns through the scapula. In their biomechanical experiment transection of the CAL during reverse shoulder arthroplasty resulted in increased strain at the scapular spine. The authors therefore suggested that preservation of the CAL could reduce the risk of scapular spine fractures. Because this ligament is routinely detached during a superolateral approach, one would expect a higher incidence of scapular spine fractures after a superolateral than after a deltopectoral approach. The review of Cho et al., however, showed that the opposite is the case [37].

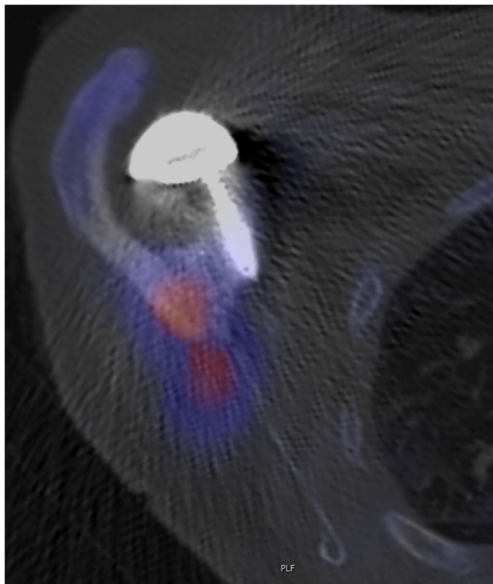
Fig. 4 Axial single-photon emission computed tomography (SPECT) image of patient 11 demonstrates a scapular spine fracture on the right side with increased uptake (red area). The superior screw for the fixation of the glenoid base plate was not in the fracture zone

The post-operative radiographs showed no malposition of the prosthetic components. The superior screw of the glenoid base plate projected onto the scapular spine in eight cases, but only in one case the rim of the scapular spine fracture passed close to the tip of the screw. All other fractures were superiorly and or laterally. CT scans of five patients revealed that the screws, which appeared to be in contact with the scapular spine on standard AP views were in reality in front of or

antero-superiorly to it (Fig. 4). Lengthening of the arm averaged 23 mm (range 19 to 36 mm). In all patients, the displacement of the fractured fragment increased from the first diagnosis to the latest follow-up, even in those patients who were treated with an abduction splint.

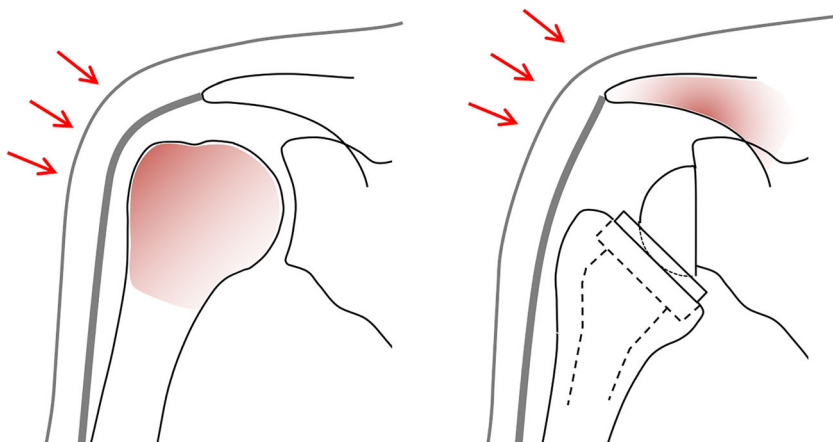
Fig. 5 Schematic representation of a normal and a reconstructed shoulder. Implantation of a reverse prosthesis alters the shape of the shoulder. It exposes the acromion and makes it vulnerable to direct trauma. The red colour marks the area that absorbs the energy during a lateral impact

the contour of the shoulder. Medialization and distalization of the humerus expose the acromion and therefore make it more vulnerable to fractures. One could assume that the lateral impacts that occur after a simple fall are no longer absorbed by the humeral head but by the more prominent acromion (Fig. 5). Patients who fall with a reverse shoulder prosthesis may therefore sustain a fracture of the scapula, rather than a fracture of the proximal humerus. In our study, not all elderly patients spontaneously reported their fall during the planned follow-up control, but mentioned the trauma after being specifically asked about it. This may be related to trivialization of a fall by elderly patients and to pain subsidence within a couple of weeks. Zmistowski et al. [43] noted that over 10% of their patients were asymptomatic at the time of radiographic diagnosis of an acromion or scapular spine fracture. This could also explain why not more fractures have been associated with a trauma in the literature. We therefore recommend a careful interview focusing on the onset of symptoms, when a fracture of the acromion or the scapular spine is diagnosed during routine controls.

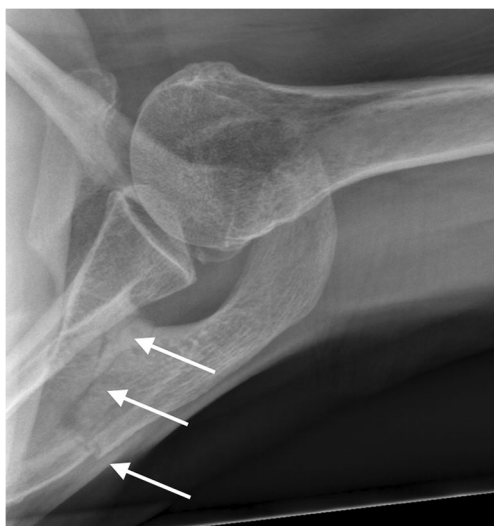
Fig. 6 Axial view of the native left shoulder of patient 11 showing a non-traumatic fracture of the scapular spine

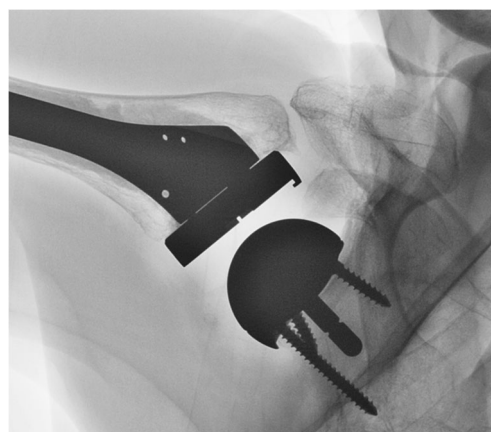
Fig. 7 Anteroposterior radiograph of a Duocentric reverse prosthesis demonstrates a mechanical conflict between the greater tuberosity and the non-fractured acromion during abduction in the scapular plane

a forceful passive mobilization of the shoulder or during a vigorous active movement with the arm, especially when the bone is weak (Fig. 7). This pathomechanism could have played a role in two of our patients (patients 1 and 11).

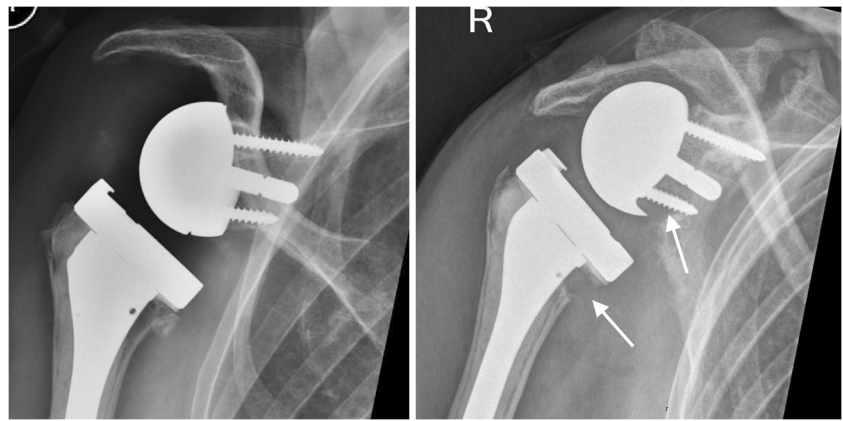
Fig. 8 Anteroposterior radiographs of patient 8 showing an intact acromion 6 weeks postoperatively and a pseudarthrosis 18 months after a traumatic scapular spine fracture. Compensatory upward rotation of the scapula to avoid the subacromial conflict caused an inferior impingement with polyethylene wear, scapular notching and osteolysis of the calcar

In our cohort, the functional results did not correlate well with the fracture type or the amount of displacement. Patient 8, for instance, had a good overhead shoulder function despite a pseudarthrosis of the scapular spine and a severely downward tilted acromion (Figs. 8 and 9). The compensatory upward rotation of the scapula, however, resulted in an inferior impingement with polyethylene wear, scapular notching and osteolysis of the calcar, an uncommon finding in patients treated with a Duocentric prosthesis.

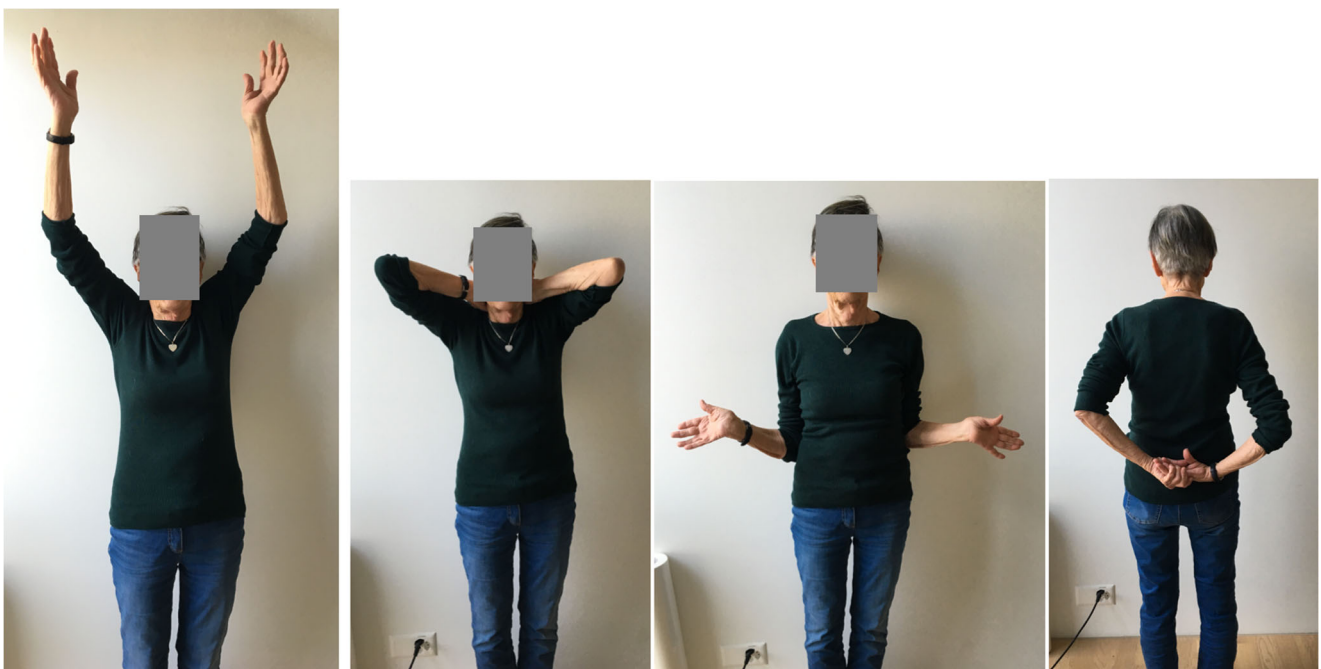
Fig. 9 Functional result of patient 8 with the pseudarthrosis of the scapular spine on the right side
