Metal-on-metal hip resurfacings—a radiological perspective

Zhongbo Chen · Hemant Pandit · Adrian Taylor ·
Harinderjit Gill · David Murray · Simon Ostlere

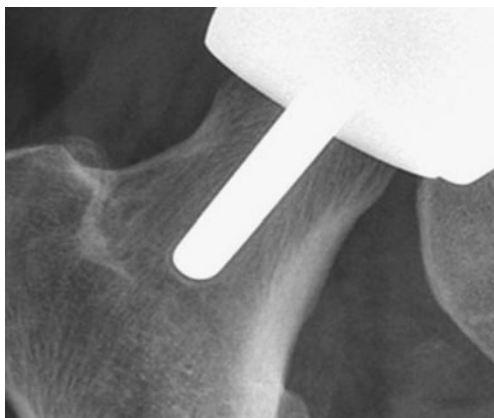
Fig. 2 Radiolucency is seen around the femoral peg. This is a normal finding

the neck should not be notched. Minor radiolucency around the femoral stem is a normal finding (Fig. 2).

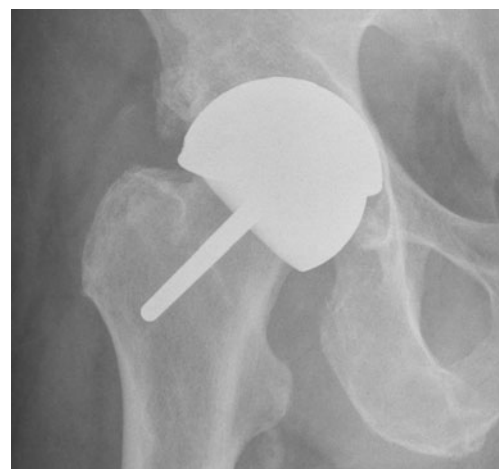
Fig. 4 Loose acetabular component, which has migrated to a horizontal position

As with conventional total hip replacements, infections occur in the early post-operative period and may result in loosening of the prosthesis. To date, the incidence of aseptic loosening is low, and more commonly involves the acetabular component (Fig. 4). [6].

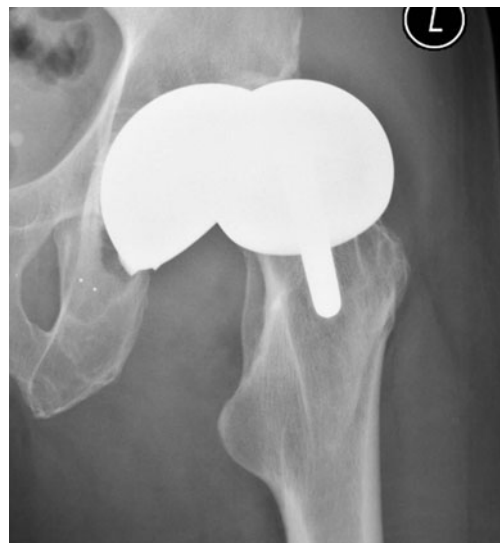
Fig. 8 Dislocation of the hip secondary to reactive mass

Dislocation is very rare [12] (Fig. 8) and may be due to underlying problems such as infection or reactive mass formation [13].

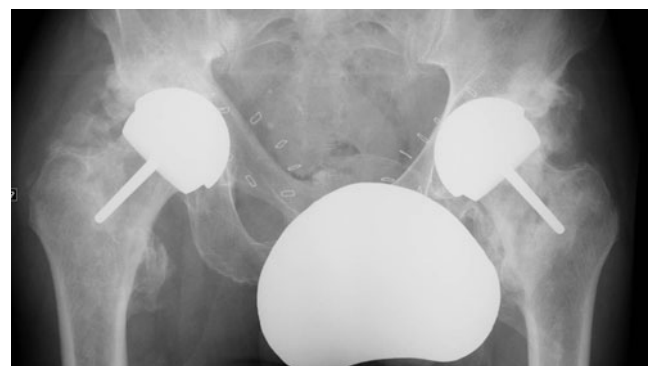
Fig. 9 Bilateral heterotopic ossification

Heterotopic ossification (Fig. 9) is unwanted bone growth around an implant that is usually asymptomatic but may cause pain and a reduced range of motion. Some degree of heterotopic ossification may be seen in over half of all cases, and is more commonly seen in male patients with osteoarthritis [14].

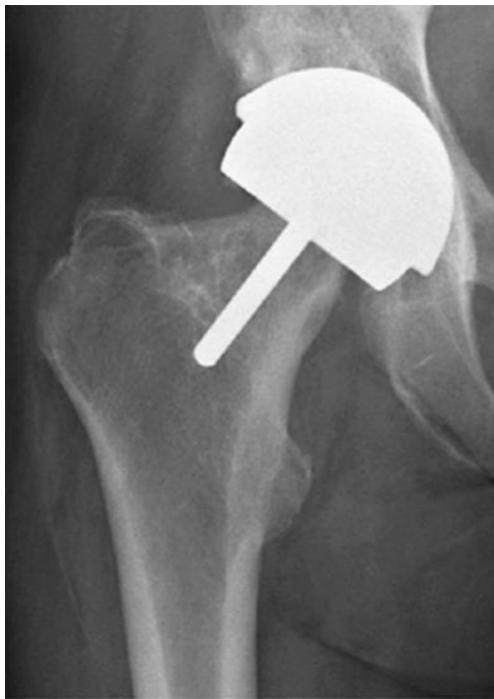
Fig. 10 Femoral neck thinning secondary to a reactive mass

narrowing is not yet known. Marked thinning may be seen in patients with reactive masses (see below) but an association has not been proven (Fig. 10).
