Mechanical failure of distal femur mega prosthesis due to polyarylether-ether-ketone (PEEK) hinge component

Abstract

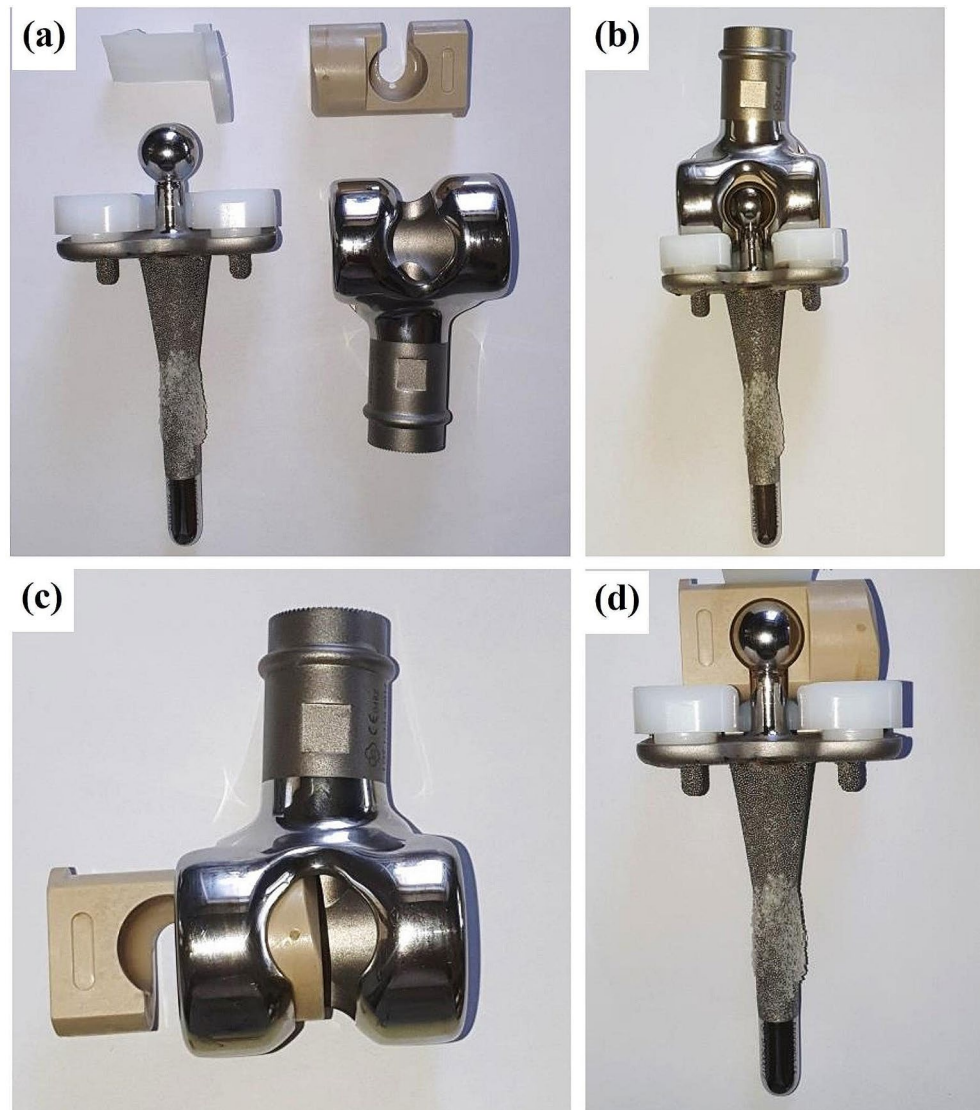
Fig. 1 The components of the distal femur prosthesis; (a) general view, (b) the assembled design, (c) the PEEK hinge component within the metallic house of the distal femur component, (d) the tibial component within the PEEK hinge component

Implant failure analyses of three PEEK lock retrievals (one broken and two worn down) were compared to a new unused PEEK Optima implant. Figure 1 illustrates the different components of the distal femur prosthesis. The PEEK failure occurred at the stress concentration at the end of the slot as shown in Fig. 2a-b. Failure occurs at the point of maximal extension due to stress concentration from cyclic loading. Figure 3 shows the macroscopic fracture modes. A flat crack is limited by a dashed line followed by a rough one with fracture features that points out the crack propagation direction (Fig. 3b). This is the slow growing subcritical crack growth which occurs initially. The second, with river lines type fracture with coarse features (Fig. 3b-d) representing catastrophic unstable crack propagation. The dashed circle line in Fig. 3a points out the fretting zone which was the source to crack initiation. Figure 4a-b shows scanning electron microscopy images of smooth fracture with the transition from a slow subcritical crack growth to catastrophic failure. Figure 4e-f depicts fatigue striation as observed in metallic materials. Here micro-cracks were detected as the crack velocity increases (see dashed line in Fig. 4f).

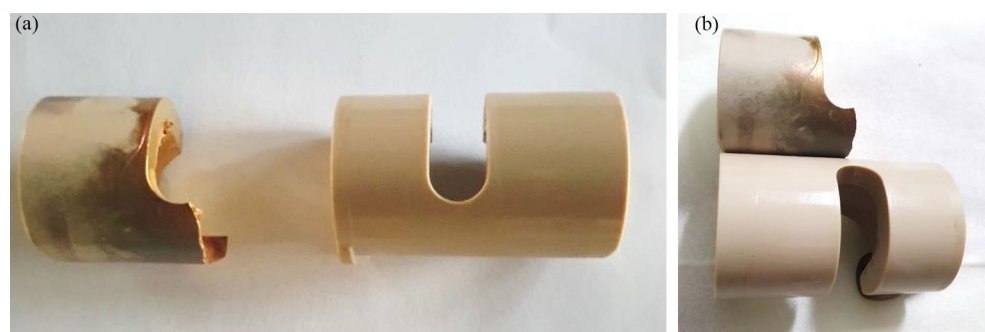
Fig. 2 Figure 2a illustrates a side-by-side view of the broken PEEK component compared to the original. Figure 2b illustrates one above the other emphasizing the fracture location as compared to the complete one. The failure occurred at the point of impact during full extension, at the root of the semicircle, where the metal post impacts the PEEK

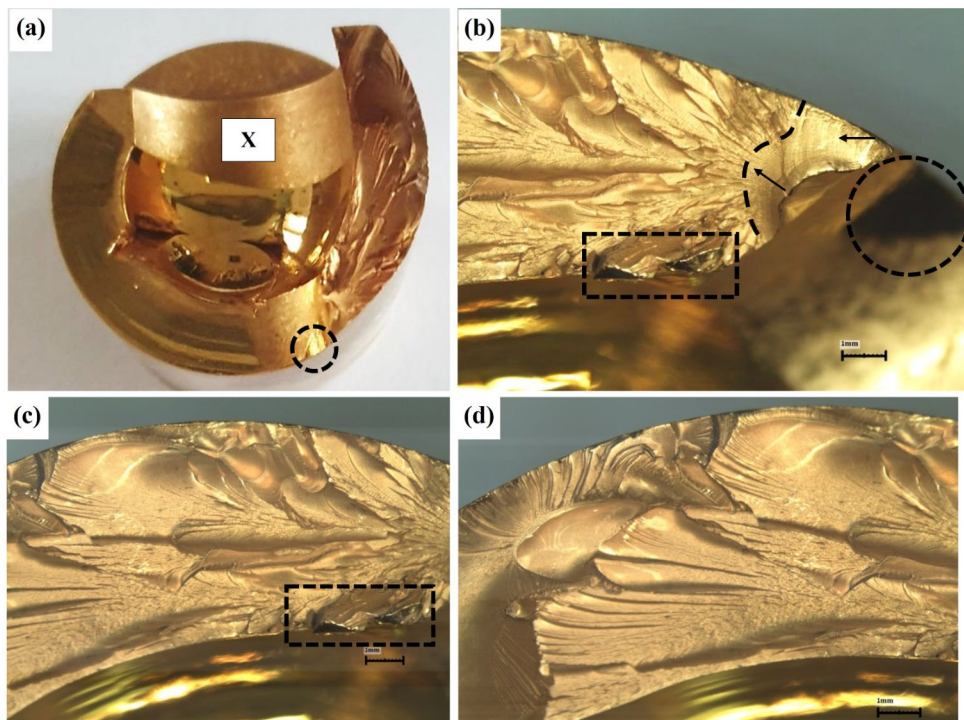
Fig. 3 Figure 4a-d depicts the macroscopic failure modes. Two main macroscopic failure modes were noticed divided by the dashed line. The first zone characterized subcritical stable crack growth followed by unstable fast crack propagation

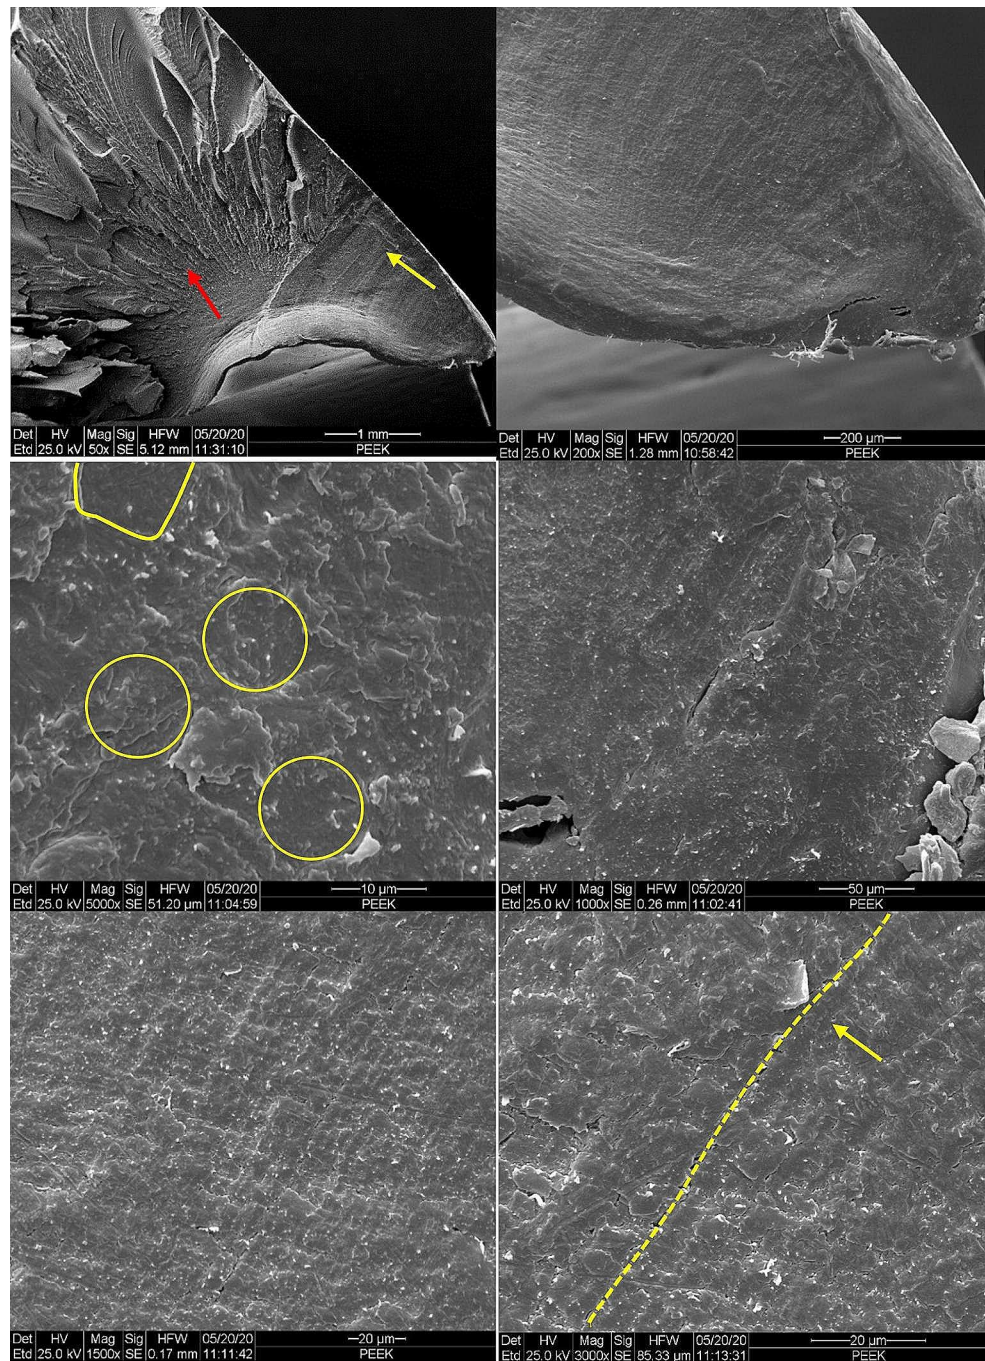
Fig. 4 Fracture mode transition during fatigue crack propagation; (a) macroscopic fracture mode slow and unstable crack growth, (b) flat fatigue mode, (c) parabolic markings like, (d) flat fracture with some indication of striations like, (e) fatigue striations, (f) additional alternative mode in the form of micro-cracking

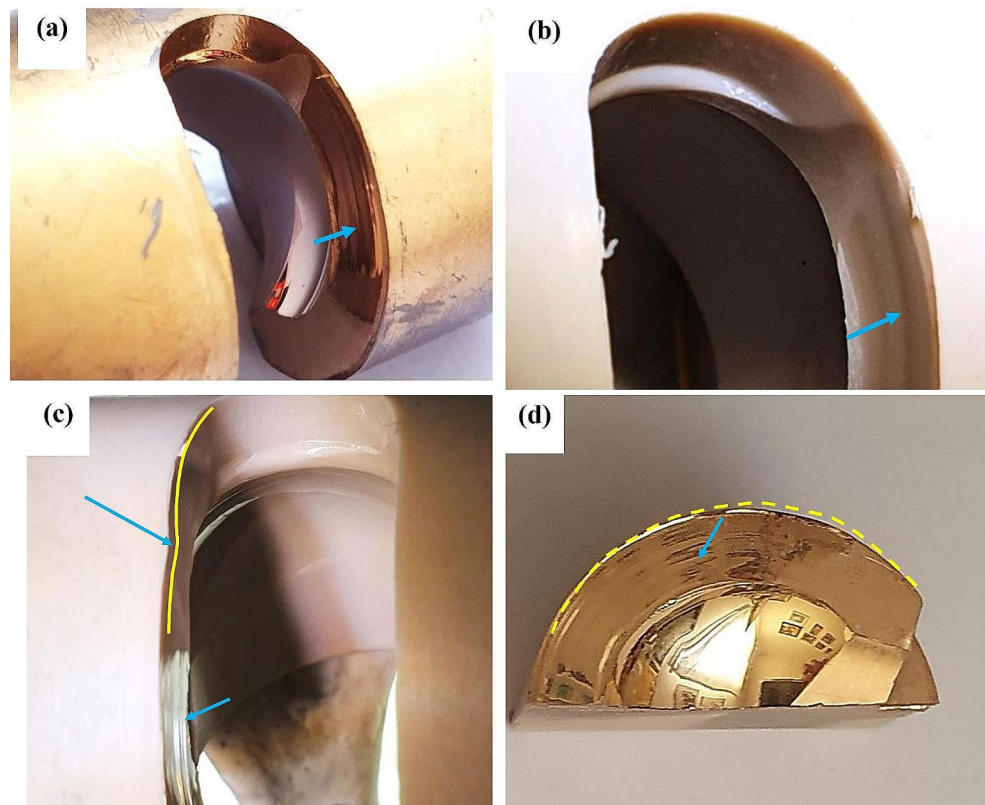
Fig. 5 Fretting wear damage on both sides of the slot walls (see arrows in Fig. 5a-d) which affected the symmetry of the slot as marked by dashed line together with an arrow (Fig. 5c). These surfaces are shinier (emphasized by the gold coating needed for the SEM characterization) as compared to the rest of the wall with a brilliant appearance, characterized by circumferential traces. The wear traces which started from the end of slot radius, extended up to 10–15 mm ahead and resulted in the formation of a miniature wall at the outer side (see dashed line in Fig. 5d)

Failure analysis of the PEEK which did not fail shows significant wear both at the tip of the slot (impacted in full extension) and along the slot sidewalls. (Fig. 5) SEM images (Fig. 6) show this sidewall fretting damage with PEEK material displacement leading to irregularity which leads to joint instability. This was shown to occur in all three failed PEEK retrievals. (Fig. 7)

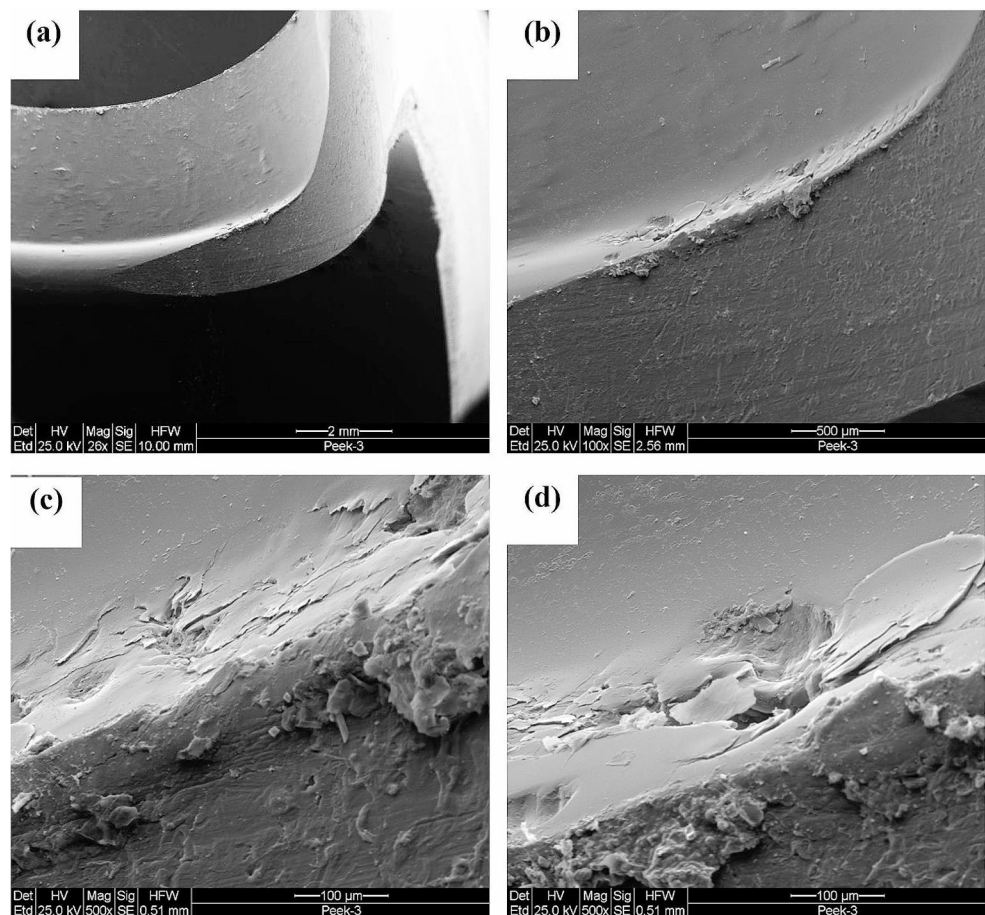
Fig. 6 Scanning electron microscope (SEM) tracking on the knoll bottom at the right side (Fig. 6a) indicates that the damage due to the material displacement appears as a surface network of micro-cracks as shown in Fig. 6c-d with different magnifications

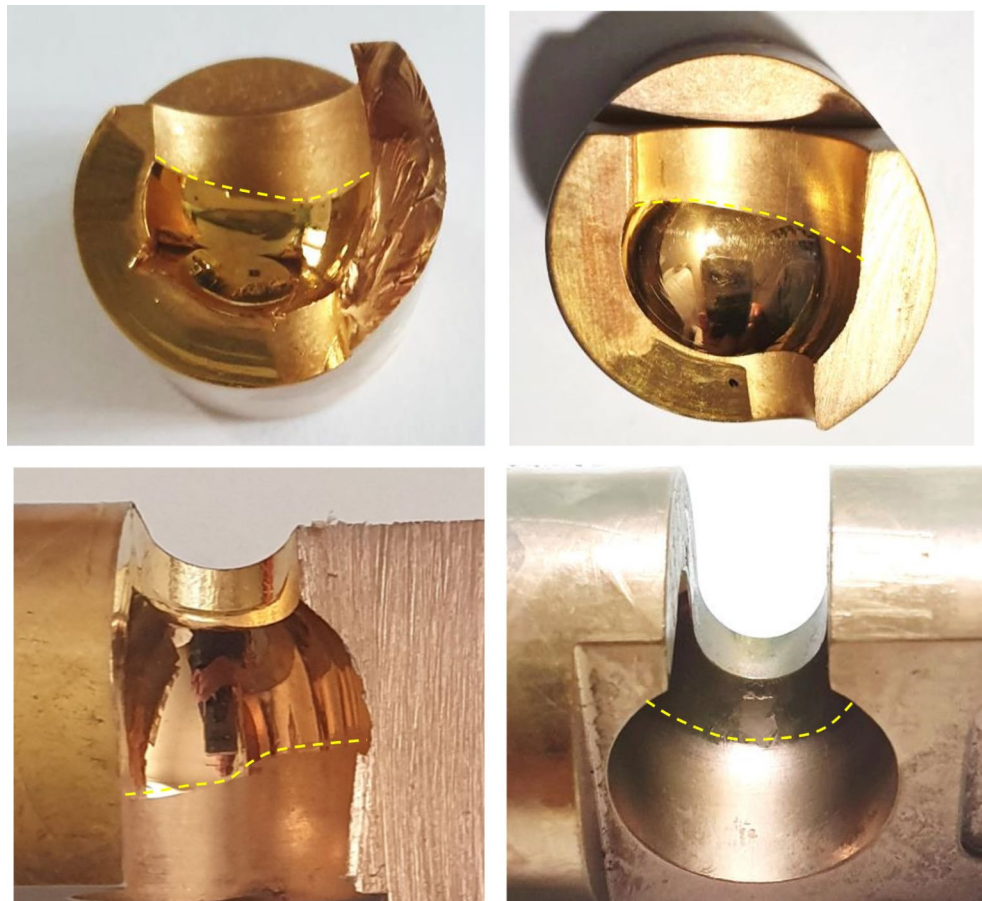
Fig. 7 The asymmetrical structure in the semi-spherical as shown in Fig. 7a-b in two separate failed PEEK components. As a result of material displacement due to cyclic loading damage. A third one PEEK shows the same phenomenon with more irregularity as shown in Fig. 7c. This unlikely condition was not detected in the reference PEEK lock as displayed in Fig. 7d. Beside this undesired shape, the transition between the two zones, the shiny and the brilliant ones is accompanied by a small step which can be sensed by passing a finger, a situation which was not found in the reference lock
