Stabbed by motorcycle? Reconstruction of an unusual traffic accident

Holger Muggenthaler¹ · Daniel Bismann² · Angelina Autsch¹ · Michael Hubig¹ · Jayant Shanmugam Subramaniam¹ · Gita Mall¹ · Daniel Wittschieber¹

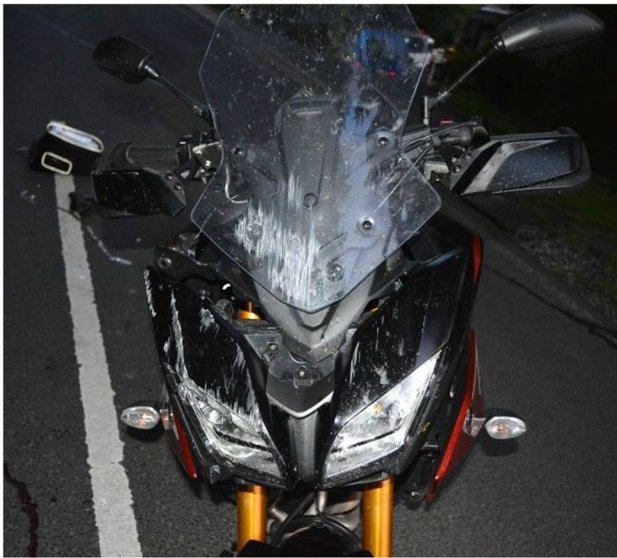
Fig. 1 Scratches of the front shield

Figure 1 shows scratch marks of the PTW front shield without deformations of the fork or the chassis. The backlight of the PTW was broken, and the back handles were marked with blood (Figs. 2 and 3). According to a photo taken by a police officer (Fig. 4), the distance between the distal ends of the handle bars was about 24.5 cm. Moderate deformations of the left rear door of the small truck are depicted in Fig. 5. Longitudinally oriented scratch marks on the top of the helmet are illustrated in Fig. 6.

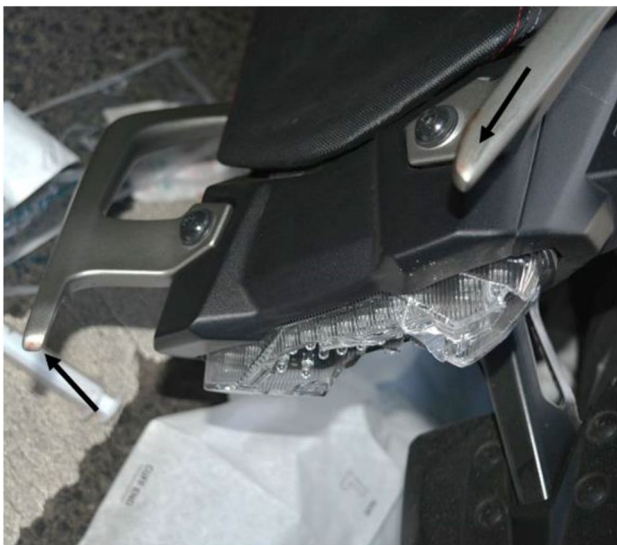
Fig. 2 Broken PTW backlight and the two back handles with blood marks (arrows)

The two wounds on the back of the PTW rider were caused by an interaction with the back handle bar of the PTW. There was a discrepancy between the distance of the distal ends of the handle bar and the distance of the two wounds, which was approximately 2.5 cm. This discrepancy may be associated to the body posture of the PTW rider during collision. Unlike the situation of the corpse during autopsy, the scapulae could have been closer to each other during the incident due to the muscle tone of the PTW rider sitting on his PTW.

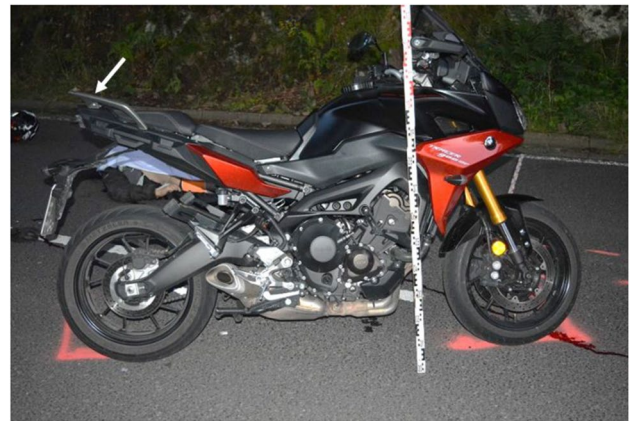
Fig. 3 PTW overview, back handles on the tail end of the PTW (arrow)

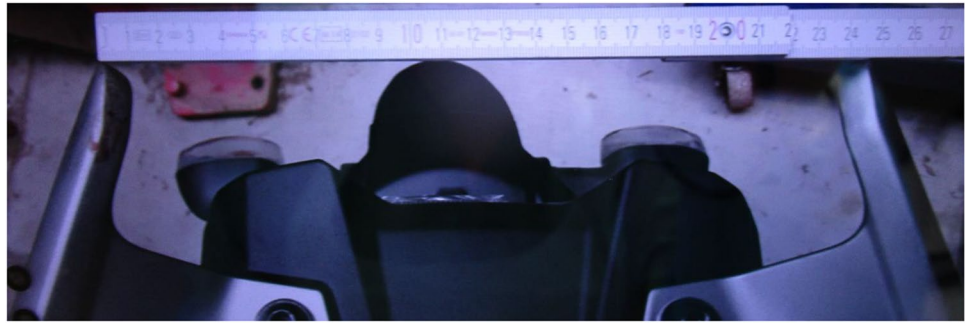
Fig. 4 Photograph of the back handles, taken by the police officer using a smart phone

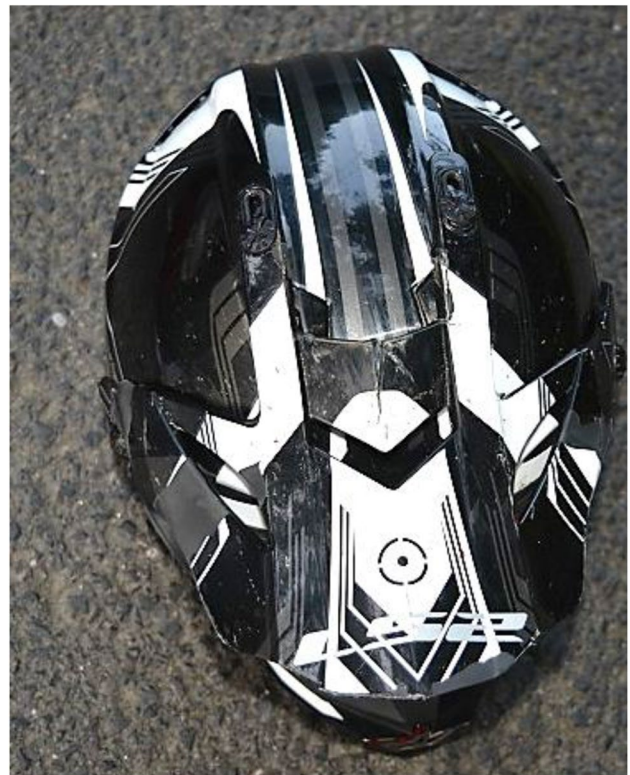
Fig. 6 Scratches on the top of the helmet

The illustration in Fig. 9 shows a reconstruction, based on the traces found on the helmet as well as on the rear door of the small truck. However, the exact position and posture of the PTW rider on the motorcycle are unknown. From a technical point of view, a certain separation of the PTW rider from the PTW has to be taken into account. On the one hand, such a separation can occur due to a higher rotational velocity of the PTW compared to that of the PTW rider, and on the other hand, actions of the rider like jumping from the vehicle prior to the impact were reported by cyclists [13].

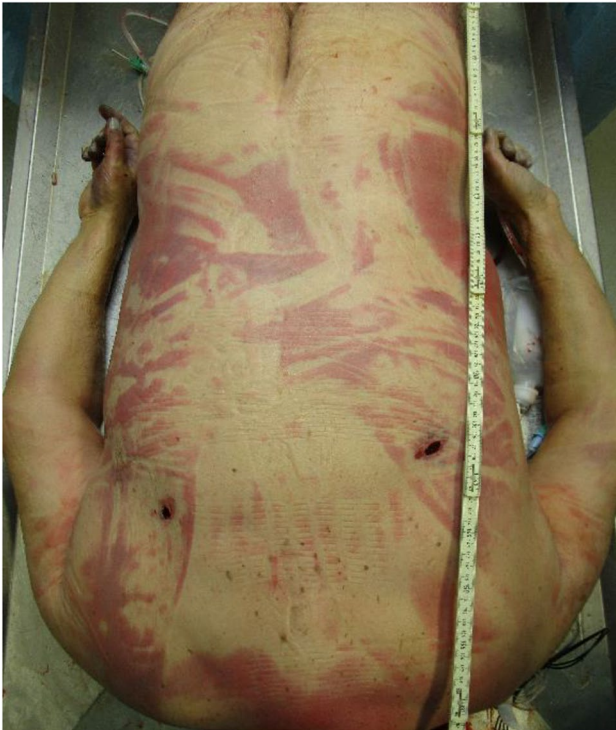
Figures 7 and 8 show the nearly sharp-edged lesions on the upper back of the PTW rider. The wounds were between 2 and 3 cm in length and penetrated the deeper back soft tissues. With respect to the ground level, the wounds were found at a height of 137 cm and 146 cm, respectively. The horizontal distance between both lesions was 27 cm. Corresponding to the skin lesions, the leather biker jacket exhibited two lacerations.

Fig. 7 Two stab-like wounds on the upper back

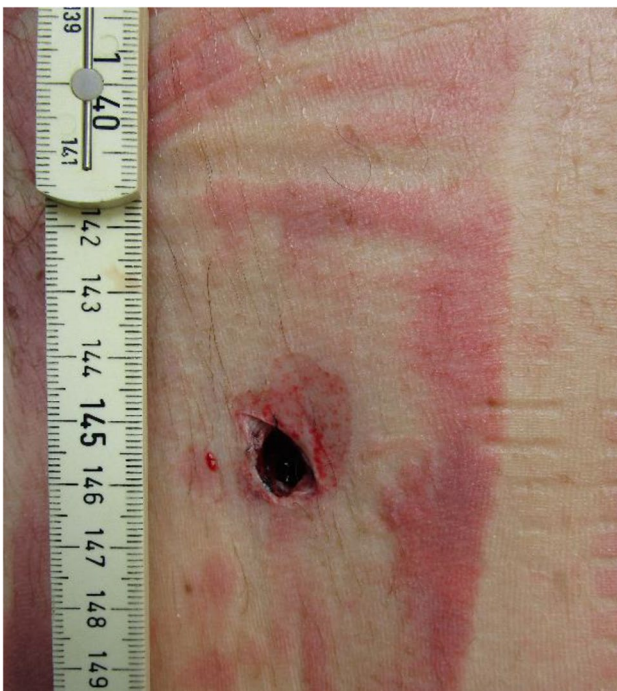
Fig. 8 Stab-like wound on the right upper back, in detail

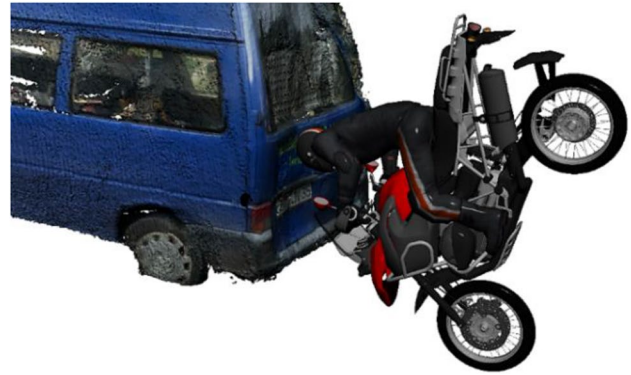
Fig. 9 Collision position, which is compatible with the available data. Note that this illustration does not show the type of motorcycle used in the present case

Figures 9 and 10 show a collision position, which is consistent with the damages to the PTW and the small truck. Injuries to the cervical spine did not occur, even though cervical injuries could have been expected in a collision position similar to Fig. 9. Using the data available concerning

In our case, the data and facts available render speed estimation impossible. However, from the fact that the PTW was in its fifth gear, we assume a pre-crash speed significantly higher than the speed limit of 30 km/h. The considerable injury severity is explained by a collision position similar to that depicted in Fig. 9, where the PTW rider could have been compressed between the small truck and the rotating PTW or between the asphalt and the PTW. The two conspicuous wounds on the back of the PTW rider prove a contact with the PTW handle bar. Extensive blunt injuries of the thorax on the PTW rider can be due to dynamic compression of the PTW rider between the PTW and the small truck or asphalt. The comparably high mass of the PTW exceeding 200 kg causes high contact forces on the PTW rider.

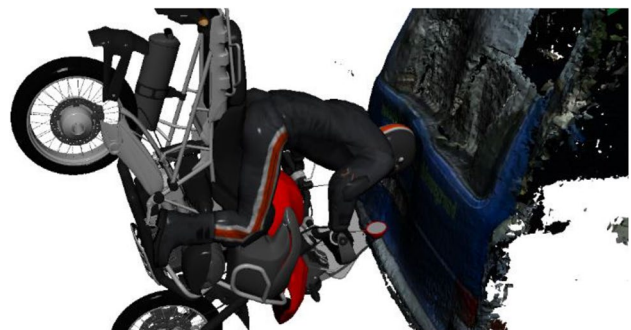
Fig. 10 Collision position, head impact

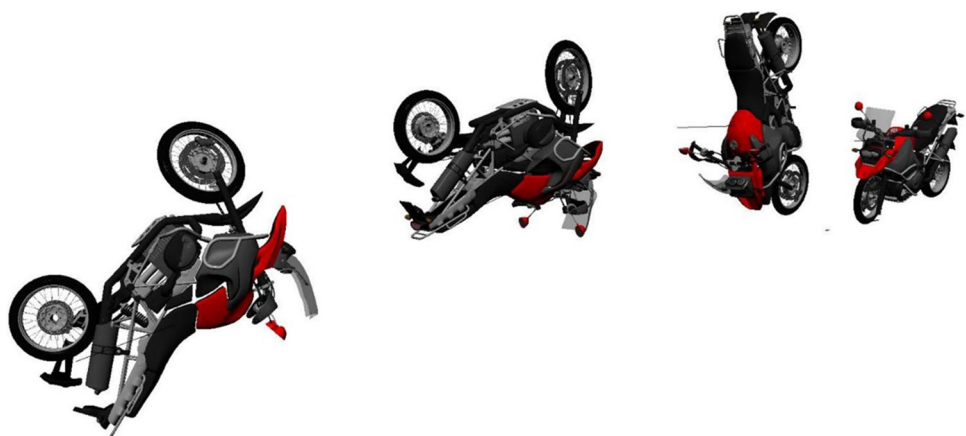
Fig. 11 Hypothetical kinematics of the PTW

From our point of view, an exact reconstruction of the kinematics is not feasible. Possibly, a separation occurred in a way that the PTW further rotated, while the PTW rider contacted the back door of the van. A possible kinematics of the PTW is shown in Fig. 11. Figure 12 depicts a hypothetical scenario with a compression between of the PTW rider between the asphalt and the PTW. The scenario in Fig. 12 is just one of several possibilities of how the compression could have occurred. We did not perform a multibody simulation, because the case-specific conditions are far too complex to be modeled using multibody technique. Accordingly, the PTW bitmap as well as the rider model in Fig. 12 is positioned without numerical simulation.

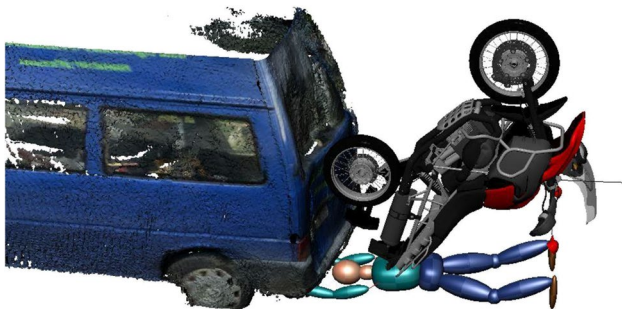
Fig. 12 Hypothetical compression of the PTW rider between the PTW and the asphalt
