Large Scale Dynamic Testing of Rock Support System at Kiirunavaara Underground Mine

Abstract A series of five large scale dynamic tests were conducted at the LKAB Kiirunavaara mine using explosives to generate the dynamic load on the support system. This was done with the aim of developing a testing methodology for in situ testing of ground support. Furthermore, the response of the installed rock support system to strong dynamic loading was evaluated. The tests included ground motion measurements, fracture investigation, ground and support motion imaging, as well as deformation measurements. The results indicated that the relation between the burden and the used amount of explosive had a vital role in either reducing or involving the effect of the detonation gases in the test results. In addition, the type of explosive which was used in the tests had a great impact on minimising the gas expansion effects. Higher peak particle velocities were measured compared to those of similar large scale tests carried out in other countries. However, the level of induced damage was limited to a fractured zone behind the support system and propagation of cracks in the shotcrete. Measured peak pa

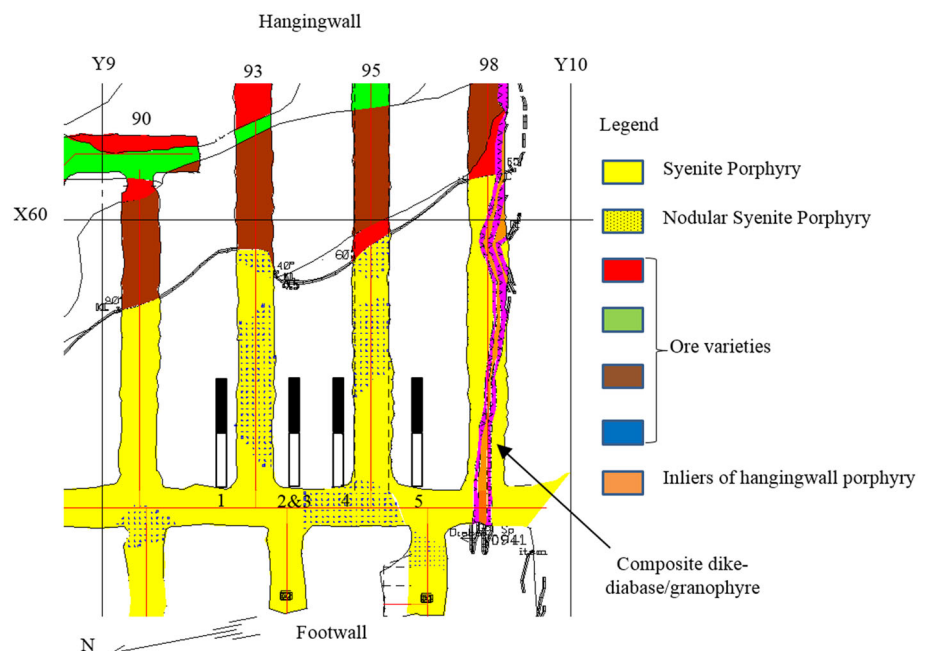
Fig. 1 Cross-cuts 93 and 95, site for Tests 1–5 [extracted from the database of underground mapping at LKAB (Andersson 2010)]

Adjacent pillars between the cross-cuts 93 and 95 in the completed production block 9 on the 741 m level were chosen for the tests 1–5. All of the tests were planned to be conducted at the chosen site because (1) no mining activity was taking place at that level, (2) the pillars were only shotcreted (3) many cross-cuts with similar rock mass conditions were available for further tests and (4) comprehensive geological investigations had been done in the area. The width of the pillars was approximately 18 m and the cross-cuts were about 7 m wide and 5.2 m high. According to Andersson (2010), the rock types in the test area have traditionally been referred to as syenite porphyries, including a nodular variety (Geijer 1910), mainly consisting of trachytes to trachyandesites (Ekström and Ekström 1997) of variable character and degree of alteration. Figure 1 illustrates the location and rock types in cross-cuts 93 and 95, where tests 1–5 were carried out.

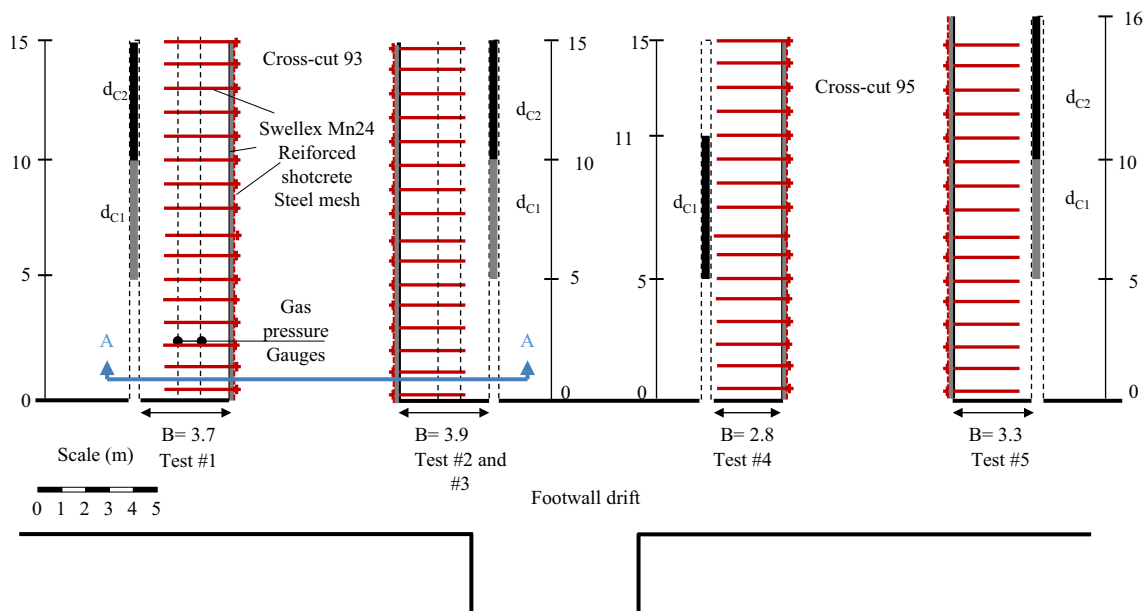
Fig. 3 Blast design in Tests 1–5

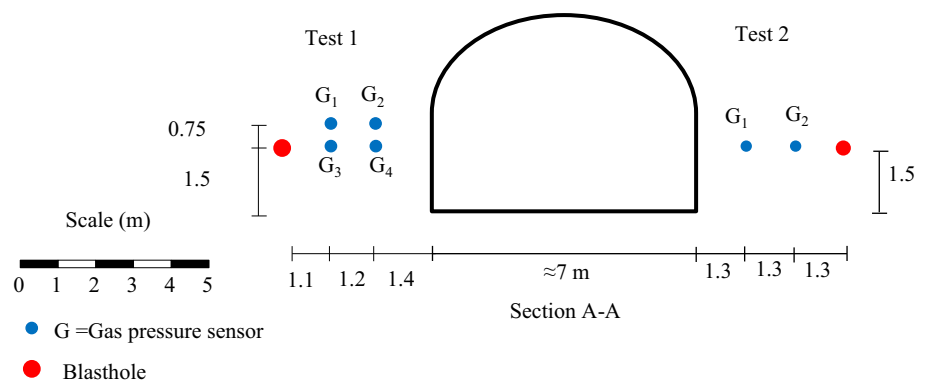
Fig. 4 Position of the gas pressure sensors Tests 1 and 2

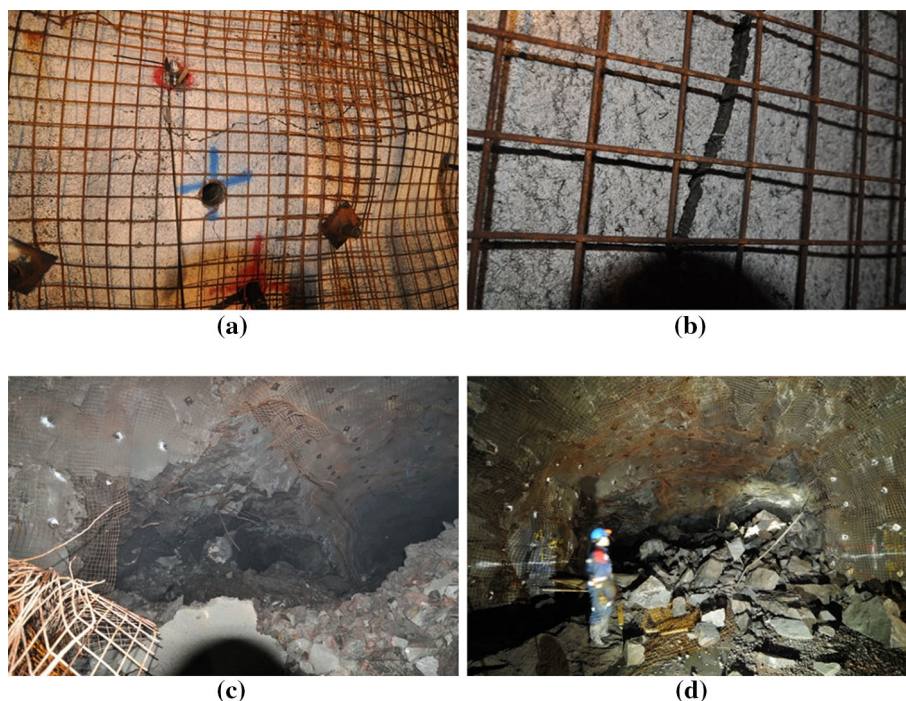
Fig. 6 Damage in **a** Test 1, **b** Test 2, **c** Test 4 and **d** Test 5

Damage mapping of the tested walls were conducted after each blast. Post-blast observations of the tested support system in Test 1 showed that cracks with a width of up to 5 mm and a length of 2–3 m were created on the surface of the reinforced shotcrete mainly within the high charge segment ($d_{C1} = 76 \text{ mm}$). No obvious damage to the rockbolts or the mesh was observed. The event magnitude of the test recorded by the mine seismic system was $M_L = 0.7$ on the local magnitude scale. An example of created cracks is presented in Fig. 6a.

Completely different results were observed in Tests 4 and 5 compared to those in Tests 1 and 2. In Tests 4 and 5 the burdens were completely destroyed. Figure 6c, d show the state of the tested wall and cross-cut after blast. The ejected rock material in Test 4 was broken into rather small pieces as a result of a high charge concentration ($d_{C1} = 120$ mm) (note that only one charge segment was used in this test), while in Test 5, the burden was broken into large blocks of rock at both charge segments. The mesh and the rockbolts had totally lost their functionality in both of these tests. Failure mapping of the rockbolts in Test 4 was performed and the results indicated that most of the rockbolts were cut into pieces of 1–2 m of length. In 95 % of the cases the face plates were detached. The local event magnitudes for Test 4 and Test 5 were $M_L = 0.8$ and $M_L = 0.9$, respectively. The local magnitude for the two tests was obtained from the mine seismic system. The following sections describe the results obtained from the installed monitoring instruments.

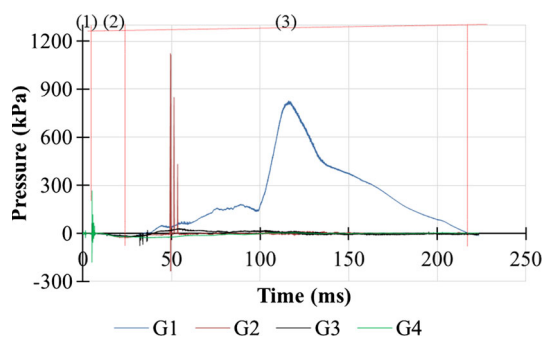
Fig. 7 Gas pressure results and three different parts after initiation in Test 1

- Part 1 is the arrival of the blast-induced wave to the sensors which occurs 1.4–4 ms after the charge detonation;
- Part 2 is the initiation of a negative gas pressure (pressure below normal air pressure). The air inside the hole might leak into fractures that became widened during the “heave” process of a blast. This will result in negative pressures which occurred 6–10 ms after charge detonation; and;

- Part 3 represents the initiation of positive gas pressure and it occurs about 34–100 ms after detonation and was recorded by the different sensors. This part cannot be observed in the wave form measured by sensors G_2 and G_4 in Test 1.

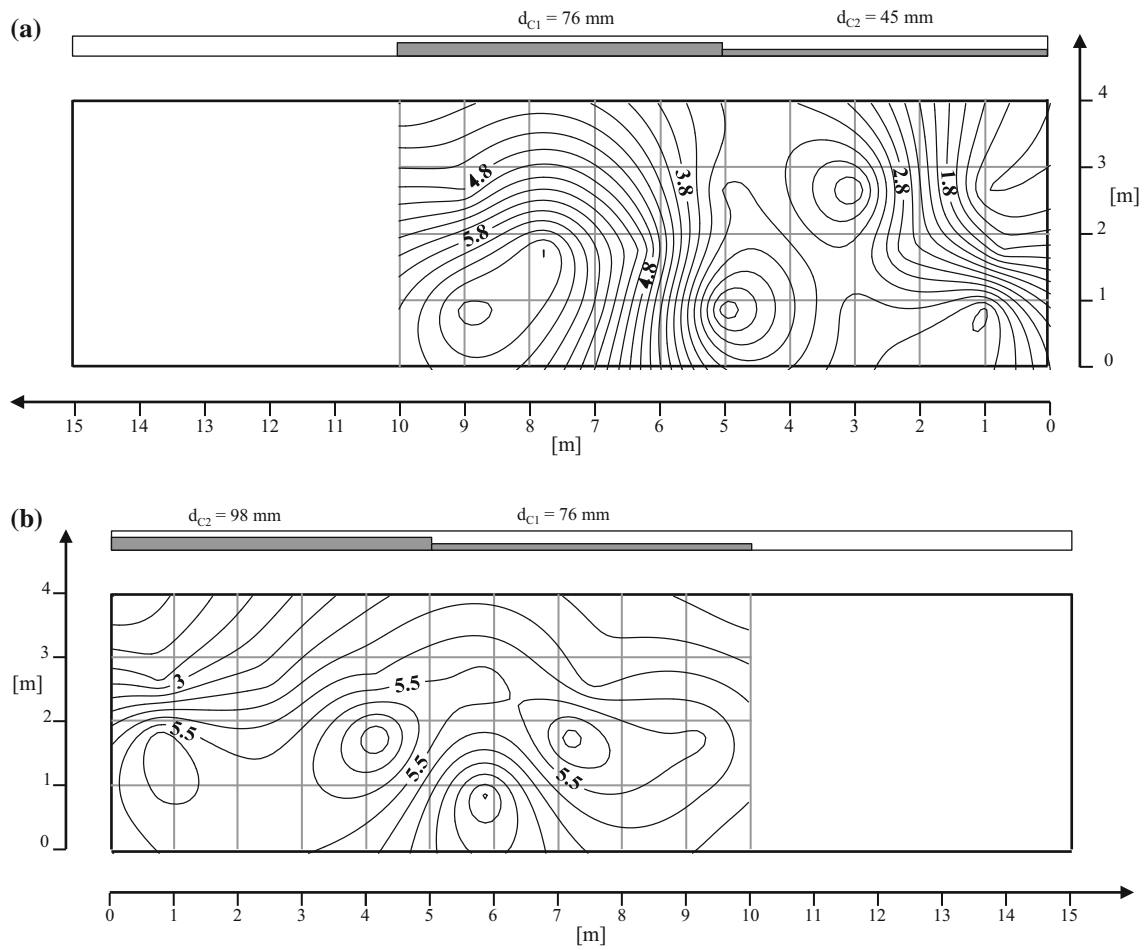
Fig. 9 PPV contour in a Test 1, and b Test 2

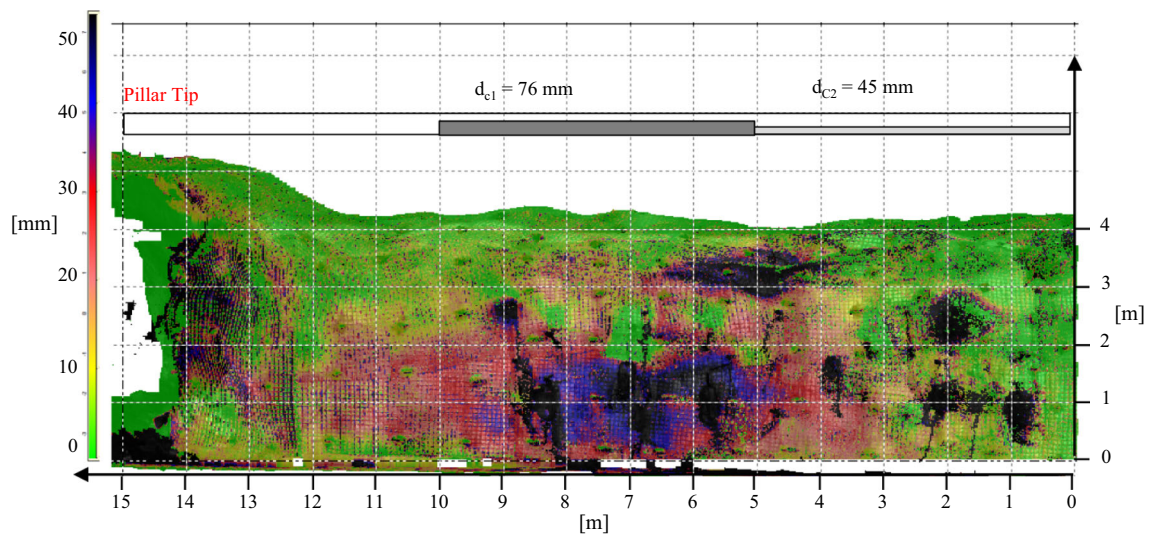
Fig. 10 Displacement of the tested wall measured by laser scanning in Test 1

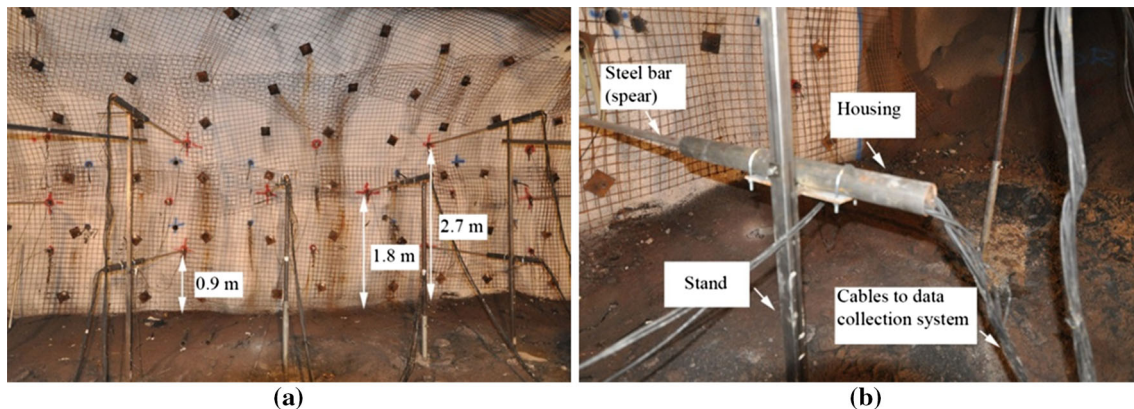
Fig. 12 Displacement probes in Tests 1 and 2

Built-in displacement probes (spears) (Olsson et al. 2009) were used as another method to measure the ground motion. The positions of the probes can be found in Fig. 12a. The instrument was constructed of a 0.5 m long cylindrical steel housing including four coaxial cables

inside the housing with separation of 20 mm. Figure 12b shows the setup of the displacement probes. An impact rod (spear) 2 m in length was mounted between the housing and the test wall to transfer the movement induced by the blast-induced wave on the test wall to the gauges and recording unit that the co-axial cables were connected to. The instruments were installed at heights of 0.9, 1.8 and 2.7 m to provide the best coverage of the test wall. The probes were installed close to the installation point of the accelerometers.

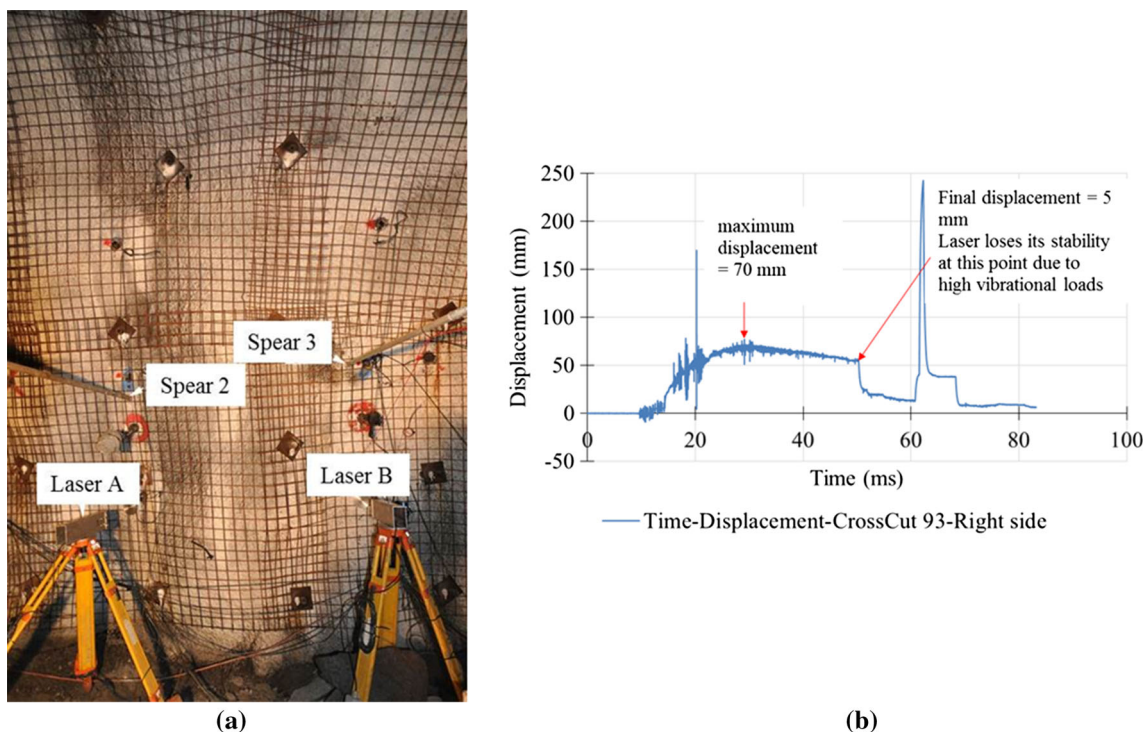
Fig. 13 a Layout of the dynamic displacement measurement in Test 2 with laser. b Displacement data measured by the left laser sensor

Two short range distance laser sensors which provide accurate distance measurements were used to measure the dynamic displacement of the test wall at two points on the shotcrete in Test 2. As it is shown in Fig. 13a, the tripods for the lasers were located close to and at the middle of the test wall. As the results provided by laser B were distorted, only the results from laser A were evaluated and the data is presented in Fig. 13b. The signal during the first 50 ms

after the detonation shows the displacement of the test wall at different times of the test. The displacement at the measuring point reached to the maximum value of 70 mm at 30 ms, and then decreased to 55 mm at 50 ms. The signal was disturbed since the tripod moved during the test due to air shock after 50 ms. A non-elastic deformation can be observed in the signal. A final displacement of 55 mm was measured by this sensor.

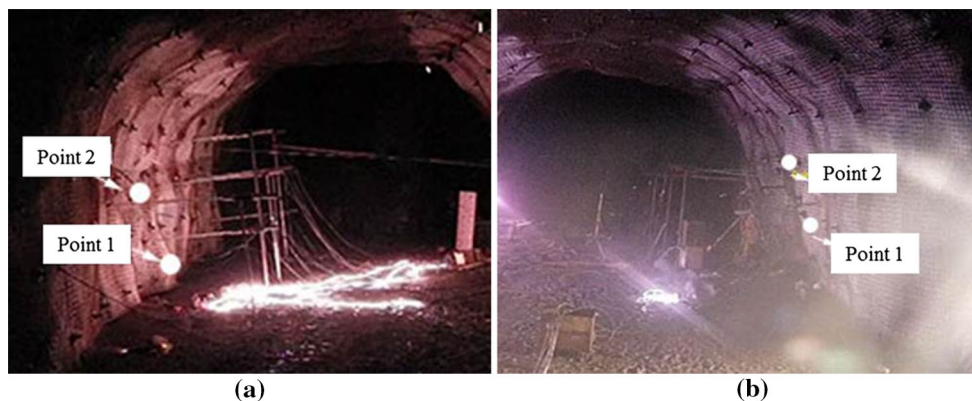
Fig. 14 Location of the selected points for PPV and displacement measurements in a Test 1 and b Test 2

1 and 2. Based on the analysis of the frames extracted from the video using the BlasterMass software (MREL 2000), the displacement and PPV of the high charge segment wall for the time period between the charge detonation and before gas expansion were estimated as presented in Table 4.

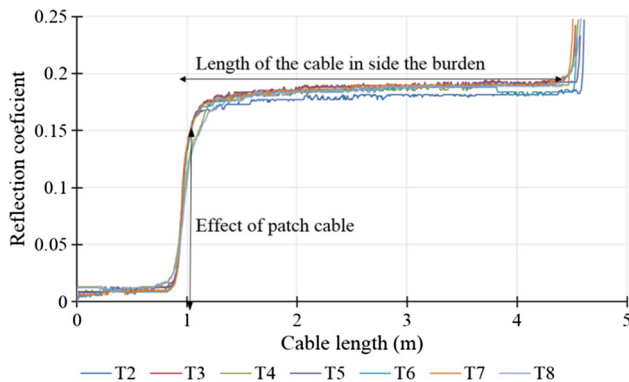
**Fig. 15** Reflected wave form from coaxial cables before blast in Test 1

Coaxial cables with the length of 3.6 m were grouted into the rock mass, perpendicular to the test wall, to investigate the location of fractures and the depth of damage in the burden after the blast. The positions of the cables in the test wall are presented in Fig. 5a, b. Figure 15

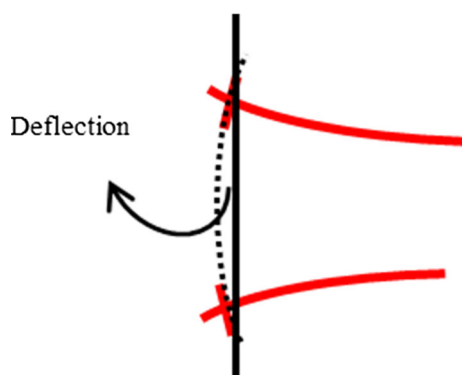
Fig. 19 Shotcrete deflection measurement in Tests 1 and 2

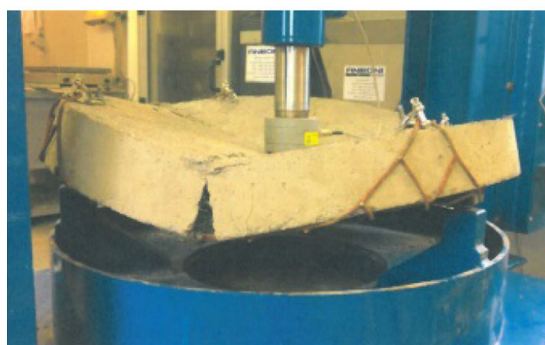
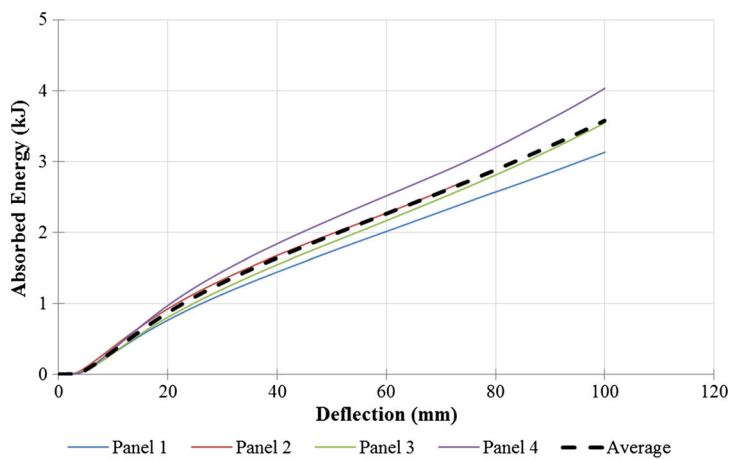
Fig. 20 **a** Round Determinate Panel Test at LKAB Kiirunavaara. **b** Energy absorption by the mesh equipped panels of 100 mm steel fibre-reinforced shotcrete (Thyri 2014)

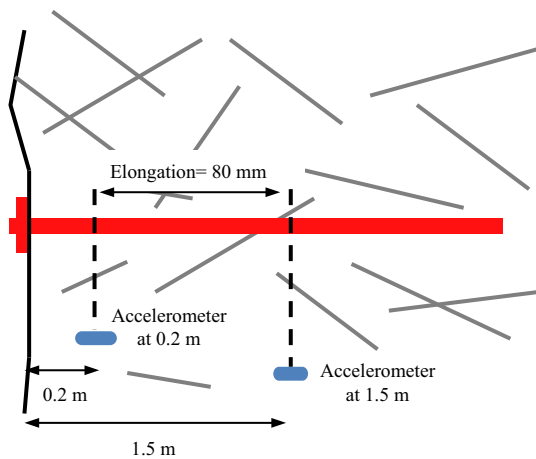
Fig. 22 Estimation of elongation of Swellex Mn24 using deep accelerometers

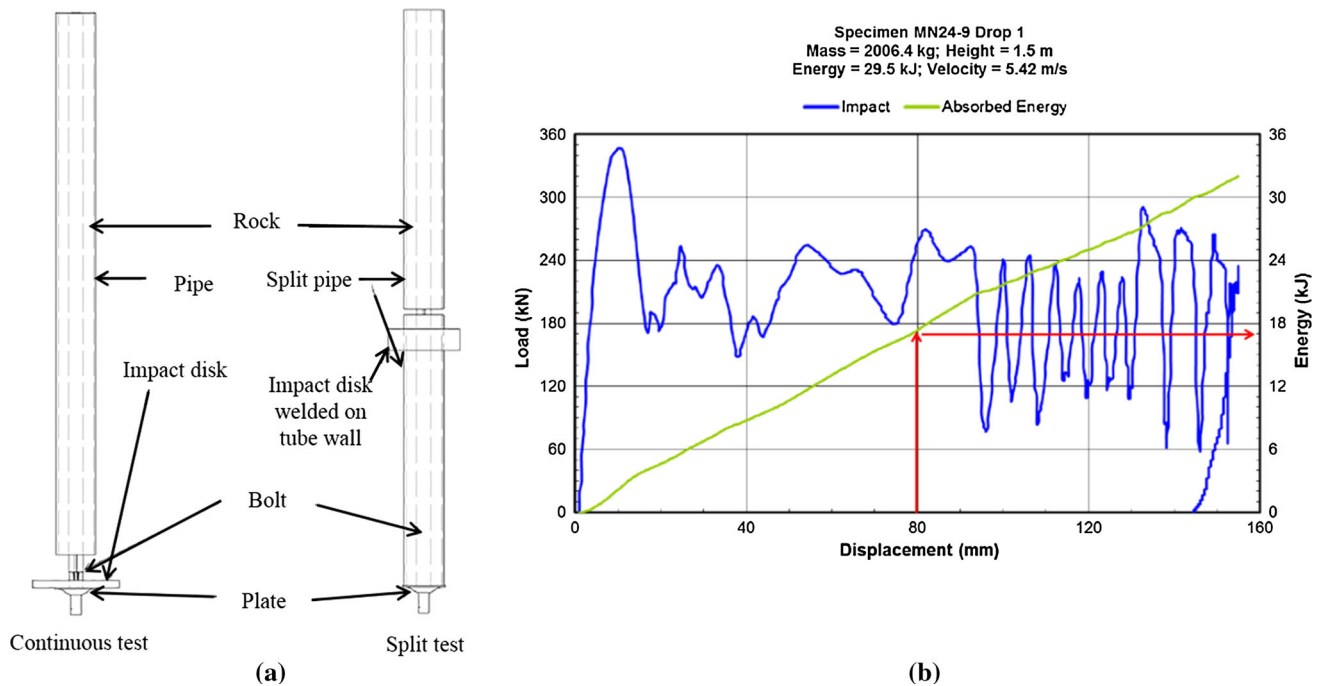
**Fig. 23** **a** Schematic illustration of continuous and split tubes for dynamic drop test, and **b** relationship of absorbed energy and displacement from impact load for Swellex Mn24 (Voyzelle et al. 2014)

Results from a series of dynamic laboratory tests on Swellex Mn24 by Voyzelle et al. (2014) was used to estimate the amount of absorbed energy by the Swellex rockbolts in Test 2. In the tests carried out by Voyzelle et al. (2014) two configurations, continuous and split tube as illustrated in Fig. 23a, were used to determine the behaviour of Swellex Mn24 under dynamic conditions. In the continuous tube configuration the bolt was installed in a steel tube and the impact load was applied directly on the bolt plate. In the split tube configuration, the bolt was installed in two separated tubes. In this setup the impact direction was parallel to the tube, at a distance from the plate.

Since the displacement measurement in Test 2 was conducted at the mid-length of the rockbolt, data from the split tube setup were considered for the estimation of the energy absorption. Results from the first drop were used since it represents a displacement similar to that observed after a single blast. The maximum 80 mm elongation estimated for the Swellex Mn24 in Test 2 was used in combination with the energy absorption curve in Fig. 23b. This resulted in an energy absorption of around 17 kJ for the Swellex MN24 for an elongation of 80 mm.
