# Forensic Excavation of Rock Masses: A Technique to Investigate Discontinuity Persistence

**Abstract** True persistence of rock discontinuities (areas with insignificant tensile strength) is an important factor controlling the engineering behaviour of fractured rock masses, but is extremely difficult to quantify using current geological survey methodologies, even where there is good rock exposure. Trace length as measured in the field or using remote measurement devices is actually only broadly indicative of persistence for rock engineering practice and numerical modelling. Visible traces of discontinuities are treated as if they were open fractures within rock mass classifications, despite many such traces being non-persistent and actually retaining considerable strength. The common assumption of 100% persistence, based on trace length, is generally extremely conservative in terms of strength and stiffness, but not always so and may lead to a wrong prediction of failure mechanism or of excavatability. Assuming full persistence would give hopelessly incorrect predictions of hydraulic conductivity. A new technique termed forensic excavation of rock masses is introduced, as a proce

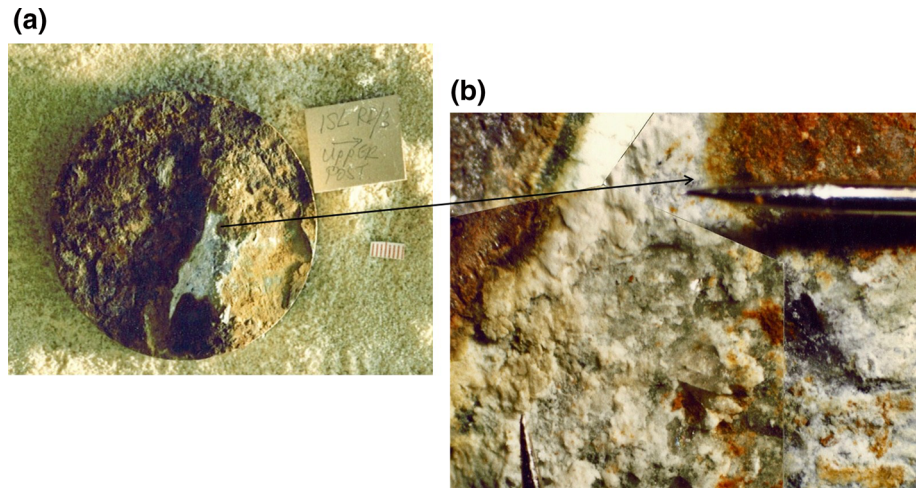
**Fig. 2** Example of a rock bridge, observed following direct shear test on section of ‘intact’ core. **a** General view of tested area of joint (cm scale). Most is *red-brown* and coated with iron oxides. **b** Close-up of part of rock bridge—*grey* with minor signs of chemical decomposition. Boundary between bridge area and coated section is marked in some areas with *lines* of discolouration derived from the chemical decomposition process as the bridge is gradually eaten away (colour figure online)

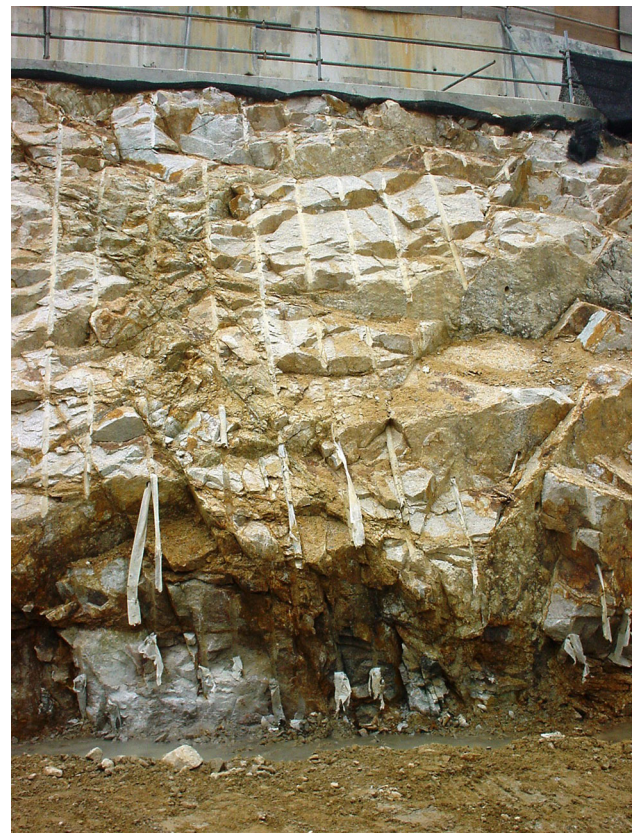
**Fig. 3** Expansive chemical grout employed in pre-drilled holes to form rock cut slope. Castle Peak Road formation works, Hong Kong

In the authors’ view, the method may well be applicable at larger scale (see, for example, Fig. 3). There are no insurmountable safety or access problems—it just needs proper planning and control.

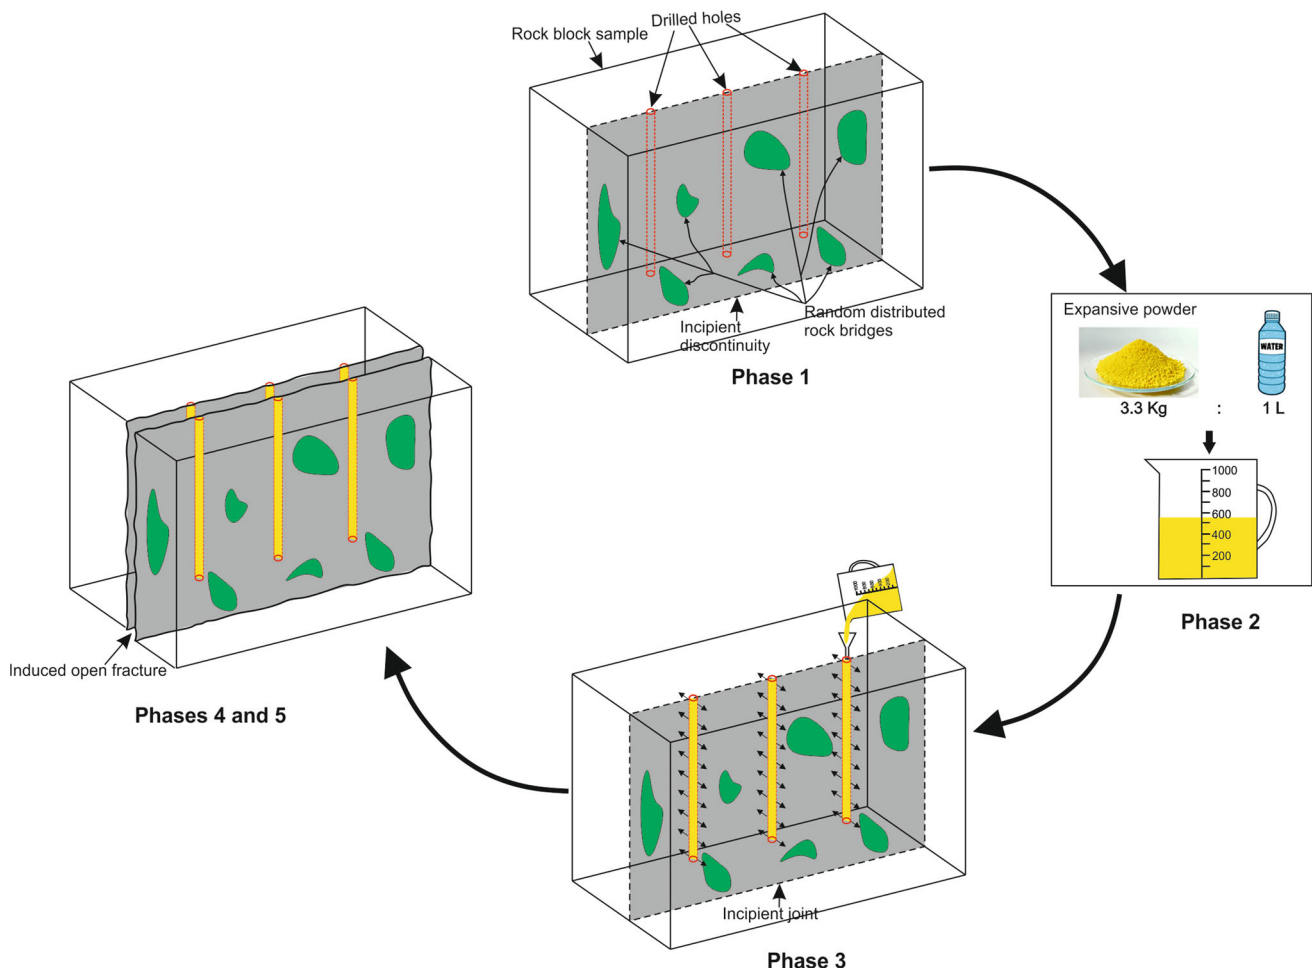
**Fig. 4** Schematic diagram of the testing procedure for FERM. Figure not to scale

Figure 4 illustrates the FERM testing procedure:

- Stage 1—Holes with diameter of 27 mm were drilled to follow the apparent planes of incipient discontinuities using a battery-powered drill and spacing of around 200 mm. Holes were terminated within the test blocks to prevent leakage of the chemical splitter.

- Stage 2—The expansive powder and water were mixed to the recommended ratio (3.3 kg/L).
- Stage 3—Holes were filled with the chemical splitter. A plastic cover was placed over the holes.
- Stage 4—The chemical splitter hardens gradually and expands to open up the incipient discontinuity, typically over 24 h. Secondary tools (an excavator, forklift, wedges and chisels) were used as necessary to complete

the opening up of the incipient fractures initiated by the expansive grout.

- Stage 5—Joint surface examination and description.

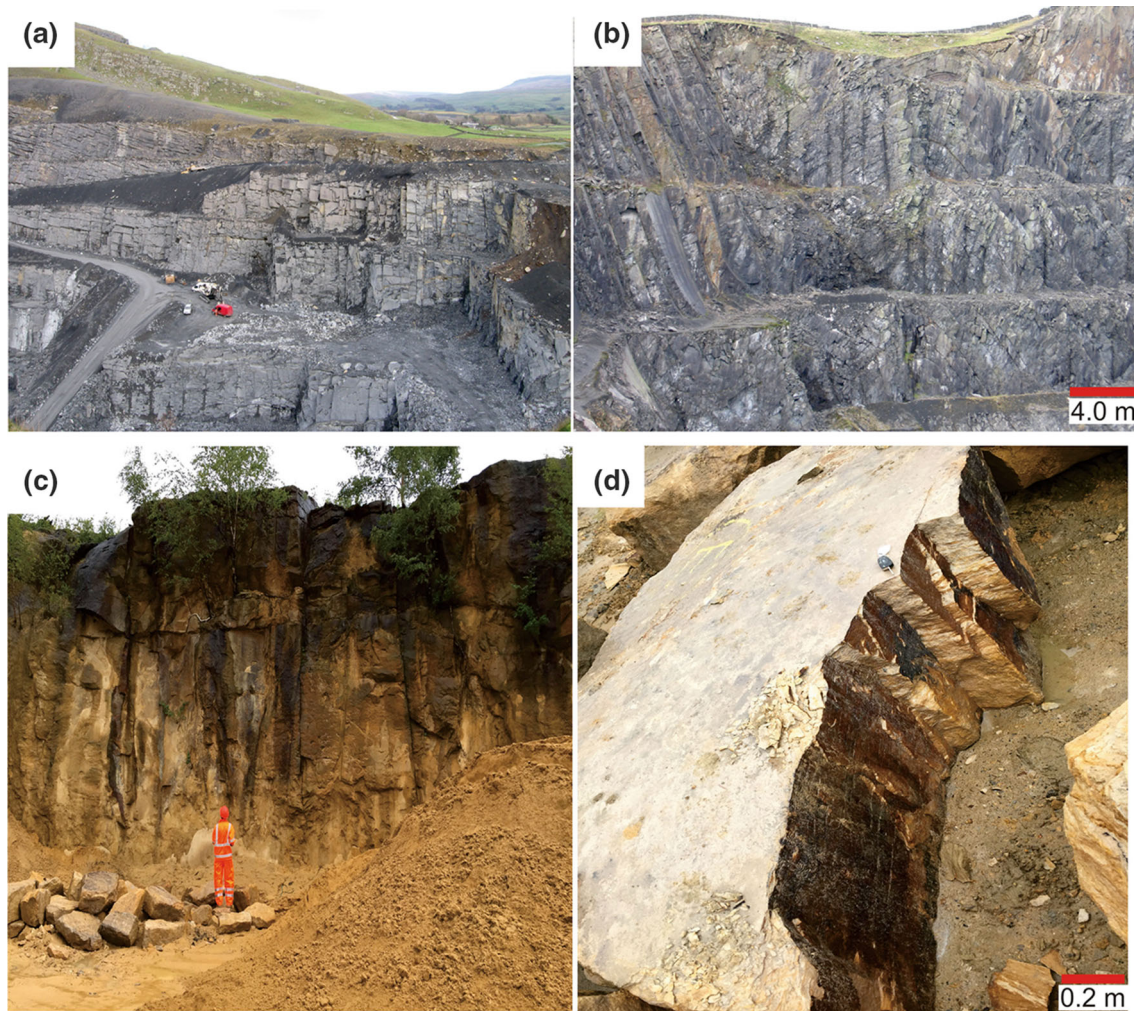
**Fig. 6** Example exposures from Dry Rigg Quarry (DRQ), North Yorkshire, and Blackhill Quarry (BQ), West Yorkshire, UK

The quarried rock at DRQ is typically medium to dark grey, strong to extremely strong siltstone. Geological structures include wonderful examples of folding and faulting; the main pervasive discontinuities include mineral veins, bedding planes and joints, and these can be seen throughout the quarry faces, varying in extent and apparent spacing with degree of weathering and stress relief (see Fig. 6a, b and refer to Hencher 2015). The

The rock at BQ comprises a sequence of 20 and 30 metres of predominantly well-cemented sandstone and gritstone (Fig. 6c, d). The rock is typically red-brown and yellow because of the presence of iron oxides that occur as pore linings and pore fillings and replace ferromagnesian grains such as biotite (Smedley et al. 2005).

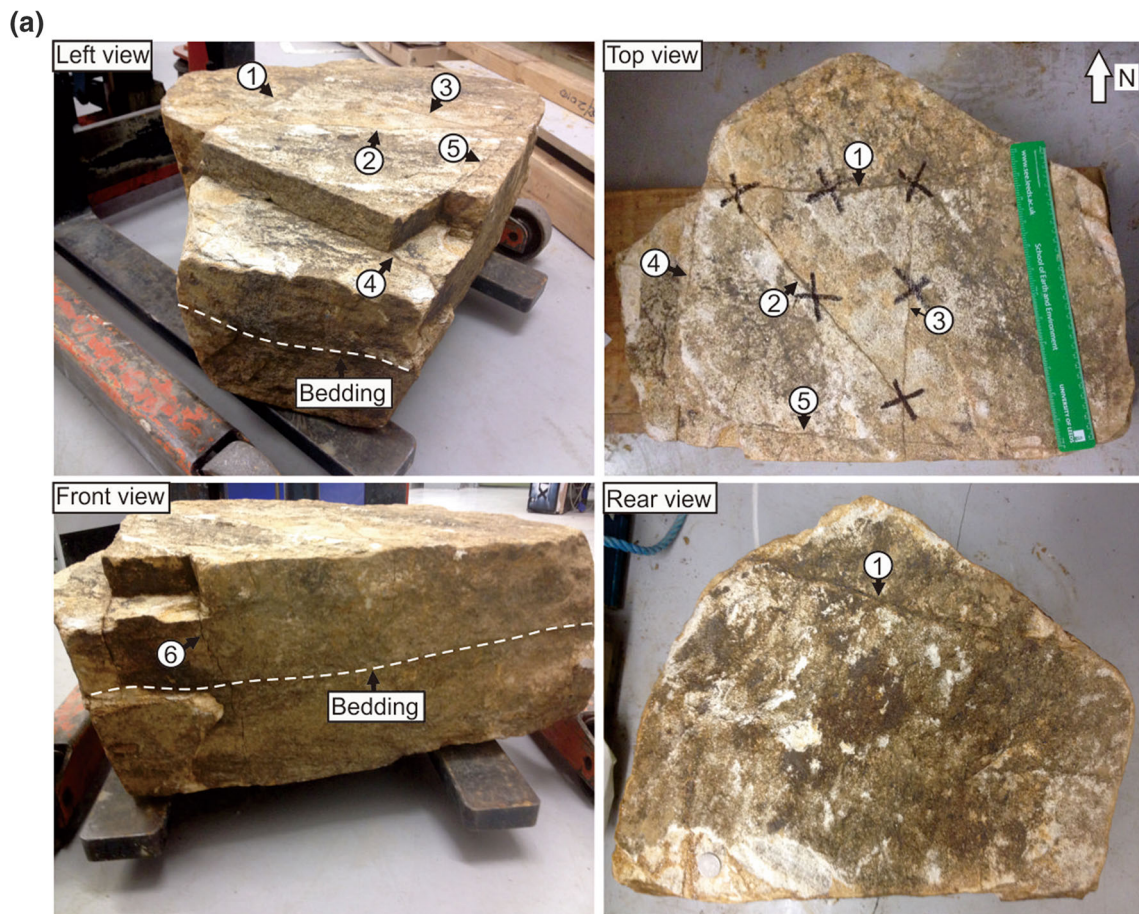
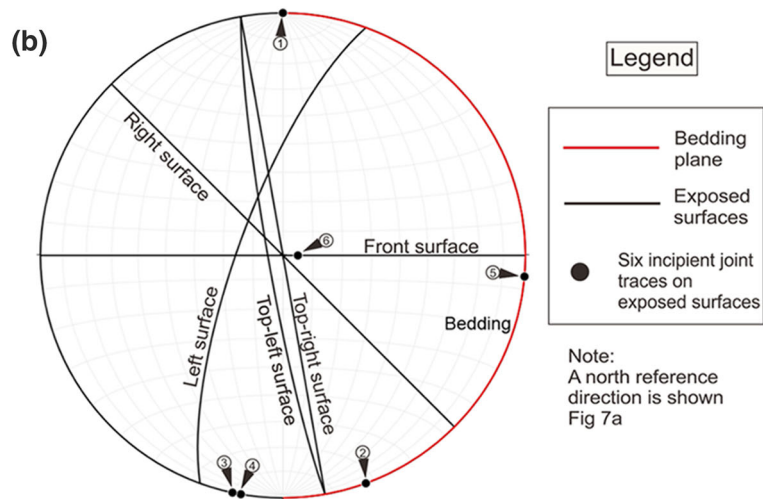
**Fig. 7 a** View of block of Midgley Grit Sandstone tested in the laboratory, with incipient bedding discontinuities and six visible joint traces. The rule for scale is 314 mm. **b** Stereographic representative of six incipient joint traces and exposed surfaces shown in **a**. Bedding

(red line in **b**) is assumed as *horizontal*. Note that discontinuity surfaces are plotted as planes and traces are plotted as poles (colour figure online)

A large block sample of Midgley Grit Sandstone was collected from BQ, as shown in Fig. 7a. The block contained six visible traces of discontinuities, labelled ①–⑥. Incipient joint traces ①, ② and ③ intersected one another (see Fig. 7a, top view). Incipient bedding (dashed lines in

Fig. 7a, left and front views) is also present. Relative orientations of these discontinuity traces including exposed surfaces are plotted in Fig. 7b assuming a north reference direction as shown in the top view. Incipient joint ① appears as a trace on all free surfaces (see Fig. 7a, top and rear views), whereas other joints appeared to be less well developed in surface expression.

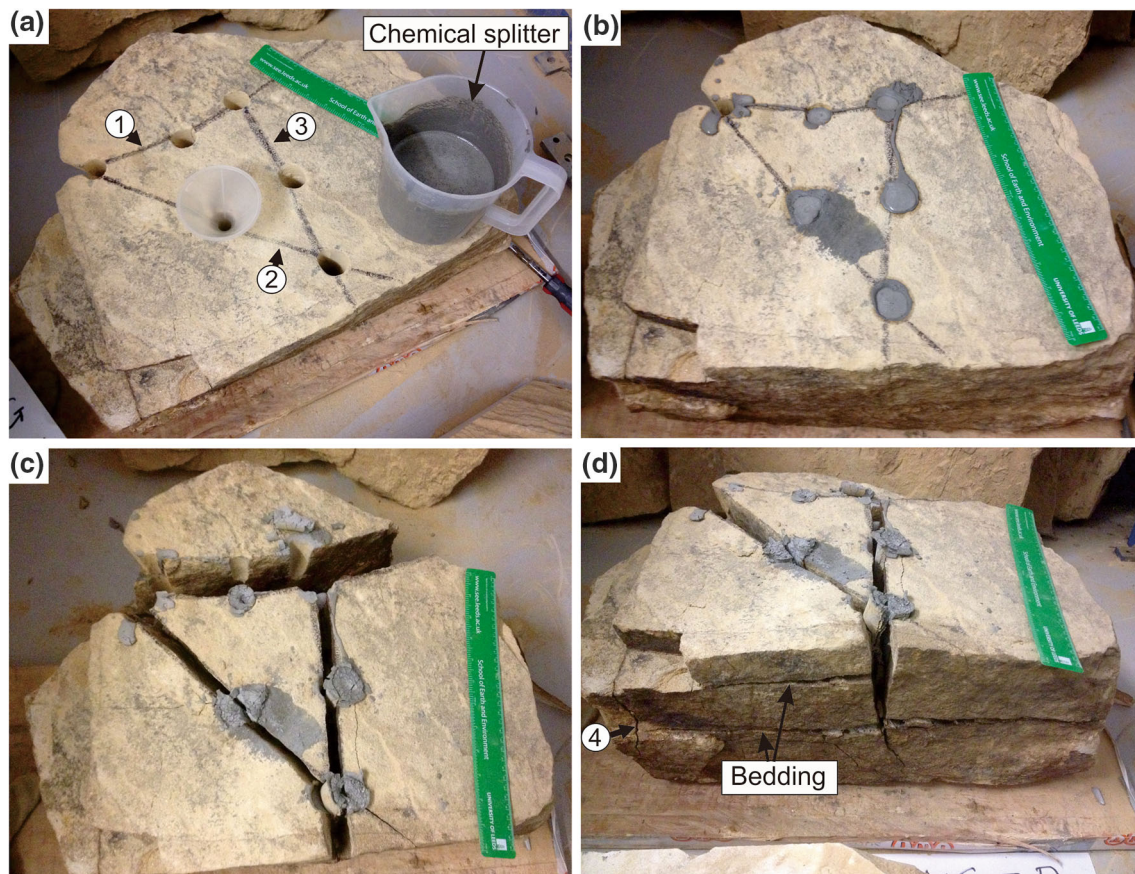
**Fig. 8** FERM testing procedure along incipient rock discontinuities ①, ② and ③ of Midgley Grit Sandstone block shown in Fig. 7a. **a** Six holes with a diameter of 27 mm were drilled along these incipient joints to a depth of 150 mm. **b** The chemical splitter was injected into

the pre-drilled holes. **c** Induced fractures along pre-existing incipient joint traces after 24 h. Two horizontal parallel fractures were induced along bedding planes as shown in **d**. The rule for scale is 314 mm

Figure 8 illustrates the FERM testing procedure in the laboratory. Holes with diameter of 27 mm were drilled along incipient joint traces ①, ② and ③ to a depth of around 150 mm, and chemical splitter injected (Fig. 8a, b).

Figure 8c and d shows the failure patterns after 24 h. As anticipated, the block sample split following pre-existing discontinuity traces. Two incipient horizontal bedding planes were also opened up (Fig. 8d). One incipient rock joint ③ changed from near-vertical to inclined below one of the opened bedding planes (Fig. 8d). Incipient joint ④ also opened up during this test although it was not targeted in the experiment.

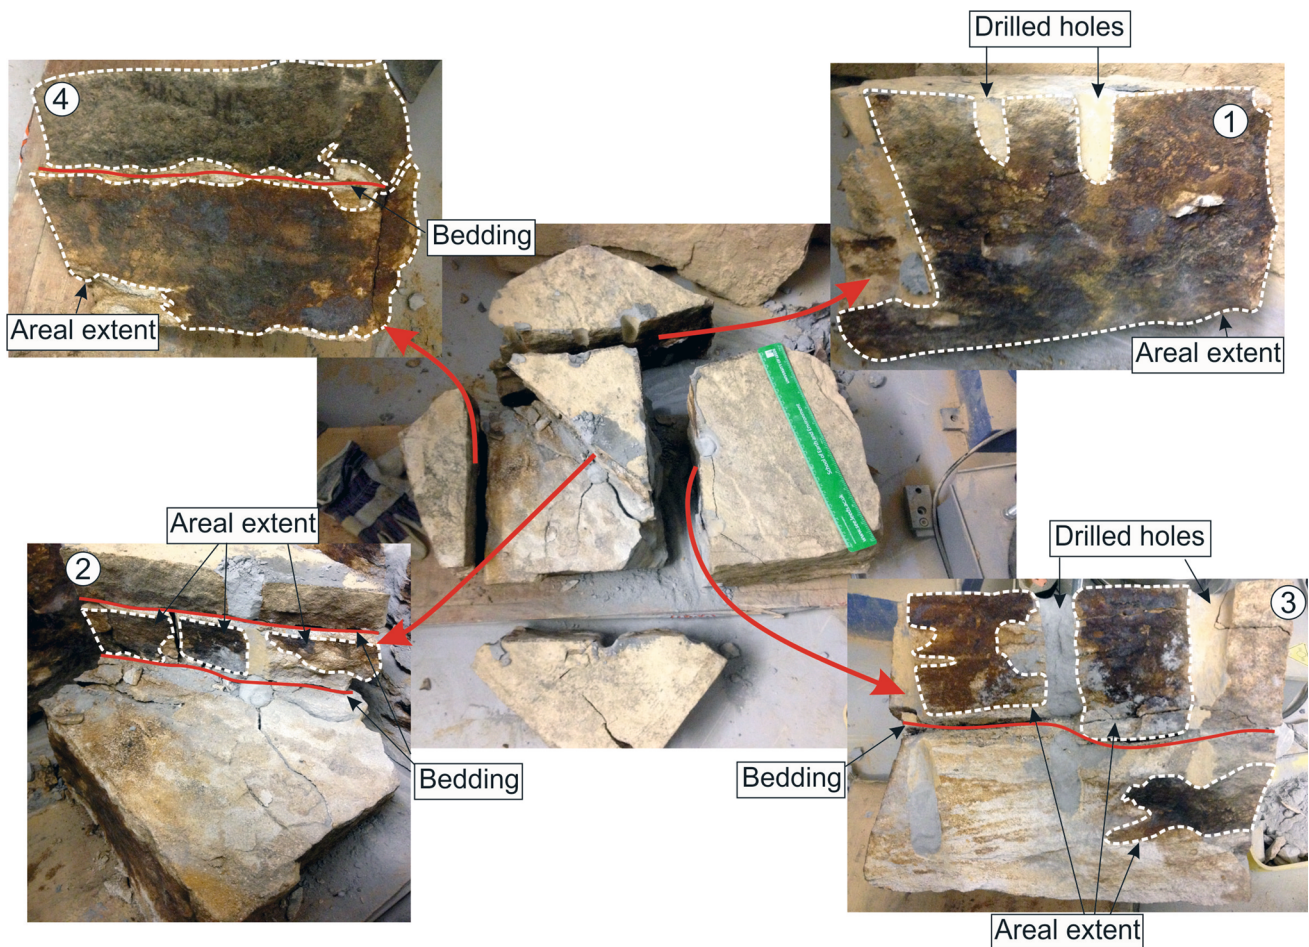
**Fig. 9** Incipient joint surfaces exposed after testing of Midgley Grit Sandstone block shown in Fig. 7a. Red lines correspond to an opened bedding plane. The rule for scale is 314 mm (colour figure online)

The split rock block pieces are shown in Fig. 9. From the revealed joint planes, it was observed that all incipient joints terminated at bedding planes (indicated by red lines).

Generally, the persistent joint segments (outlined by white dashed lines) exhibited various degrees of weathering in a similar manner to the samples described by Shang et al. (2016). The stained segments were identified, and their areal extent measured approximately using AutoCAD. Pre-existing areal persistence values of incipient rock joints

①, ②, ③ and ④ were calculated as 85, 37, 32 and 90%, respectively, according to the areal extent definition in Fig. 1a. The persistence was quantified under the assumption that persistent areas were stained. This assumption may not be true for some newly generated fractures for which surfaces are still in fresh state, but for many cases, especially those situations exposed in the field (like the tested sample), the discoloration of minerals on persistent discontinuity areas is evidence for the identification of persistent areas.

As for Midgley Grit Sandstone tested, both in the laboratory (Fig. 9) and in the field (Fig. 13), the weathering process has left a clear morphological signature with brown and black staining on pre-existing persistent areas. Iron oxides (haematite) and biotite appeared in the brown and black weathered areas (Shang et al. 2016). In comparison, weathering did not penetrate deeply into the Horton Formation Siltstone (for the samples tested).

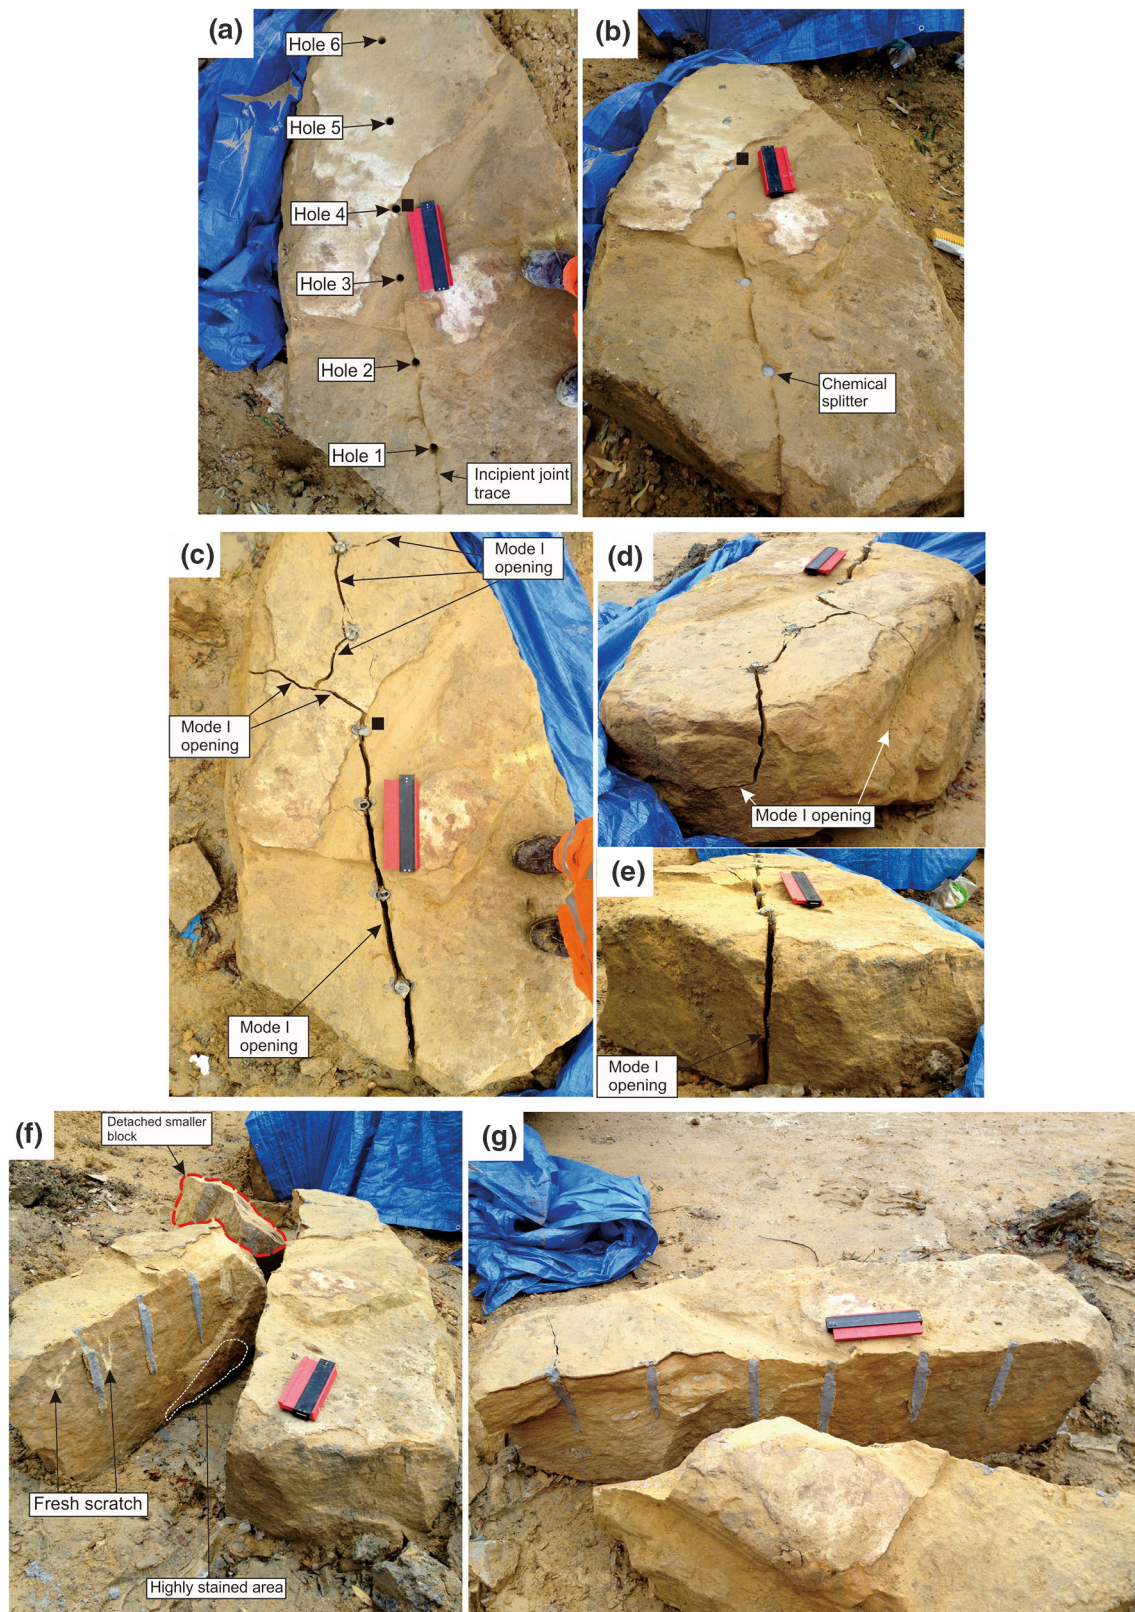
**Fig. 10** Procedures and failure patterns of the FERM testing performed on Midgley Grit Sandstone Block 1 tested in Blackhill Quarry, West Yorkshire, UK. **a** Single joint trace terminating in rock and six holes drilled to split the block. **b** Chemical splitter injected

into the pre-drilled holes. **c–e** Failure patterns and fractures induced after 24 h. **f** Two separated blocks and one smaller block. **g** The two larger separated blocks. *Black rectangular dot* shows the joint trace termination point. The profile meter for scale is 270 mm

Figures 10 and 11 illustrate the field-scale testing procedure and the failure patterns that were created after 24 h. For Block 1, holes were drilled with a separation of 200 mm along the joint trace on the top surface (Fig. 10a). All holes were drilled to a depth of approximately 280 mm, i.e. more than 50% of the block depth. Figure 11b shows Block 2 with a single vertical incipient joint. The linear extent of the joint trace on the top surface is 56%. Seven holes with diameter of 27 mm were drilled along the incipient joint plane.

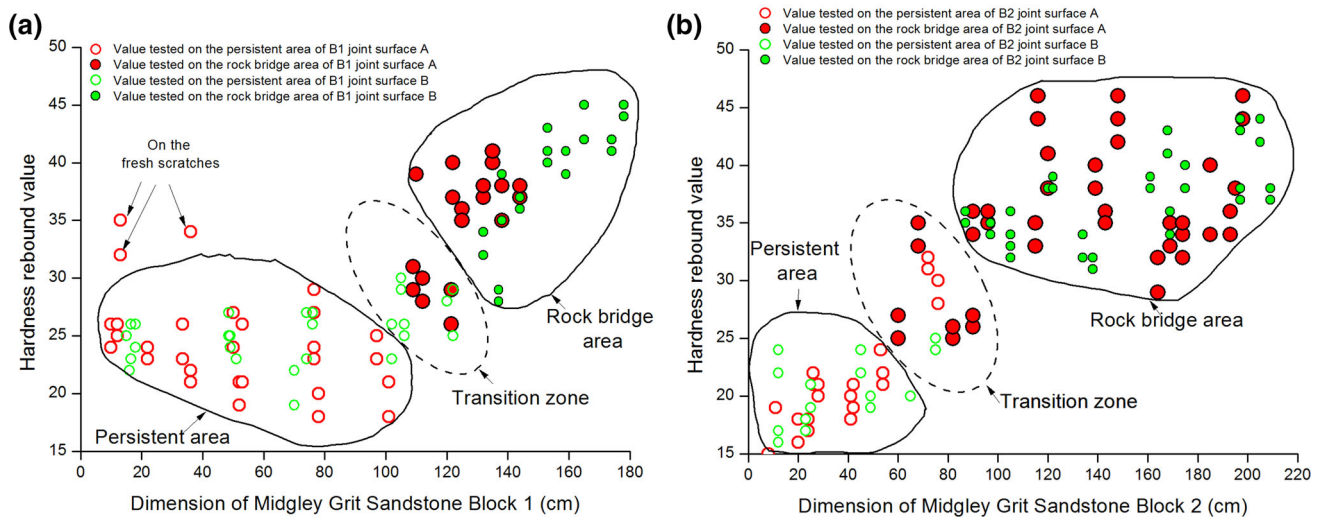
**Fig. 14** Distribution of L-Schmidt hammer hardness rebound values of the exposed surfaces A and B of **a** Block 1 and **b** Block 2. (Please refer to the web version of this article for *colour* interpretation.) (colour figure online)

Schmidt hammer (SH) tests (L-type) were performed on the four exposed joint walls, shown in Figs. 12a, b, 13a and b, respectively, according to the ISRM standard (Aydin 2014). Red and green dots on exposed surfaces correspond to the SH testing points on persistent joint area and rock bridges, respectively. Joint walls were cleaned to eliminate effects from loose debris prior to SH testing. Each point was tested twice perpendicular to the surface.

Figure 14a shows hardness rebound values against the distance along Midgley Grit Block 1, measured from the left edge of the Block. For the heavily stained areas (persistent areas), rebound values ranged from 18 to 28, while the values ranged from 25 to 32 for the transition zone and 28–45 for rock bridge area. For Block 2, rebound values ranged from 28 to 47 for the rock bridge area, but were much lower for persistent area (14–24).

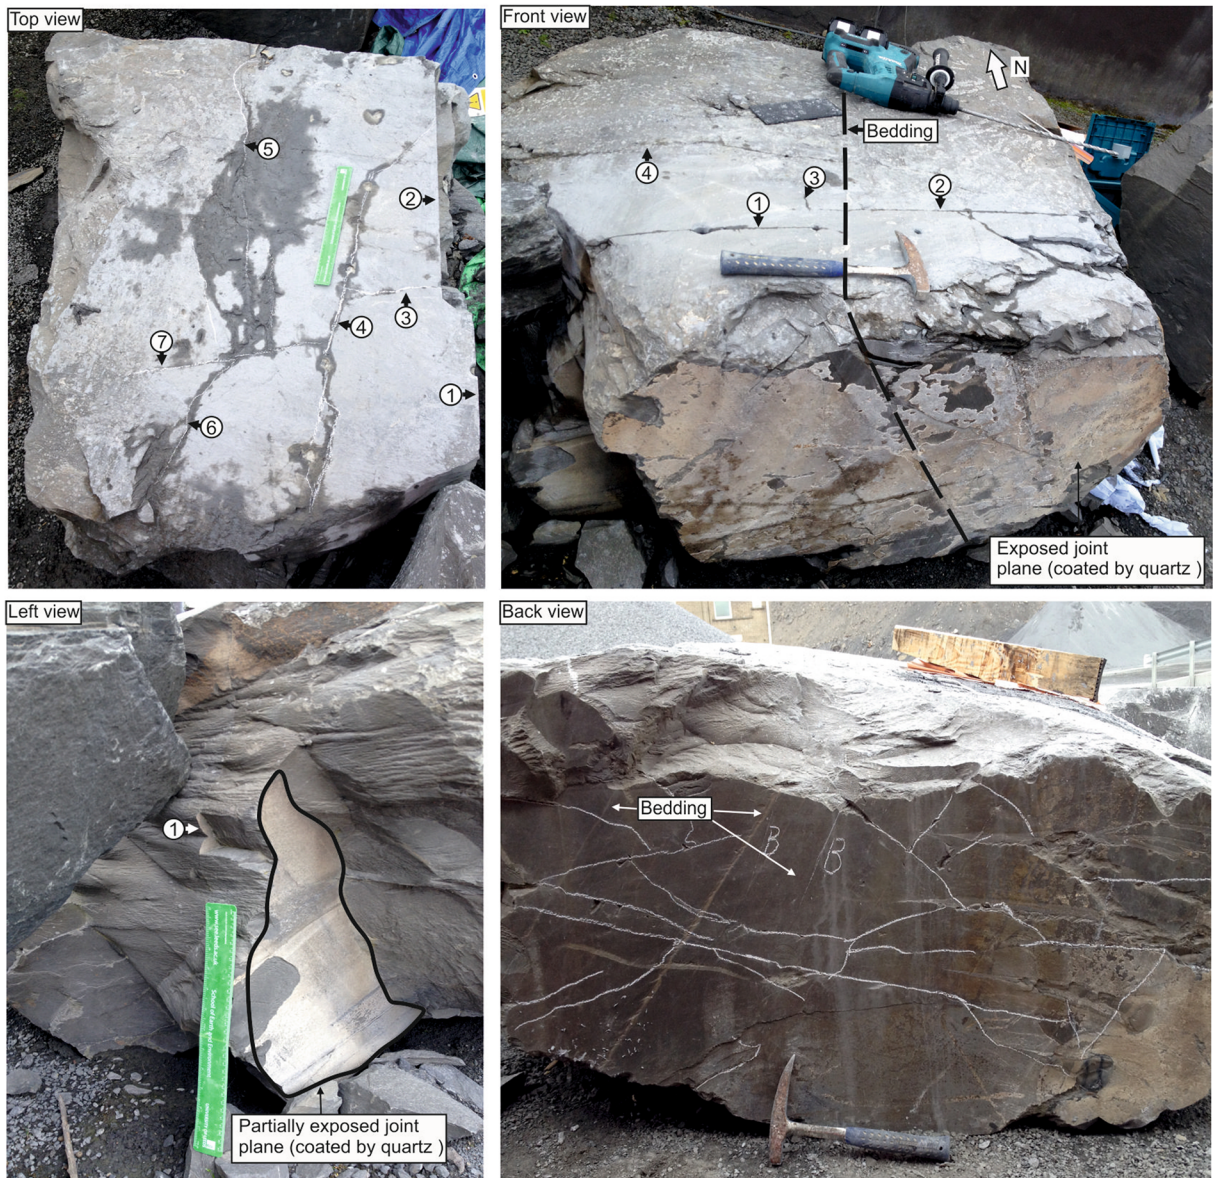
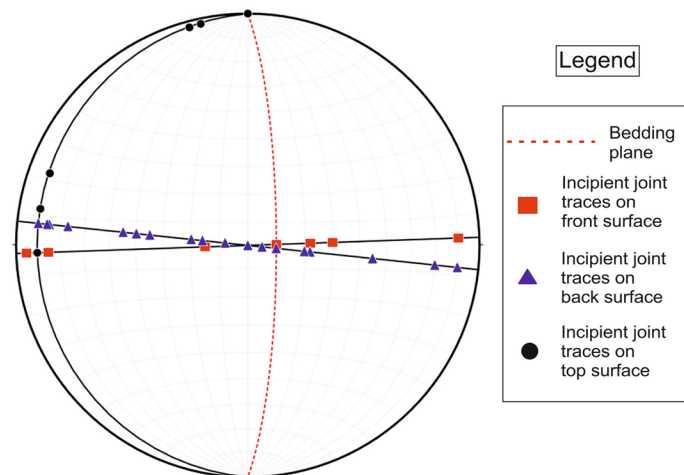
◀ **Fig. 15** **a** Horton Formation Siltstone block tested at Dry Rigg Quarry, North Yorkshire, UK. The geological hammer for scale is 310 mm. **b** Relative orientation of planar incipient discontinuity traces and exposed free surfaces on the Horton Formation Siltstone block in **a**. Note that discontinuity surfaces are plotted as plane and traces are plotted as poles

Figure 15a shows the tested rock block containing seven visible incipient discontinuity traces on the top surface. Relative orientations of these incipient discontinuity traces (considering only planar or near-planar traces including exposed free surfaces as representing discontinuities), are plotted in Fig. 15b assuming a north direction as shown in Fig. 15a, front view.

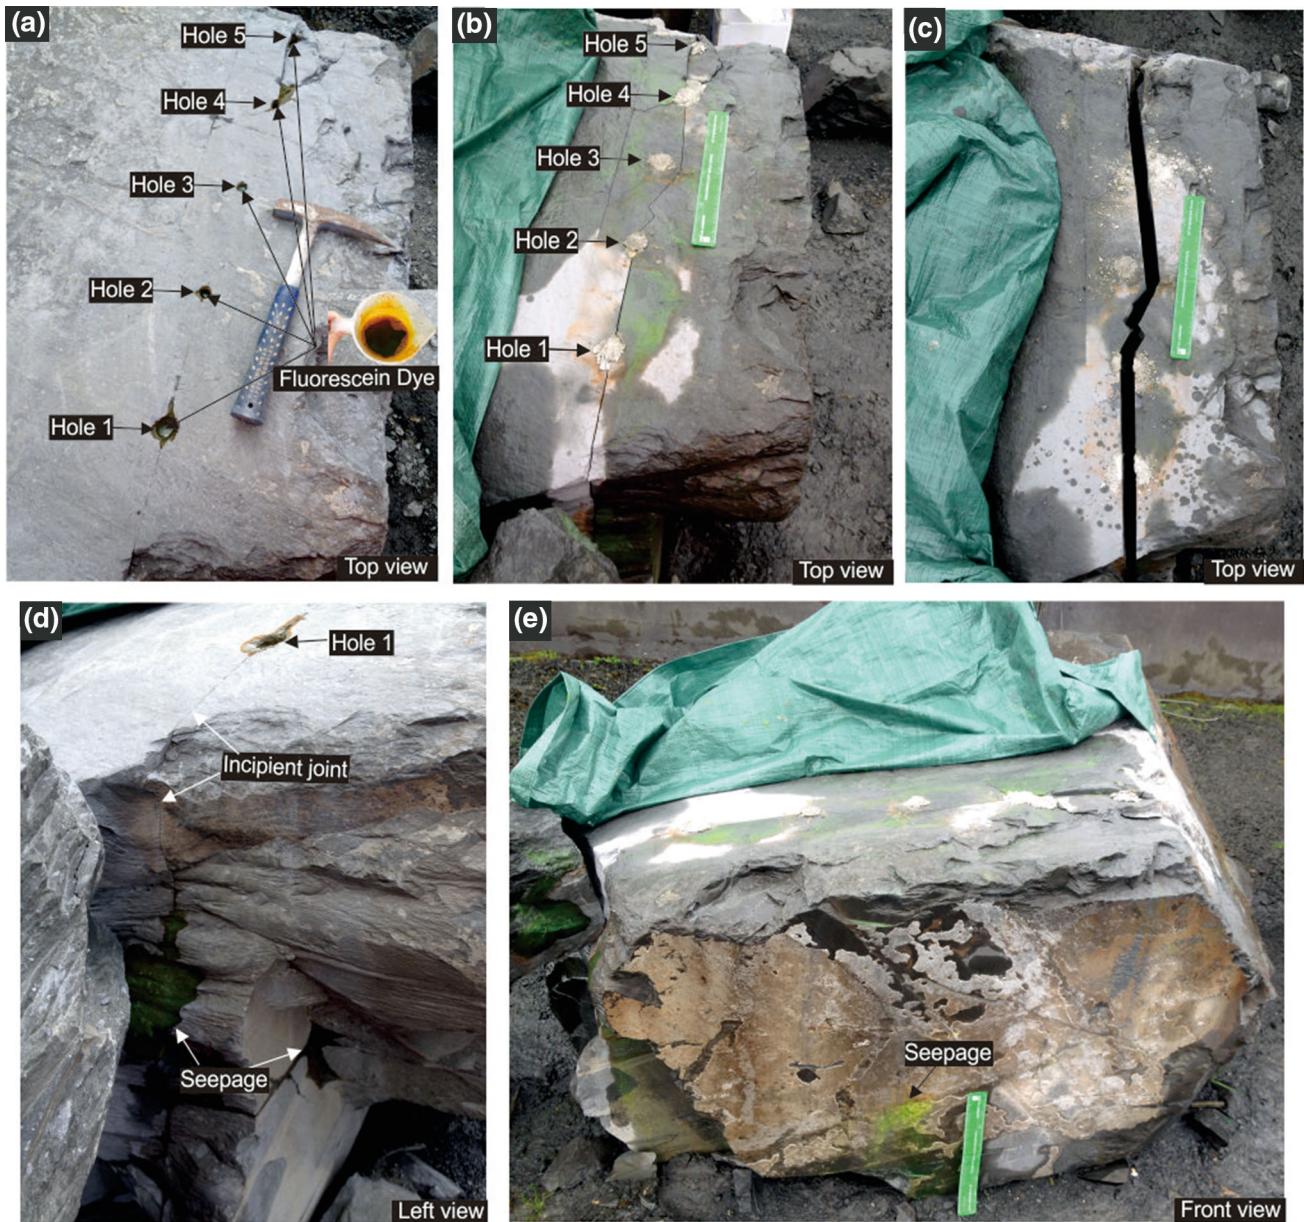
**Fig. 16** FERM testing along incipient joint ① from the Horton Formation Siltstone block. **a** Fluorescein dye ( $C_{20}H_{12}O_5$ ) was poured into the pre-drilled holes prior to the forensic splitting. **b** Chemical splitter was injected and one fracture with an aperture of about 2 mm

was induced after 24 h. Block was still not fully split, even though the aperture on the top reached  $>50$  mm as shown in **c**. **d** and **e** Dye flowed out along persistent joint segments after 24 h before splitting. The geological hammer for scale is 310 mm

Five holes with depth of approximately 450 mm were drilled along the incipient rock joint trace ①, and fluorescein dye ( $C_{20}H_{12}O_5$ ) was injected in an attempt to identify persistent portions (Fig. 16a). The block was then protected by a plastic cover and left for 24 h for the dye to penetrate by gravity. Chemical splitters were then injected as for the previous field experiments.

A fracture with an aperture of around 2 mm was induced after 24 h following the joint trace ① which terminated at Hole 2 and then followed a zigzag pattern between Hole 2 and Hole 3 (Fig. 16b). Unexpectedly, it did not pass through Hole 3. A high tensile strength contribution (true cohesion) arising from rock bridges along this incipient rock joint was evident as the slab was not fully split, even though the fracture aperture at the top approached 50 mm (see Fig. 16c). The slab was eventually split using an excavator, and the exposed joint surfaces are presented in Fig. 17a and b.

Regarding the dye injection it was noted that seepage appeared from a section of one incipient joint trace on the front exposed surface (Fig. 16e) and from the incipient joint trace ① on the left face of the block (Fig. 16d).
