# Corrosion Level of Rock Bolts Exposed to Aggressive Environments in Nordic Road Tunnels

**Keywords** Rock bolt · Rock support tunnel · Durability · Corrosion · Probability of failure

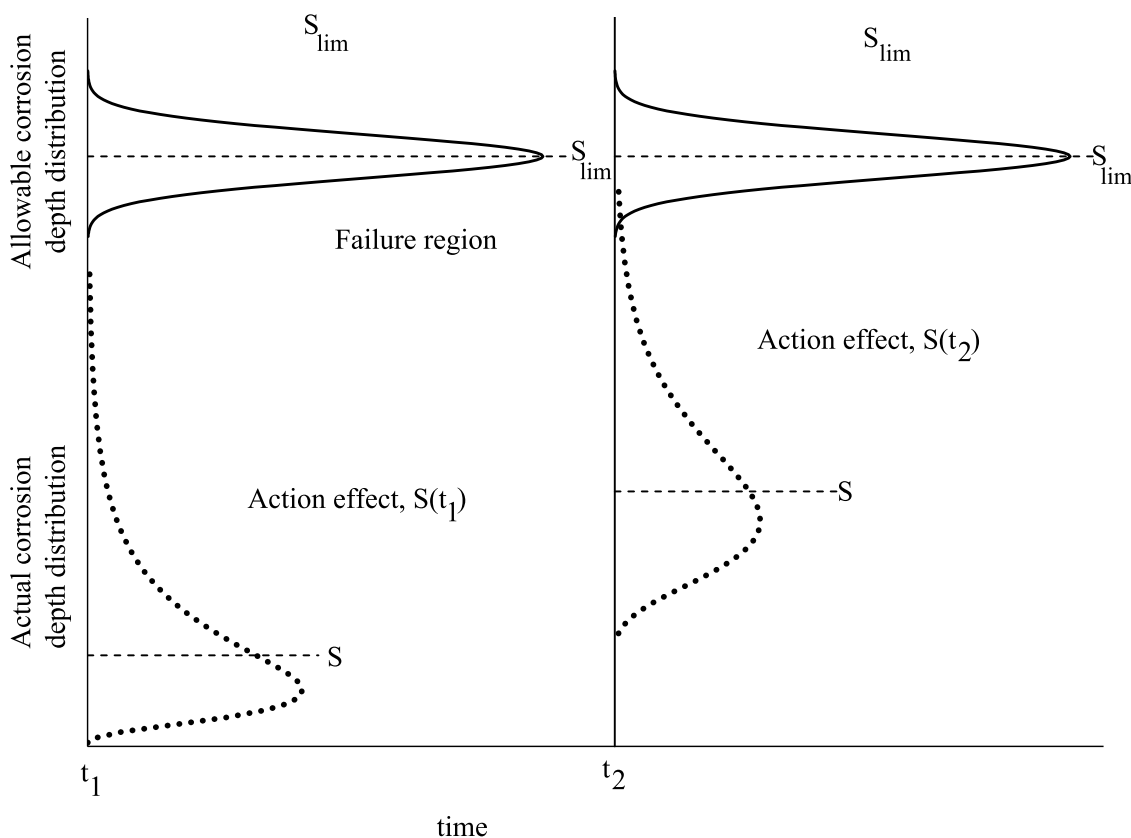
Fig. 1 Probabilistic limit-state approach for predicting the useful life applied to rock bolt corrosion. Modified from standard ISO 13823 (2008)

The consequence of corrosion on rock bolts with a higher probability of failure over time can be visualized in Fig. 1. This figure shows the general principles of the probabilistic limit-state approach for the durability design of structures according to the standard ISO 13823 2008. In this approach,

an appropriate probability distribution is assigned to both the allowable corrosion depth  $S_{lim}$  and the action effect  $S$  for a specific exposure time. In this context, corrosion increases the probability of failure once the probability distribution curve of the action effect increases to such a level that it starts to overlap with the allowable corrosion depth curve. This failure region, highlighted as the shaded area in Fig. 1, is related to the probability of failure. For simplicity, Fig. 1 does not show changes in the allowable depth distribution over time. However, time-dependent geohazards, such as swelling or squeezing, aggravate the situation with an increasing load exerted by the rock mass over time (Stille and Palmström 2018).

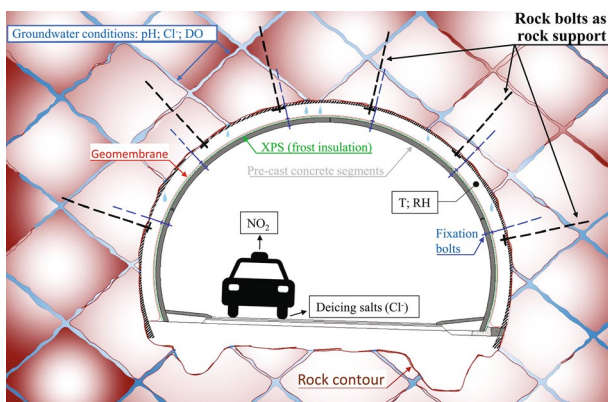
**Fig. 2** Pre-accepted solution in Norwegian road tunnels with an inner lining modified from NPRA (2016a). The following atmospheric parameters are also included: temperature (T), relative humidity (RH) and nitrogen dioxide ( $\text{NO}_2$ ). In groundwater: pH, chloride content ( $\text{Cl}^-$ ) and dissolved oxygen concentration (DO)

Figure 2 shows the key role of temporary (and permanent) rock support in the safety of road tunnels with this layout. It also describes some atmospheric and aqueous environmental parameters that may affect the longevity of rock bolts. In current Norwegian regulations, the useful life of permanent rock support must be 100 years regardless of the actual

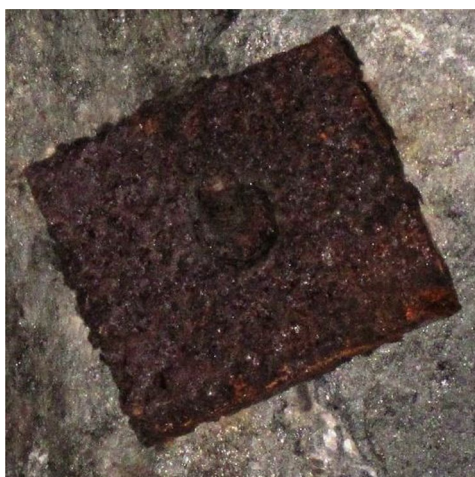
**Fig. 4** Fully grouted uncoated rebar with unprotected steel accessories in the Hamregjøel tunnel after 47 years in service (Ongstad 2012)

Figure 4 shows the case of a rock bolt whose accessories and the protruding end of the rebar are corroded.

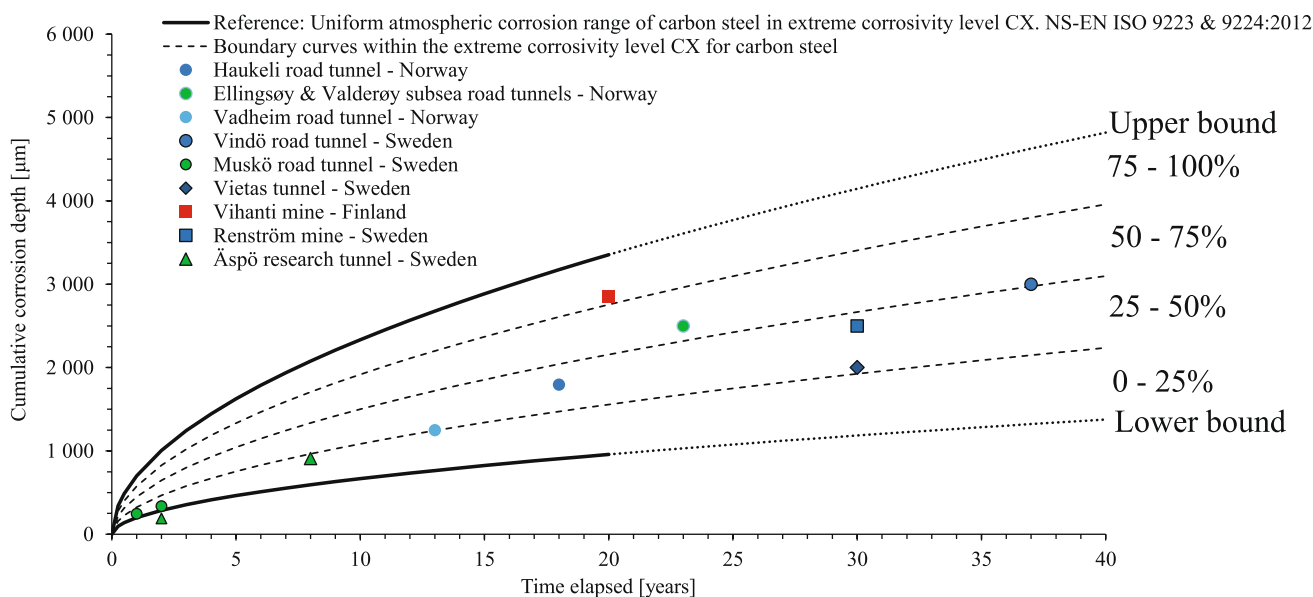
**Fig. 5** Long-term collection of corrosion progression on carbon steel in different underground structures. Blue and light blue dots reflect dripping/flowing water as the presumably predominant corrosion

environment. Green dots represent chloride-rich groundwater. Red dot reflects a sulfide-rich environment with presumably low pH

Both uniform and localized (pitting) corrosion have been described in rock bolts installed in underground structures. Figure 5 summarizes the highest corrosion levels of carbon steel reported in nine underground structures in Nordic countries. Further details about these underground structures are

described in Table 1. Figure 5 shows 11 corrosion observations because in two underground structures, corrosion measurements took place in two different years. The collected data come from mainly rebars with grout defects and rock bolt ends protruding from the tunnel contour. Apart from examples from Norwegian and Swedish road tunnels, some other corrosion data from underground structures are given to complement the scarce long-term exposure data found in road tunnels.

Figure 5 shows that 10 out of the 11 long-term corrosion observations on carbon steel are within the range established for the extreme corrosivity level CX. This is equivalent to an approximately 91% confidence level for the corrosion observations shown in Fig. 5. This trend arises in observations from different aggressive environments, underground structures, and exposure times. Thus, this research will use this band as the expected corrosion depth range on carbon steel for longer exposure times in underground structures. Then, it is assumed that the corrosion kinetics of the carbon steel given in Eq. (1) will persist in the long-term. In addition, a confidence level of 91% will be extrapolated for longer exposure times (this corresponds to a 9% significance level for longer exposure times).

The following step is to find a suitable probability distribution. In this regard, Fig. 5 shows that most of the observations are closer to the lower bound of the extreme corrosivity level CX. To quantify this observation, three subdivisions are introduced for this corrosivity level. These subdivisions are evenly spaced for a given exposure time. The aim is to create a histogram based on the intervals shown on the right-hand side of Fig. 5 to reflect the distribution of the corrosion observations. Figure 6 shows the resulting histogram, where zero represents the lower bound and one represents the upper bound defined in Fig. 5.

Figure 5 indicates that a corrosion depth of  $500 \mu\text{m}$  in uncoated carbon steel can be achieved after approximately 4 years of exposure in marine environments. Hence, a rough estimate of the minimum lifespan extension by the duplex protection system is 14 years. This is considered the lower bound of lifespan extension by the duplex protection system.

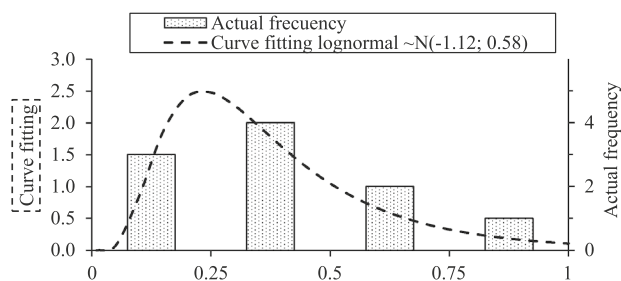
**Fig. 6** Frequency distribution for the different intervals defined in Fig. 5. In addition, a fitting curve following a lognormal distribution

Figure 6 includes the 10 corrosion observations within the extreme corrosivity level CX. The results show a higher density towards the lower bound, where seven out of the 10 observations lie below the median or 50th percentile. This suggests that a lognormal probability function might fit the corrosion observations classified for the different intervals of the extreme corrosivity level CX. In fact, the international standard NS-EN-ISO-9223 (2012) states that the corrosion rates of metals usually follow a lognormal distribution.

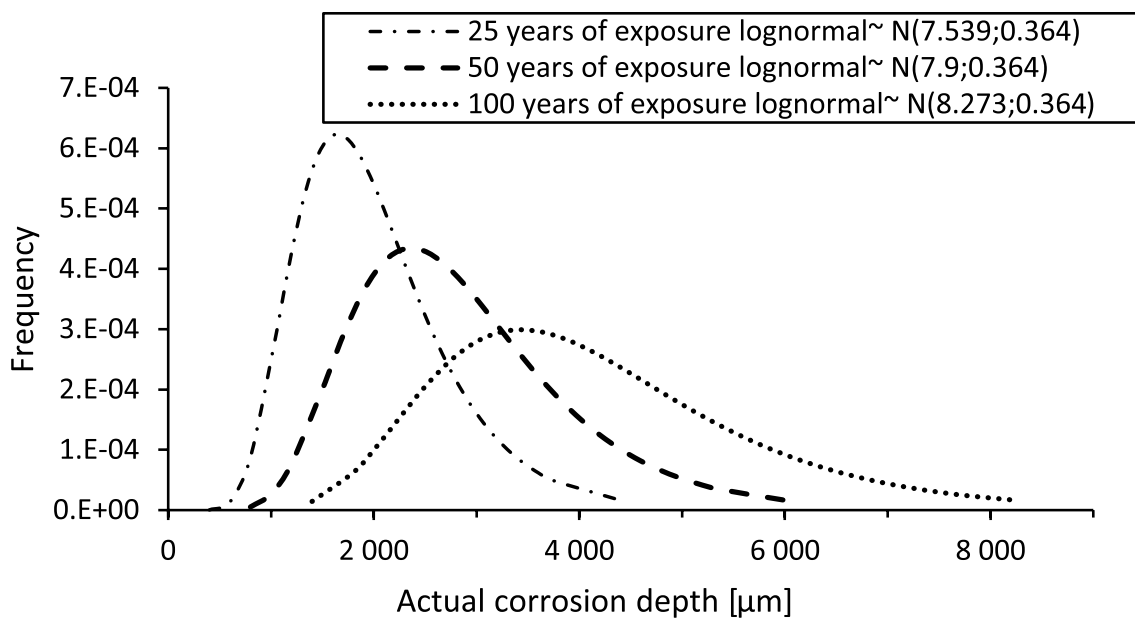
**Fig. 8** Probability distributions for the actual corrosion depth expected in carbon steel exposed to the aggressive environments described in this research for 25, 50, and 100 years

The three exposure time curves given in Fig. 8 comply with a confidence level equal to 91% for the extreme corrosivity level CX band and the probability of exceeding its upper bound is 3%.

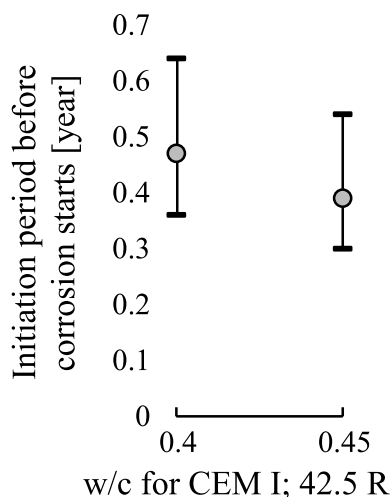
**Fig. 9** Time elapsed before a critical chloride concentration reaches the grout/steel interface

An  $\alpha$  value equal to 0.3 is adopted according to fib (2006) for CEM I. The environmental transfer variable  $b_e$  usually varies between 3300 and 5500 K. A value of 4800 K is adopted, as suggested by fib (2006). The temperature  $T_{\text{real}}$  of cement mortar varies with geographical location, tunnel length, ventilation type, traffic volume, frost protection applied, etc. Based on a random selection of Norwegian literature about the temperature conditions in tunnels (Luke 2013; Holter and Geving 2016) a temperature  $T_{\text{real}}$  equal to 7 °C was chosen. The results are given in Fig. 9.

In Fig. 9, the circles represent the predicted time for corrosion initiation. The range shown for each  $w/c$  ratio corresponds to one standard deviation from the mean of the expected chloride diffusivity value

Based on this figure, the expected useful life extension of mortar in chloride-rich groundwater is less than one year, even for a  $w/c$  ratio of 0.4. After this period, the steel starts to corrode. Then, for practical purposes, the corrosion protection of cement grout against chloride penetration is considered negligible.

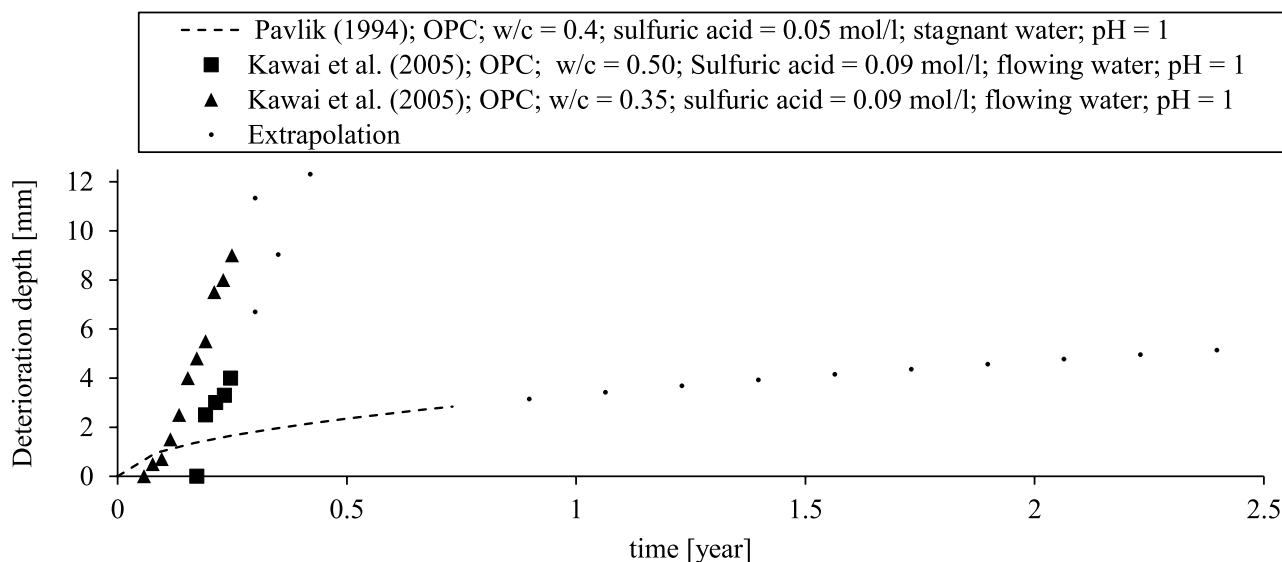
**Fig. 10** Kinetics of degradation in hardened cement paste triggered by sulfuric acid (Pavlik 1994; Kawai et al. 2005). Extrapolation dots represent deterioration depth projections not given by the original source

A comparison of the degradation kinetics of ordinary Portland cement (OPC) mortar/concrete samples under sulfuric acid attack measured in the laboratory exposed to stagnant water (samples submerged in sulfuric acid) and flowing water (circulating acidic water in the laboratory) is given in Fig. 10.

In stagnant water, the degradation kinetics are proportional to the square root of time, as described in Eq. (5), and the degradation kinetics in flowing water are approximately linear with time. It is important to highlight as well that the sulfuric acid concentration in both cases is quite high, resulting in extremely acidic solutions (pH 1). In the same type of mortar shown in Fig. 10, Kawai et al. (2005) observed negligible degradation kinetics after 90 days with a lower sulfuric acid concentration (0.06 mol/l) and a less acidic solution (pH 2). By considering an annulus grout thickness  $x_c$  equal to 12.5 mm, Fig. 10 indicates that the grout thickness may protect the rebar under flowing groundwater for only 3–5 months. In the case of stagnant acidic water, the projected lifespan extension is more than 13 years.

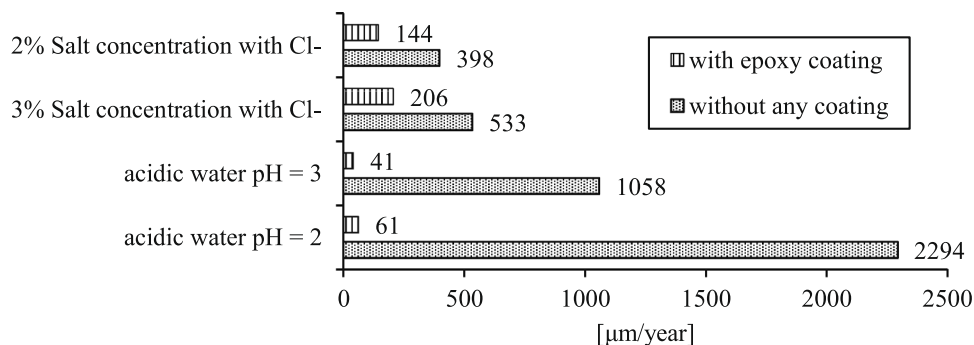
**Fig. 11** Corrosion rates of mild steel immersed in different aqueous solutions for five hours at 30 °C with and without epoxy coating (Khodair et al. 2019)

If the organic coating is damaged in an acidic environment, the zinc coating is exposed, and there will not be any additional protection for the surrounding epoxy coating (Knudsen and Forsgren 2017). Nevertheless, it has been reported that undamaged organic coatings can provide excellent resistance against acids (Møller et al. 2017). Khodair et al. (2019) measured the corrosion rate of mild steel with and without epoxy coating in acidic and saline environments as shown in Fig. 11.

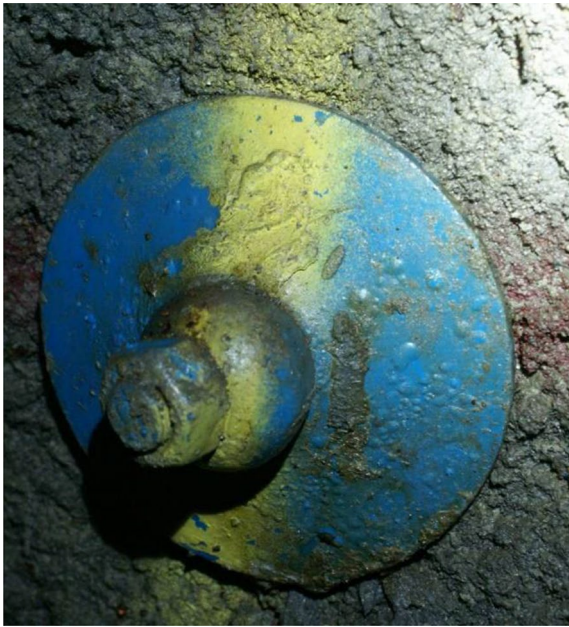
**Fig. 12** Blisters observed in the rock bolt plate in the Oslofjord sub-sea road tunnel after 10 years of exposure (Ongstad 2012)

Blistering of the epoxy coating in bolt accessories has been reported in subsea tunnels (Ongstad 2012). An illustration is given in Fig. 12. In some cases, steel corrosion was found behind the powder coating.
