# Historical earthquake parameters by geological and seismic site analysis: the 1908 Cerbón earthquake (Spain)

Eugenio Sanz Pérez<sup>1</sup> · Ignacio Menéndez-Pidal<sup>1</sup> · Rubén Galindo Aires<sup>1</sup> · Susana López-Querol<sup>2</sup> · Carlos Pascual-Arribas<sup>1</sup>

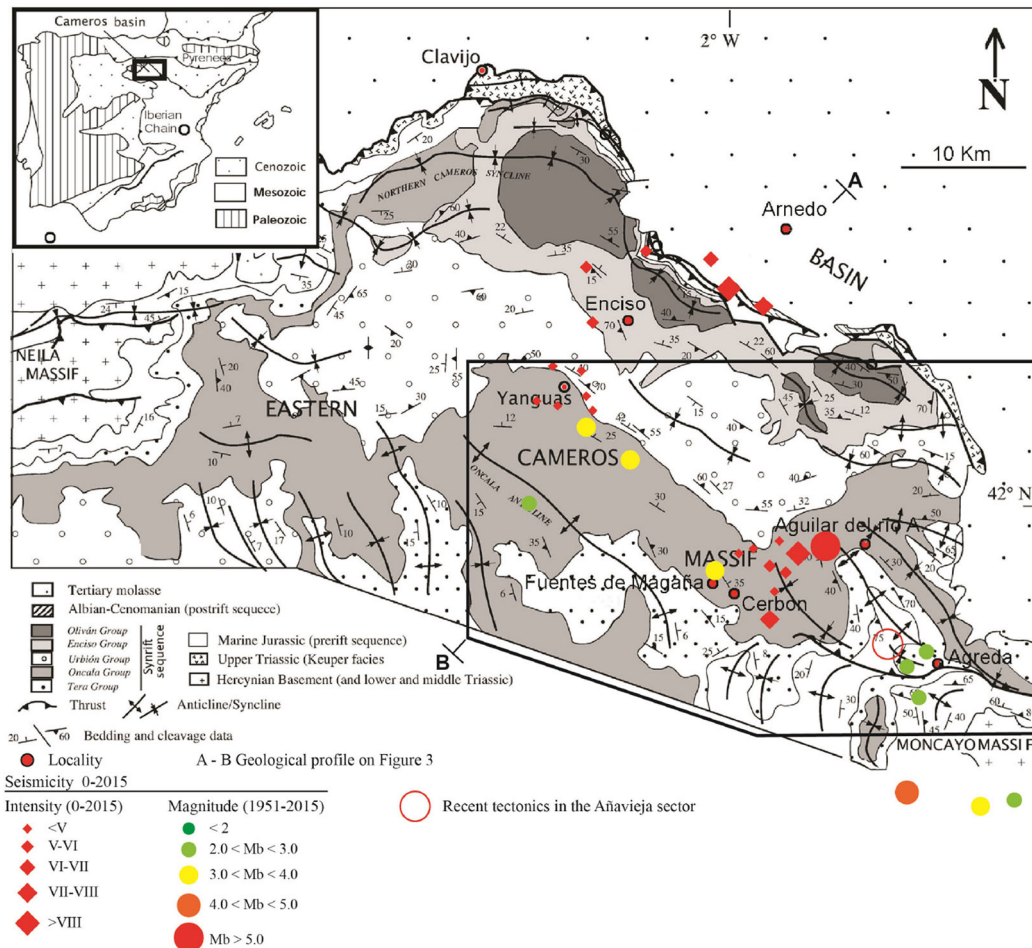
**Fig. 1** Geological map through the Sierra de Cameros (adapted from Gil Imaz 2001). Seismicity occurred in the zone until 2015. Intensity and magnitude are indicated. The site and intensity of the historical

earthquakes are approximate. The circles represent the epicentres, the different colours depicting the magnitude of each event. In the lower square of the figure (SE), the Fig. 2 is allocated

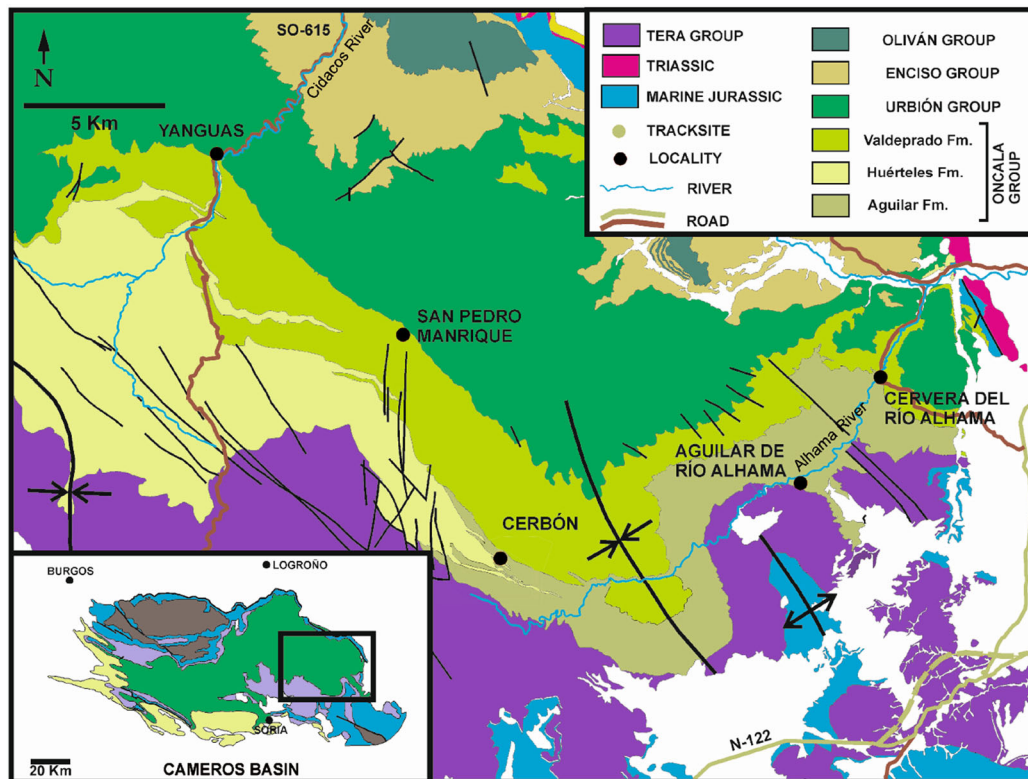
**Fig. 2** Geological map of the studied site (after Quijada et al. 2013)

The Oncala Group outcrops in Cerbón Tischer et al. (1966) (Fig. 2). It comprises some 2000 m of clastic and carbonate sediments. In the eastern part of the Cameros Basin, this group is differentiated into a number of formations/altoformations, which form part of the sedimentary fill sequence III of the Basin (Mas et al. 2004, 2011). Given the lithological characteristics of the sediments (Clemente 2010; Quijada et al. 2013), in this sub-basin, we can differentiate three large formations: Fm. Huérteles, Fm. Aguilar and Fm. Valdeprado. The first of these is characterized by a predominance of clastic sediments, and the other two by a preponderance of carbonate sediments. They are considered to date from the Middle Berriasian (Mas et al. 2004; Clemente 2010).

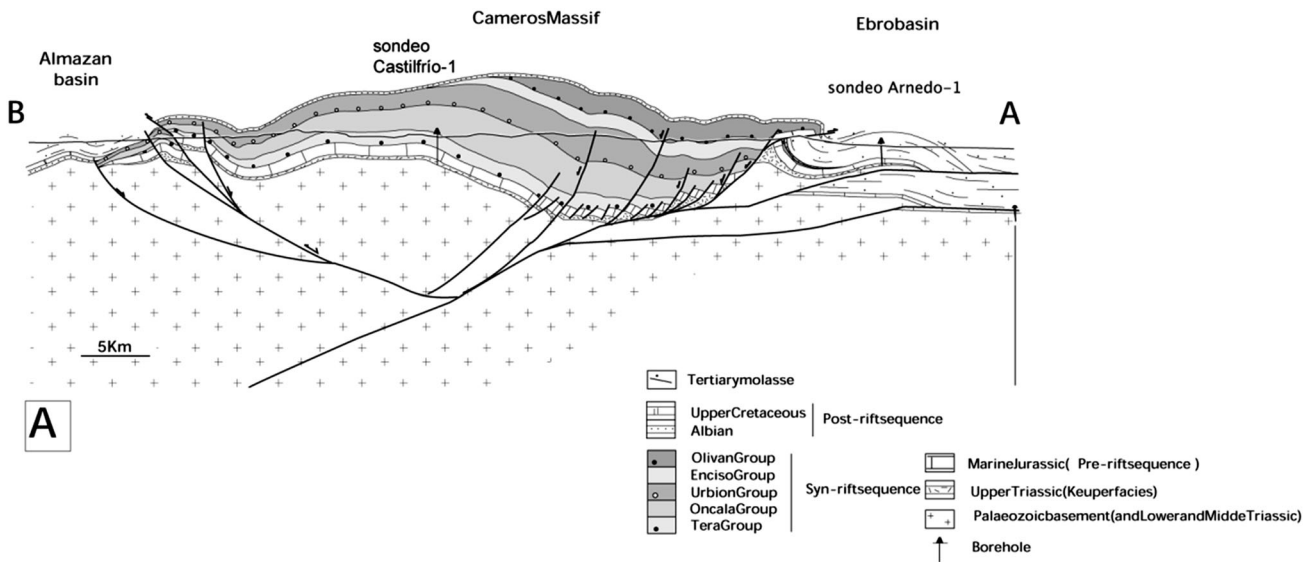
Fig. 5 Geological cross section through the Sierra de Cameros, see Fig. 1

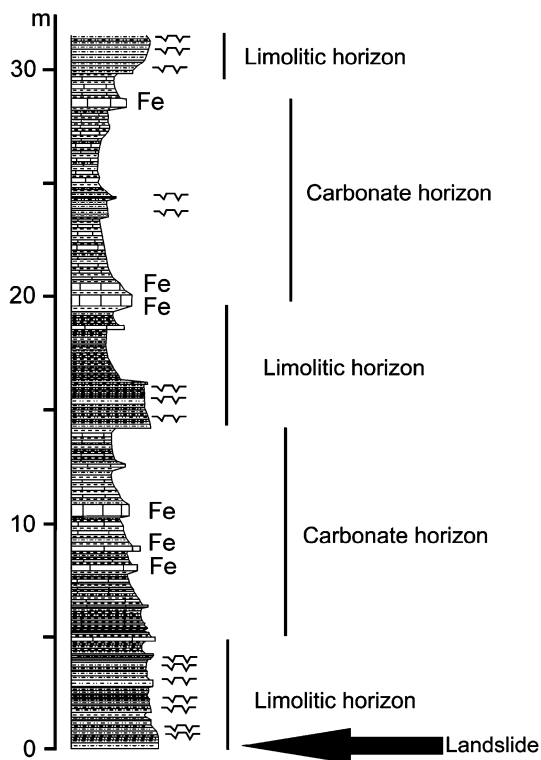
Fig. 6 Detailed stratigraphic column showing the horizons involved in the landslide and the localization of the detached gypsiferous marls. The arrow shows the clayey-loamy gypsiferous level through which the sliding took place

Given that the stratigraphic succession is apparently quite similar throughout, a 30-m sample of the column from the study area was logged in detail (Fig. 6) in order to

get a precise understanding of the materials involved and the incompetent levels, to be able to explain the geomechanical characteristics of the landslide. As can be seen from Fig. 6, the stratigraphy consists of alternating limolitic and carbonate horizons. The landslide affects a packet

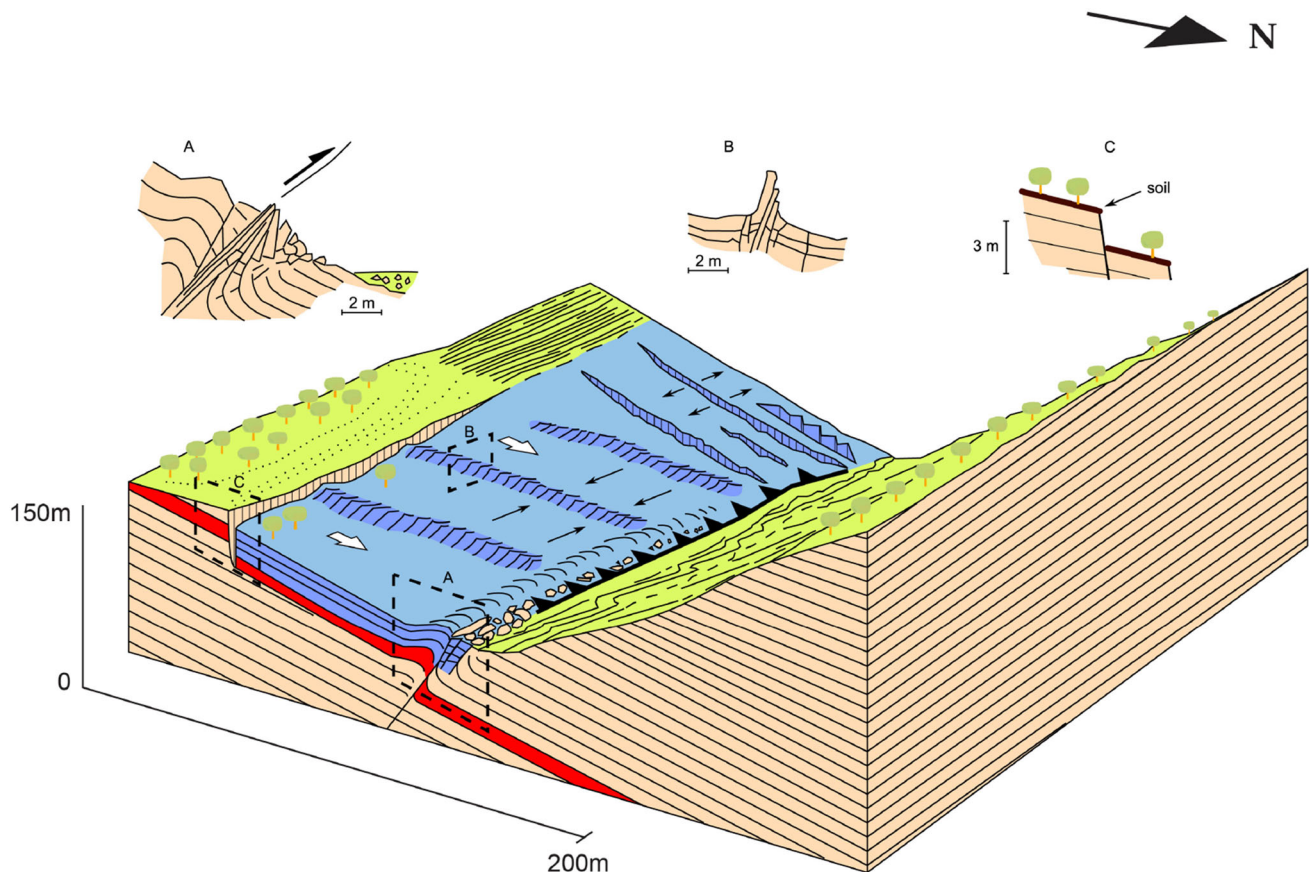
**Fig. 7** Land deformation associated with Cerbón earthquake (1908). **a** Scarp of the lower fissure formed during the earthquake and the parallel micro-anticline. **b** Traction fractures. **c** Escarpment of the upper crack

- In the middle of the rectangle (Figs. 7, 9), three pressure ridges are folded and fractured subparallel to each other, where the strata have been uplifted. They are systematically folded with the same orientation ( $N30^{\circ}$  E approx.). These ridges are subperpendicular to the open fracture above, and they are crossed by a fracture along the axis of the ridge, as well as by other small fractures perpendicular to the axis (Figs. 7, 9).

- In the western part, three or four fractures have opened up to about 2 m depth, parallel to the above-mentioned ones (Figs. 7, 9). Naranjo (1908) described them as follows: to the SW, and along the minor axis of that ellipse, a large crack appeared, which swallowed the debris to a general depth of around 2 m; it left the walls perfectly vertical, separated by 1–2 m and, at some points, by up to 10 m, with an accompanying crack to the NE. There was another shorter one a short distance away. In the NW, there was another long, rectilinear fissure, divergent from that in the SE, but smaller. Likewise, there is another central fault following the longer middle axis of this ellipse. These fissures are quite easily recognized today.

In the SE part of the landslide, but apart from it, there is a small straight, narrow gully that opens like a trench (Figs. 7, 9), whose morphology does not fit the kind of gully found in this zone and whose origin could perhaps be related to the formation of a fissure arising from this seismic event.

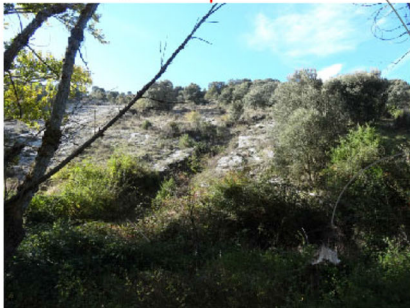
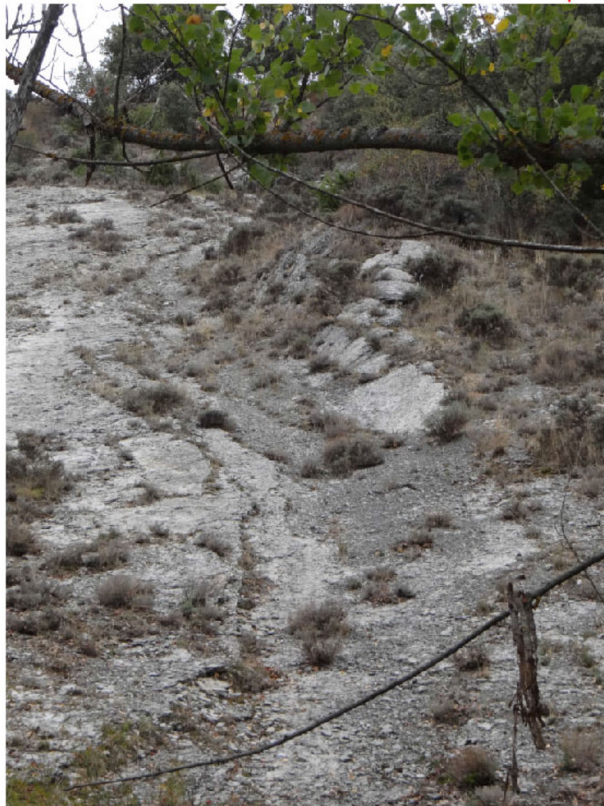
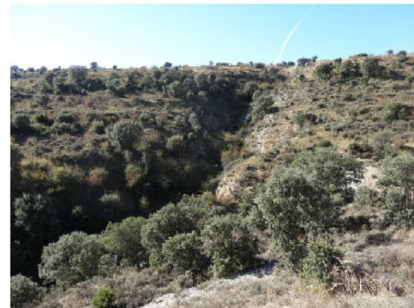
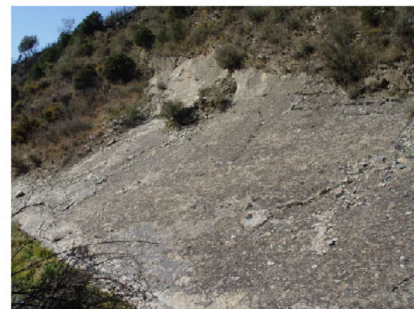
Traction fractures

Pressure ridges

Inclined strata near reverse fault

**Fig. 9** Ruptures and folds of rocky landslide induced by the 1908 Cerbon earthquake

slope, except in the E-SE where the relief is elevated as a gentle promontory, on which the ruins of the Majada del Colorado are found. The area resembles a rectangle of some 350 m in the direction of the strata, by around 200 m wide, and it has been delimited by fractures that have individualized the block that was displaced by an earthquake (Fig. 9).

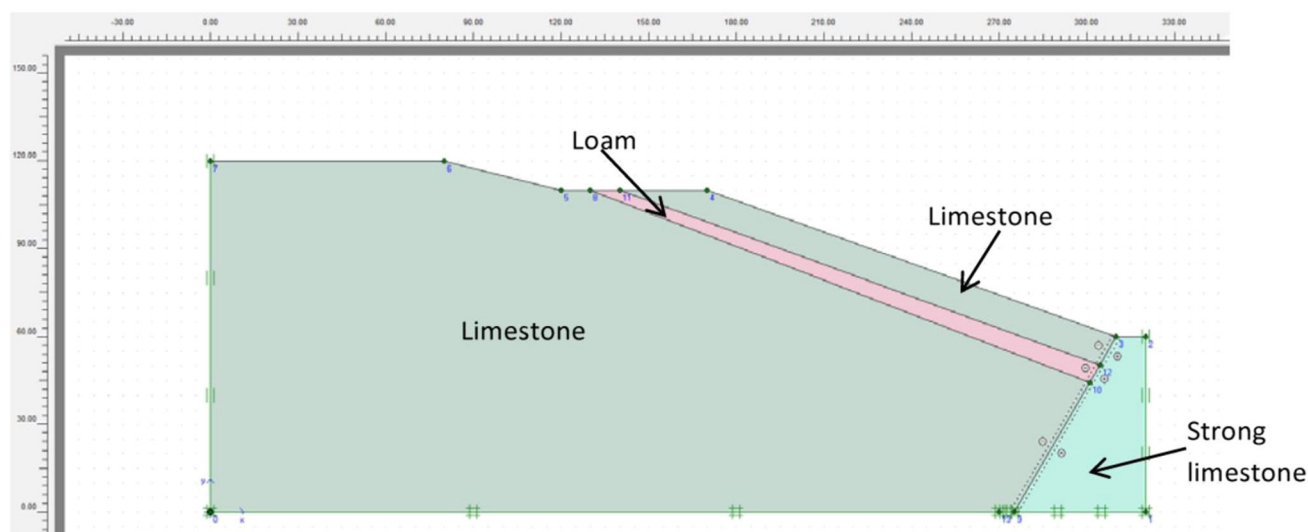
**Fig. 10** Simplified cross section considered for the 2D FEM simulation

A two-dimensional (2D) Finite Element model of the main cross-section where the above described induced landslide took place has been performed, using PLAXIS 2D software. Figure 10 shows the considered simplified geometry, taken from the available cartography and site information. The main material is limestone, with the inclusion of an impervious loam stratum, as obtained from the geological analyses previously described. At the toe of the slope, an interface clearly appears; it could be due to a pre-existing fault or to a fracture produced during the earthquake itself, previous to the landslide. The material on the right hand of this interface has been modelled as strong limestone, less deformable than the main material. The interface allows sliding of the materials at both sides of it, with a considered sliding coefficient of 0.2, because the fracture has a very smooth appearance, according to the research carried out.

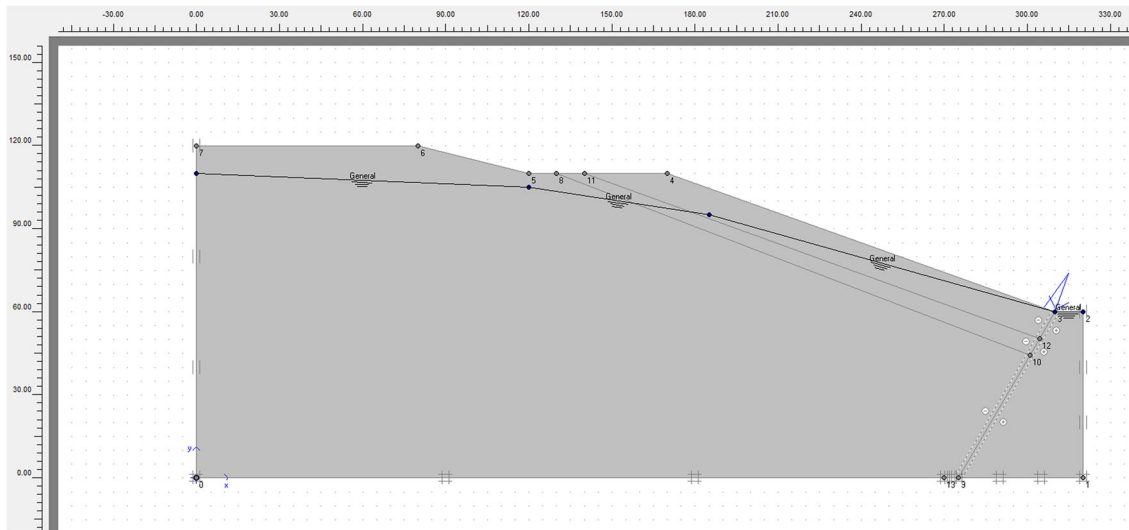
**Fig. 11** Estimation of the water table in the numerical simulations (10 m deep on the left boundary)

First of all, initial stresses under static conditions (only under vertical gravity loading) are calculated considering the water pressure caused by the water table, as previously described. The estimation of horizontal effective stresses has been performed with Jaky's formula, since, even if this is clearly not a horizontal layered soil configuration, it can be considered accurate enough for this estimation. As a conclusion of this first calculation, stability of this slope under static conditions was found.

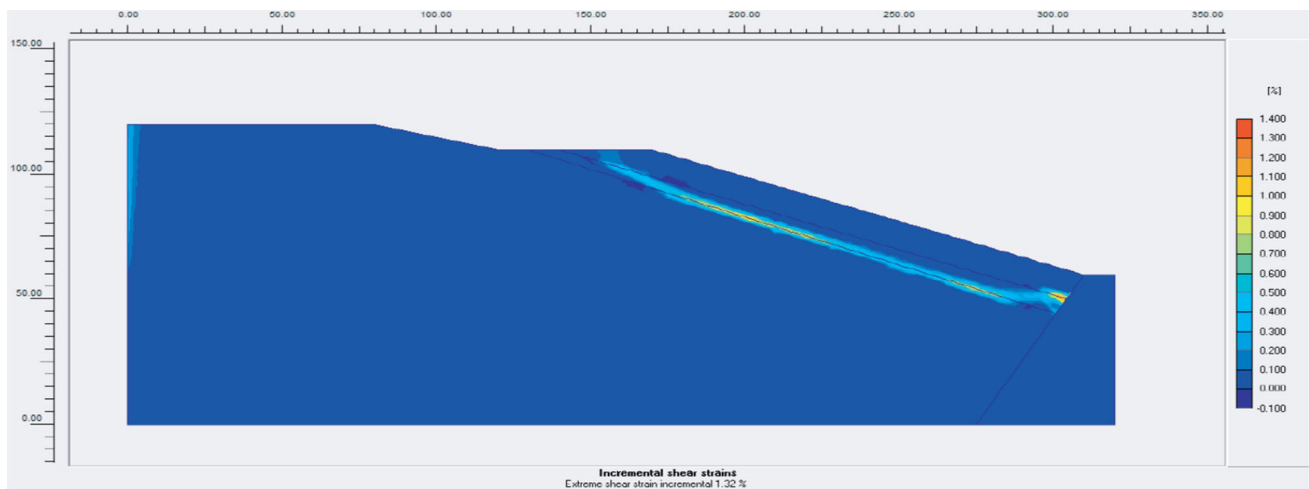
**Fig. 12** Sliding surface obtained with the numerical simulation, for a pseudo-static horizontal acceleration of 0.051 g, with the water table as estimated in Fig. 10

Under the above-mentioned conditions, the pseudo-static horizontal acceleration triggering the landslide is estimated as 0.051 g, which would represent a dynamic peak acceleration of 1.5 times this value, i.e.  $1.5 \times 0.051 \text{ g} = 0.076 \text{ g}$ . This value is not negligible at all, demonstrating a site seismicity level above the minimum threshold established by the current seismic regulations of application in Spain. The obtained failure surface is the one

depicted in Fig. 12, which fits very well the field observations.

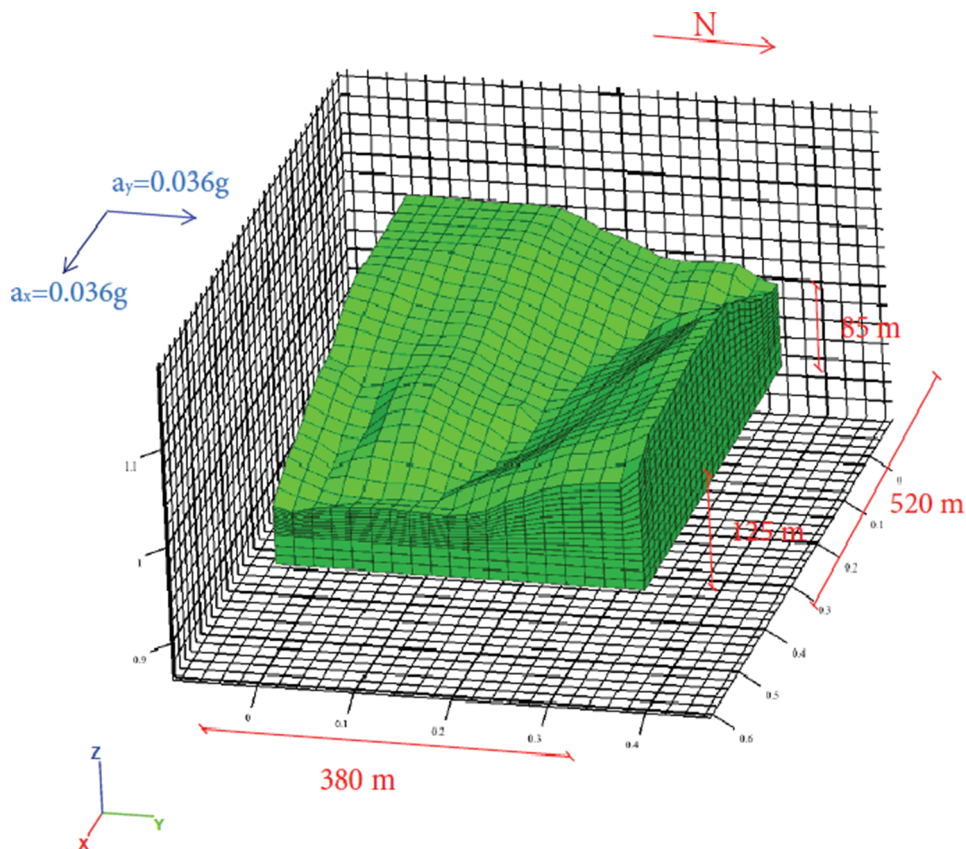
**Fig. 13** Initial geometrical model considered for the 3D simulation. The components of the *horizontal* acceleration are indicated

The 2D model provides a first estimate of the landslide and allows us to calculate an appropriate value for the seismic design load as it has been explained above. Moreover, since the current actual topography is known, it has also been possible to recreate the original topography before landslide and develop a 3D modelling using FLAC 3D. Figure 13 shows the 3D topography of the area before the landslide that was introduced in the calculation software. This finite differences approach was selected to check if the results found with these different methodologies are in agreement with the previous finite method simulation.
