Shear behavior of sliding zone soil of loess landslides via ring shear tests in the South Jingyang Plateau

Rongsen Zhu¹ · Wan-li Xie¹ · Qiqi Liu¹ · Hui Yang¹ · Qiyao Wang²

Received: 14 May 2021 / Accepted: 20 April 2022 / Published online: 23 May 2022
© The Author(s) 2022

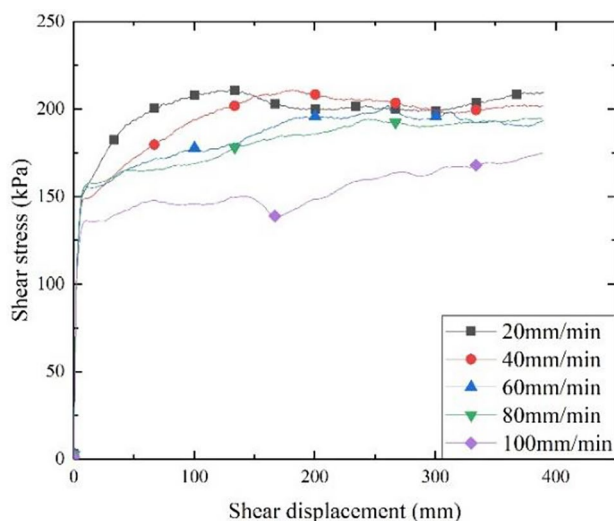
Fig. 6 Relationship between shear stress and shear displacement under different shear rates (saturated soil sample)

To examine the influence of shear rate on residual strength, the test results of the saturated water content and normal stress of 300 kPa were taken as an example, the relationship between shear stress and shear displacement under different shear rates (Fig. 6) was determined, and the curves of shear stress and normal stress under unloading (Fig. 7) were drawn. Figure 6 shows that the shear stress decreases with the increase in the shear rate. The displacement required to reach the residual strength increases with the increase in the shear rate, which indicates that it takes a long time for the soil particles to complete the directional arrangement under high-speed shear likely because the shear plane under low speed transforms into the shear band under high speed (Fig. 8). The shear mode is not fixed; the increase

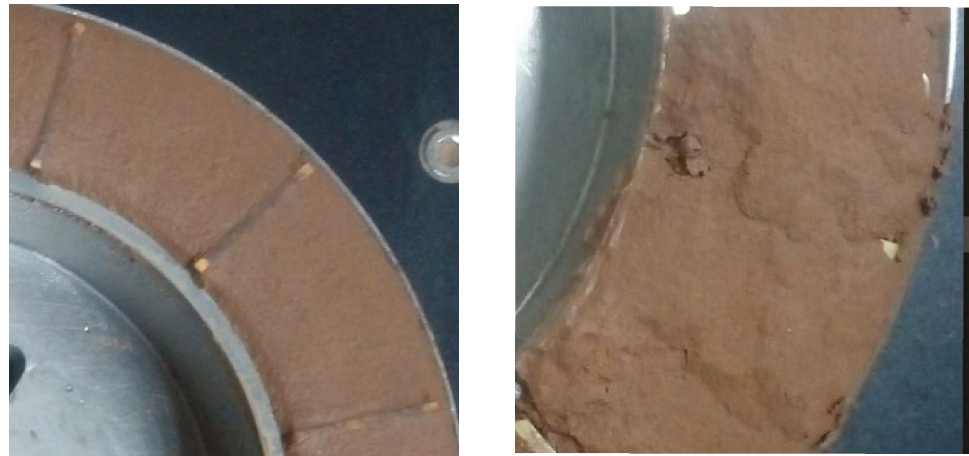
Fig. 8 (a) Smooth surface. (b) Non-smooth surface

(a) Smooth surface

(b) Non smooth surface

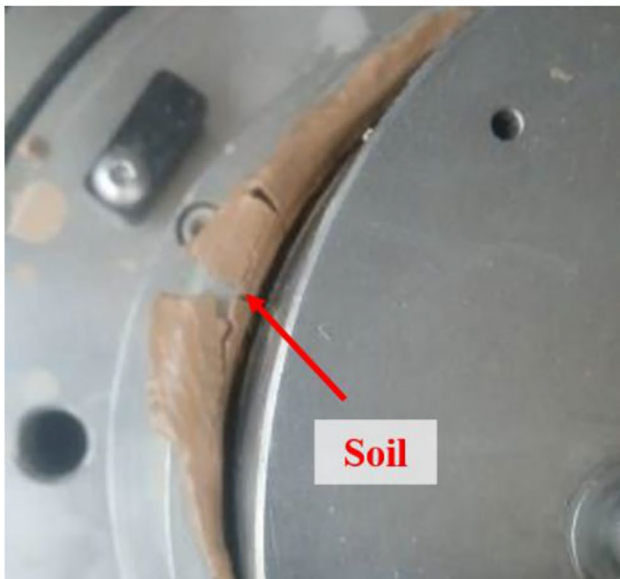
Fig. 10 Soil sample extruded from the shear box

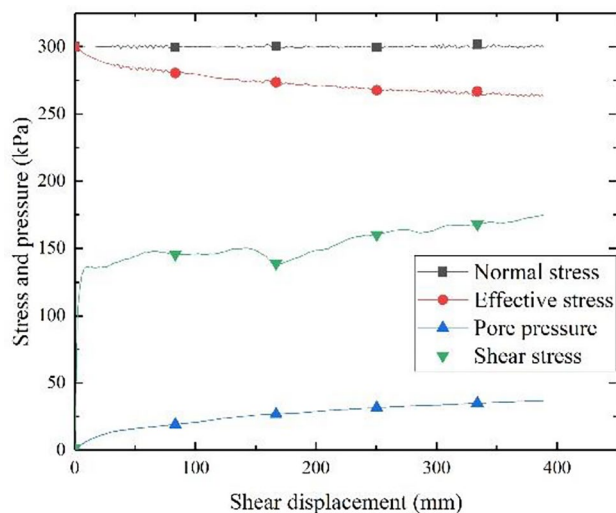
Fig. 11 Stress-shear displacement curve at the shear rate of 100 mm/min

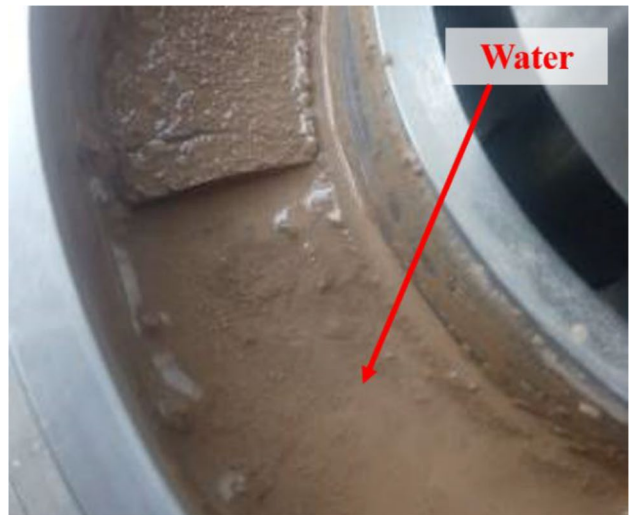
Fig. 12 Accumulation of water at the shear plane
